# **Deterioration of Iowa Highway Concrete Pavements: A Petrographic Study**

Paul E. Stutzman

December, 1999

Building and Fire Research Laboratory  
National Institute of Standards and Technology  
Gaithersburg, MD 20899

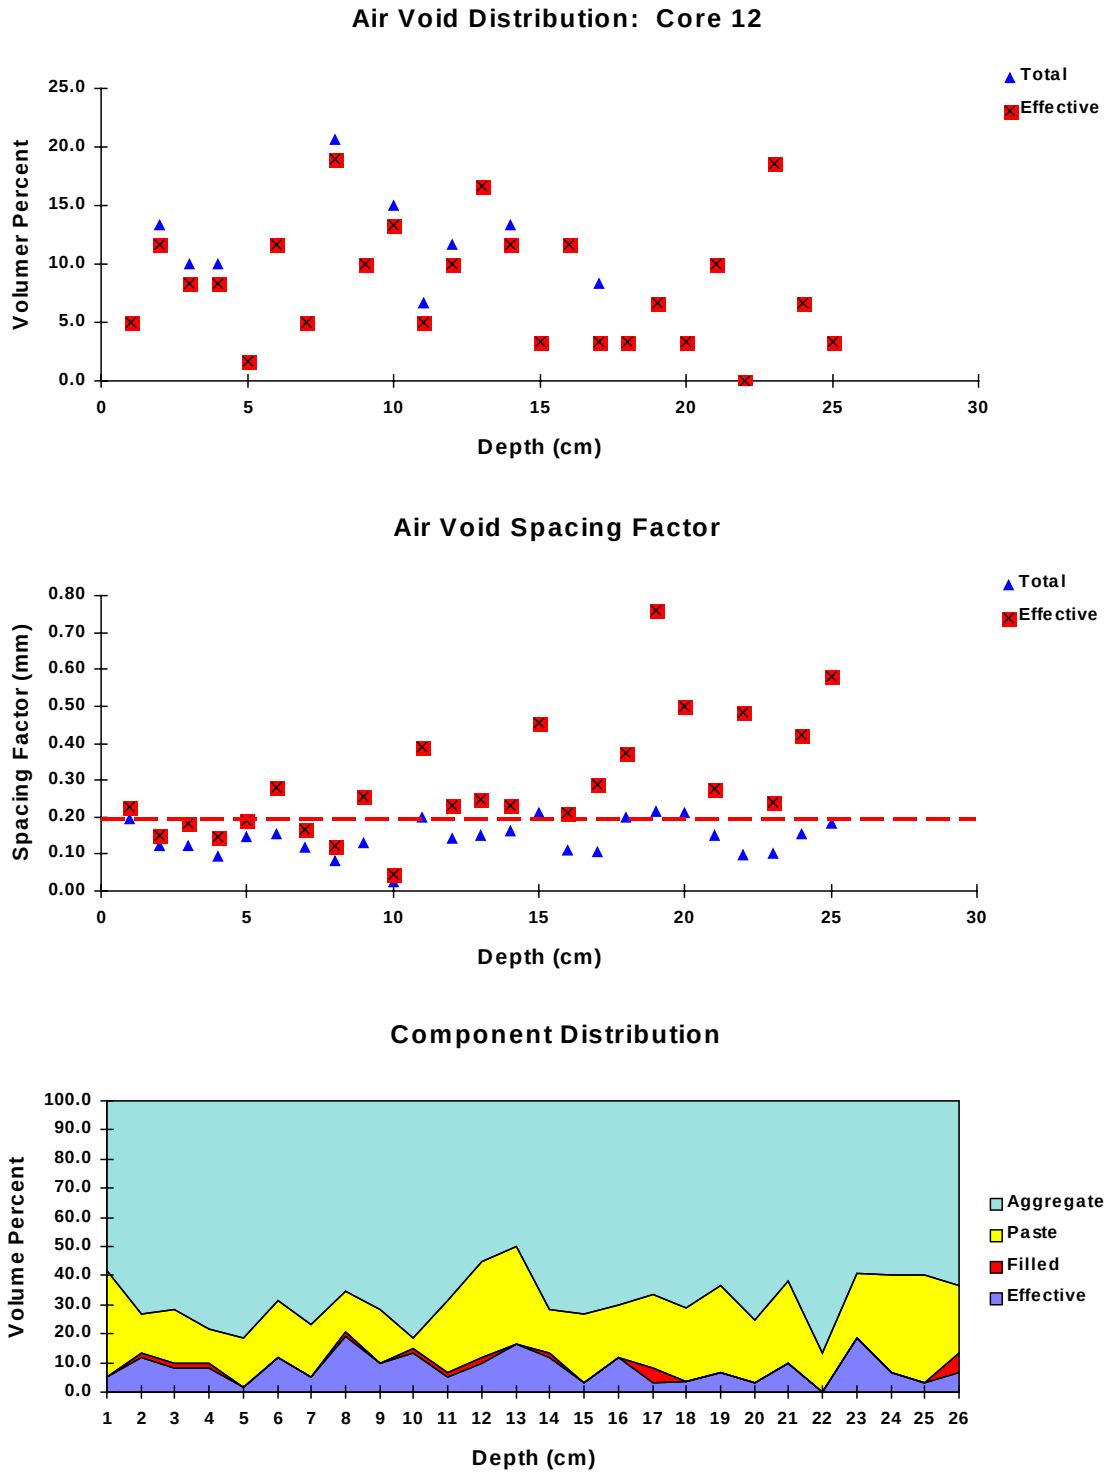
Figure 42. Core 12 air void volume and spacing parameters, and component distribution shows an increased degree of entrained air void filling with depth.

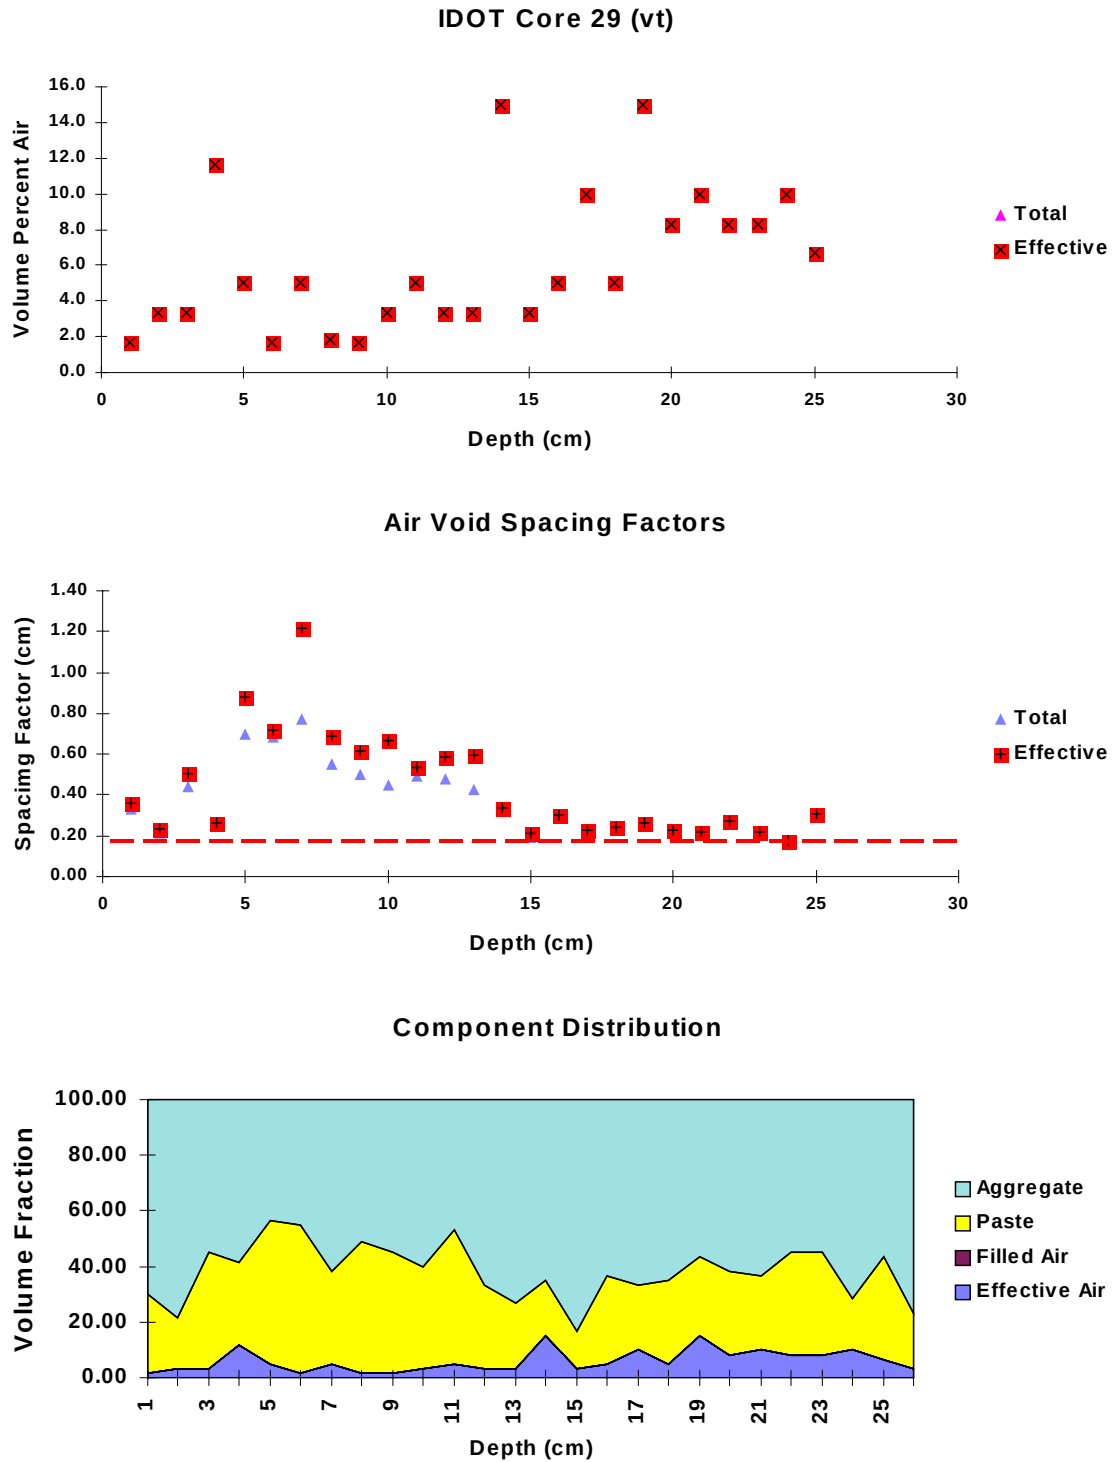
Core 29 contains a large surface crack about 0.5 mm wide running parallel to the long axis of the pavement (Figure 43). The crack appears to extend about 40 mm into the core. Other less prominent surface cracks trending vertically extend a few centimeters into the core through the mortar. The plots of air void parameters clearly illustrate the lower half of the core having greater entrained and entrapped air compared to the upper half (Figure 44). These plots also indicate that the spacing factors are substandard the entire depth of the core for both the original and effective air void system. Materials distribution appears fairly uniform with mortar-rich regions common throughout the core. The plot of materials distribution shows a slight increase in paste in the upper half of the core. Cracking observed using optical microscopy appears confined to the upper portions of the core and pass through both the mortar and coarse aggregate. Filling of the entrained air voids occurs in the upper portion of the core and was not seen in the top 4 cm. This may reflect the availability of water along the surface crack. The decrease in filling in the upper-most 4 cm may reflect the zone of drying. The lack of filling in the lower portion of the core may indicate a lack of a microcrack network at depth and / or lack of water at the slab base.

Figure 44. Core 29, centered on a well-defined vibration trail exhibits a significant increase in spacing factor in the upper half. This probably represents the zone of influence of the immersion vibrator probe. Note that the spacing factor is generally not satisfactory at any depth.
