**NISTIR 89-4061**

**AN ENGINEERING VIEW  
OF THE  
FIRE OF MAY 4, 1988  
IN THE  
FIRST INTERSTATE BANK  
BUILDING  
LOS ANGELES, CALIFORNIA**

**Harold E. Nelson**

**March 1989**

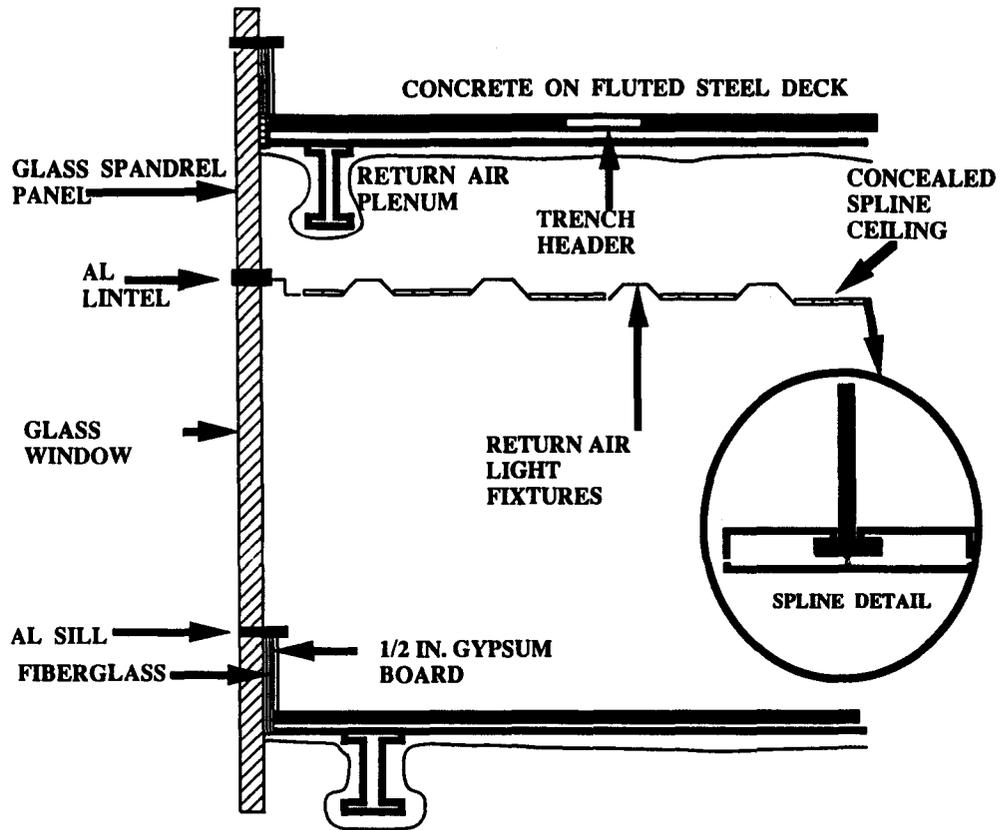
**FIGURE 1. SELECTED BUILDING ELEMENTS**

The building is a 62-story steel-frame tower. Figure 1 shows a number of the details in schematic elevation section. Structural members and floor decks are protected by direct-applied fire proofing.

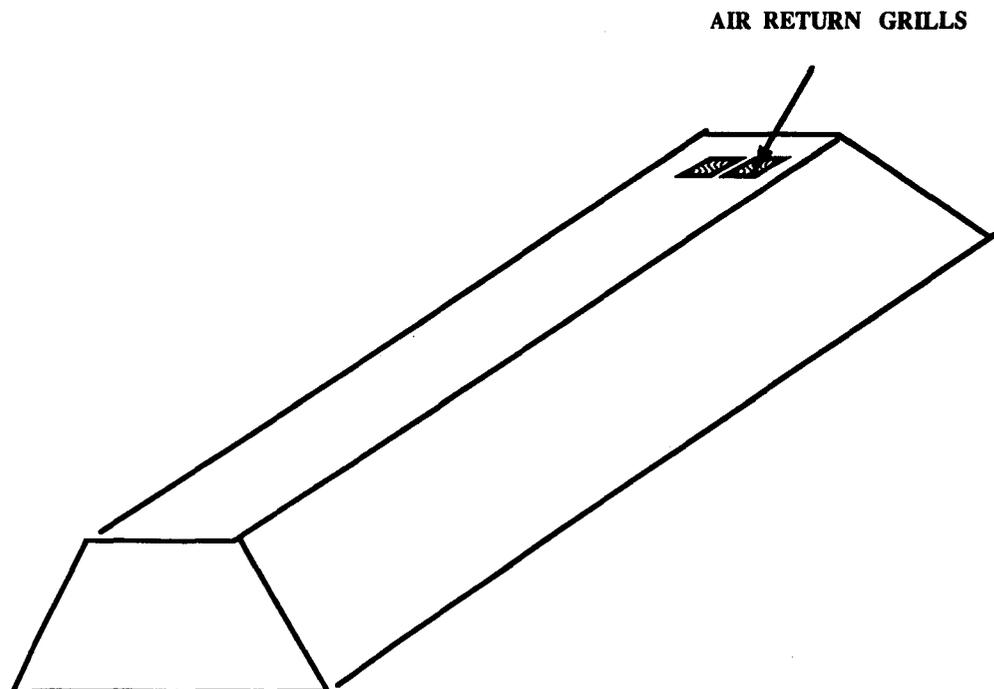
**FIGURE 2. RETURN AIR LIGHT FIXTURE**

Each floor has a suspended ceiling hung approximately four feet below the floor slab. The ceiling system is a concealed spline system with non-fire rated mineral tiles. Light fixtures (see figure 2) are interspersed at about five foot intervals in both directions in the ceiling.

The heating ventilating and air conditioning (HVAC) system supplies air at the perimeter and through every fifth light fixture. The other light fixtures are return air fixtures with two approximately 6-inch square return air grills in each fixture. The ceiling void is a return air plenum with air drawn to four return air shafts. There is one return air shaft in each corner of the central core. As shown in figure 3, the HVAC system is divided into four vertical zones. The floors involved (12-16) are in a zone that covers the 12th through 32nd floors. The plenums on all of these floors are common to the same return air shafts. Each opening from a plenum to a return air shaft is protected by a fusible link operated fire damper. The shafts are enclosed with fire rated gypsum board on both sides of steel studs.

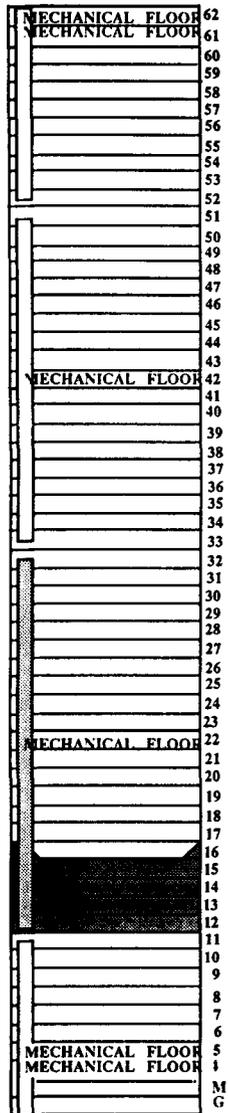
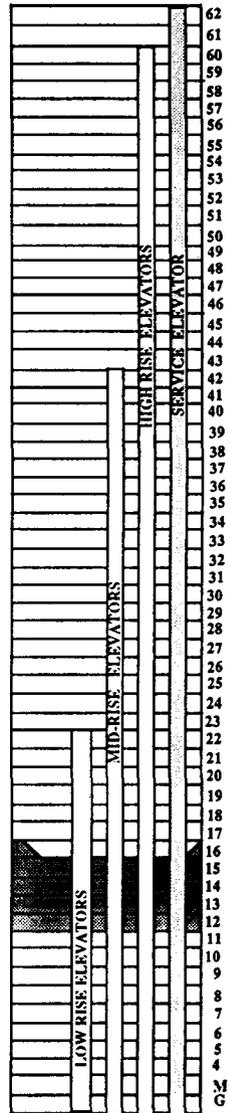
FIGURE 3. SHAFTS

There are multiple rises of elevator shafts (see figure 3.) The fire floors are served by the low rise elevators. The entrances to all of these elevators are located in an elevator lobby. On floors (including the 12th, but not the 13th, 14th, 15th or 16th floors) this lobby is separated from the office area by smoke detector operated fire doors. The mid- and high rise elevator shafts have no openings to the fire floors. In addition there are two elevator in a full building height portion of the high rise shaft that open on all floors. One (elevator 33 where the victim perished) opens to a separate freight elevator lobby.

Smoke from the plenum sweeps up through the return air shafts. During the next 2 minutes, smoke detectors respond for multiple zones on almost all of the floors between 12 and 32. These are the floors served by common return air shafts. (See figure 3.)

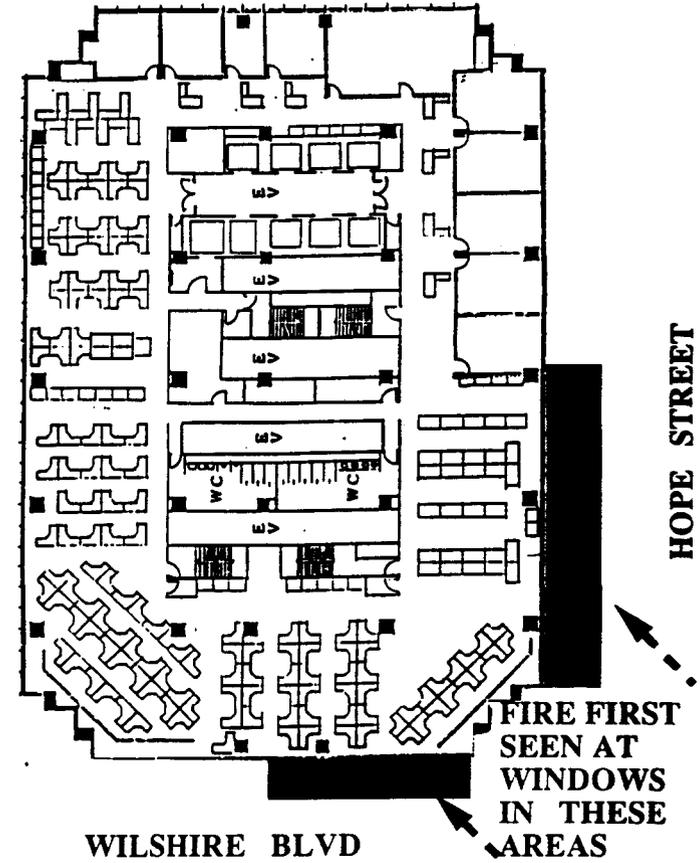
FIGURE 4. LAYOUT OF 12TH FLOOR

Figure 4 shows the layout of the 12th floor at the time of the fire. Most of the 12th floor was an open office landscaped "trading floor." The individual workstations were equipped with personal computers, monitors, and other electronic equipment. Extensive power and signalling wiring systems were involved. There was a small series of perimeter offices along the north end of the building and the north half of the east side of the 12th floor.

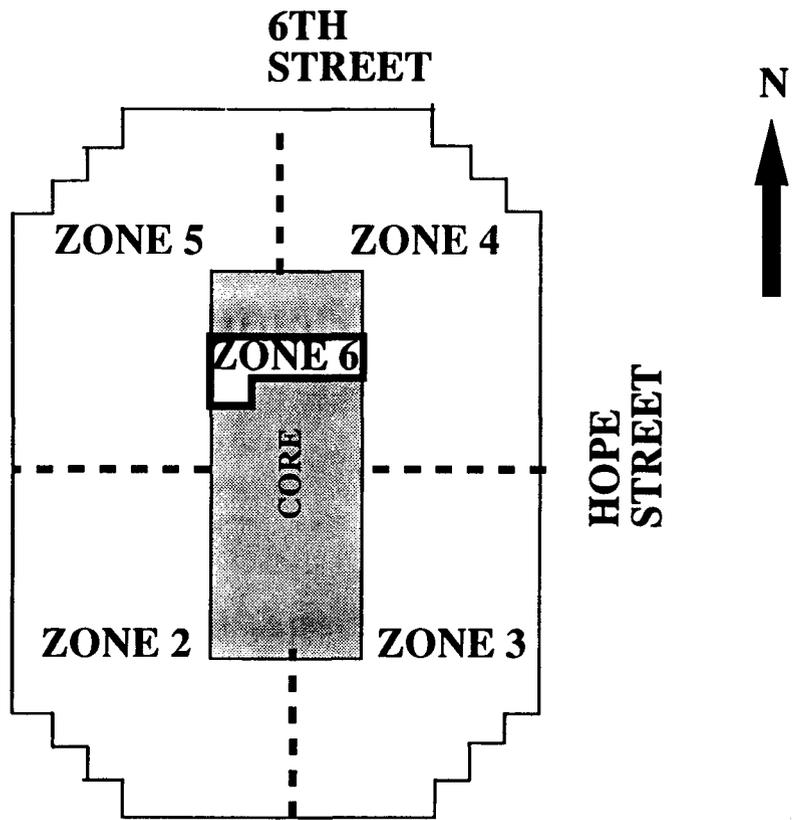
**FIGURE 5. FIRE ALARM SYSTEM ZONES**

The response of the smoke detectors was a principal source of data in recreating the fire. Each office floor has five smoke detector zones numbered zones 2 through 6. The layout is shown in figure 5. Zone 3 covers the area where the fire originated. Zone 6 is a special zone covering both the main elevator lobby and the small lobby in front of the freight elevator. There are smoke detectors located in the plenum space above the ceiling in zones 2-5. The smoke detectors in zone 6 are under the ceiling in the elevator lobbies and the freight elevator vestibule. In zone 3, there is one additional smoke detector located beneath the ceiling at the entrance door to the exit stair. That exit stair has a pressurized vestibule. In addition to the detectors described above, there were detectors connected to magnetic-hold opens for doors at each end of the 12th floor elevator lobby. These detectors, however, were reported as not connected to the fire alarm system.

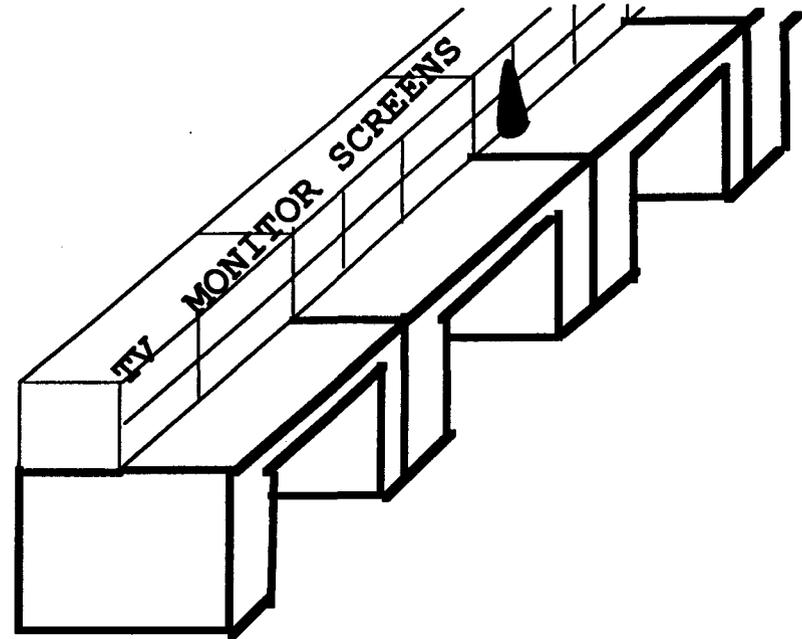
**FIGURE 6. INITIAL FIRE ON A WORKSTATION**

The fire trace discussed above indicates an open flaming fire of 10-20 kW approximately 3 minutes prior the 10:30 pm operation of the first smoke detector. The flame probably had a base about 6 inches in diameter and a height of about 18 inches. This is the start of analysis in this presentation. While figure 6 depicts the flame on top of the workstation it might actually have been on top of the workstation, under it, or between workstations.

**12TH FLOOR ABOUT 10:25 - 10:27 A SMALL FLAME (<20KW) EXISTS INVOLVING SOME PART OF A WORKSTATION**

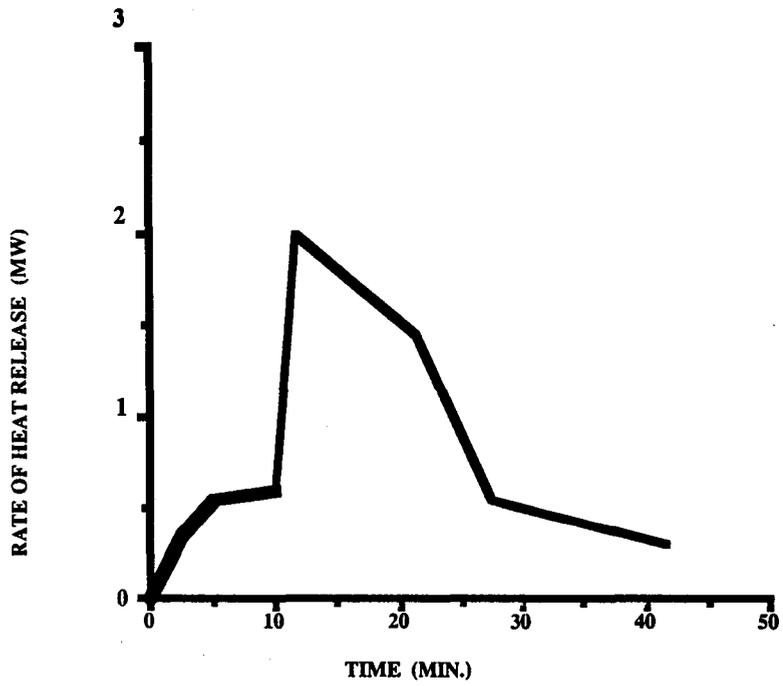
**FIGURE 7. RATE OF HEAT RELEASE, TYPICAL COMPUTER WORKSTATION**

The burning of the initial workstation is believed to have approximated that produced in a test of a computer workstation complex previously tested in the furniture calorimeter at the Center for Fire Research [6]. The rate of heat release curve used is shown in figure 7.

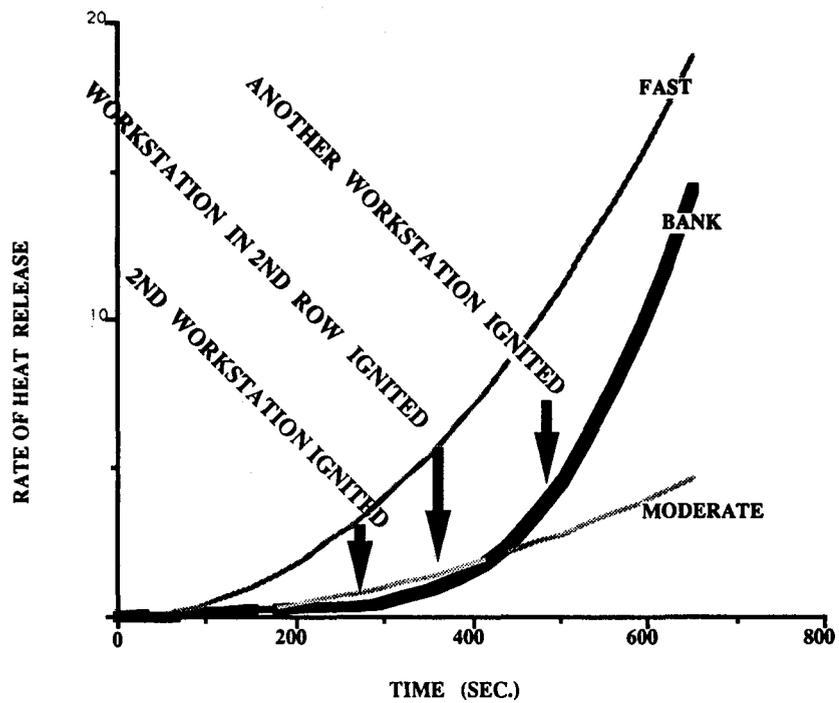
**FIGURE 8. ESTIMATED FREE-BURN RATE OF HEAT RELEASE OF GROUPS OF WORKSTATIONS AS FOUND ON TRADING (12TH) FLOOR**

Consequently, the growth rate assigned in analyzing subsequently ignited workstations was that used for a "fast fire" as described in NFPA 72E. The resultant free-burn fire growth curve, derived from calculating this spread as a series of individual radiant ignitions of workstations, is shown in figure 8. This curve is compared to both the fast and moderate fire growth curves of NFPA 72E.

The calculated burning rate starts out at a growth rate somewhat slower than that for the moderate curve but increases after several workstations are involved to a rate greater than the fast curve. Only the first 11 minutes of fire development is shown. As the fire approached that time the onset of flashover conditions and resulting fire environment rather than free-burn characteristics controlled the burning rate.

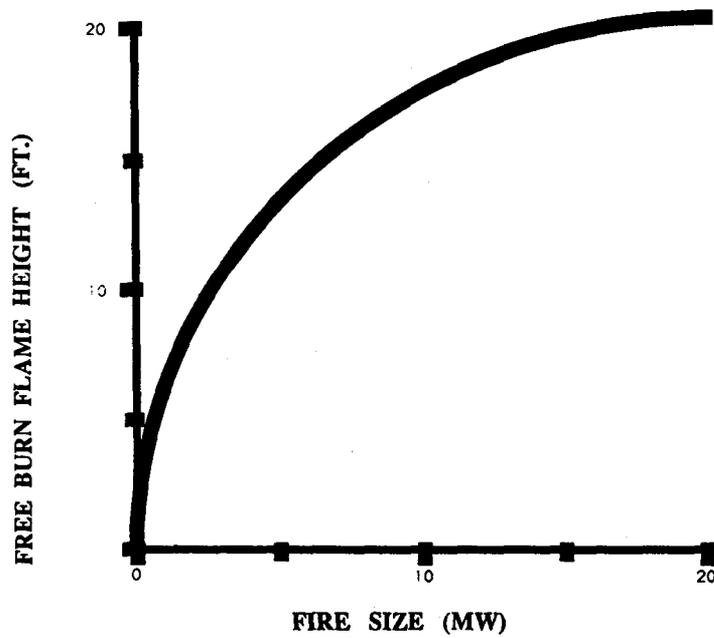
**FIGURE 9. APPROXIMATE FREE BURN FLAME HEIGHT**

As the fire grew, the fire base increased and the rate of heat release from the fire increased. Flame height is a function of rate of heat release and area of fire base. The theoretical free burn flame height from the fuel array presented by the rows of workstations peaked at about 18-20 ft. See figure 9. Since the ceiling was only 6-9 ft. above the fire (depending on whether the

fire was on the floor or the top of the workstation), the flame touched the ceiling when the rate of heat release was between 1/2 and 1 MW, (i.e. 5 1/2 to 6 1/2 minutes into the fire.) After the flame reached the ceiling, it extended along the ceiling spreading radially a distance about equivalent to that portion of the theoretical flame height cut off by the ceiling.

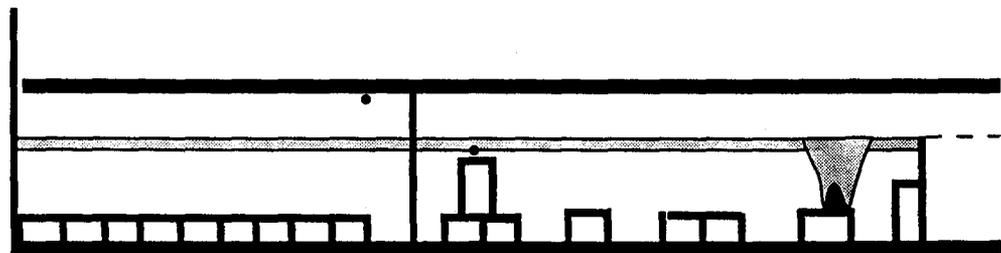
**FIGURE 10. CONDITIONS AT 10:30 P.M.**

The analysis of smoke conditions includes the temperature, thickness of the upper layer, and the oxygen content in that layer. Until flashover (10:37 p.m.) these values were calculated using the ASET model [1]. By 10:30 p.m., the fire has grown to 250 kW. There is a ceiling jet starting to fill the ceiling area. The depth of this ceiling jet is less than 1 ft. The smoke temperature is estimated at 150°F.

The time of response of each smoke detector zone is recorded by the fire alarm system. The times used are from the building fire alarm system records. At 10:30 p.m., the first detector response occurs in zone 3. The location of smoke detectors in zone 3 is indicated by the black dots over the exit door and in the ceiling space in figure 10. It is believed that this response is from the detector located in front of the exit stairway. Calculations using DETACT-QS [1] indicate that this response is appropriate for a detector located about 40 ft. (plus or minus 10 ft.) away and 6 ft. over the fire source. Once this detector operated, there is no more additional discernable data from zone 3. It is therefore impossible to determine when the detector in the plenum in zone 3 responds.

By 10:30 p.m. (depending on the relationship of the sprinkler head location relative to the point of fire origin) one or more sprinkler heads have fused. Sprinkler head response calculations (again using DETACT-QS) place the size of fire at time of fusing of the first head at 40 to 250 kW. In tests at CFR, fire control of test cribs allowed to burn until a burning rate of 250 kW was achieved were controlled by application rates as low as 0.1 gpm/ft.<sup>2</sup>.

**12 TH FLOOR - 10:30 PM - 250 KW FIRE - CEILING  
 JET <1FT. DEEP  
 SMOKE TEMPERATURE 150 F - DETECTOR RESPONDS IN  
 ZONE 3 - ONE OR MORE SPRINKLER HEADS FUSED**

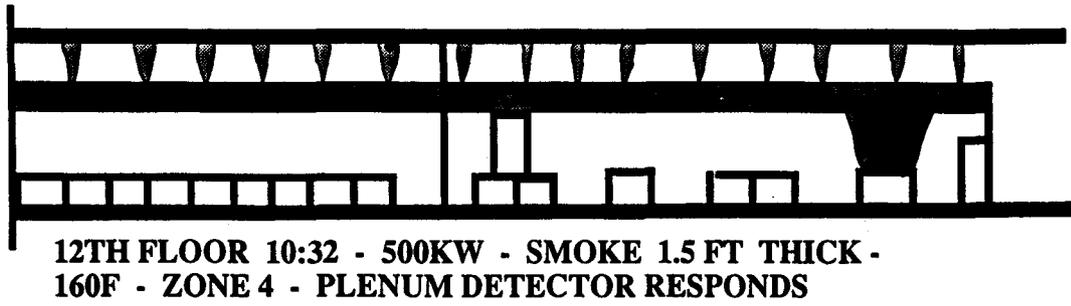
FIGURE 11. CONDITIONS AT 10:32 P.M.

The assumption of equal smoke conditions throughout the floor is, of course, incorrect. Temperature, if not depth of smoke is less at positions more distant from the fire source. Lower temperatures at locations more remote from the fire source reduce the rate of flow into the ceiling in those areas. As a first order assumption, it can be concluded that the zone that came in second (zone 4) was closer to the fire. Lacking any other information, this is a reasonable speculation. However, since zone 2 responds during the following minute, this speculation must be treated with caution.

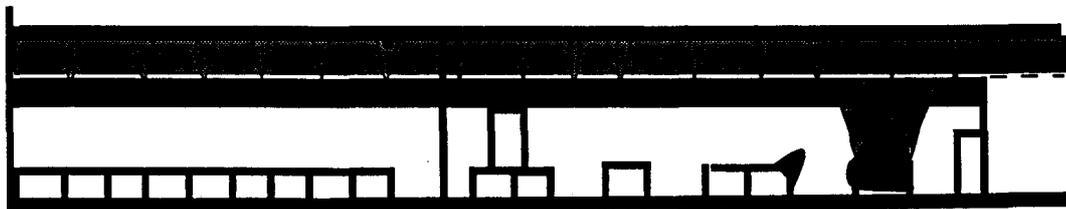
**FIGURE 14. CONDITIONS AT 10:33 P.M.**

**12TH FLOOR 10:33 - 1000KW - SMOKE <2 FT THICK - 200F - ZONE 2 - PLENUM DETECTOR RESPONDS**

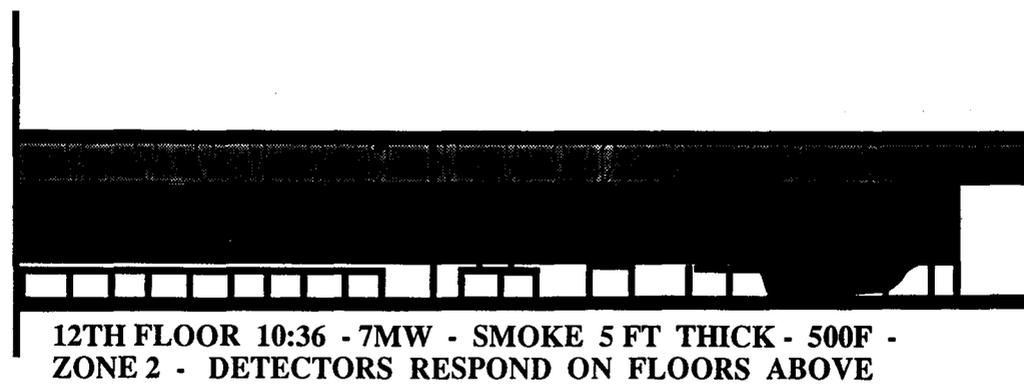
FIGURE 16. CONDITIONS AT 10:36 P.M.

Smoke of this temperature (1100 F) emits heat radiation capable of igniting most common combustible materials. Such a sudden ignition results in the phenomenon often called flashover. If sufficient air for combustion of all of the newly release fuel vapors is unavailable, all or a portion of the fuel vapors produced from the radiant heating may not all burn. Hence, whether or not the full involvement of a large space in flame usually associated with flashover is actually achieved depends on whether the windows break prior to or subsequent to the development of flashover triggering conditions (i.e. smoke temperature of 1100 F.) In this fire, neither the evidence nor physics provides a basis for an assumption on whether window breakage or flashover conditions occurred first. (See the later discussion of glass breakage.)

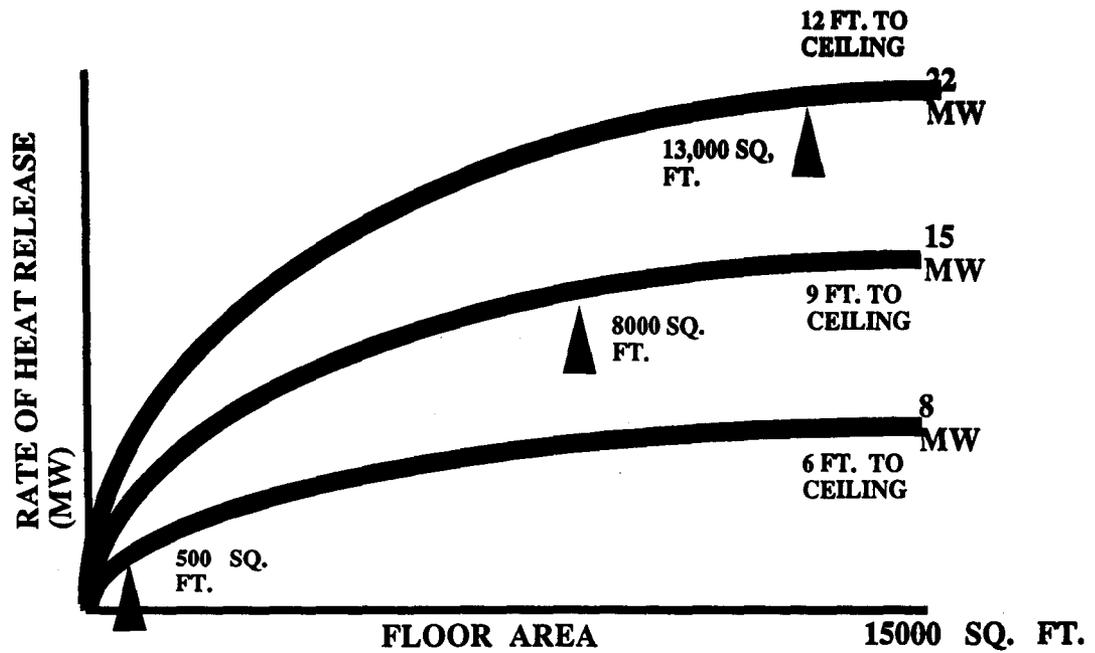
**FIGURE 18. MAXIMUM FIRE SIZE IN A CLOSED SPACE AS A FUNCTION OF FLOOR AREA AND DISTANCE FROM FIRE TO CEILING**

In a fast developing fire, key parameters include the area of the floor and the height between the base of the fire and the ceiling. The closer the base of the fire to the ceiling, the more likely that the fire will develop ceiling temperatures capable of causing flashover (thereby causing window breakage, resulting in a continuous air supply) before the smoke layer both reduces its oxygen level below that capable of supporting combustion and descends low enough to starve the fire. Where the base of the fire is further from the ceiling, the cooling effect of the entrained air slows down the development of ceiling temperatures. In such case a much larger floor area is necessary to provide a sufficient air reservoir to produce flashover temperatures in a closed space. The differences are shown in figure 18.

Further study to better relate these factors as well as fire growth rates and maximum fire size to flashover in closed space would be valuable. However, these calculations demonstrate a potential associated with open office arrangements with concentrated grouping of combustible work areas. Where such concentrations occur in spaces involving large floor areas and relatively low ceilings, there can be sufficient combustion air within the space to allow a developing fire to reach flashover conditions. This even if no additional air is introduced into the space.

▲ DIVIDING POINT -- AT FLOOR AREAS LESS THAN THIS THE FIRE CONSUMES ENOUGH OXYGEN TO LIMIT FIRE DEVELOPMENT TO SMOKE TEMPERATURES LESS THAN 1112 F (600 C) - ABOVE THIS POINT THERE IS SUFFICIENT AIR ON THE FLOOR FOR THE FIRE TO CONTINUE TO HIGHER TEMPERATURES.

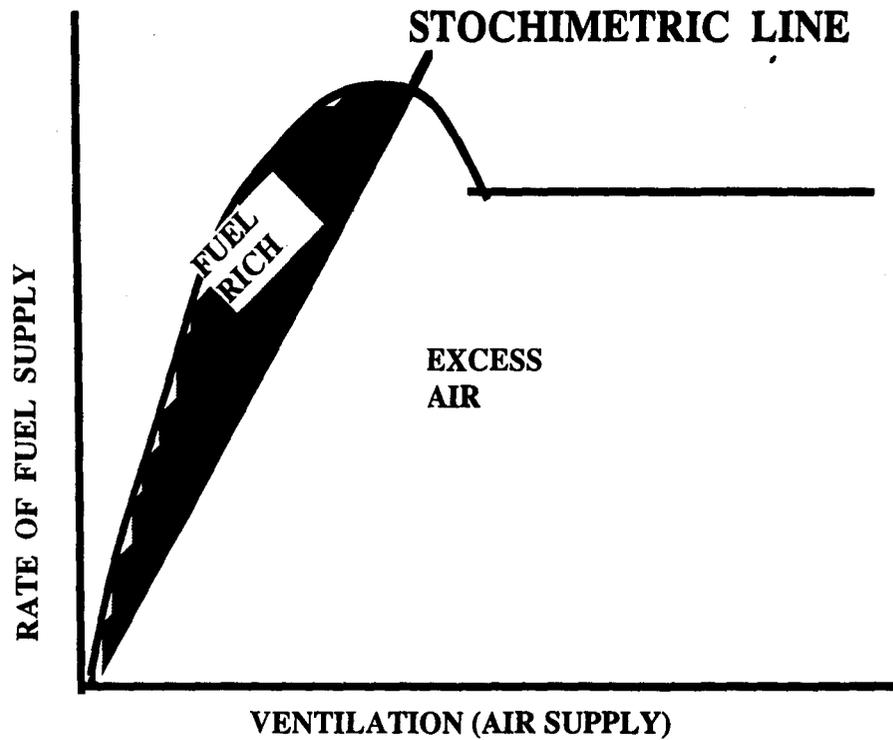
FIGURE 21. COMPARTMENT BURNING RATE THEORY

Figure 21 depicts the possible burning states of a fire in a compartment for a fixed amount of involved combustibles (i.e. fuel load.) The ventilation air supply represents the possible variation in window or door vents (or other features) that can be the source of air supply for the fire. For low ventilation the fuel produced can exceed the stoichiometric value. This depends on the degree of heat transfer from the fire and the compartment environment and the nature of the combustibles. As ventilation increases (e.g. windows break,) the same combustible fuel load can achieve different rate of fuel gas generation. Ultimately, in every vented compartment fire, this reaches a state in which excess air prevails. This fire undoubtedly experienced all aspects of this fire behavior. Before the windows broke and the initial oxygen was consumed, the fire on the 12th floor was to the left of the stoichiometric line as shown on figure 21. As the windows broke the fire state moved to the right of that line.

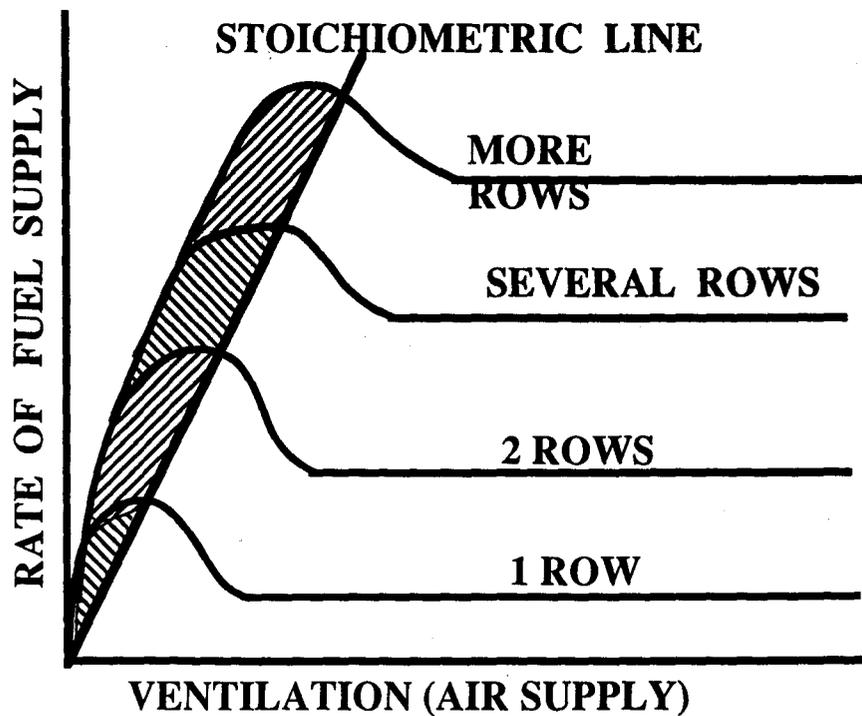
FIGURE 22. COMPARTMENT BURNING RATE THEORY APPLIED TO EARLY STAGES OF THIS FIRE

Figure 22 depicts a growing condition such as occurred in the bank building. As more and more fuel enters the picture, the required ventilation to move from fuel rich to air rich increases. It is believed that a condition stepping through these ranges probably occurred as the fire propagated around the 12th floor. Unfortunately, the lack of photographs or eye witness descriptions during the that period prevents confirmation.
