**NIST NCSTAR 2**

# **Draft Report of the Technical Investigation of The Station Nightclub Fire**

March 2005

A fire occurred on the night of Feb. 20, 2003, in The Station nightclub at 211 Cowesett Avenue, West Warwick, Rhode Island. A band that was on the platform that night, during its performance, used pyrotechnics that ignited polyurethane foam insulation lining the walls and ceiling of the platform. The fire spread quickly along the ceiling area over the dance floor. Smoke was visible in the exit doorways in a little more than one minute, and flames were observed breaking through a portion of the roof in less than five minutes. Egress from the nightclub, which was not equipped with sprinklers, was hampered by crowding at the main entrance to the building. One hundred people lost their lives in the fire. On Feb. 27, 2003, under the authority of the National Construction Safety Team (NCST) Act, the National Institute of Standards and Technology (NIST) established a National Construction Safety Team to determine the likely technical cause or causes of the building failure that led to the high number of casualties in that fire. This report documents the procedures, findings, and

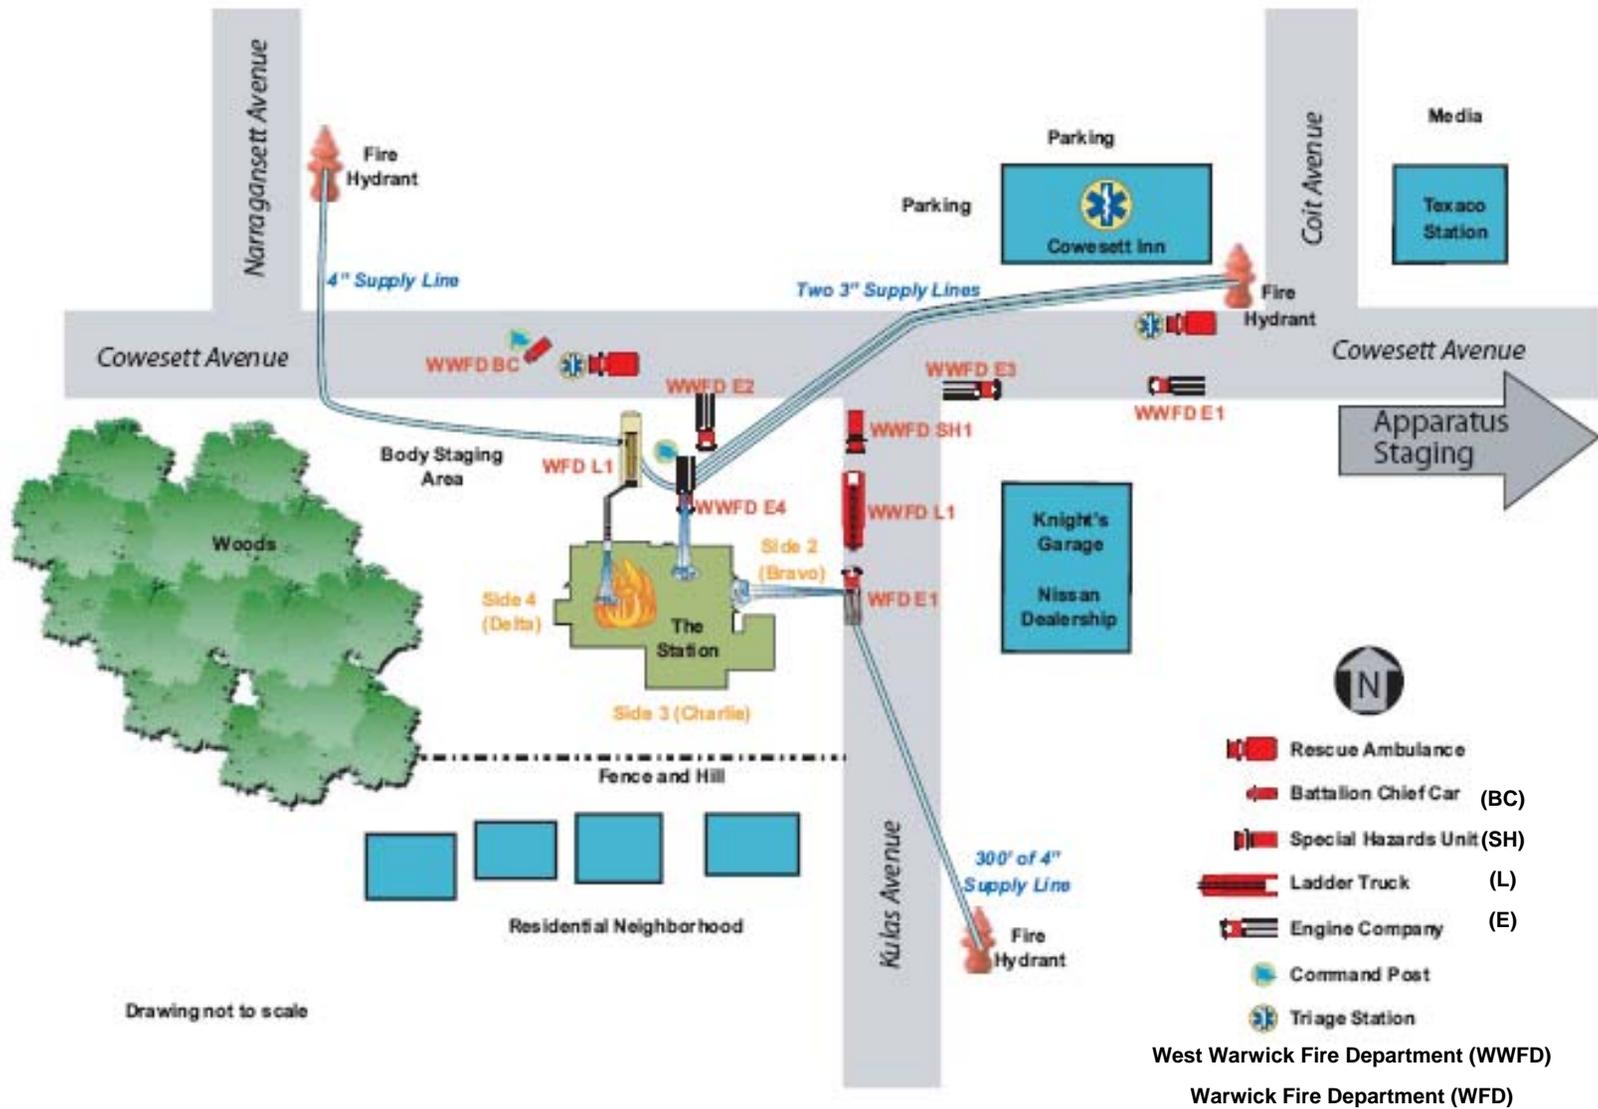
Figure 3-1 shows the layout of the fire ground during the fire attack and suppression activities. The initial attack was mounted by WWFD's first unit, Engine 4, approximately 6 ½ minutes into the fire with the advance of a 1 ¾" line to the main entrance of the structure and the primary victim cache, and continued until the unit's on board water supply was exhausted. While the two, 3" supply lines to the front of the structure were being laid and charged, rescue efforts continued along the building's north face, through both the broken windows and exits. However, these efforts were pursued without the benefit of protective hose lines and were substantially hampered by the rapid fire propagation, radiant heat and heavy volumes of smoke discharge from the structure.

Figure 3-1. Schematic of primary apparatus deployment

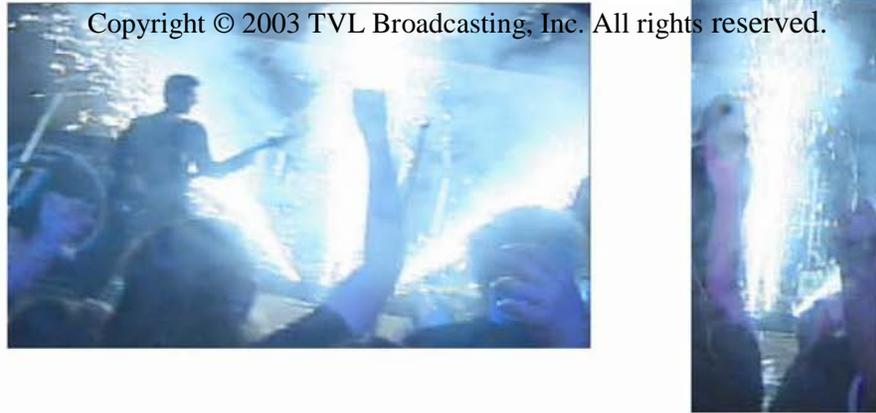
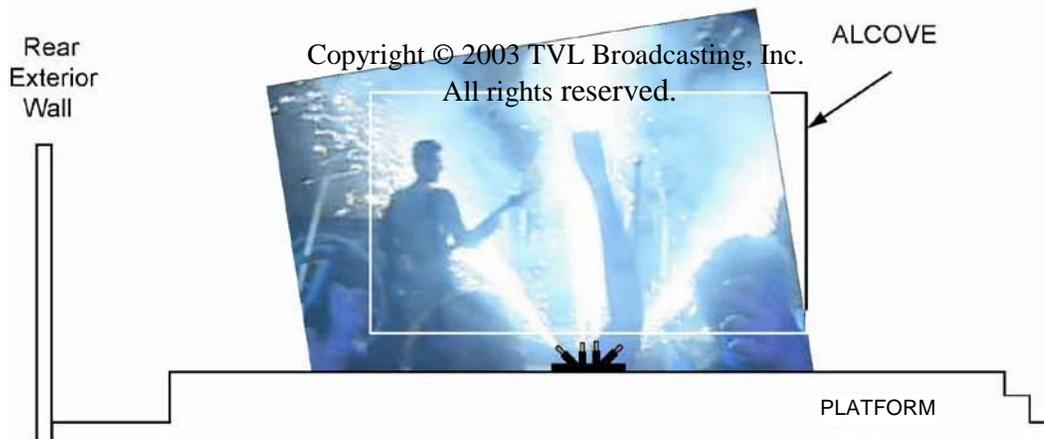
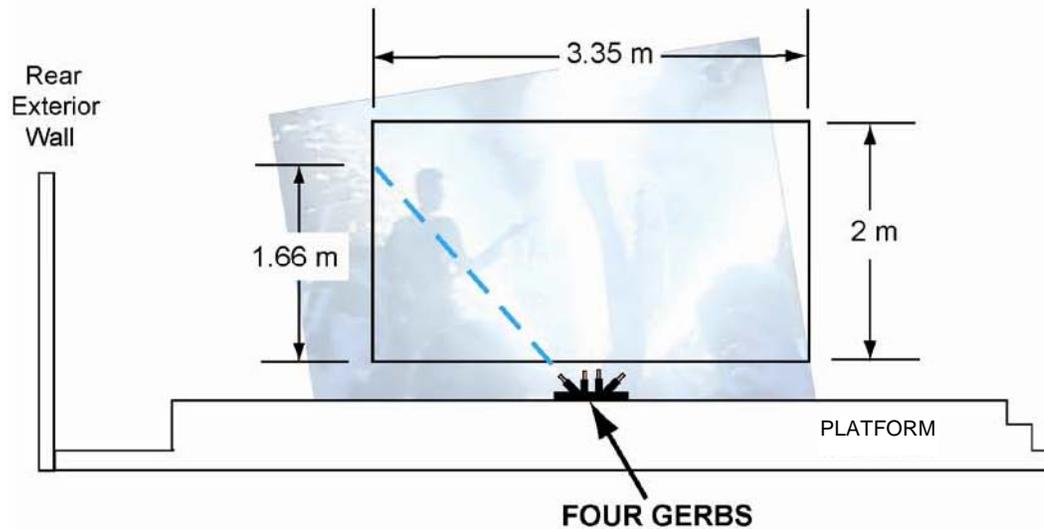
A series of full scale experiments was conducted to document the thermal characteristics of a discharging pyrotechnic device like those that were ignited in the nightclub on Feb. 20, 2003. At the beginning of the show, four separate pyrotechnic devices, or gerbs, were discharged on the platform in front of the alcove. Two gerbs, which had been positioned on the floor of the platform, discharged vertically along the centerline of the alcove opening (Figure 4-10). Two additional pyrotechnic gerbs, which were located near the other two gerbs on the platform floor, sprayed white "sparklers" at a 45 degree angle to both the left and right sides of the alcove. The WPRI-TV video of the nightclub interior showed that glowing particles or "sparklers" ignited the foam on both sides of the alcove in approximately 10 seconds.

**Figure 4-10. Pyrotechnics (15 x 15 gerbs) positioned on nightclub platform. Video image copyright © 2003 TVL Broadcasting, Inc. All rights reserved.**

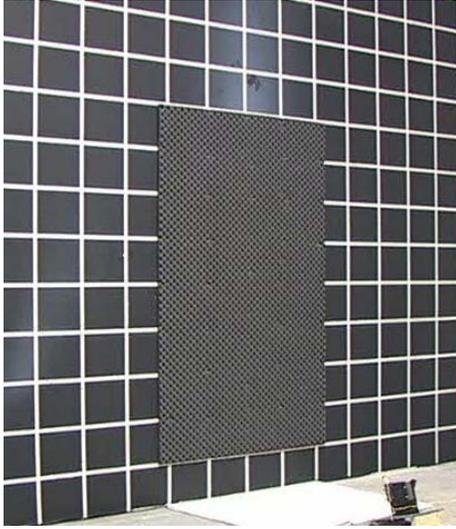
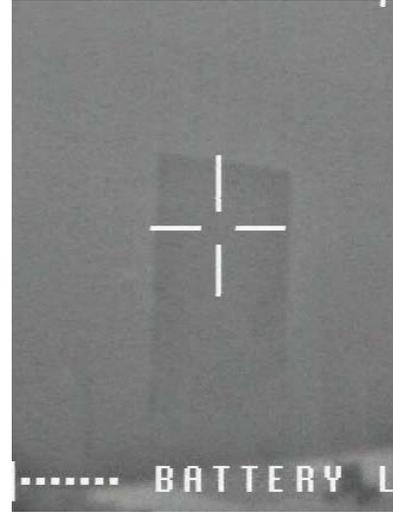
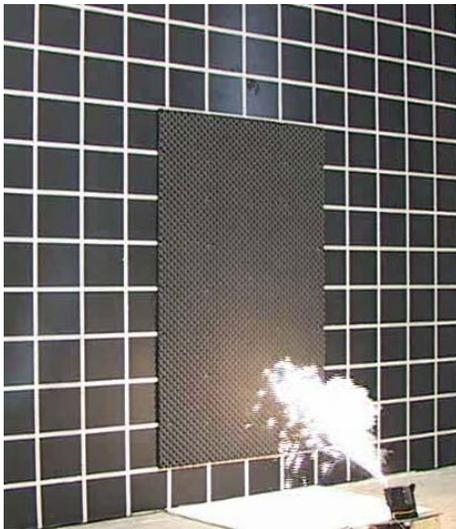
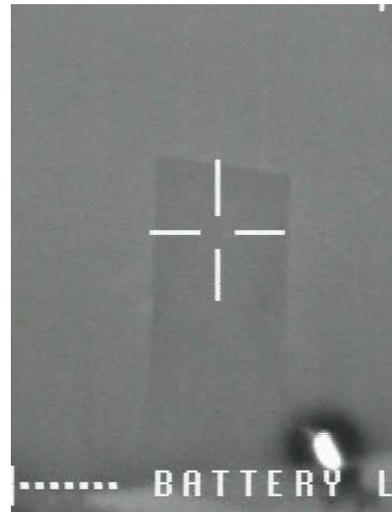
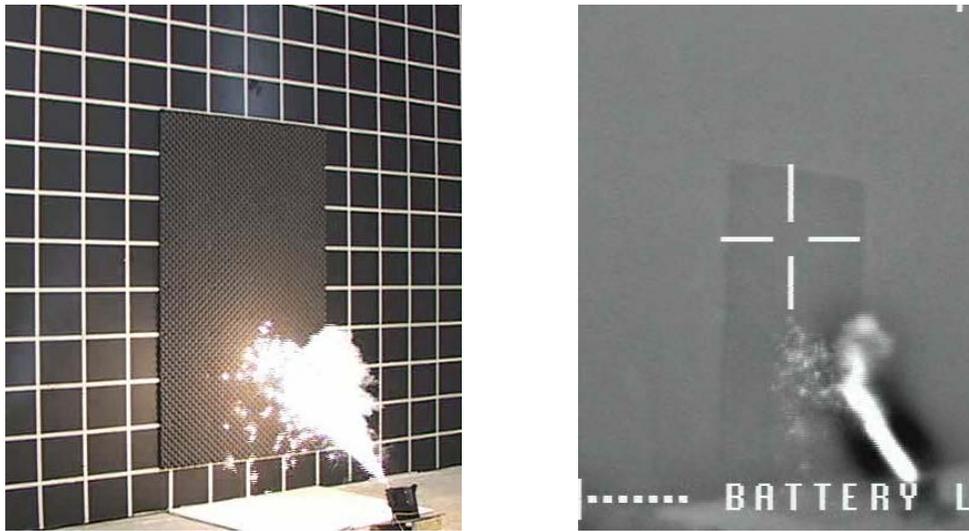
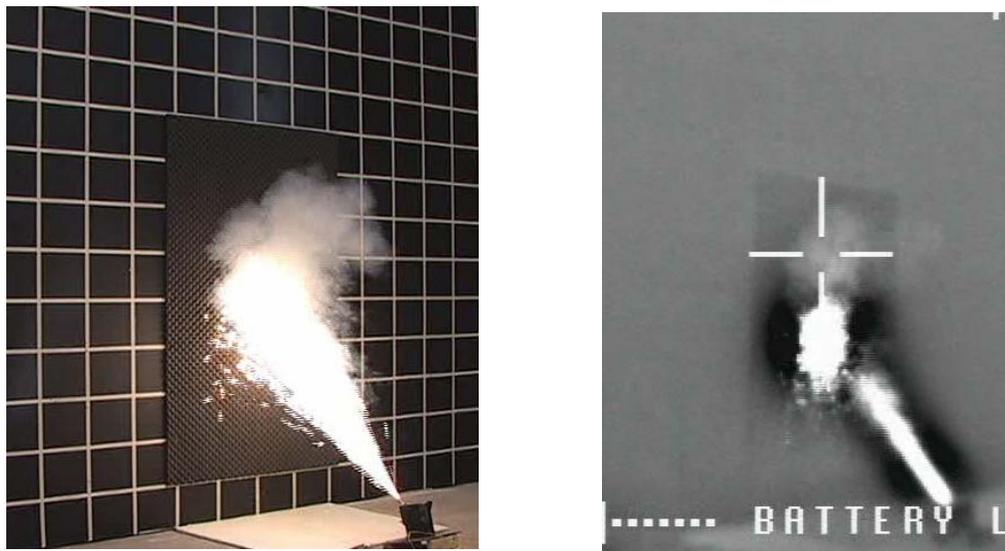
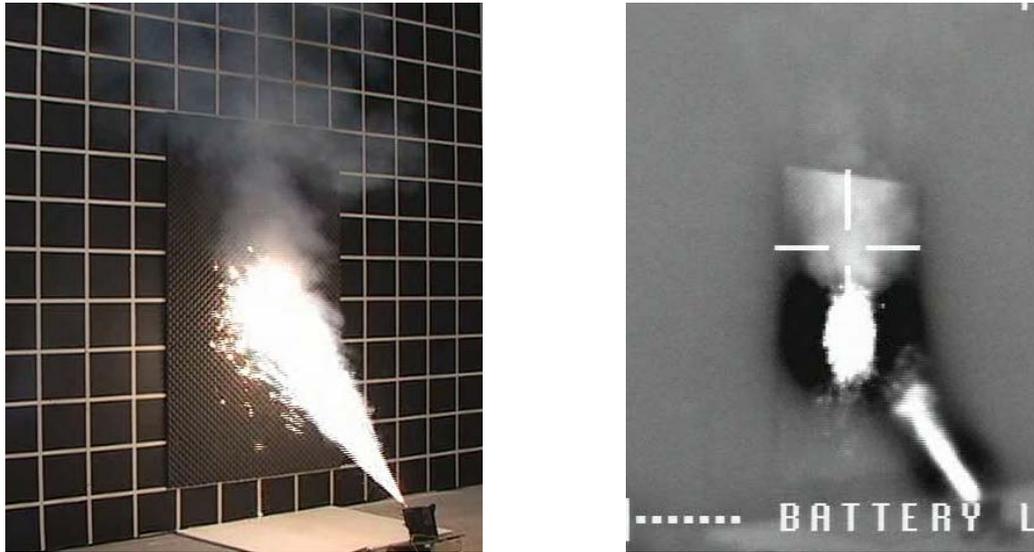
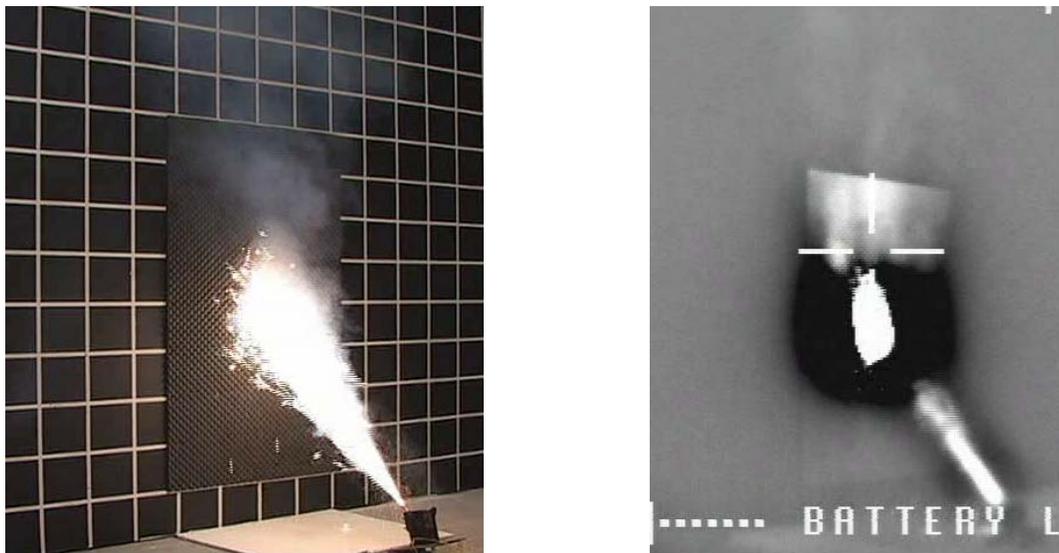
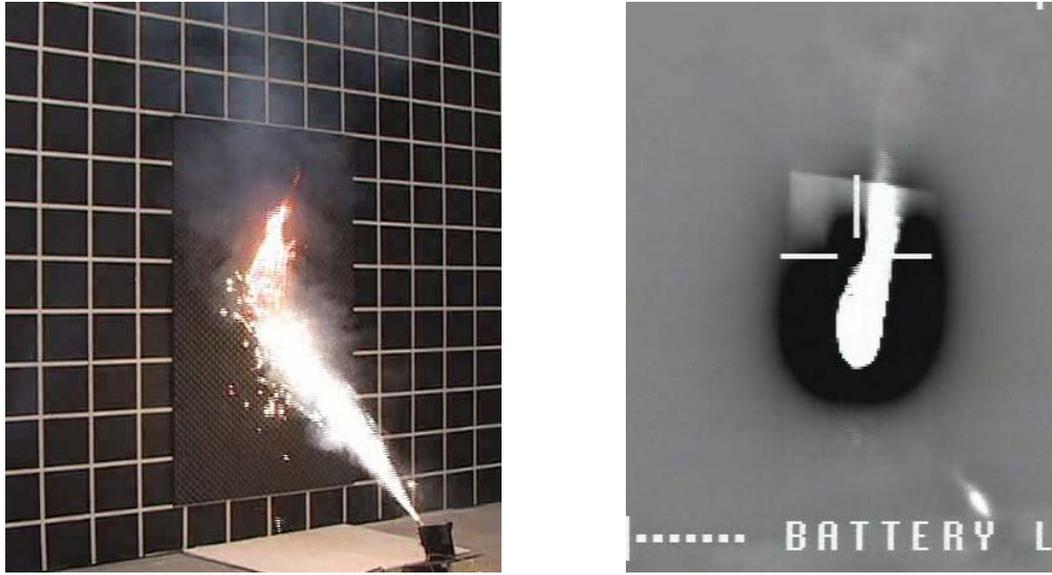
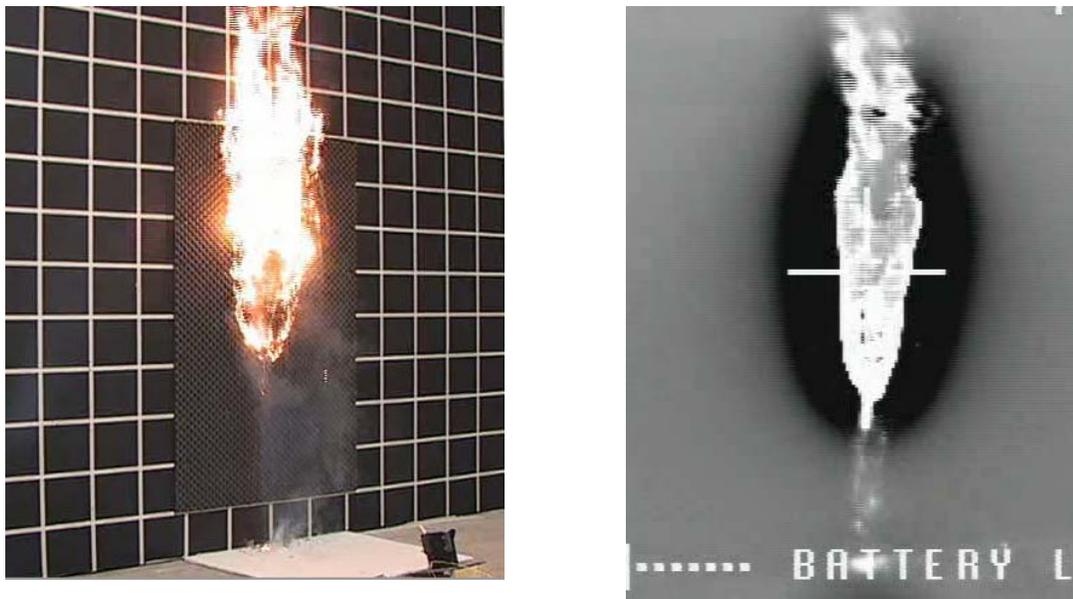
The width of the alcove in the nightclub was 3.0 m (10 ft) and the end of each gerbs was offset from the center of the opening by about one foot. The NIST tests demonstrated that a 15 x 15 gerb which was angled at 45 degrees and discharged against (and in a plane perpendicular to) a wall from a distance of 1.22 m (4 ft) could ignite a sheet of polyurethane foam in approximately 10 seconds. This is similar to the ignition sequence observed in the WPRI video.

**Figure 4-13a. Standard and Infrared Video Images of Non-fire Retarded Polyurethane Foam on Gypsum Board Wall just before ignition at t = 0 seconds.**

**Figure 4-13b. Standard and Infrared Video Images of Gerb Discharge onto a Non-fire Retarded Polyurethane Foam Sheet on Gypsum Board Wall at t = 0.5 seconds.**

**Figure 4-13c. Standard and Infrared Video Images of Gerb Discharge onto a Non-fire Retarded Polyurethane Foam Sheet on Gypsum Board Wall at t = 1 second.**

**Figure4-13d. Standard and Infrared Video Images of Gerb Discharge onto a Non-fire Retarded Polyurethane Foam Sheet on Gypsum Board Wall at t = 2 seconds.**

**Figure 4-13e. Standard and Infrared Video Images of Gerb Discharge onto a Non-fire Retarded Polyurethane Foam Sheet on Gypsum Board Wall at  $t = 5$  seconds.**

**Figure 4-13f. Standard and Infrared Video Images of Gerb Discharge onto a Non-fire Retarded Polyurethane Foam Sheet on Gypsum Board Wall at  $t = 10$ seconds.**

**Figure 4-13g. Standard and Infrared Video Images of Gerb Discharge onto a Non-fire Retarded Polyurethane Foam Sheet on Gypsum Board Wall at  $t = 15$  seconds.**

**Figure 4-13h. Standard and Infrared Video Images of Gerb Discharge onto a Non-fire Retarded Polyurethane Foam Sheet on Gypsum Board Wall at 30 seconds.**

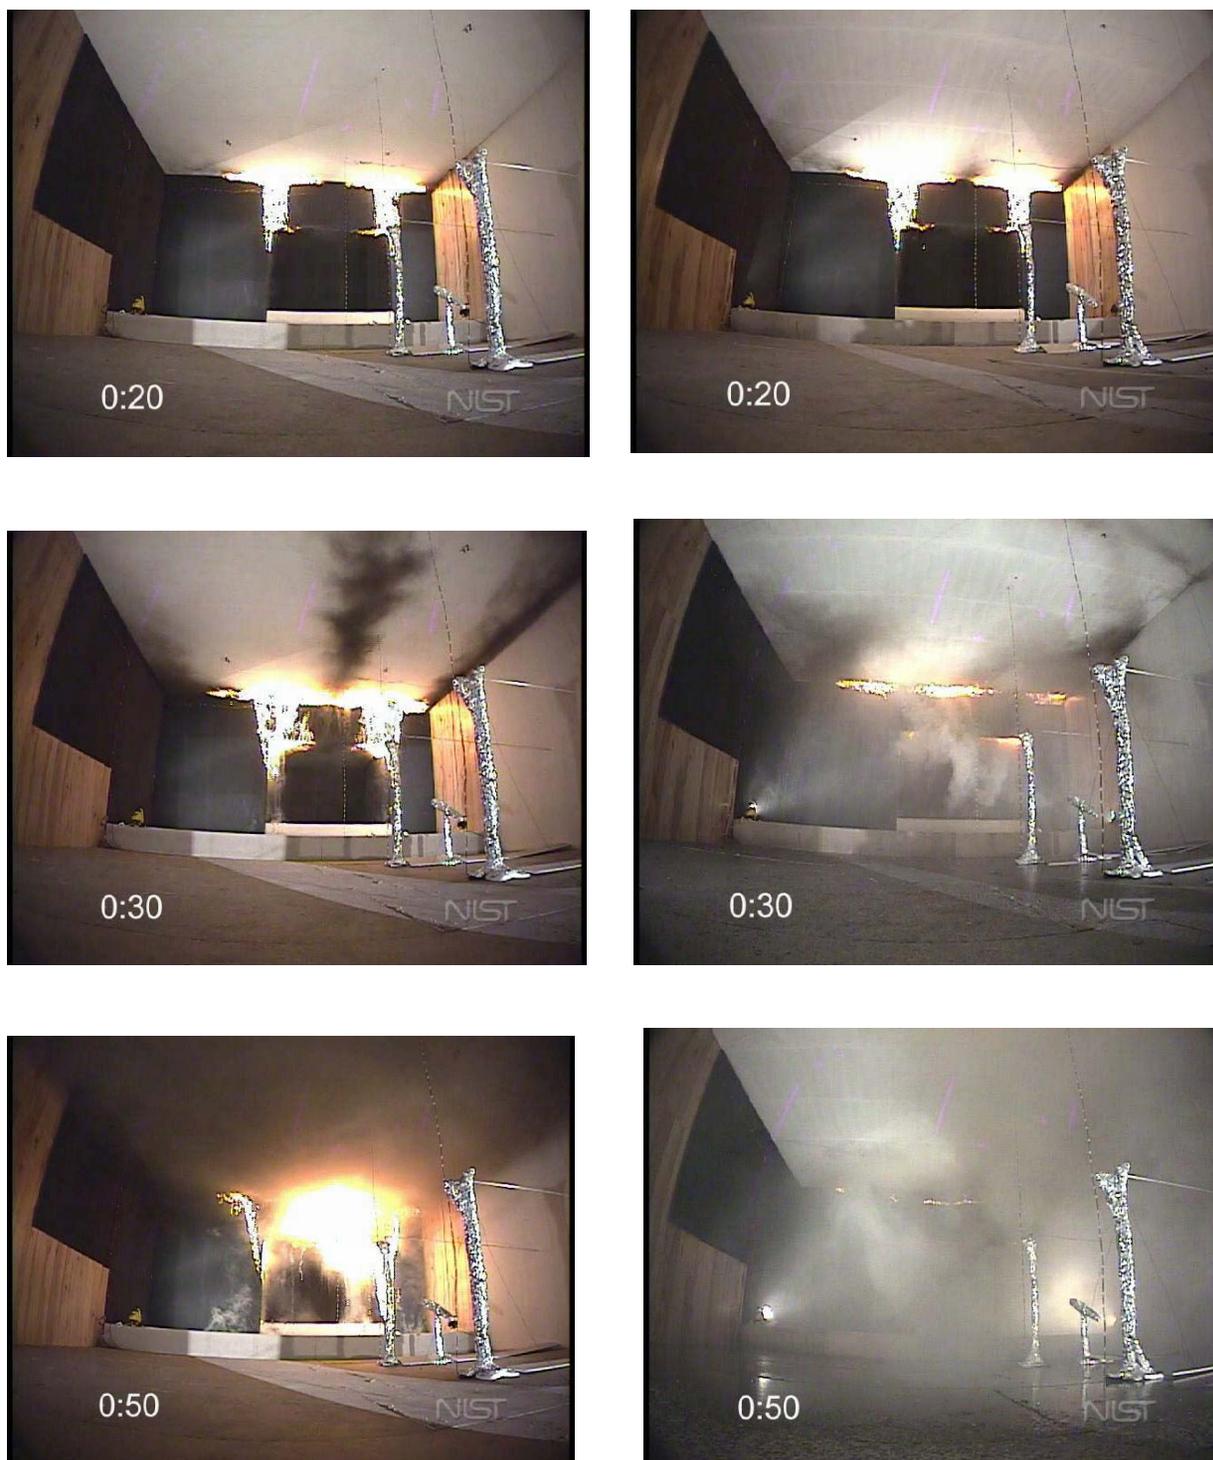
The succession of video frames on the left of Fig. 4-20 show how rapidly the fire spreads during the first 50 seconds, compared to how quickly the fire is controlled with sprinklers in the frames along the right. The first sprinkler activates on the right of the platform 24 seconds after ignition. By 30 seconds the sprinkler above the platform on the left and the sprinkler in the alcove have activated.

**Figure 4-20. Still frames taken from video of full-scale mock-up experiments. Time after ignition is indicated in lower left of each frame. Left column: unsprinklered; right column: sprinklered (first head activates at 24 seconds)**

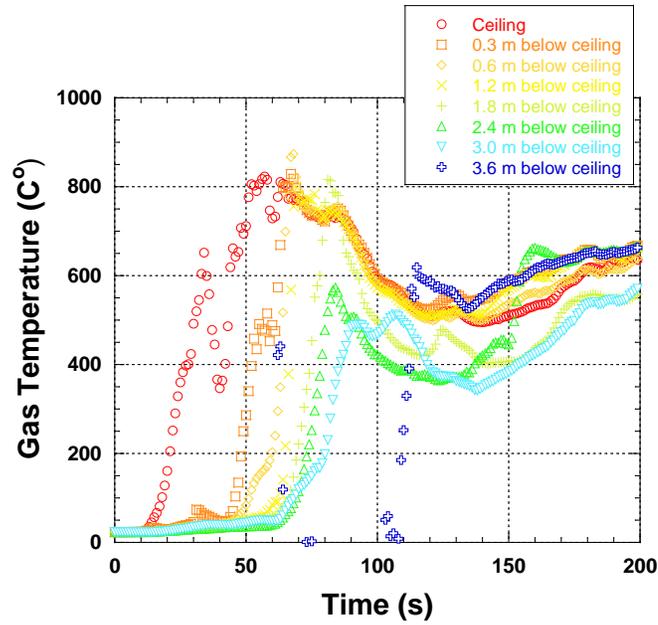
**Figure 4-22. Temperatures versus Time for Unsprinklered Mockup Test. Thermocouples positioned on Platform (Location B) from ceiling to platform floor.**

For the unsprinklered case, the temperature at the ceiling measured at location B (Fig. 4-22) began to increase within 10 seconds of ignition and continued to increase to over 800 °C in approximately 50 seconds. In less than 60 seconds, the temperature exceeded 50 °C 1.4 m (4.5 ft) above the floor (2.4 m below the ceiling). The hot gases began to form an upper layer and the layer began to descend; in just over 110 seconds, the temperature at the floor of the platform had increased to over 600 °C.

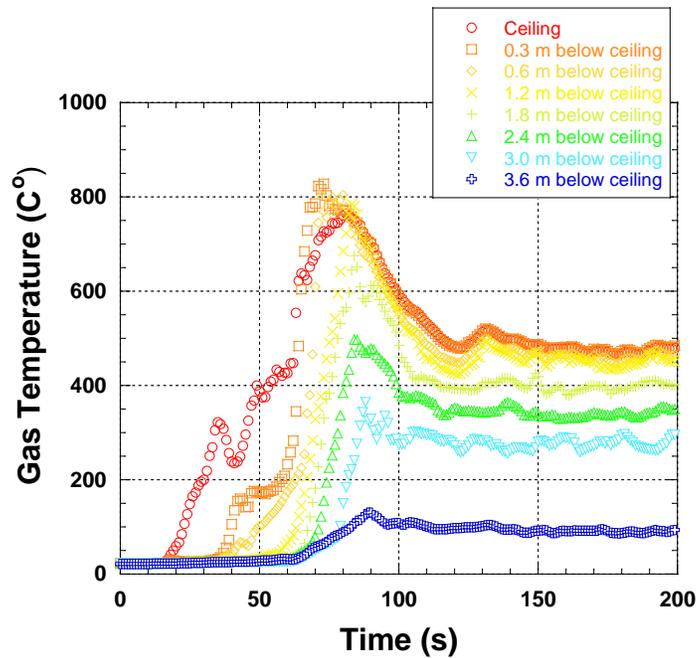
**Figure 4-23. Temperatures versus Time for Unsprinklered Mockup Test. Thermocouples positioned on Main Floor (Location C) from ceiling to floor.**

The thermocouple array at location C was installed 6.7 m from the foam covered platform wall, 3 m further away from the platform wall than the thermocouples at location B. The temperatures required about 15 seconds longer to begin increasing than those measured at location B, and required approximately 70 seconds to reach peak temperatures of 800 °C. From Fig. 4-23 one can see that the temperatures at 3.6 m below the ceiling did not begin to increase until 60 seconds after ignition and then the temperatures reached peak values of approximately 100 °C in 90 s. The temperatures at location C exceeded 50 °C at the 1.4 m (4.5 ft) above the floor (2.4 m below the ceiling) elevation in less than 70 seconds.

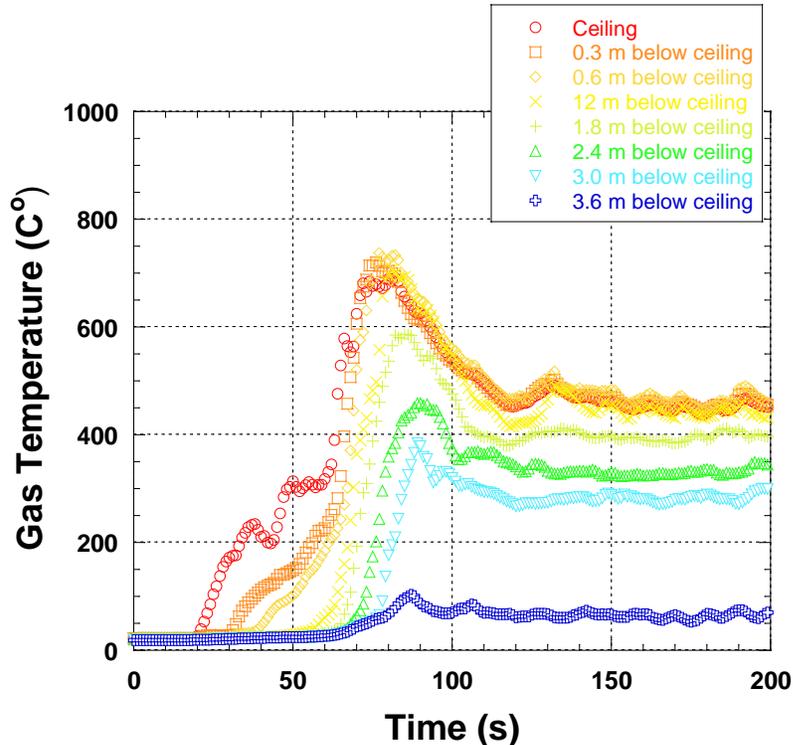
**Figure 4-24. Temperatures versus Time for Unsprinklered Mockup Test. Thermocouples positioned on Main Floor (Location D) from ceiling to floor.**

The thermocouple array at location D was installed 8.5 m from the foam covered platform wall, an additional 1.8 m further away from the platform wall than the thermocouples at location C. The temperatures began to rise in about 20 seconds (see Fig. 4-24), and required approximately 80 seconds to reach peak temperatures of 700 °C. The temperatures at 3.6 m below the ceiling did not begin to increase until 70 seconds after ignition and reached peak values of approximately 100 °C in 90 s. The temperatures near the floor at location D were about the same as the values recorded at the floor on the platform, Location C.

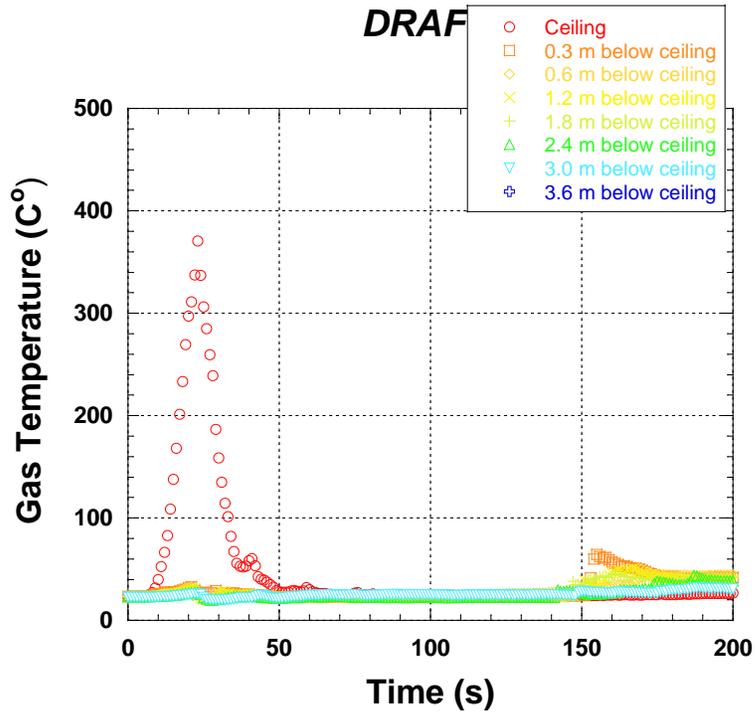
Figure 4-25. Temperatures versus Time for Sprinklered Mockup Test. Thermocouples positioned on Platform (Location B) from ceiling to platform floor.

For the sprinklered test burn, the ceiling thermocouple at location B (on the platform) recorded a peak temperature of 380 °C about 20 seconds after ignition, as can be seen in Fig. 4-25. When the sprinkler activated, the ceiling temperature quickly decreased, dropping to about 20 °C within 40 the next seconds of ignition. The activation of the sprinklers caused the other thermocouples at lower elevations to record near ambient temperatures throughout the test burn.

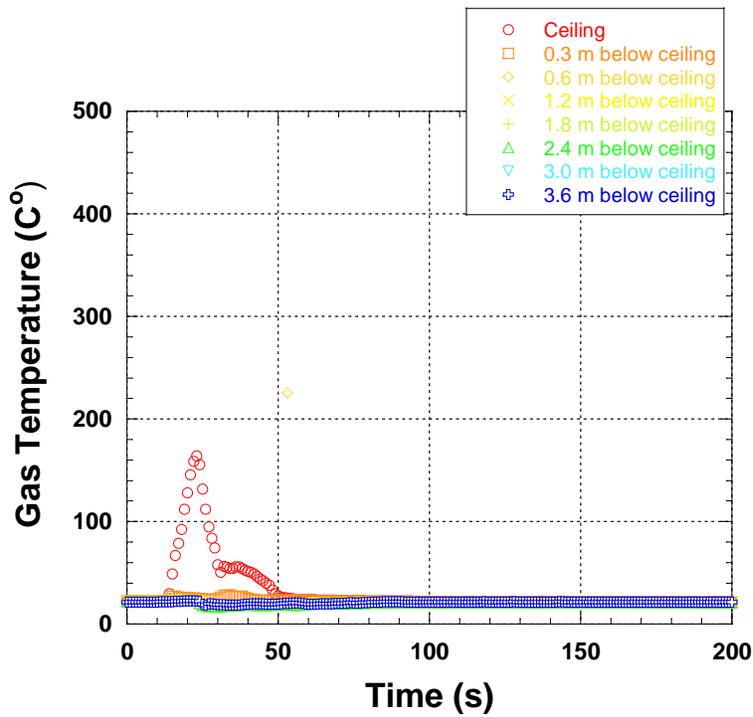
Figure 4- 26. Temperatures versus Time for Sprinklered Mockup Test. Thermocouples positioned on Main Floor (Location C) from ceiling to floor.

At location C (Fig. 4-26), the ceiling temperatures reached a peak temperature of 170 °C in about 20 seconds and declined to near ambient temperatures within 60 seconds. For location D (Fig. 4-27), the ceiling temperatures reached a peak temperature of 130 °C in about 20 seconds and declined to near ambient temperatures within 60 seconds. Thermocouples at lower elevations for both locations appeared to remain at near ambient temperatures throughout the test .

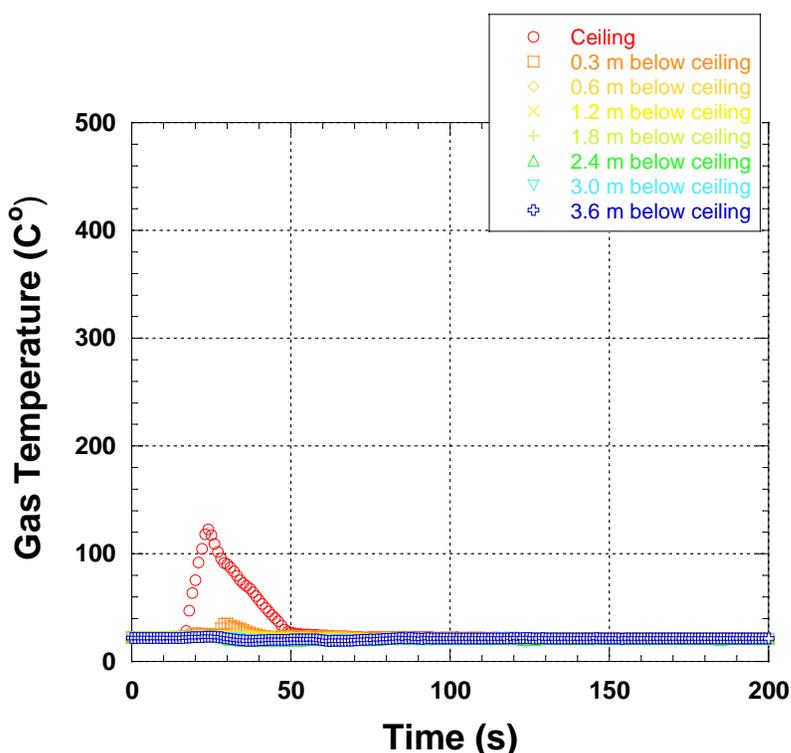
**Figure 4-27. Temperatures versus Time for Sprinklered Mockup Test. Thermocouples positioned on Main Floor (Location D) from ceiling to floor.**

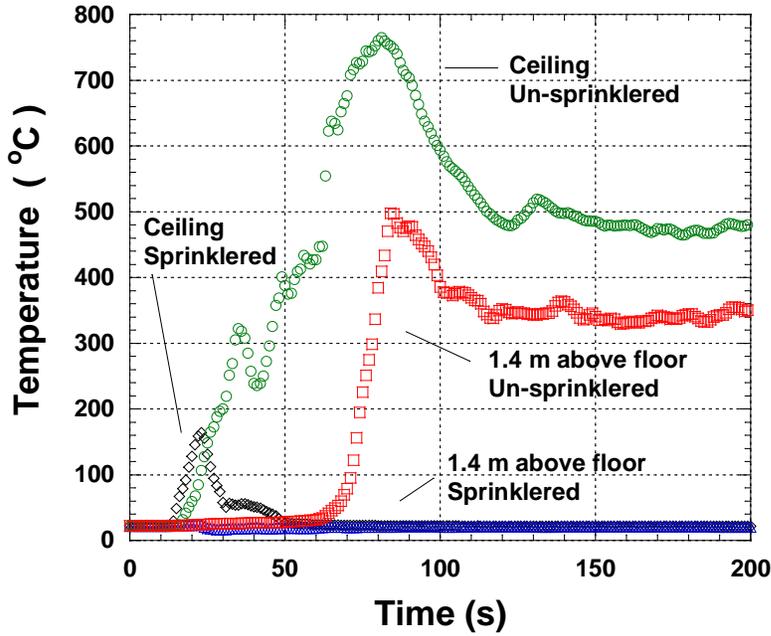
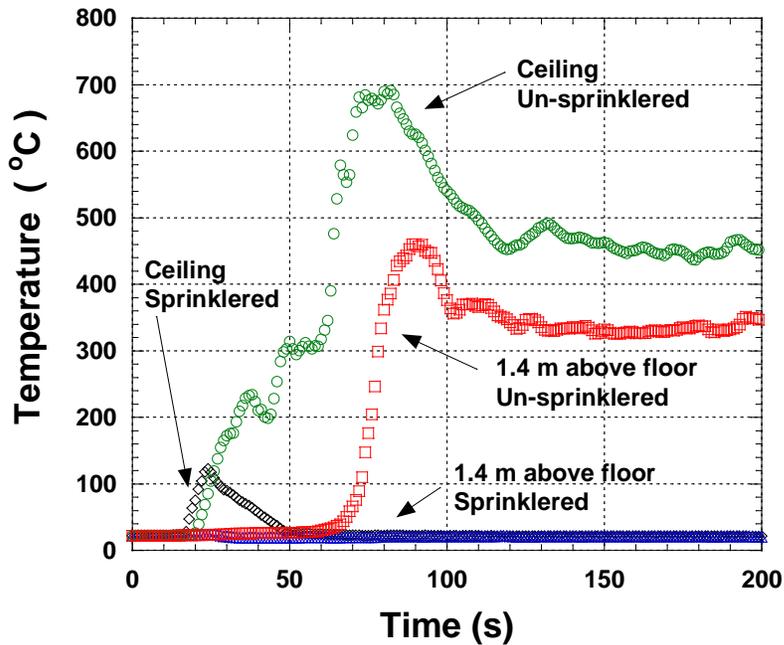
The comparison between the temperatures at the ceiling and 1.4 m above the floor for the sprinklered and unsprinklered experimental data is striking, as demonstrated in Fig. 4-28a for location C and Fig. 4-28b for location D. At 25 seconds, the temperatures at the ceiling were about 175 °C at location C and 125 °C at location D for both experiments, indicative of the fire being properly replicated up to the point when the sprinkler activated. During the next 25 seconds the temperatures throughout the compartment returned to close to ambient conditions in the sprinklered compartment. This compared to a continuing rapid rise in temperatures for the unsprinklered compartment, which reached ceiling temperatures in excess of 300 °C at 50 seconds, and peaks of 700 °C plus in the following 25 seconds. Peak temperatures of 400 °C to 500 °C were reached 1.4 m above the floor for the unsprinklered test; temperatures did not rise at all for the sprinklered compartment at this location.

Figure 4-28a. Temperatures versus Time for Unsprinklered and Sprinklered Mockup Test. Thermocouples positioned on Main Floor (Location C) at ceiling and 1.4 m (4.5 ft) above floor.

Figure 4-28b. Temperatures versus Time for Unsprinklered and Sprinklered Mockup Test. Thermocouples positioned on Main Floor (Location D) at ceiling and 1.4 m (4.5 ft) above floor.

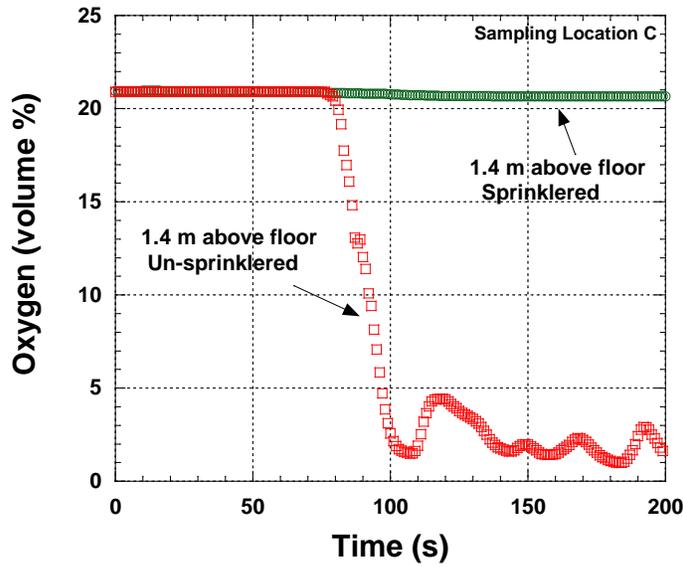
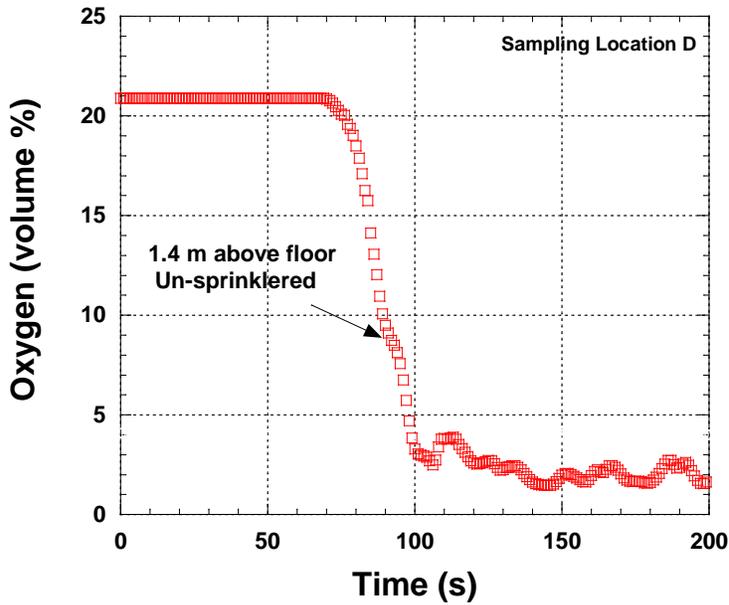
Figure 4- 30. Oxygen Volume Fraction vs Time for Unsprinklered and Sprinklered Mockup Test. Gas Sampling probe positioned on Main Floor (Location C) at 1.4 m (4.5 ft) above floor.

Figure 4-31. Oxygen Volume Fraction vs Time for Unsprinklered Mockup Test. Gas Sampling probe positioned on Main Floor (Location D) at 1.4 m (4.5 ft) above floor.

Gas volume fractions versus time are plotted for the unsprinklered and sprinklered tests in Figures 4-30 through 4-35 for O<sub>2</sub>, CO and HCN. (Additional gas volume fractions measurements are discussed in Appendix G.) At both locations C and D, oxygen volume fractions did not begin to drop at the 1.4 m elevation until 70 seconds to 80 seconds after ignition for the unsprinklered mock-up experiments. At both locations, the oxygen volume fractions descended to less than 4 % in less than 100 seconds, then fluctuated between 1 % and 4 % . During the sprinklered test burns, the oxygen mole fraction at location C did not appear to drop much below ambient oxygen levels. (A malfunctioning oxygen analyzer prevented the oxygen concentrations from being monitored at location D during the sprinklered burns.)

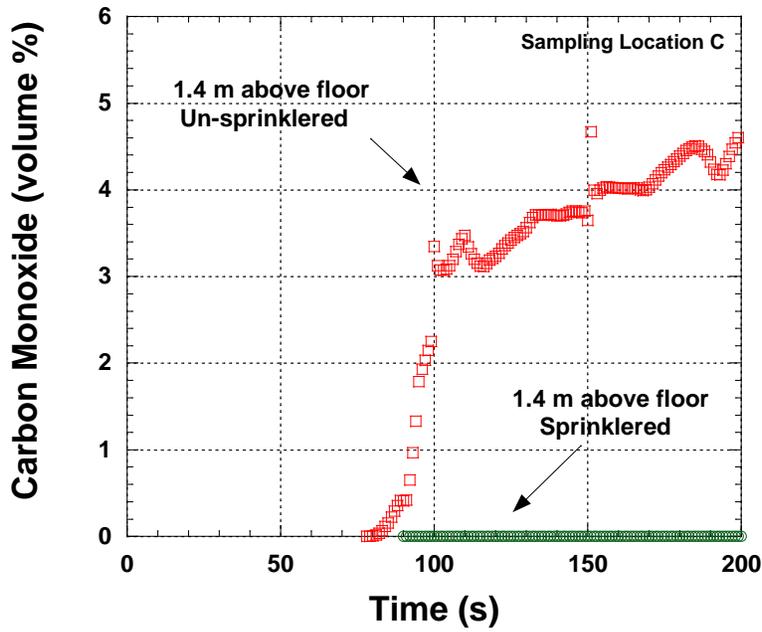
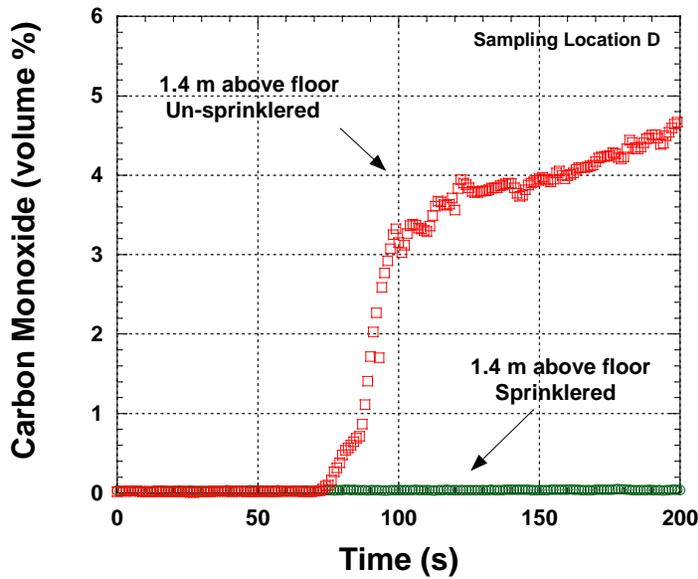
**Figure 4-32. Carbon Monoxide Volume Fraction vs Time for Unsprinklered and Sprinklered Mockup Test. Gas Sampling probe positioned on Main Floor (Location C) at 1.4 m (4.5 ft) above floor.**

**Figure 4-33. Carbon Monoxide Volume Fraction vs Time for Unsprinklered and Sprinklered Mockup Test. Gas Sampling probe positioned on Main Floor (Location D) at 1.4 m (4.5 ft) above floor.**

At both locations C and D, volume fractions of carbon monoxide at the 1.4 m elevation did not begin to increase until 70 seconds to 80 seconds after ignition for the unsprinklered mock-up experiments, but then increased to 3 % in the next 20 seconds to 30 seconds and reached 4.5 % by 200 seconds after ignition. During the sprinklered test burns, the carbon monoxide concentration at neither location C nor location D appeared to increase much above ambient levels.

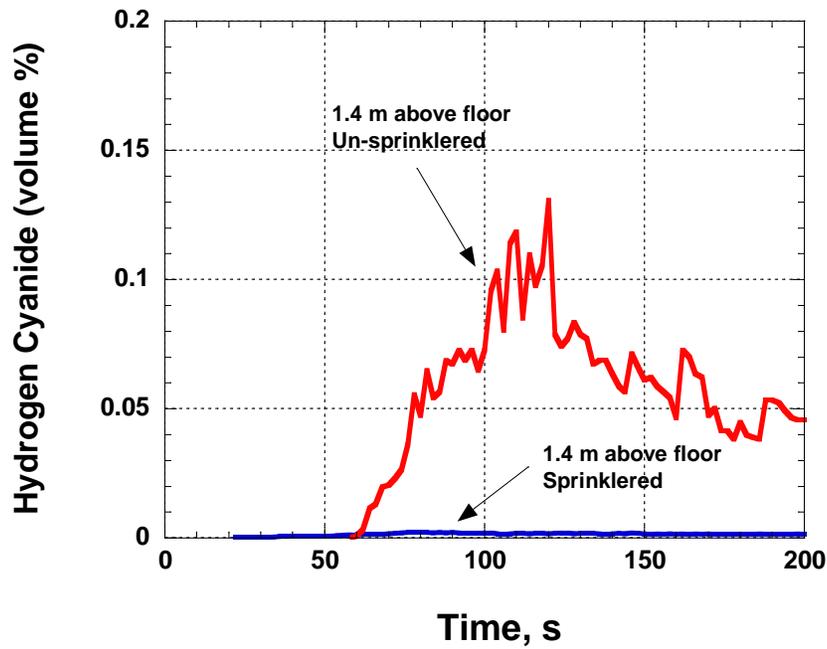
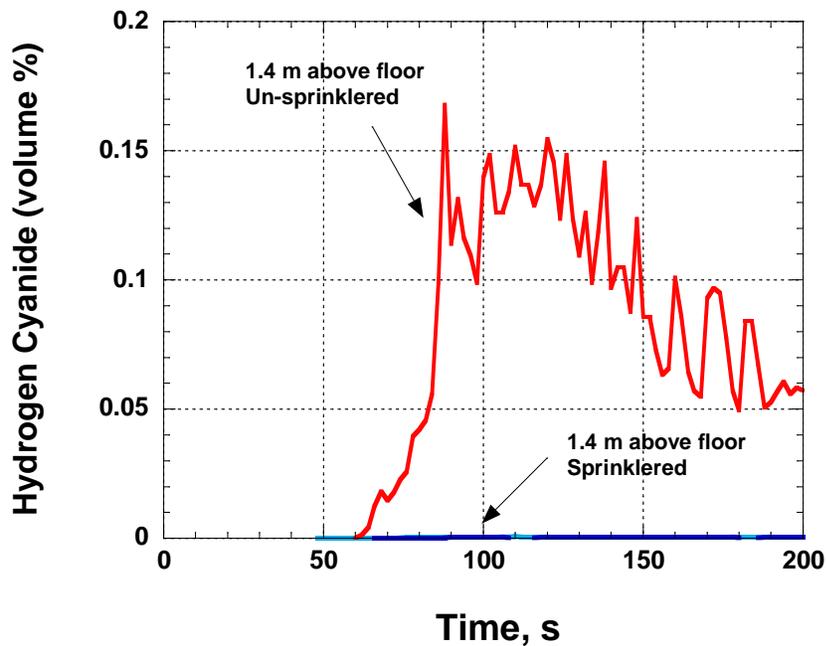
Figure 4-34. Hydrogen Cyanide Volume Fraction vs Time for Unsprinklered and Sprinklered Mockup Test. Gas Sampling probe positioned on Main Floor (Location C) at 1.4 m (4.5 ft) above floor.

Figure 4-35. Hydrogen Cyanide Volume Fraction vs Time for Unsprinklered and Sprinklered Mockup Test. Gas Sampling probe positioned on Main Floor (Location D) at 1.4 m (4.5 ft) above floor.

The volume fractions of hydrogen cyanide at the 1.4 m elevation began to increase 60 seconds after ignition for the unsprinklered mockup experiments. At location C, the HCN reached its peak value of 0.13 % in 120 seconds. The HCN increased slightly faster at location D, where it reached a peak volume fraction of 0.17 % in about 90 s. During the sprinklered test burns, the hydrogen cyanide concentration at locations C and D were barely above the measurable limit.

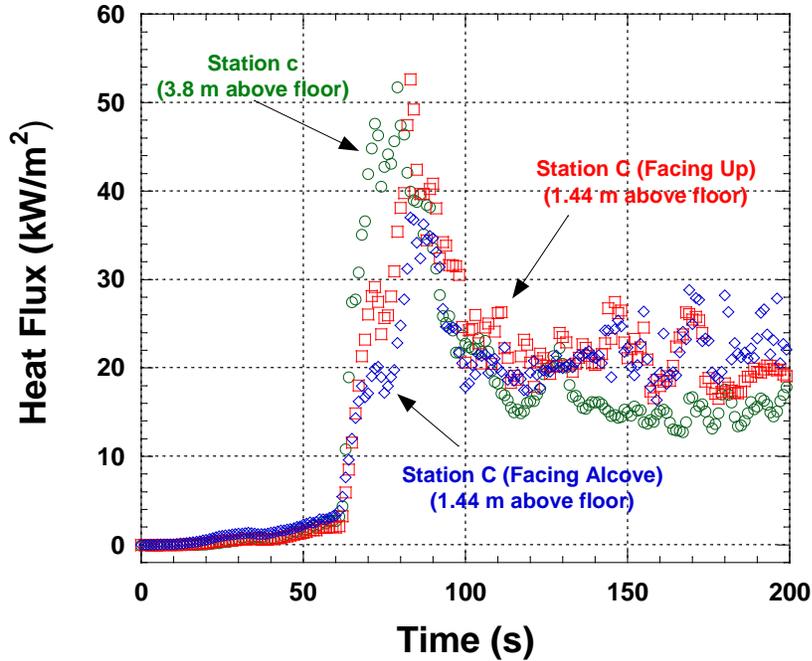
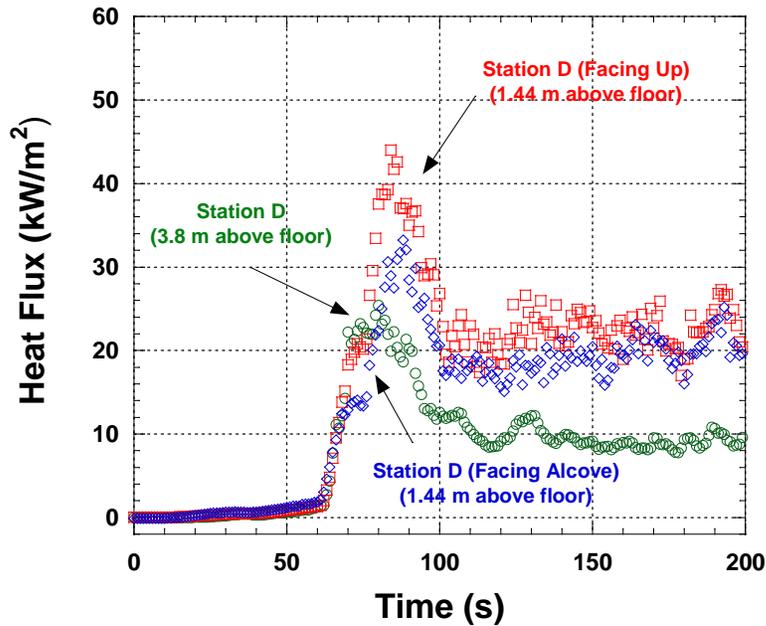
For the unsprinklered compartment test, the output of the thermal radiation and total heat fluxes for the radiometer and heat flux gauges at locations C and D are shown in Fig. 4-37 and Fig 4-38. At location C, peak fluxes in excess of 50 kW/m<sup>2</sup> were reached about 70 seconds after ignition. Peak fluxes at location D were about 20 % lower than location C. At 100 seconds after ignition, radiation and heat flux at

location C and the heat flux at location D decreased significantly to 20 kW/m<sup>2</sup> and appeared to remain relatively constant at both locations. The radiometer in the ceiling at location D dropped to 10 kW/m<sup>2</sup> before becoming relatively steady. (Additional plots of heat flux are shown and discussed in App. G.)

Figure 4- 37. Heat Fluxes versus time for unsprinklered mockup test. Radiometer positioned flush with ceiling (3.8 m above floor); heat flux gauges facing up (1.44 m above floor), and facing alcove (1.44 m above floor) at sampling location C.

Figure 4- 38. Heat fluxes versus time for unsprinklered mockup test. Radiometer positioned flush with ceiling (3.8 m above floor); heat flux gauges facing up (1.44 m above floor), and facing alcove (1.44 m above floor) at sampling location D.

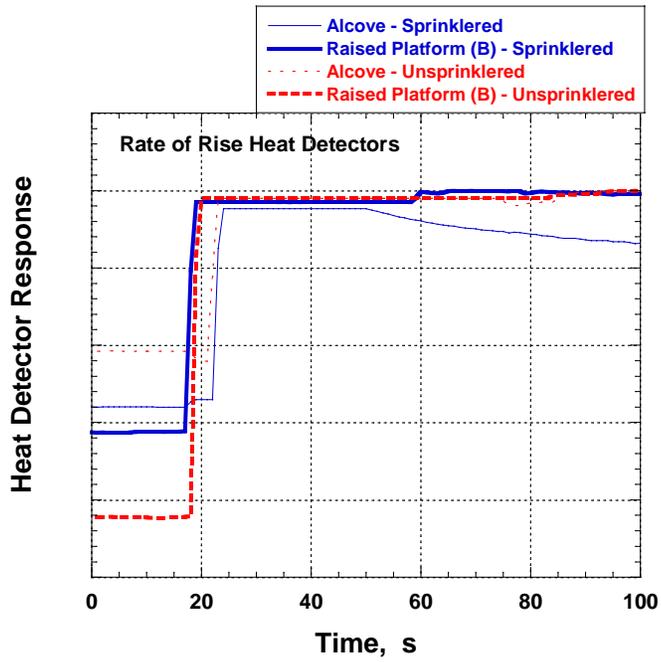
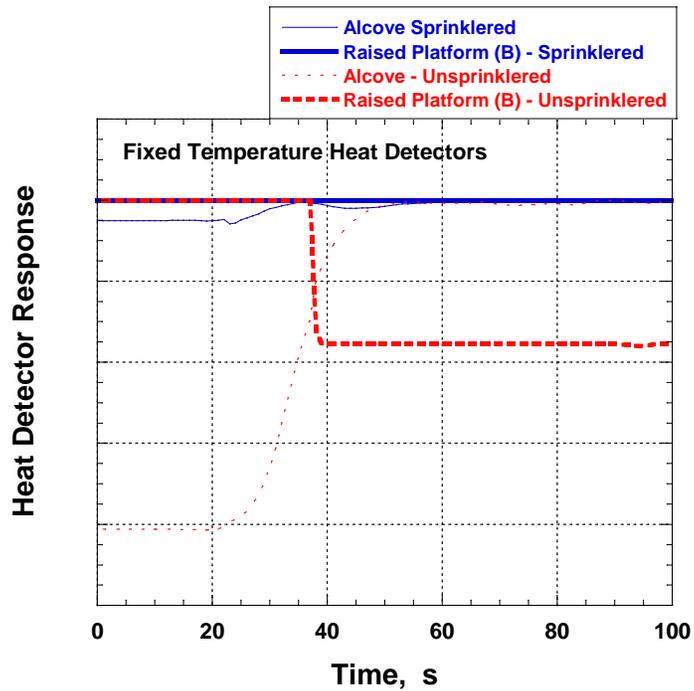
The responses of rate of rise heat detectors and fixed temperature detectors are plotted in Fig. 4-39 and Fig. 4-40, respectively. For both unsprinklered and sprinklered test burns, each of the rate of rise detectors activated in less than 20 seconds. Only in the unsprinklered experiments did the fixed temperature detectors activate. The fixed temperature detector in the alcove activated in about 20 seconds while the fixed temperature detector above the platform required almost 40 seconds to respond.

**Figure 4- 39. Response of Rate of Rise Heat Detectors versus Time for Unsprinklered and Sprinklered Mockup. Detectors located in Alcove and at Location B.**

**Figure 4- 40. Response of Fixed Temperature Heat Detectors versus Time for Unsprinklered and Sprinklered Mockup. Detectors located in Alcove and at Location B.**
