**NIST NCSTAR 2**

# **Draft Report of the Technical Investigation of The Station Nightclub Fire**

March 2005

A fire occurred on the night of Feb. 20, 2003, in The Station nightclub at 211 Cowesett Avenue, West Warwick, Rhode Island. A band that was on the platform that night, during its performance, used pyrotechnics that ignited polyurethane foam insulation lining the walls and ceiling of the platform. The fire spread quickly along the ceiling area over the dance floor. Smoke was visible in the exit doorways in a little more than one minute, and flames were observed breaking through a portion of the roof in less than five minutes. Egress from the nightclub, which was not equipped with sprinklers, was hampered by crowding at the main entrance to the building. One hundred people lost their lives in the fire. On Feb. 27, 2003, under the authority of the National Construction Safety Team (NCST) Act, the National Institute of Standards and Technology (NIST) established a National Construction Safety Team to determine the likely technical cause or causes of the building failure that led to the high number of casualties in that fire. This report documents the procedures, findings, and

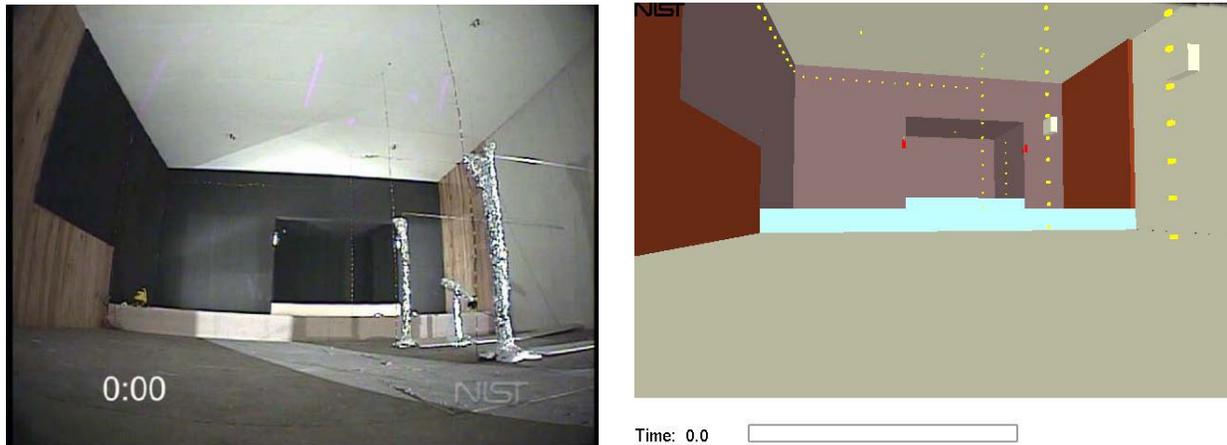
**Figure 5-2. Ignition at the corners of the drummer's alcove,  $t = 0$  s.**

Figure 5-2 shows the experiment and the simulation at the time of ignition. The video frame on the left shows the foam covered walls, the wood paneling, and the carpeted platform. Gypsum board covered the ceiling, floor and the remaining wall areas which were not covered with wood paneling or foam. Some of the instrumentation can be seen in the foreground of the video frame. In the image from the simulation, on the right, the comparable interior finishes can be seen. The instrumentation in the right figures is represented by colored dots. The thermocouples appear as yellow dots in evenly spaced arrays. The light gray blocks represent the locations of the heat flux sensors and the gas sampling locations, which were installed at approximately 1.5 m (5 ft) above the floor.

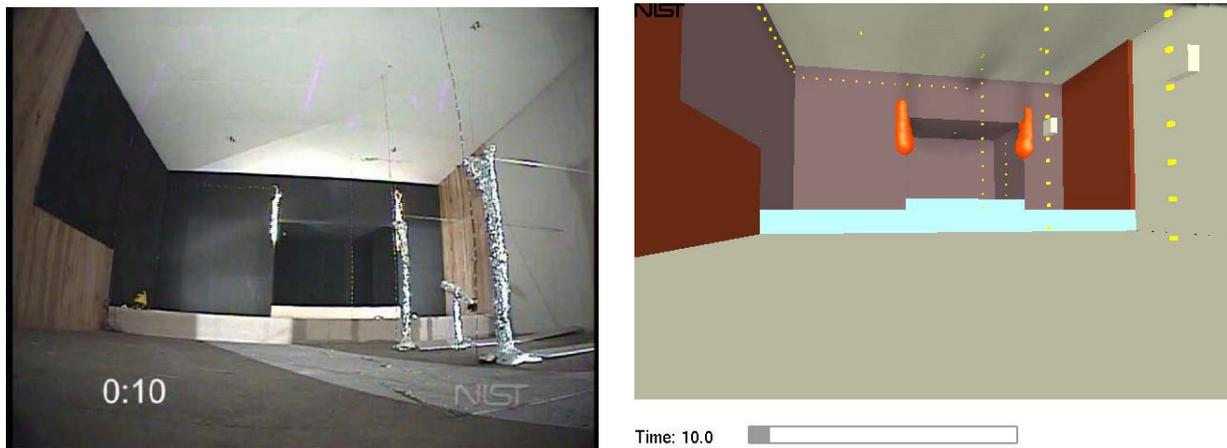
**Figure 5-3. Flames spreading toward ceiling,  $t = 10$  s after ignition.**

Figure 5-3 compares the fire development at 10 seconds after ignition. A flame is shown on both corners where the platform wall intersects with the drummer’s alcove. In the case of FDS, the area that appears to be involved with flames is based on the stoichiometric mixture fraction, where there is the ideal mixture of fuel and oxygen for a robust flame to exist. The heat release rate per unit volume represented by the simulated flames is  $285.5 \text{ kW/m}^3$ . The flames in the simulation appear wider due to the grid resolution, which is 100 mm (4 in) throughout the room.

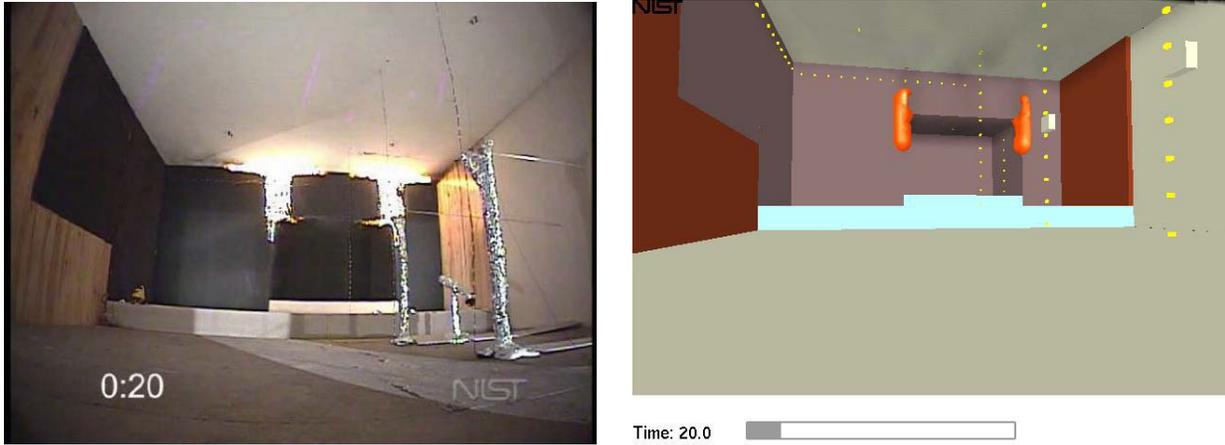
**Figure 5-4. Flames impinging on ceiling, t = 20 s after ignition.**

The video frame to the left in Figure 5-4 shows flames 20 seconds after ignition growing vertically and impinging on the ceiling. The simulated flames on the right, however, have not yet reached the ceiling. As noted above, the simulated flame is constrained to grow in 100 mm (4 in) increments, both vertically and laterally. This may account for the wider flame and the accompanying redistribution of energy which would reduce the propensity for rapid vertical flame spread. Light smoke can be seen in both images along the ceiling of the alcove, with light wisps of smoke along the ceiling above the platform.

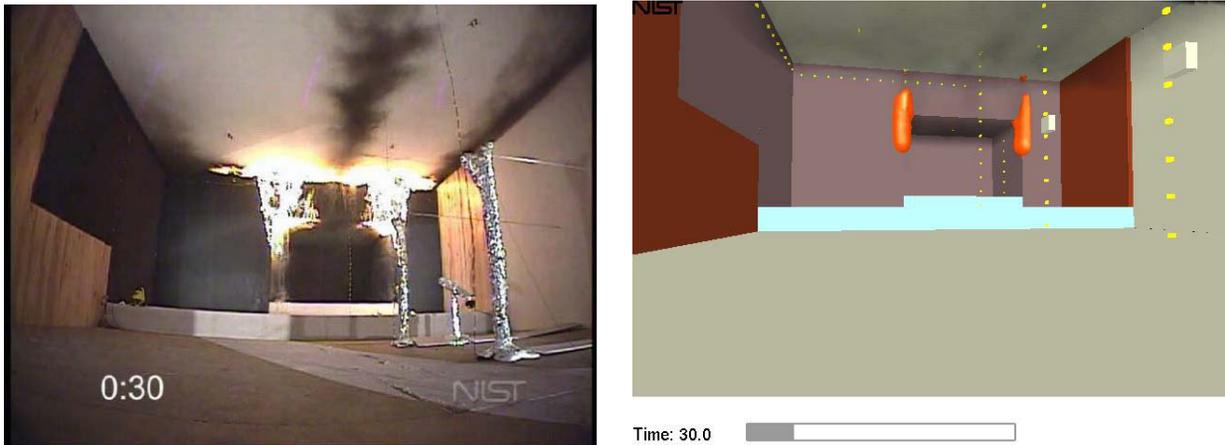
**Figure 5-5. Visible smoke spreading across ceiling, t = 30 s, after ignition.**

Figure 5-5 shows an increased amount of smoke flow across the ceiling at 30 seconds after ignition. The actual fire continues to grow at a faster rate than the simulated flames. In the video frame on the left the flames

have formed twin V-patterns on each side of the alcove and the flames are spreading across the alcove ceiling. Notice the light smoke that is coming up from the carpeting below the two fire plumes. This is the result of foam melting and the burning foam droplets falling to the floor. This mode of flame spread is not accounted for within the FDS model. At 40 seconds after ignition, the video frame in Figure 5-6 shows areas of the foam on the platform wall have burned out (note the dark area directly above the point of ignition on the left side of the alcove). The actual flame fronts have continued to spread and into the alcove, where fire is visible on portions of the side walls and the ceiling of the alcove. The flames simulated with FDS have also grown, although at a slower rate. Both of the simulated flames have impinged on the ceiling.

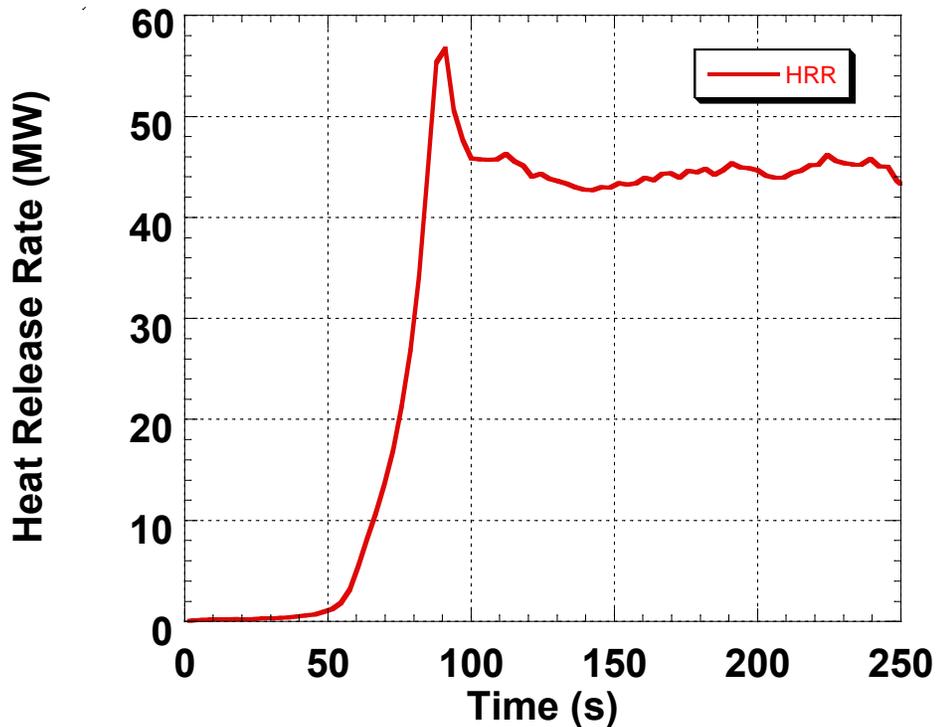
**Figure 5-42. Total Heat Released in Building Fire Simulation as a Function of Time**

The total heat released in the fire is plotted in Figure 5-42. The graph shows that after the alcove became fully involved with fire, at approximately 50 to 60 seconds, the heat release rate increased from approximately 2 MW to 54 MW in less than 50 seconds. Hence the rate of increase was more than 1 MW per second. As the fire spread throughout the structure and the fire became oxygen limited the heat release rate became steady at approximately 45 MW for approximately 150 seconds. After that time, the simulation began to deplete the fuel contained in the interior finish materials. The fire in the actual night club had spread into the structure and burned in and through areas of the roof and walls by this time. The simulation only provided fuel based on the interior finish and did not account for fuel being provided by structural elements and materials in building outer envelope.

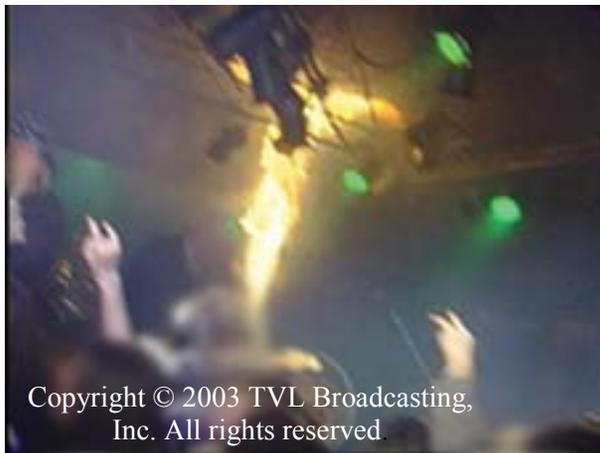
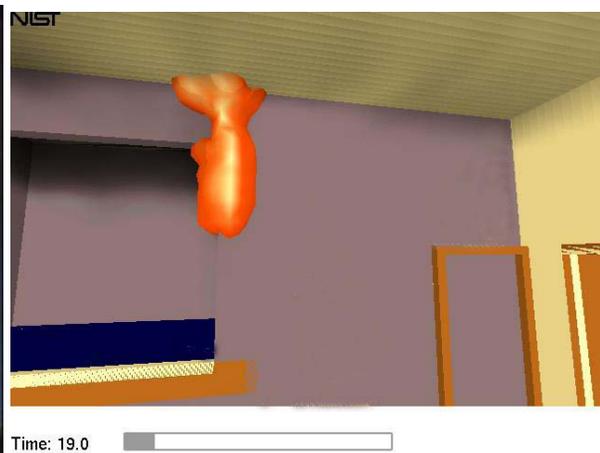
**Figure 5-44. Flames impinging on ceiling (19 seconds)**

placement of the ignition vents on both sides of the corner. In both the simulation and the actual incident the flames impinge on the ceiling within 20 seconds after ignition.

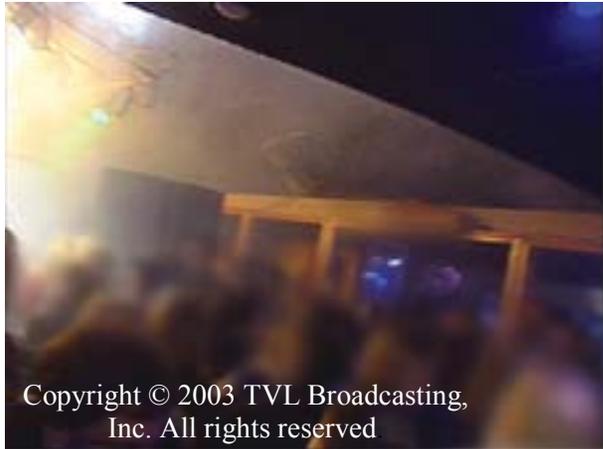
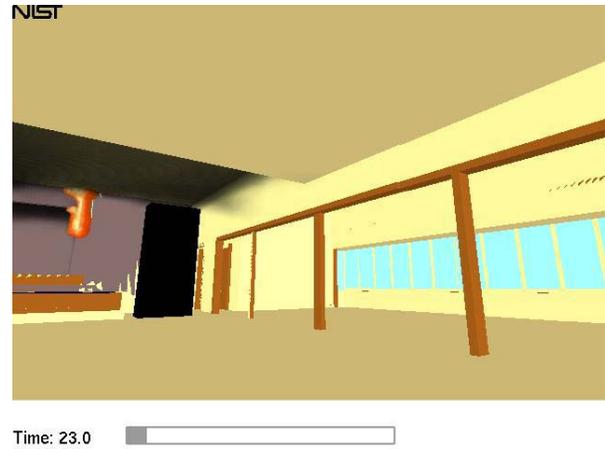
**Figure 5-45. Videographer backing away from platform (23 seconds)**

At 23 seconds after ignition, Figure 5-45, the videographer has begun to move toward the exit as have many in the crowd. Notice that many people are still facing the platform. The fire continued to grow and smoke has collected in the raised ceiling area over the dance floor. The smoke filling can be seen in the image from the simulation. (Note the black rectangular image on the floor is representative of the speaker cabinet, whereas the boundaries of the smoke layer are irregular.) At 53 s after ignition, the flames have grown and spread along the platform wall and into the alcove as shown in video image in Figure 5-46. In addition, the smoke is spreading across the lower level ceiling area toward the main exit. The flames have spread in the simulation as well and smoke is beginning to spill over from the dance floor area towards the exits and the main bar room, although it takes a few more seconds into the simulation for this to occur. Again the black rectangular objects on the floor are representative of speaker cabinets (near the platform) and the sound and lighting board (left side).

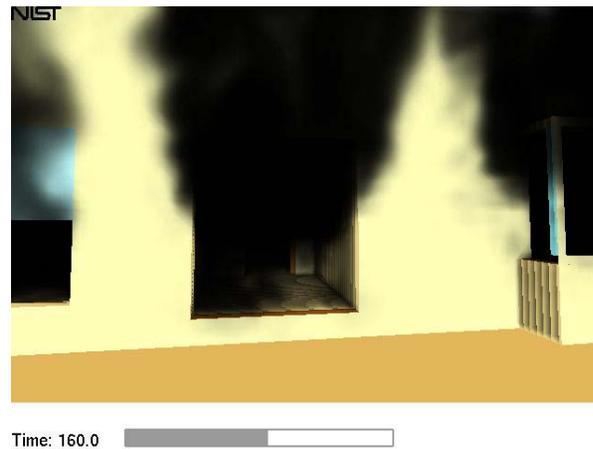
**Figure 5-49. Heavy smoke leaving front door and open main bar window (160 seconds)**

The Smokeview image in Figure 5-49 shows the smoke flow from the front door at 160 seconds after ignition in the simulation. In Figure 5-50, the simulated smoke flow from the main bar room windows is shown. More smoke is coming from the center window than the two side windows because the upper and lower portions of the center window have been removed while only the lower portion of the side windows are open in the simulation.

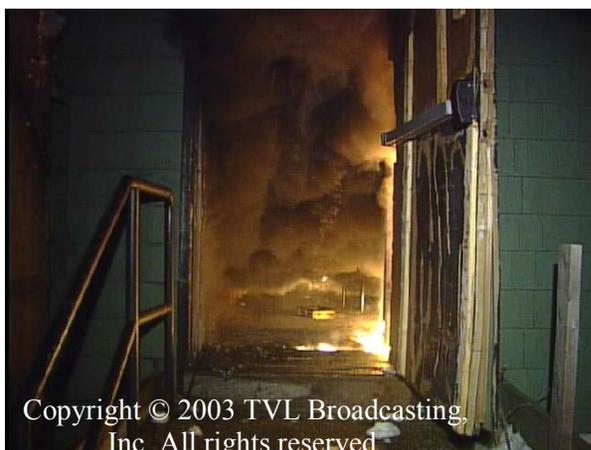
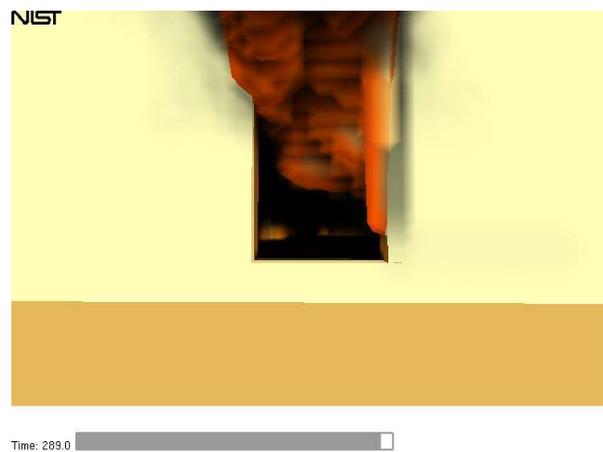
**Figure 5-51. Looking into stage door exit (289 seconds)**

The videographer moves around to the stage door again. The view inside the open door at approximately 289 seconds after ignition is shown in Figure 5-51. The image from the simulation agrees with the video image on the level of combustion products in the doorway. However without a comparison to the temperature in the doorway, the mixture fraction alone would indicate that more flames are in the area of the stage doorway than can be seen in the video image. The videographer continues around to the backside of the nightclub, at 300 s after ignition flames are coming through a small portion of the back wall (south wall) of the dance floor area and smoke is leaking from the bathroom hallway wall. The videographer moved toward the front of the night club again, at 309 seconds flames can be seen in the area of the front door. It takes another 25 seconds before he is in a position to record the images of the flames coming from the sunroom windows and the main door. The simulation stops at 300 s after ignition, short of the time that the entire night club reaches flashover conditions.

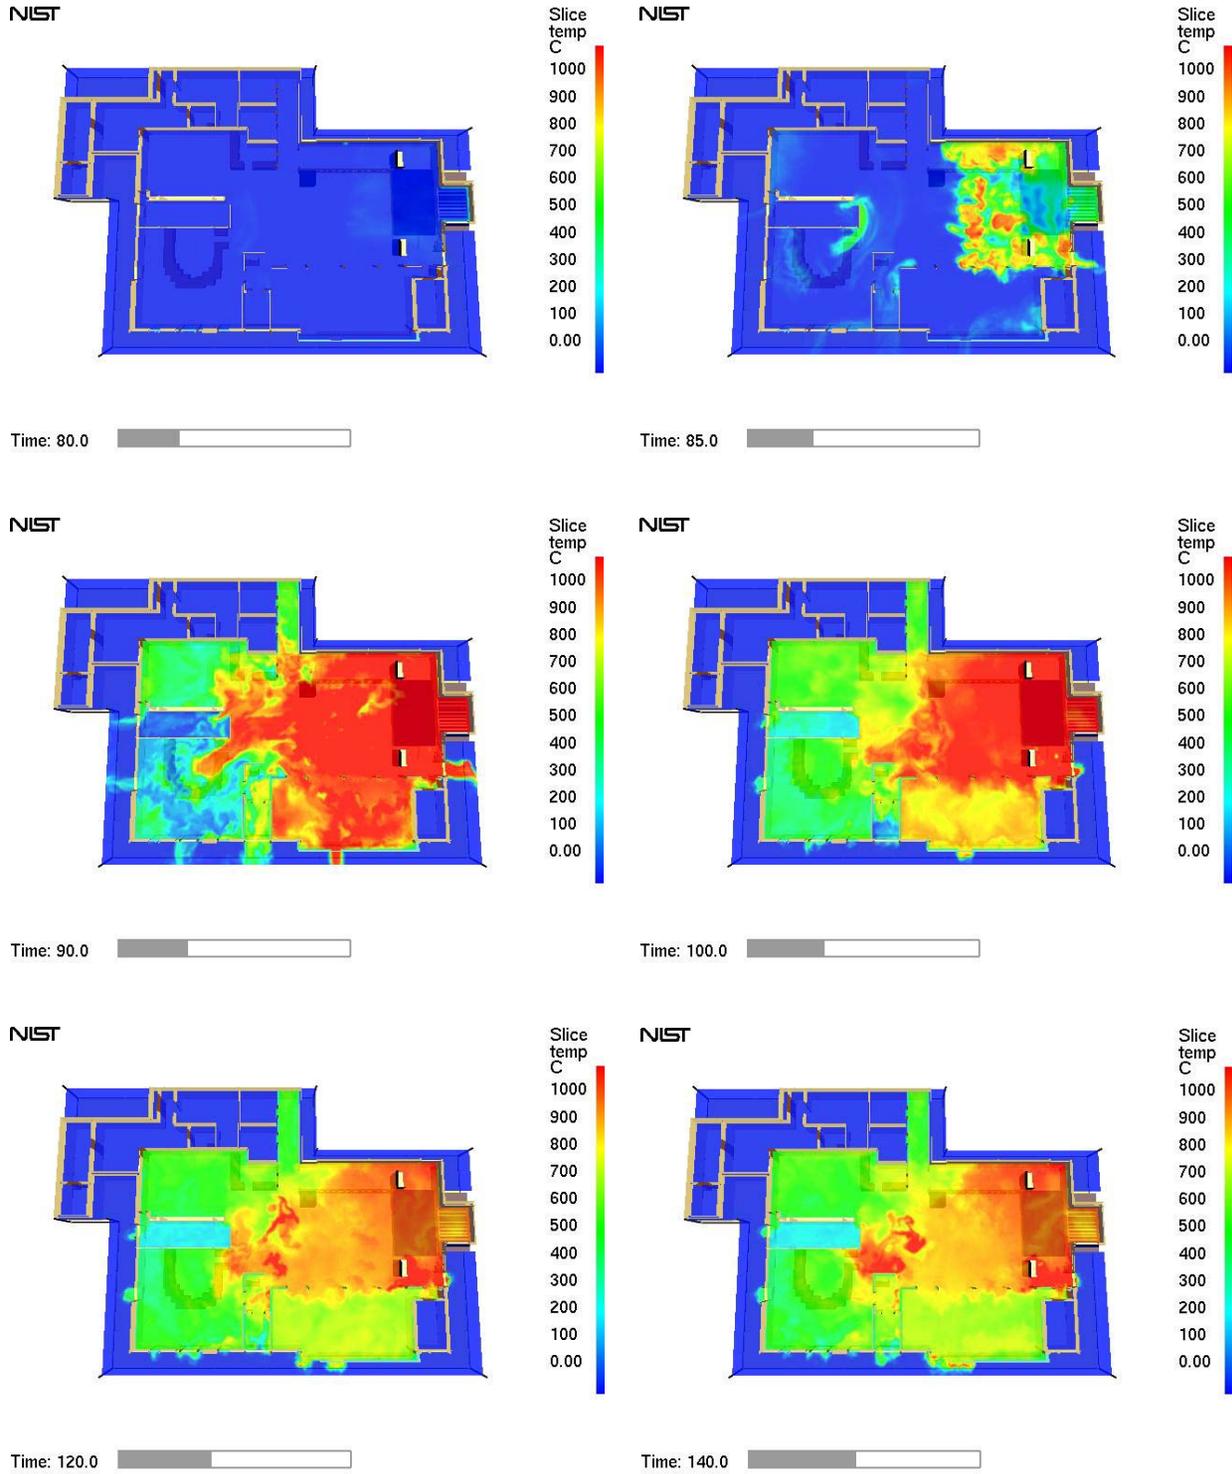
**Figure 5-55a. Temperatures at 1.5 m (5 ft) above the floor, 80 seconds to 140 seconds**

Temperatures increase dramatically shortly after the alcove area reaches flashover conditions at approximately 65 seconds and then the platform area becomes fully involved in flames. The first two images in Figure 5-55a show the temperatures at 1.5 m (5 ft) above the floor at 80 and 85 seconds. Within that 5 second time interval the simulation predicts that dance floor area of the nightclub would have become untenable due to temperature. By 100 seconds after ignition, the simulation shows a large portion of the structure had become untenable due to temperature at the 1.5 m (5 ft) level. Figure 5-55b continues with the presentation of simulation temperature results from 160 second to 250 seconds after ignition. During this time interval temperatures continue to remain in the untenable range throughout the simulated nightclub, with the exception of areas that are considered closed off from the hot gas flow such

as the bathrooms, office and storage areas. These areas were assumed to be separated from the rest of the nightclub by closed doors, so they were modeled without a path for the gases to enter the spaces, hence they appear to remain in the tenable range. The kitchen area has an open door from the dart room and an open door that exits to the outside. The hot gas flow goes directly from the dart room to the exit doorway. This leaves the kitchen at a cooler temperature than the surrounding rooms.

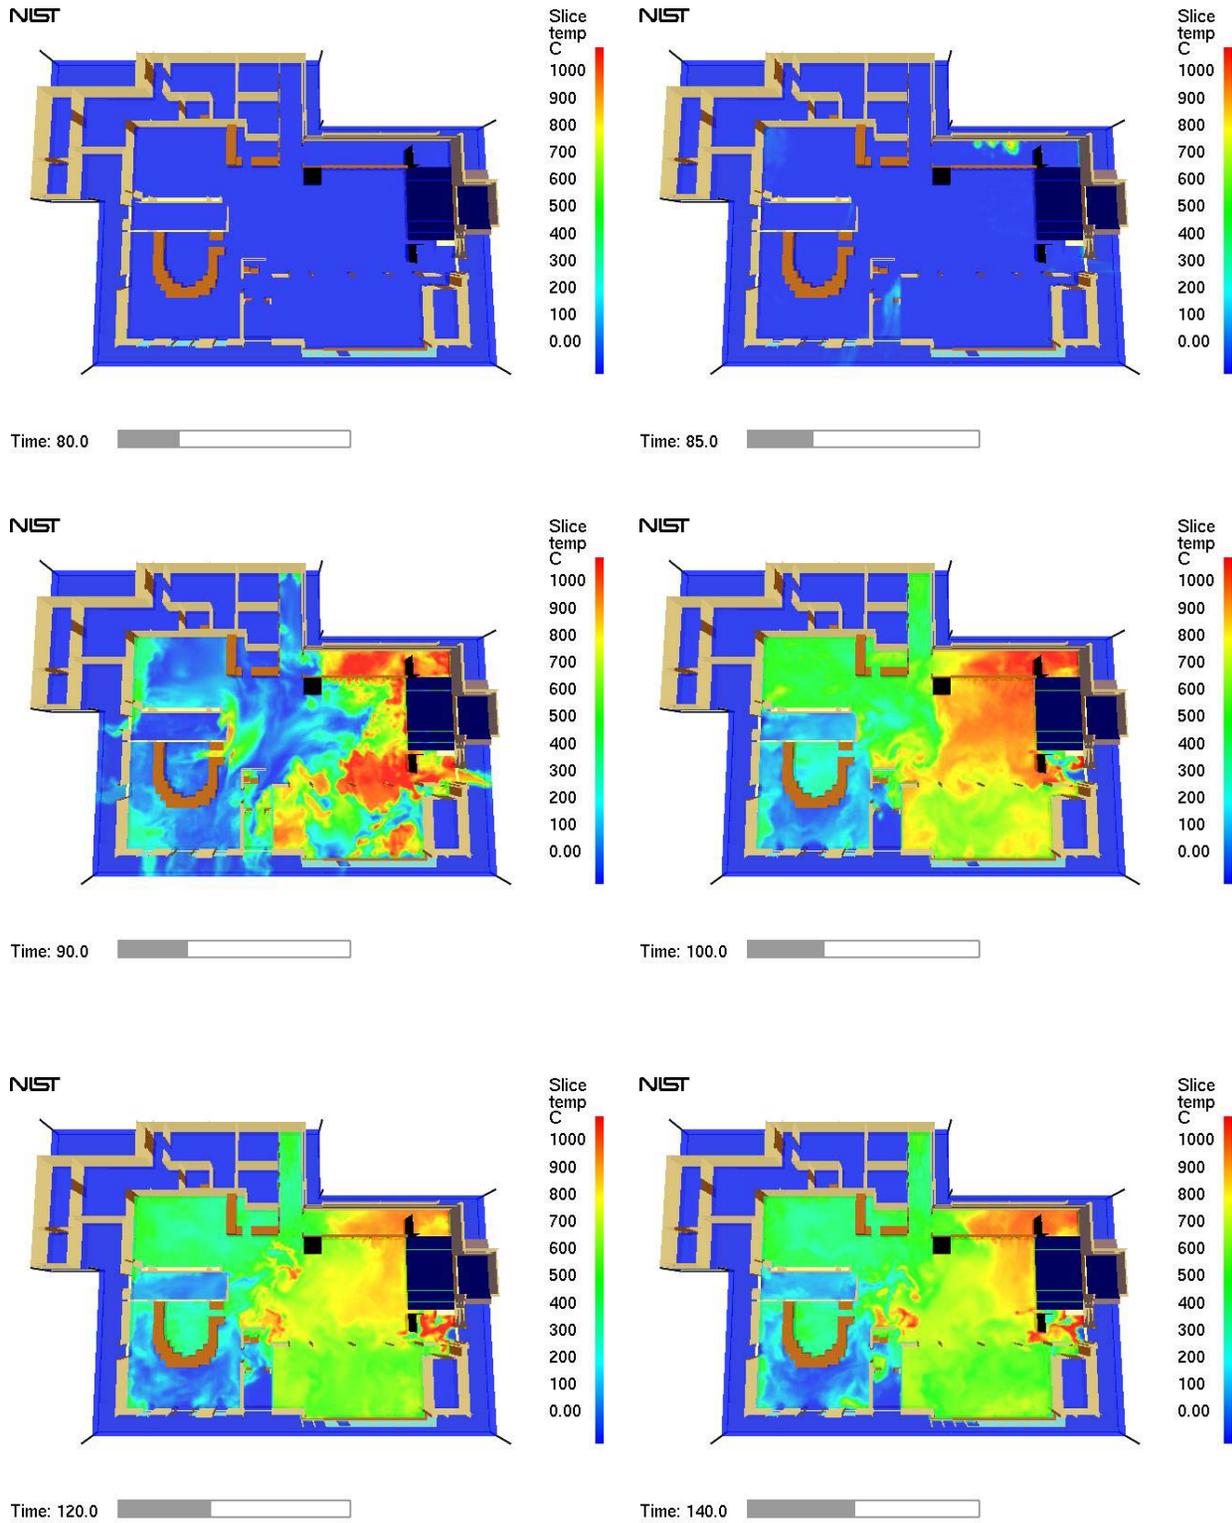
Figure 5-56a. Temperatures at 0.6 m (2 ft) above the floor, 80 seconds to 140 seconds

At the 0.6 m (2 ft) height above the floor conditions remain tenable for a longer period of time than at the higher elevation. Figures 5-56a and 56b contain images captured at the same time intervals as in the previous figure. Figure 5-56a shows the dance floor and adjacent areas reach untenable temperatures in the simulation within 90 seconds after ignition. The sun room and dart room areas are predicted to reach untenable temperatures within another 10 seconds.

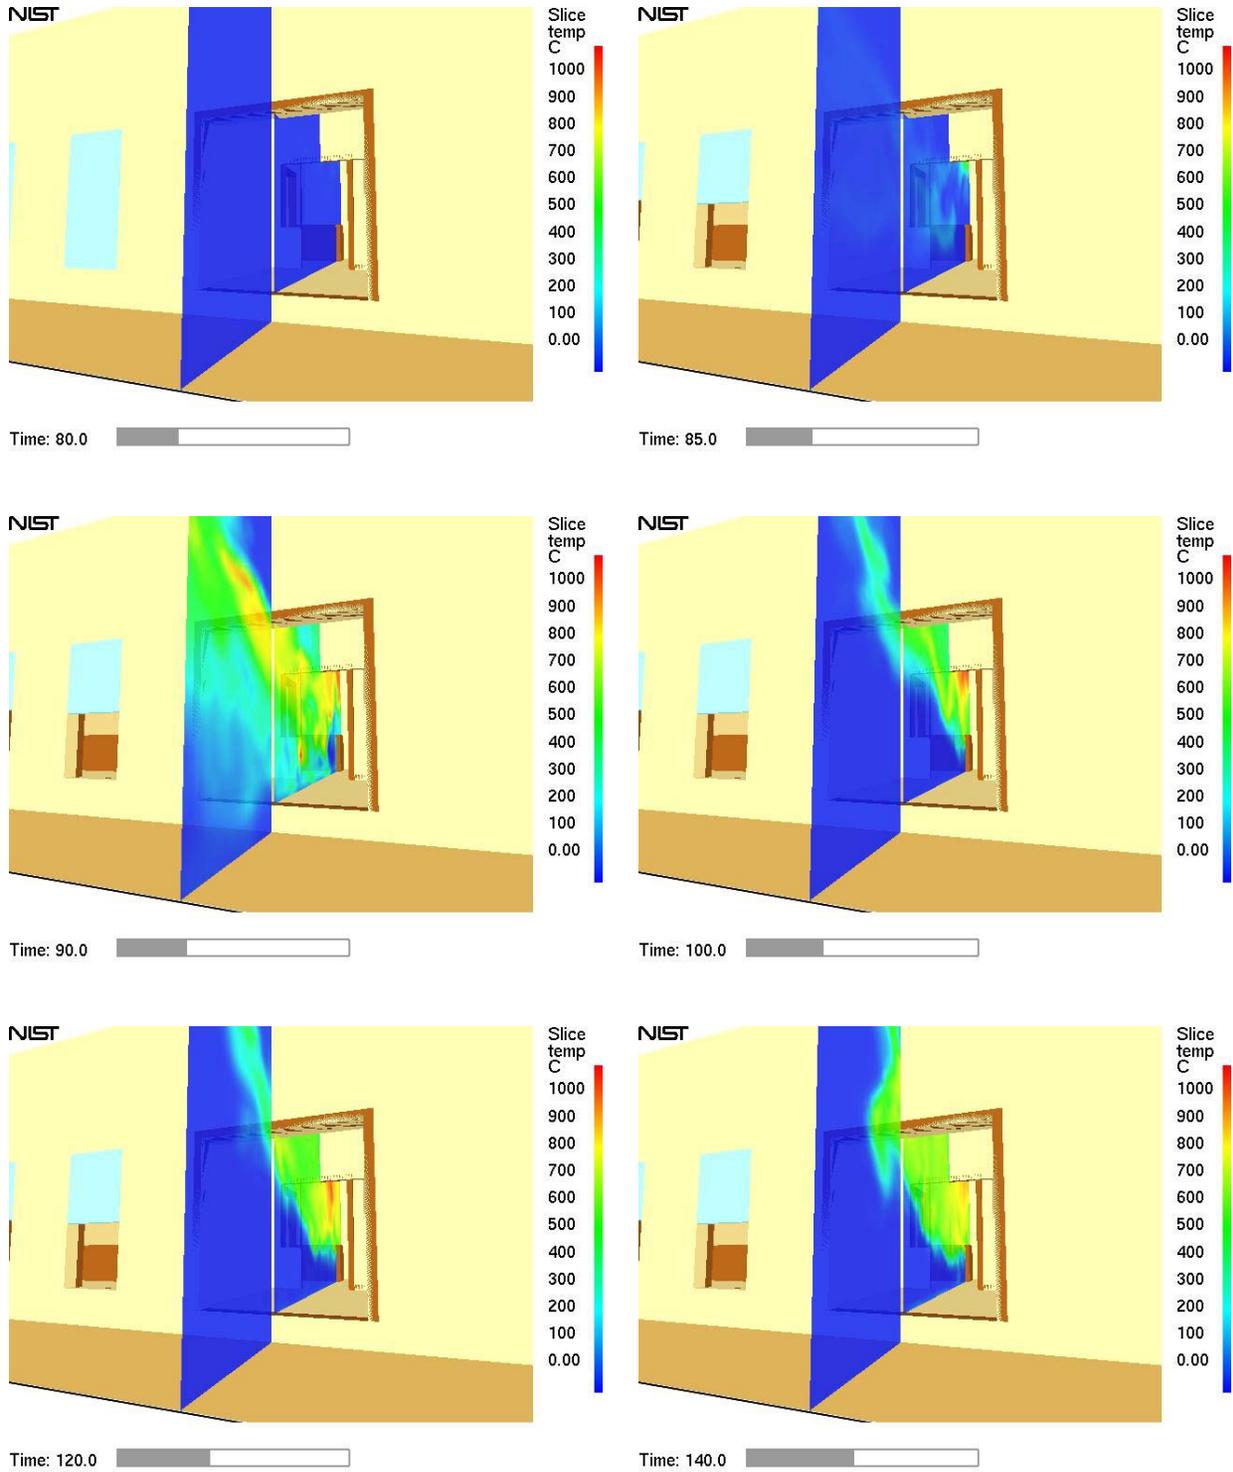
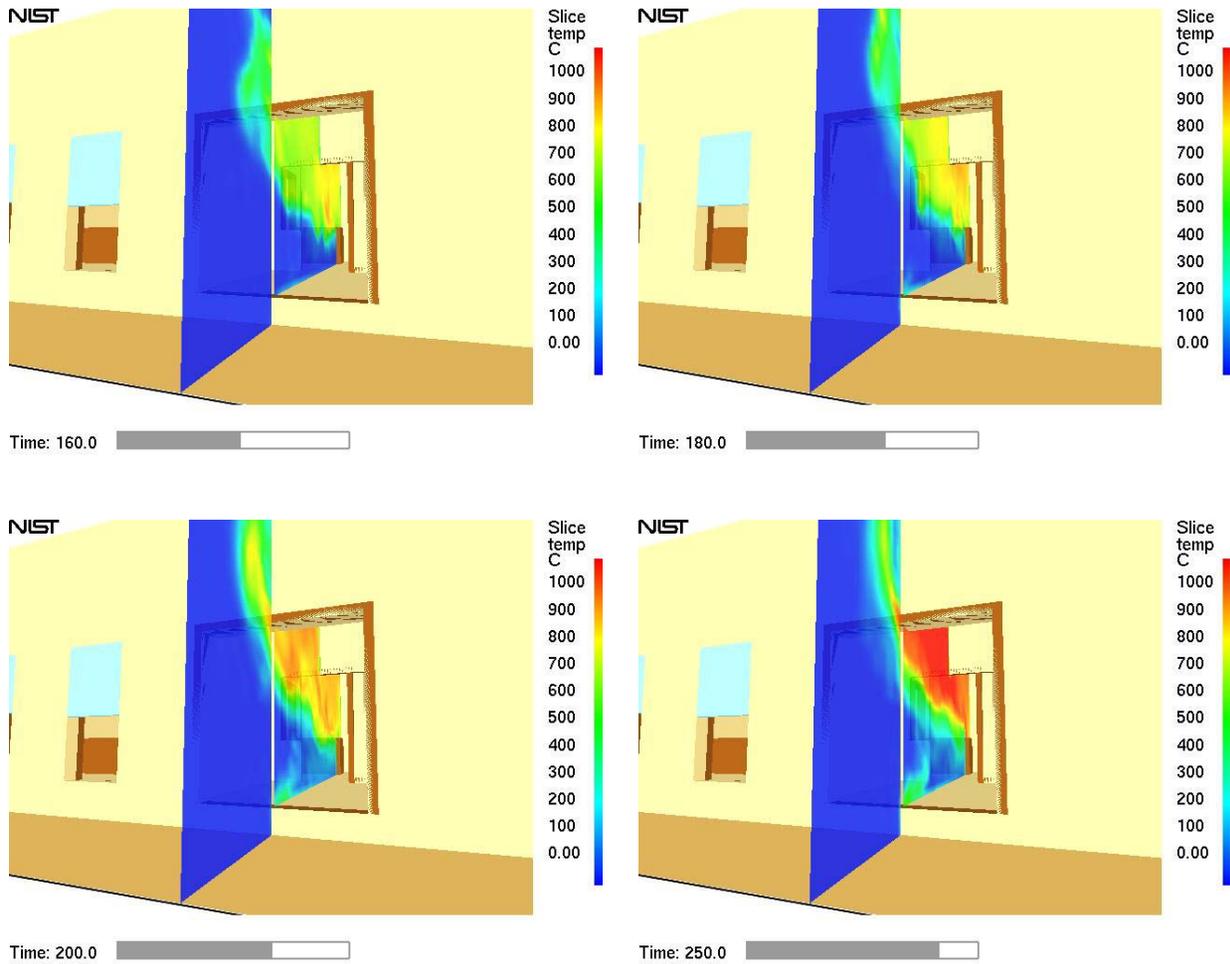
Figure 5-57a. Temperature profile through the center of the entry foyer, 80 seconds to 140 seconds

Figure 5-57a and 57b show the temperature predictions for the plane of data that is centered along the axis of the entry foyer. Temperatures just inside the front door, near the floor remain below the tenable limit because of the fresh air being drawn in through the doorway. This region of tenability decreases in a triangular orientation as the entranceway goes into the structure and gets smaller as the simulation continues. This simulation does not account for the occupants that accumulated in the doorway. Thirty-one victims were located in this area.

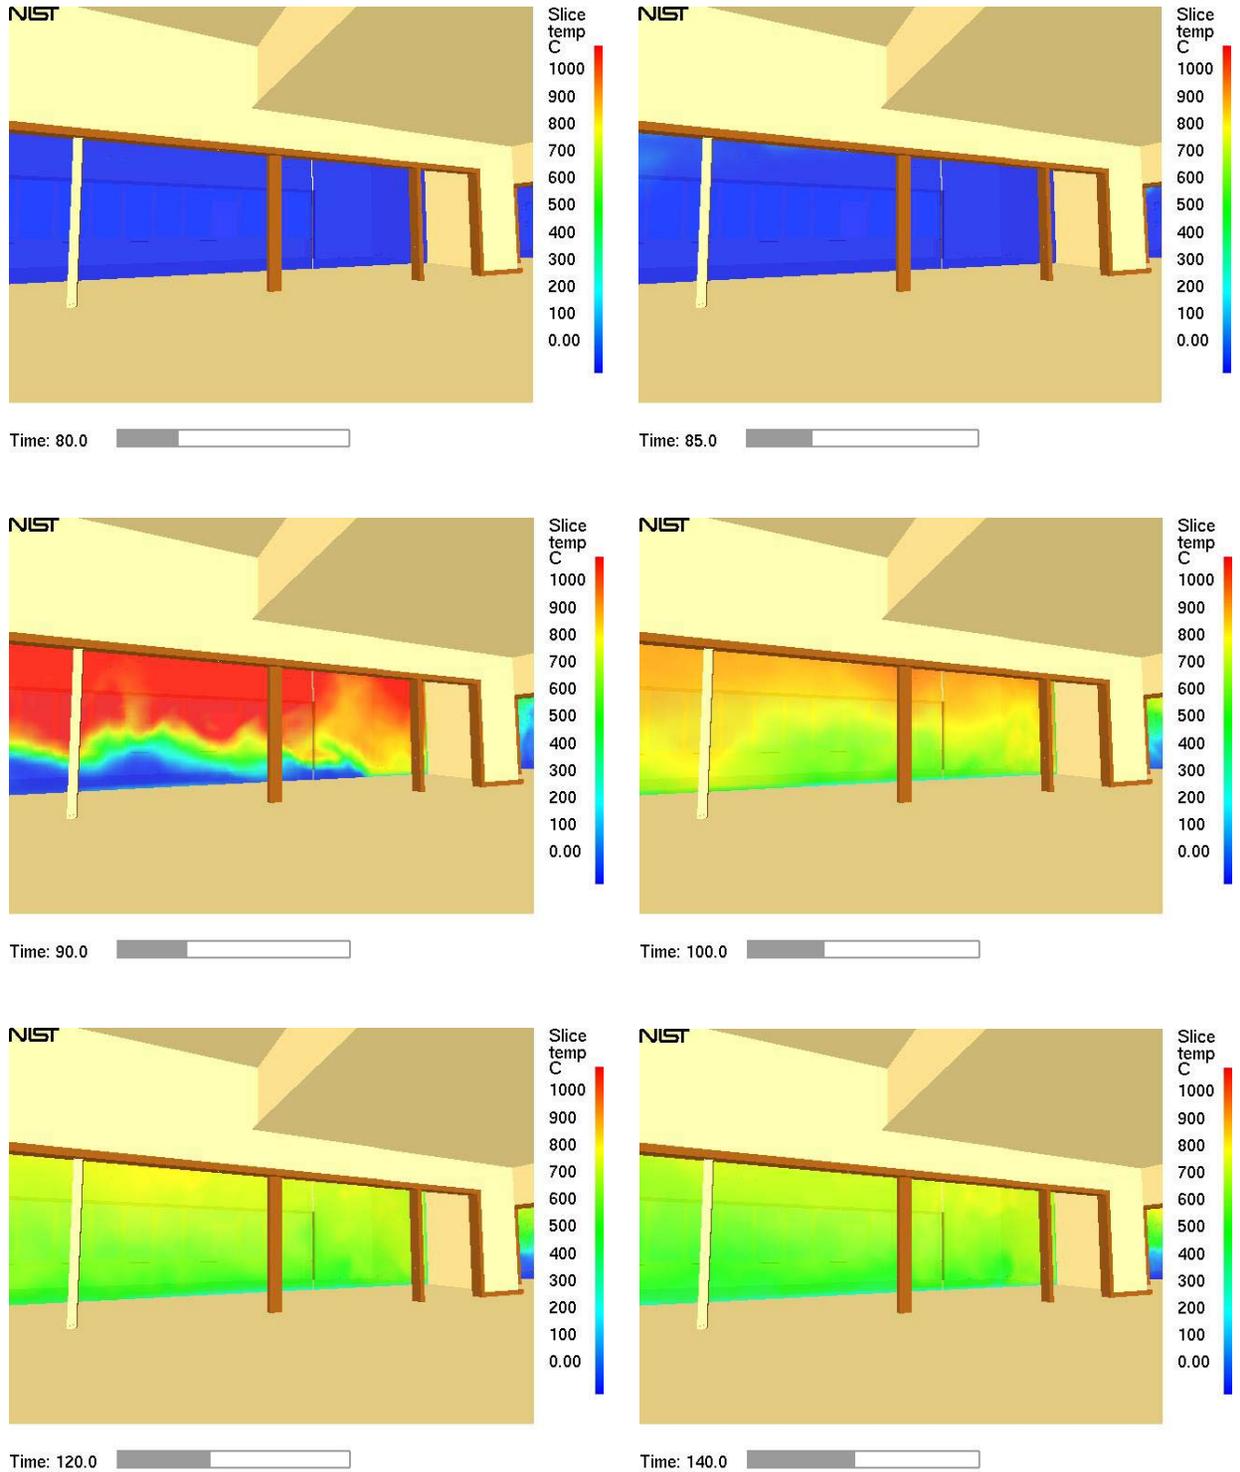
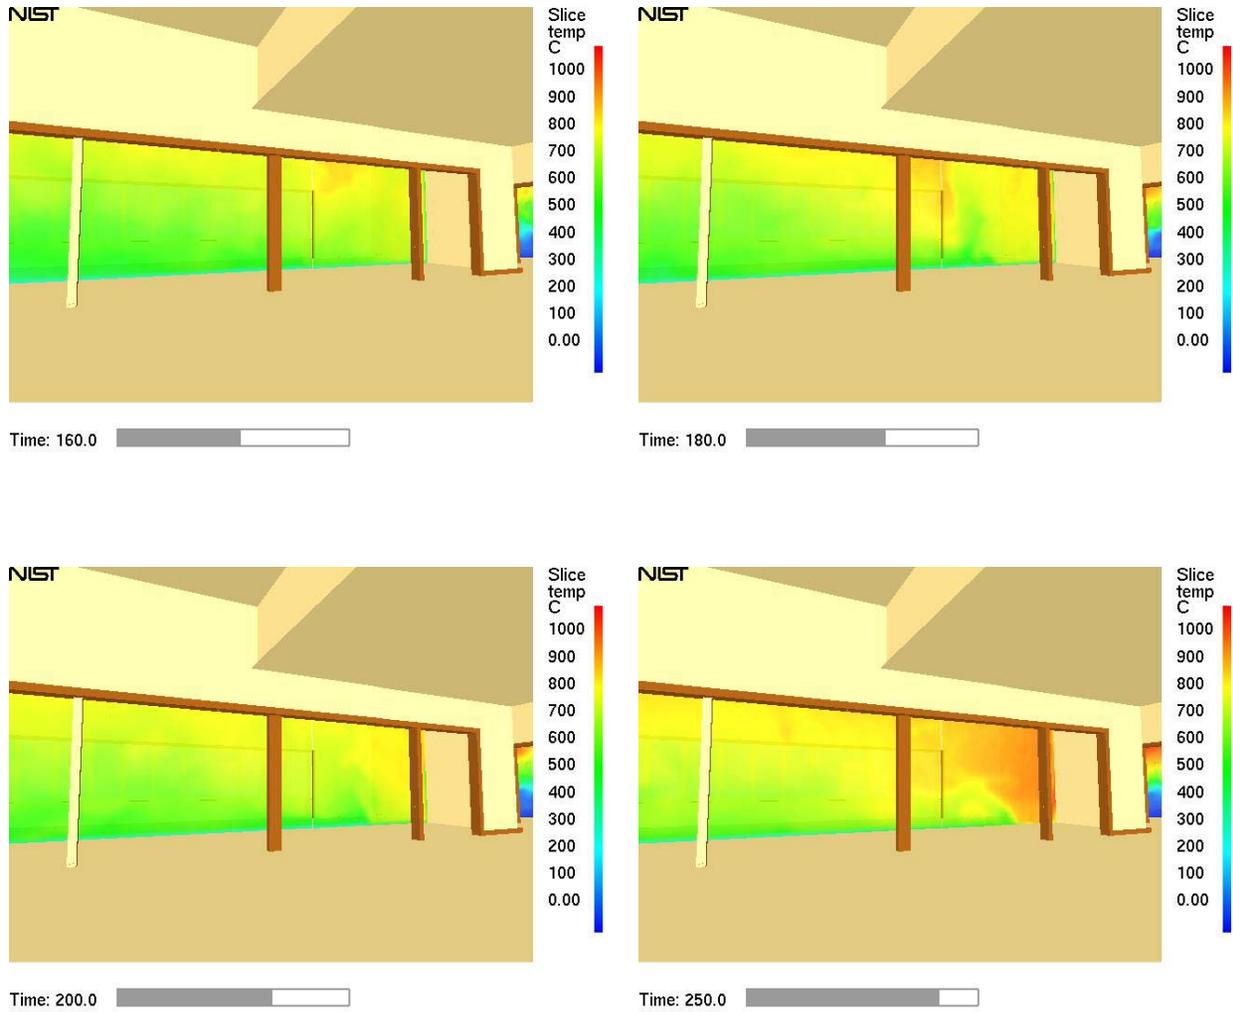
**Figure 5-58a Temperature profile through the center of the sunroom, 80 seconds to 140 seconds**

The area in the end of the sunroom adjacent to the entranceway was also a location that many victims were found. A vertical temperature slice through this area, shown Figures 5-58a and 5-58b, suggests that these victims did not have much time before the heat overcame them. Temperatures exceeded the 120 °C (248 °F) tenable threshold within 90 seconds after ignition. The simulation indicates that this change was rapid and extreme with temperatures in the upper portion of the space increasing from ambient conditions to flame temperatures on the order of 1000 °C (1830 °F) within 10 seconds. After the initial energy release due to the burning polyurethane foam (90 seconds), the predicted temperature decreased, but remained in the untenable range throughout the remainder of the simulation. Figure 5-58b shows that the temperatures increased again to 900 °C (1650 °F) at 250 s after ignition. The opening of portions of the bay windows between 78 seconds and 120 seconds after ignition had a minimal impact on reducing the temperatures in this part of the building. Eighteen victims were located in this area.

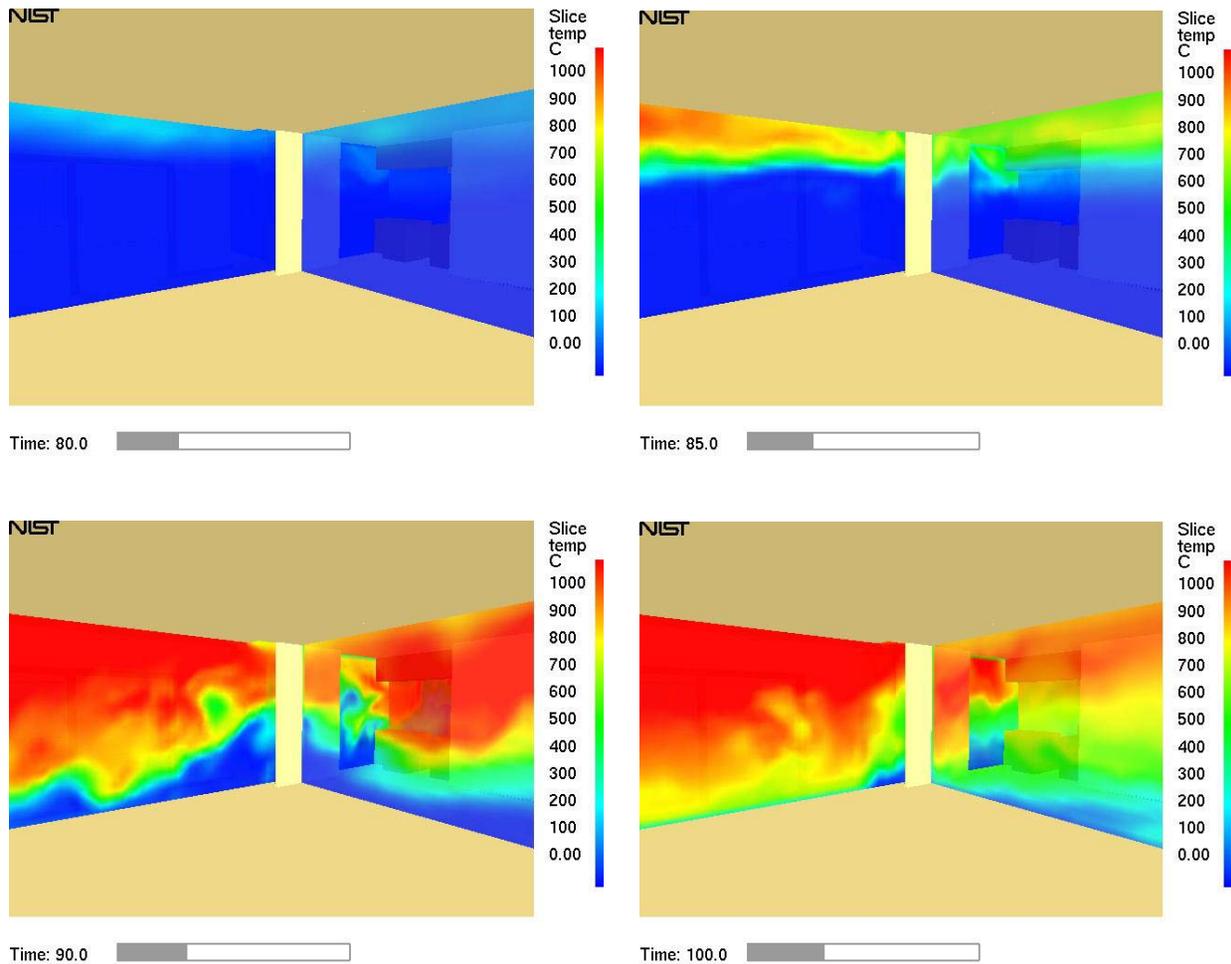
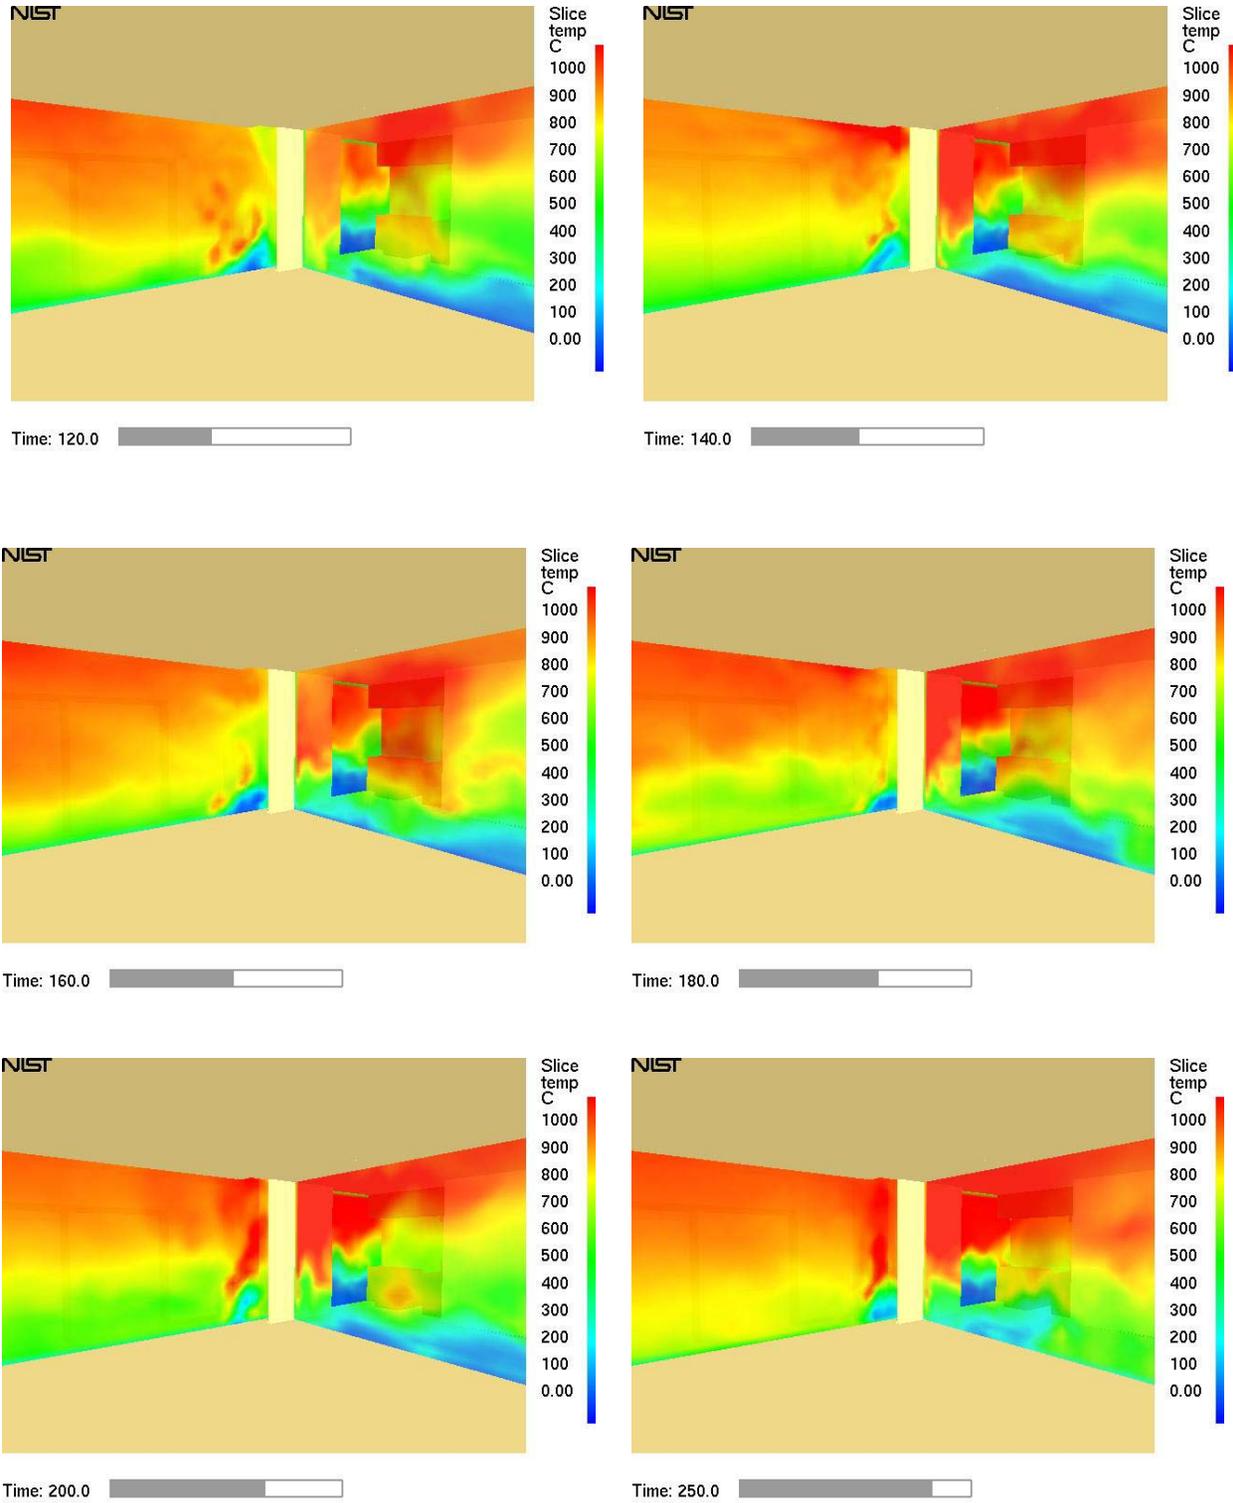
**Figure 5-59a. Temperature profiles approaching main entry foyer, 80 seconds to 100 seconds**

Figures 5-59a and 5-59b depict the temperatures in the approaches to the main entry foyer. The vertical temperature slices cover the area at the end of the entrance foyer and next to the ticket booth. The view is from the dance floor area looking toward the main entrance (front door). What appears to be a pillar in between the intersection of the two vertical slices is a portion of the wall that separates the sunroom from the main entry foyer. The images demonstrate that temperatures were untenable outside of the entranceway and that if the occupants were not able to make it into the area of cool air coming in from the front doorway, they did not have a chance of survival. Temperatures near the floor exceeded 400 °C (750 °F) within 100 seconds of ignition. Nine victims were located in this area.
