**NIST NCSTAR 2**

# **Draft Report of the Technical Investigation of The Station Nightclub Fire**

March 2005

A fire occurred on the night of Feb. 20, 2003, in The Station nightclub at 211 Cowesett Avenue, West Warwick, Rhode Island. A band that was on the platform that night, during its performance, used pyrotechnics that ignited polyurethane foam insulation lining the walls and ceiling of the platform. The fire spread quickly along the ceiling area over the dance floor. Smoke was visible in the exit doorways in a little more than one minute, and flames were observed breaking through a portion of the roof in less than five minutes. Egress from the nightclub, which was not equipped with sprinklers, was hampered by crowding at the main entrance to the building. One hundred people lost their lives in the fire. On Feb. 27, 2003, under the authority of the National Construction Safety Team (NCST) Act, the National Institute of Standards and Technology (NIST) established a National Construction Safety Team to determine the likely technical cause or causes of the building failure that led to the high number of casualties in that fire. This report documents the procedures, findings, and

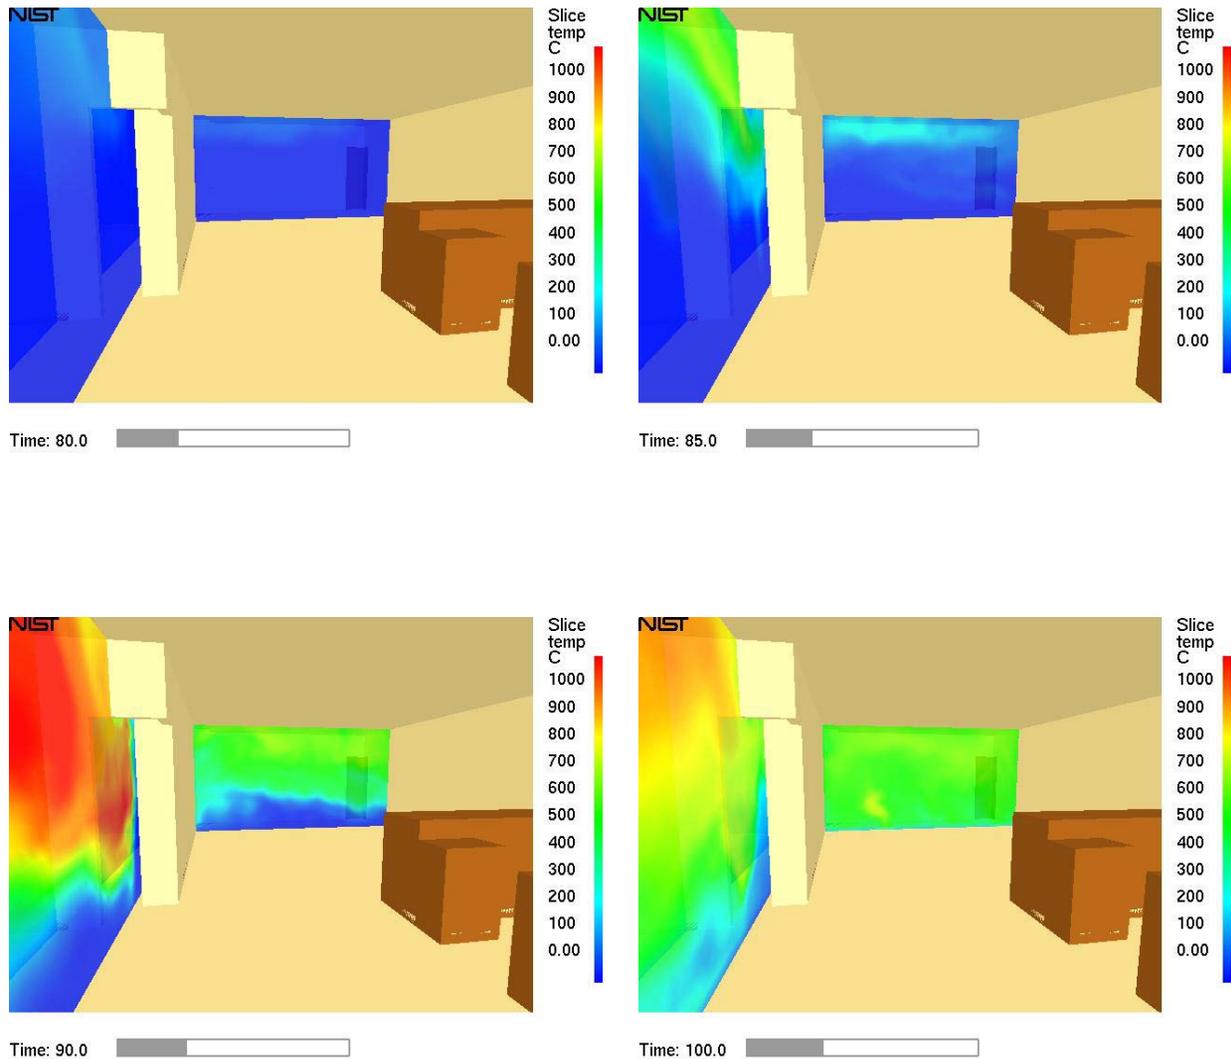
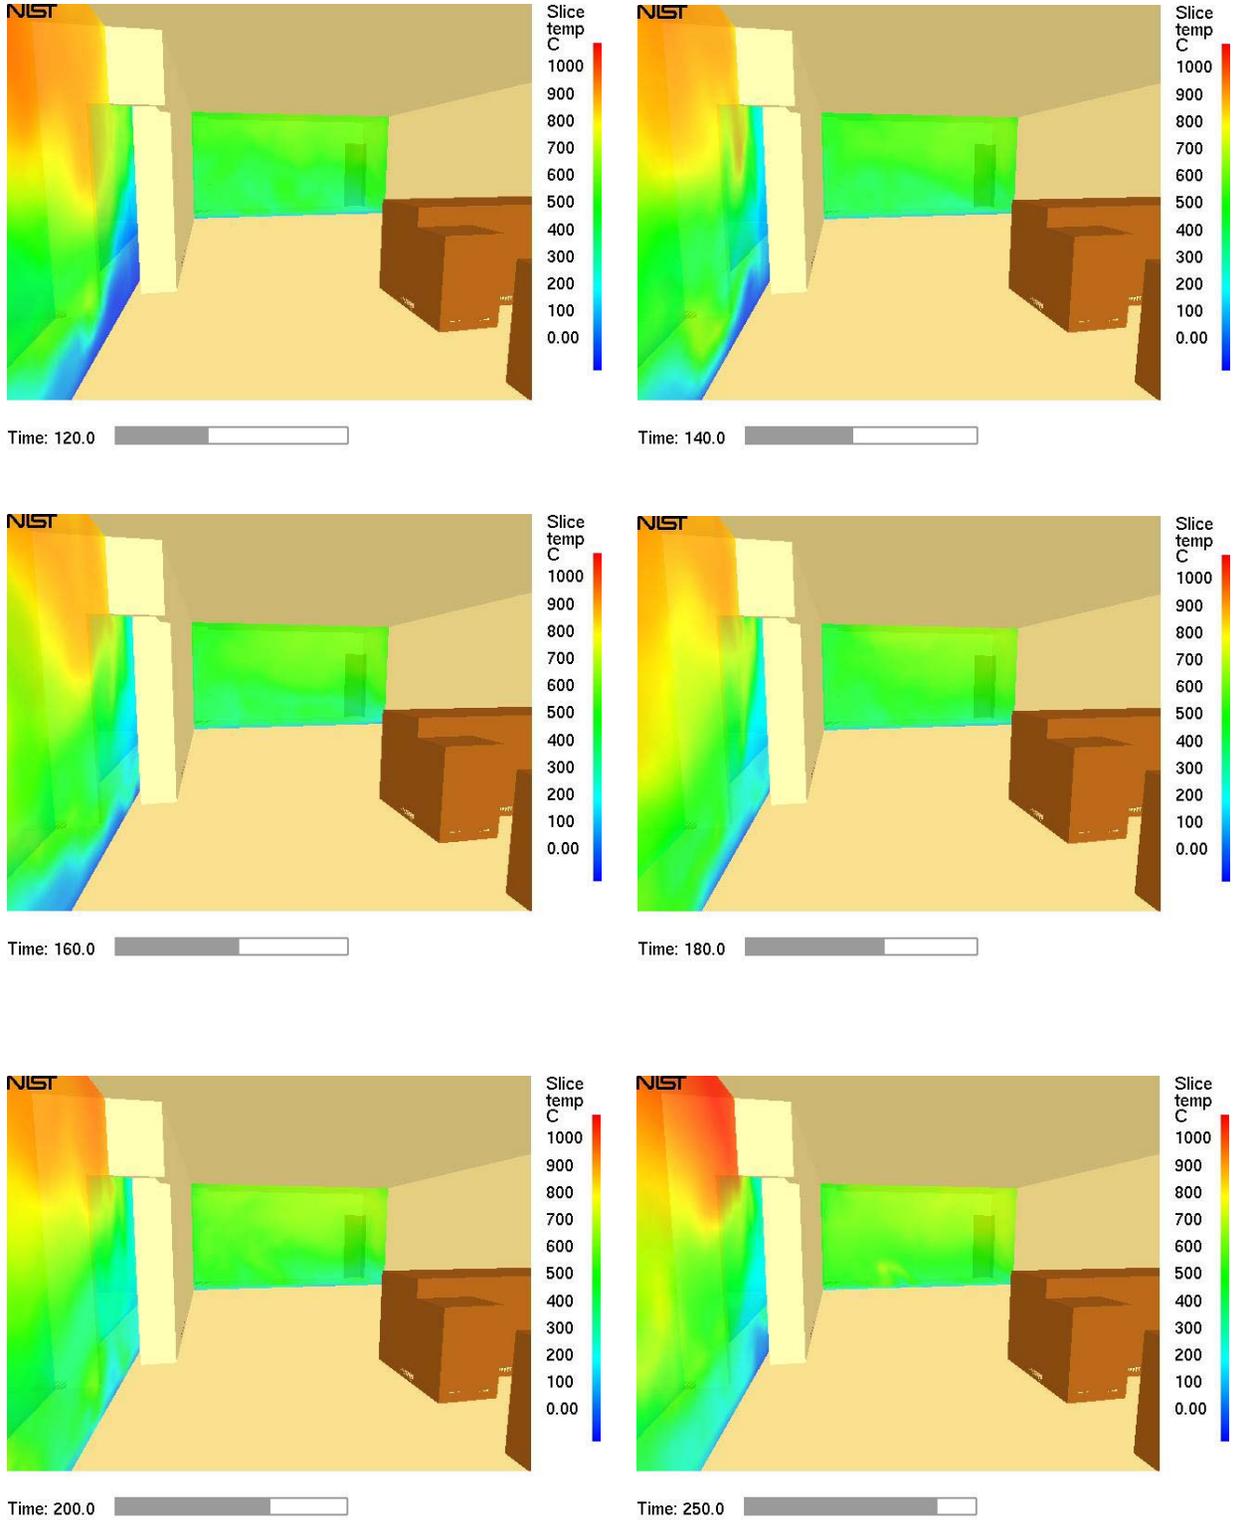
**Figure 5-60a. Temperature profiles in the dart room, 80 seconds to 100 seconds**

The area of the night club with the side bar and the dart room is shown in the simulated images with vertical temperature slices bounding the area to the north (toward the main entrance) and to the east (toward the storage/office area entrance). Figures 5-60a and 5-60b show the rapid change in thermal conditions between 80 seconds and 90 seconds after ignition. As in other parts of the night club simulation this significant increase in temperature was due to the burning of the polyurethane foam. Temperatures near the floor ranged from 200 °C (390 °F) to 600 °C (1110 °F) at 100 seconds. Figure 5-60b indicates that the temperatures remained in the untenable range throughout the rest of the simulation. In the incident, nine victims were found in this area.

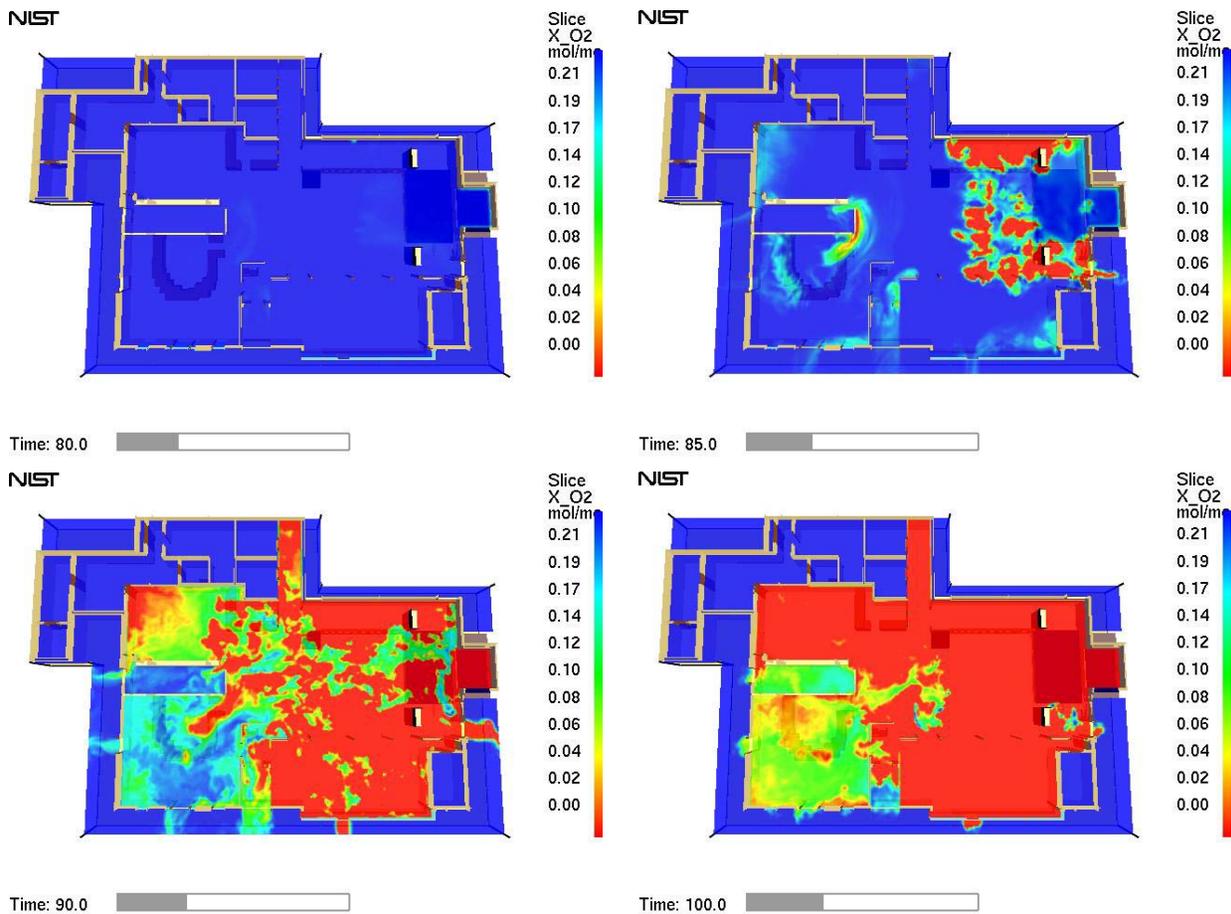
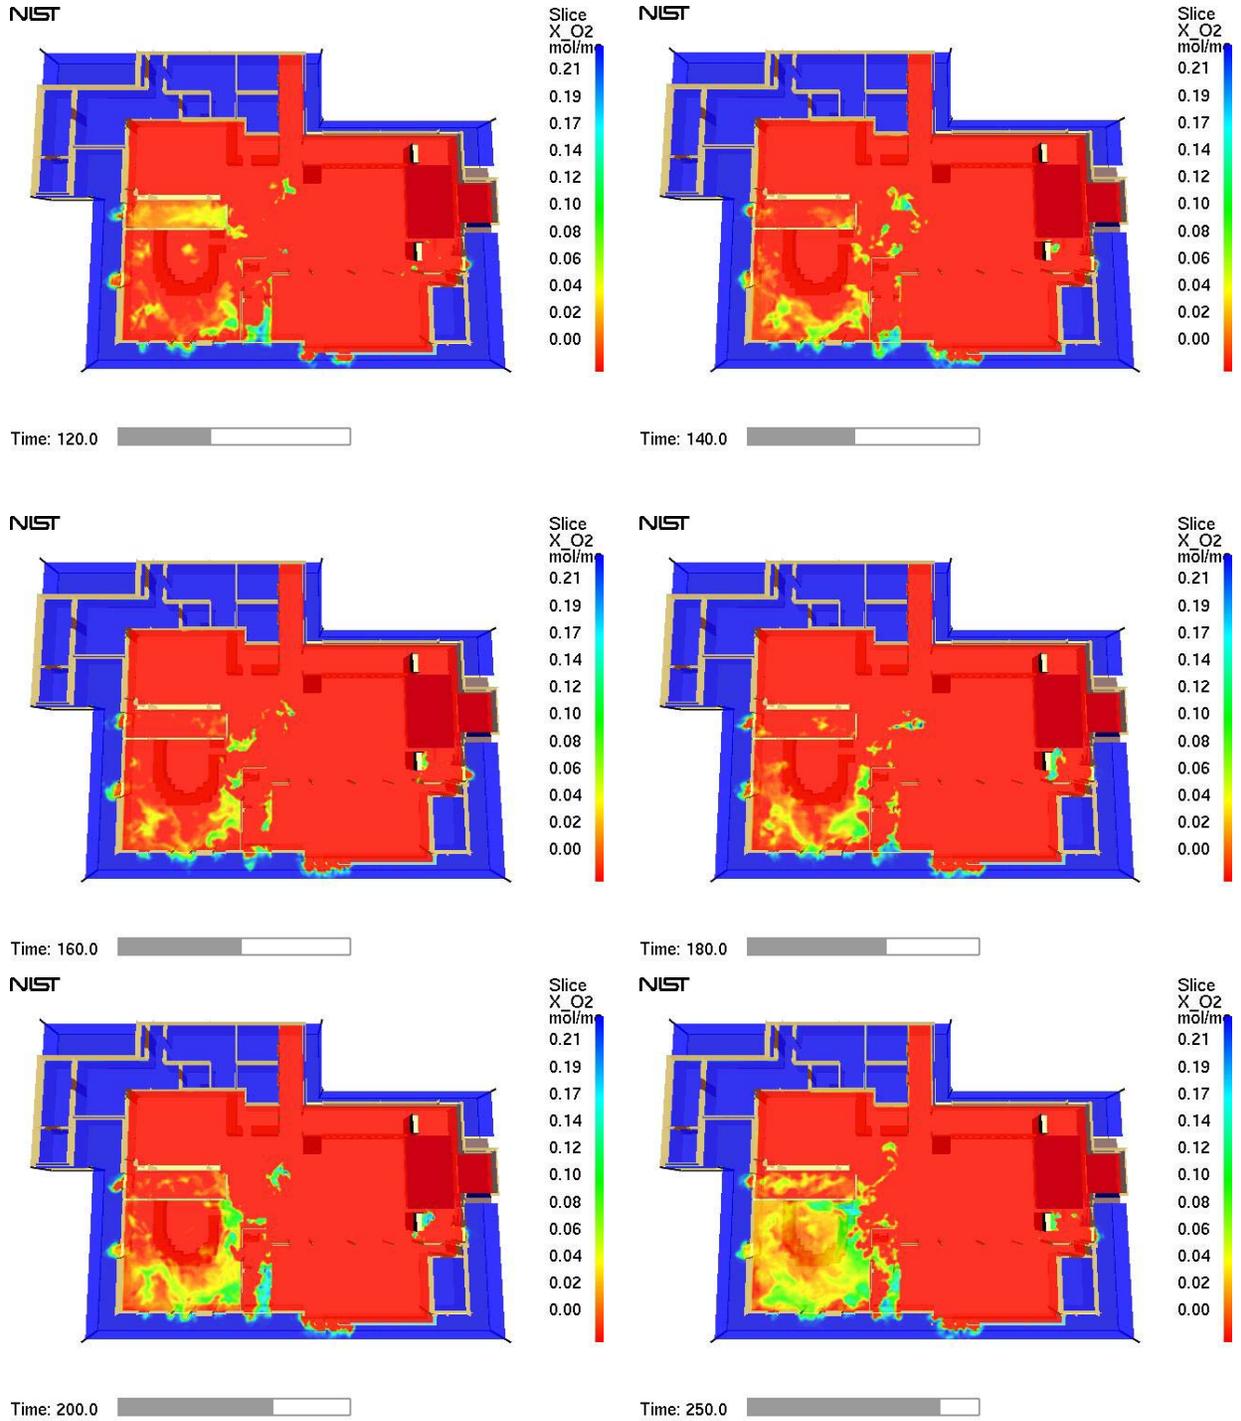
Figure 5-61a. Oxygen volume fractions at 1.5 m (5 ft) above the floor, 80 seconds to 140 seconds

Just as the temperature levels rose rapidly after the platform area became fully involved in flames, the oxygen levels drop proportionally. As shown by the three dimensional smoke output in the previous section, the smoke spreads quickly through the structure. Figure 5-61a contains four images ranging from 80 seconds after ignition to 100 seconds after ignition. This sequence has the most dramatic changes in oxygen concentration. Beyond 100 seconds the entire structure is untenable at the 1.5 m (5 ft) height. Tenability exists for the longest duration in the main bar area. Figure 5-61b shows the progression of the oxygen levels through the end of the simulation at 250 seconds. Most of the building, including the platform and dance floor areas, the dart room, the main entry foyer and the main bar room, is shown by the simulation to be significantly depleted of oxygen to less than 2 %.

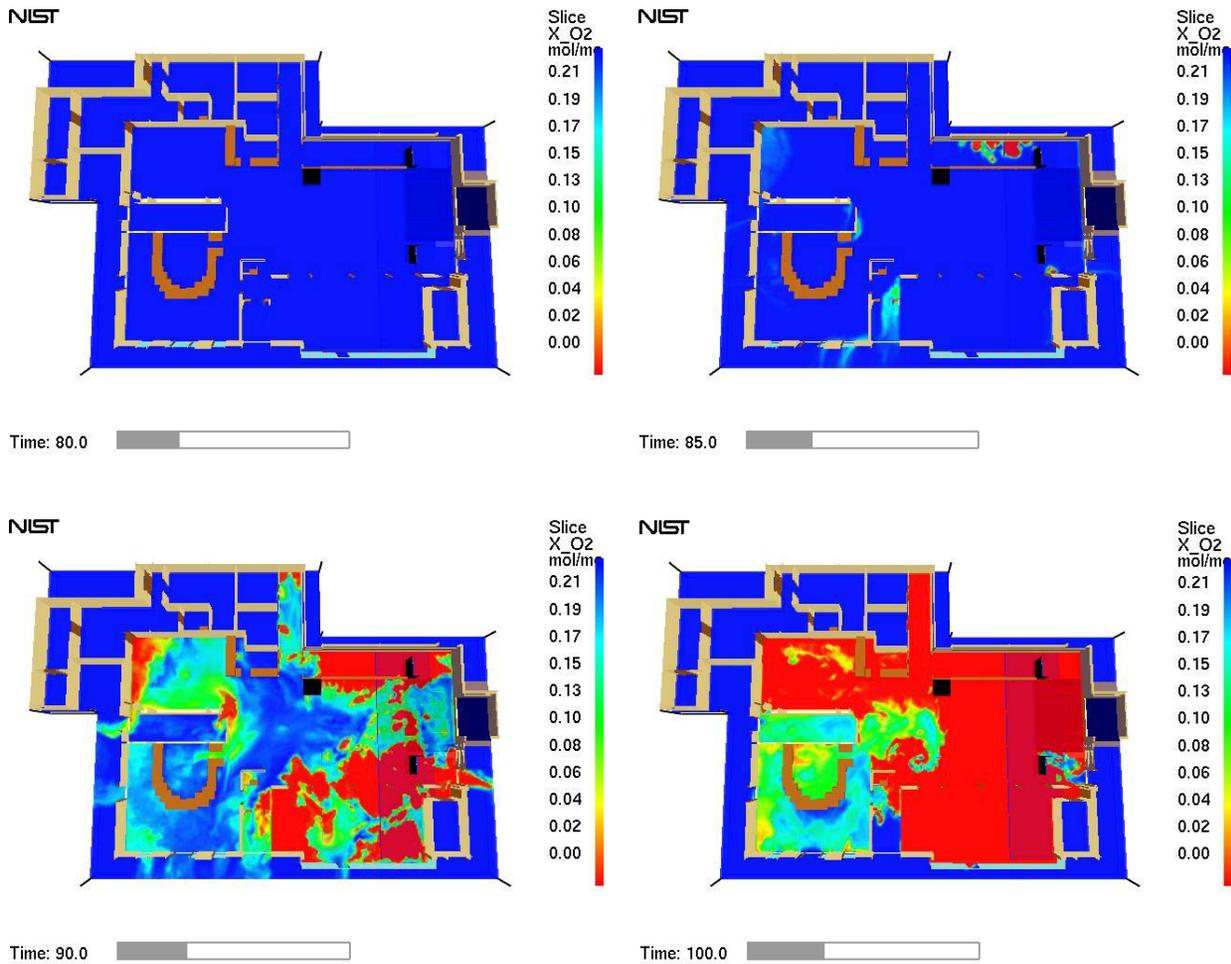
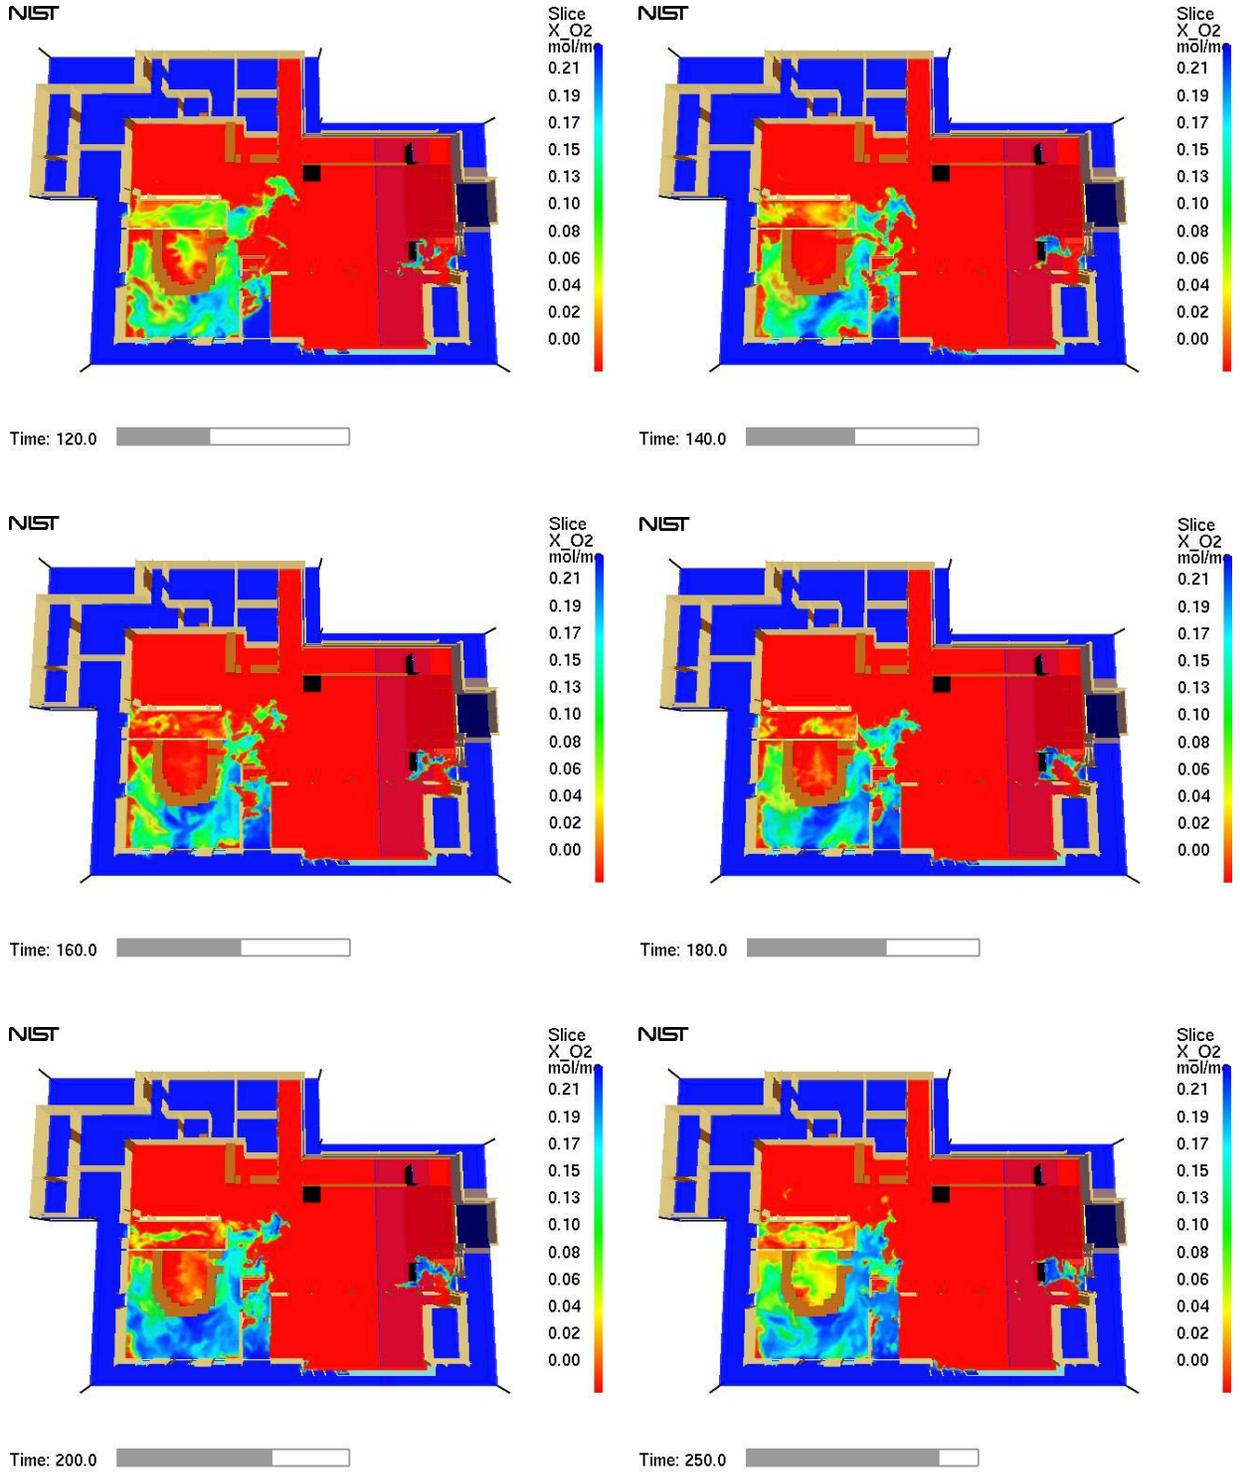
**Figure 5-62a Oxygen volume fractions at 0.6 m (2 ft) above the floor, 80 seconds to 100 seconds**

Figures 5-62a and 5-62b show the predicted oxygen volume fraction 0.6 m (2 ft) above the floor, beginning at 80 seconds after ignition through 250 seconds after ignition. At this lower level it is apparent that tenability is also not likely in any area other than the main bar area and the entranceway right inside the front door. The opening of the windows at the front of the main bar room creates a more tenable atmosphere, probably saving the lives of occupants as they can be seen being pulled from the windows in the WPRI video. Occupants that stayed low in the main bar area had a better chance of survival.

The images in Figure 5-62b, once again show a rapid decrease in tenable conditions due to oxygen depletion throughout most of the simulated nightclub with the exception of the main bar room and the main entry foyer. Due to the open doors and windows in these areas, the simulation indicates that sufficient fresh air was drawn in to maintain a level of tenability with respect to oxygen in the areas adjacent to the open windows and the main entry way. This trend is shown to continue through the end of the simulation. In the WPRI video, the last person recorded being assisted through a window from the main bar room occurs at 250 s seconds after ignition. This is consistent with the predicted oxygen concentrations near the windows.

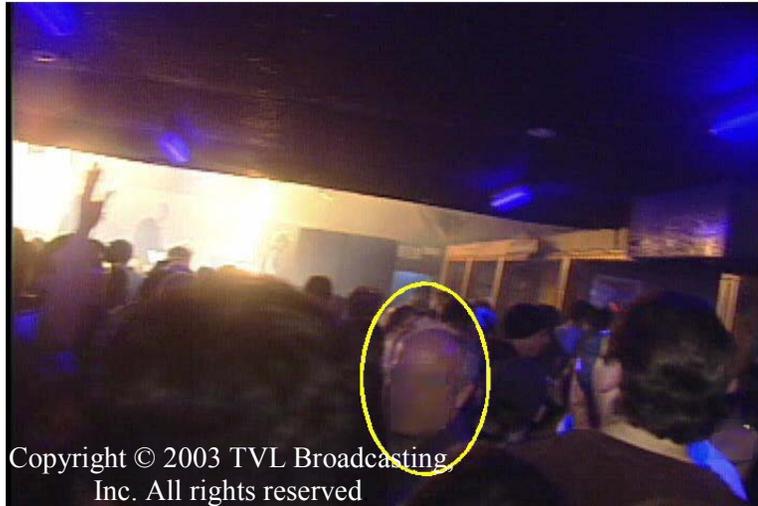
Efforts were made to track individuals from their location in the club when the fire ignited until they had evacuated. One male occupant, shown facing the camera in Figure 6-1, was tracked through evacuation. The time of this still frame is 0:06:51 video time (0:00:29 fire time). The occupant's face has been blurred in the figures below in order to preserve his anonymity; his facial features were not critical for the identification analysis.

After the ignition of the fire, the camera operator began moving towards the main exit before most other occupants did. The camera passed the occupant shown in Figure 6-1 before this individual had begun to evacuate, and he can be seen still facing the platform. At 29 seconds after the ignition of the fire, this individual was seen to turn and to begin moving towards the door. At this point, the camera was approximately two rows of people behind this man (between him and the main exit). This occupant can be seen reaching and crossing the main exit at 0:07:31 video time (0:01:09 fire time), 39 seconds later, in Figure 6-2.

**Figure 6-1. Occupant at Start of Evacuation [2]**

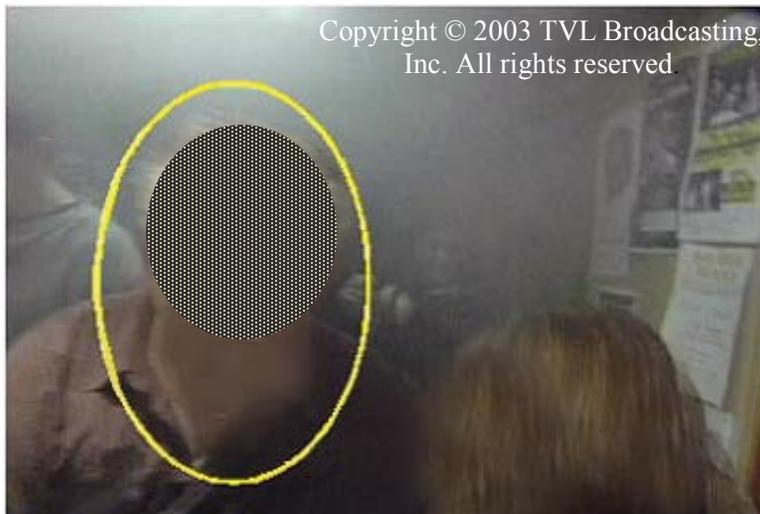
**Figure 6-2. Occupant Exiting the Building [2]**

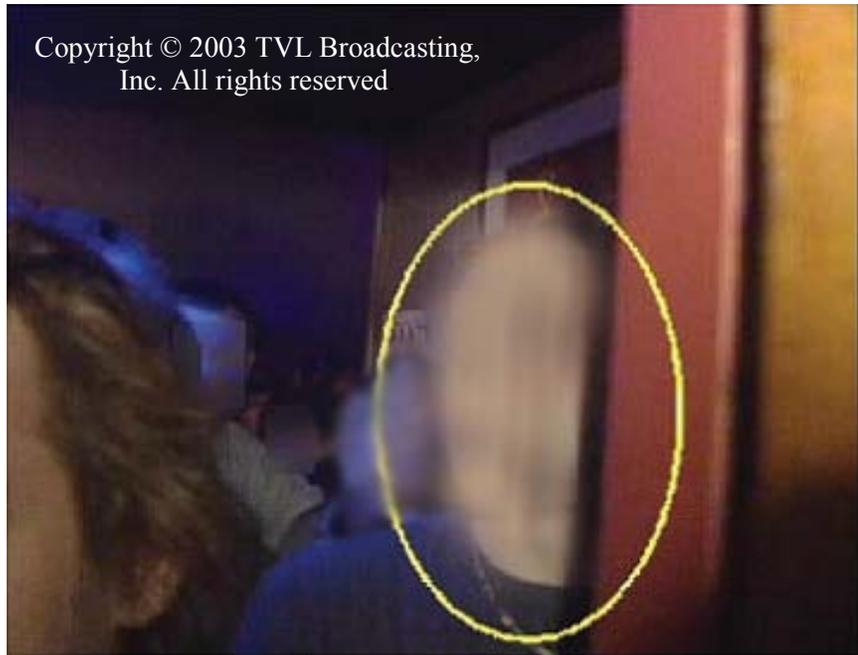
**Figure 6-4 Occupant Attempting to Evacuate [2]**

Forty-one seconds elapsed between Figure 6-4 (0:01:02 fire time) and when the occupant was first seen near the bottom of the pile. Because the camera operator moved to the side of the building immediately upon exiting through the main exit, it is not known when the individual shown in these figures reached the door and fell to that position.

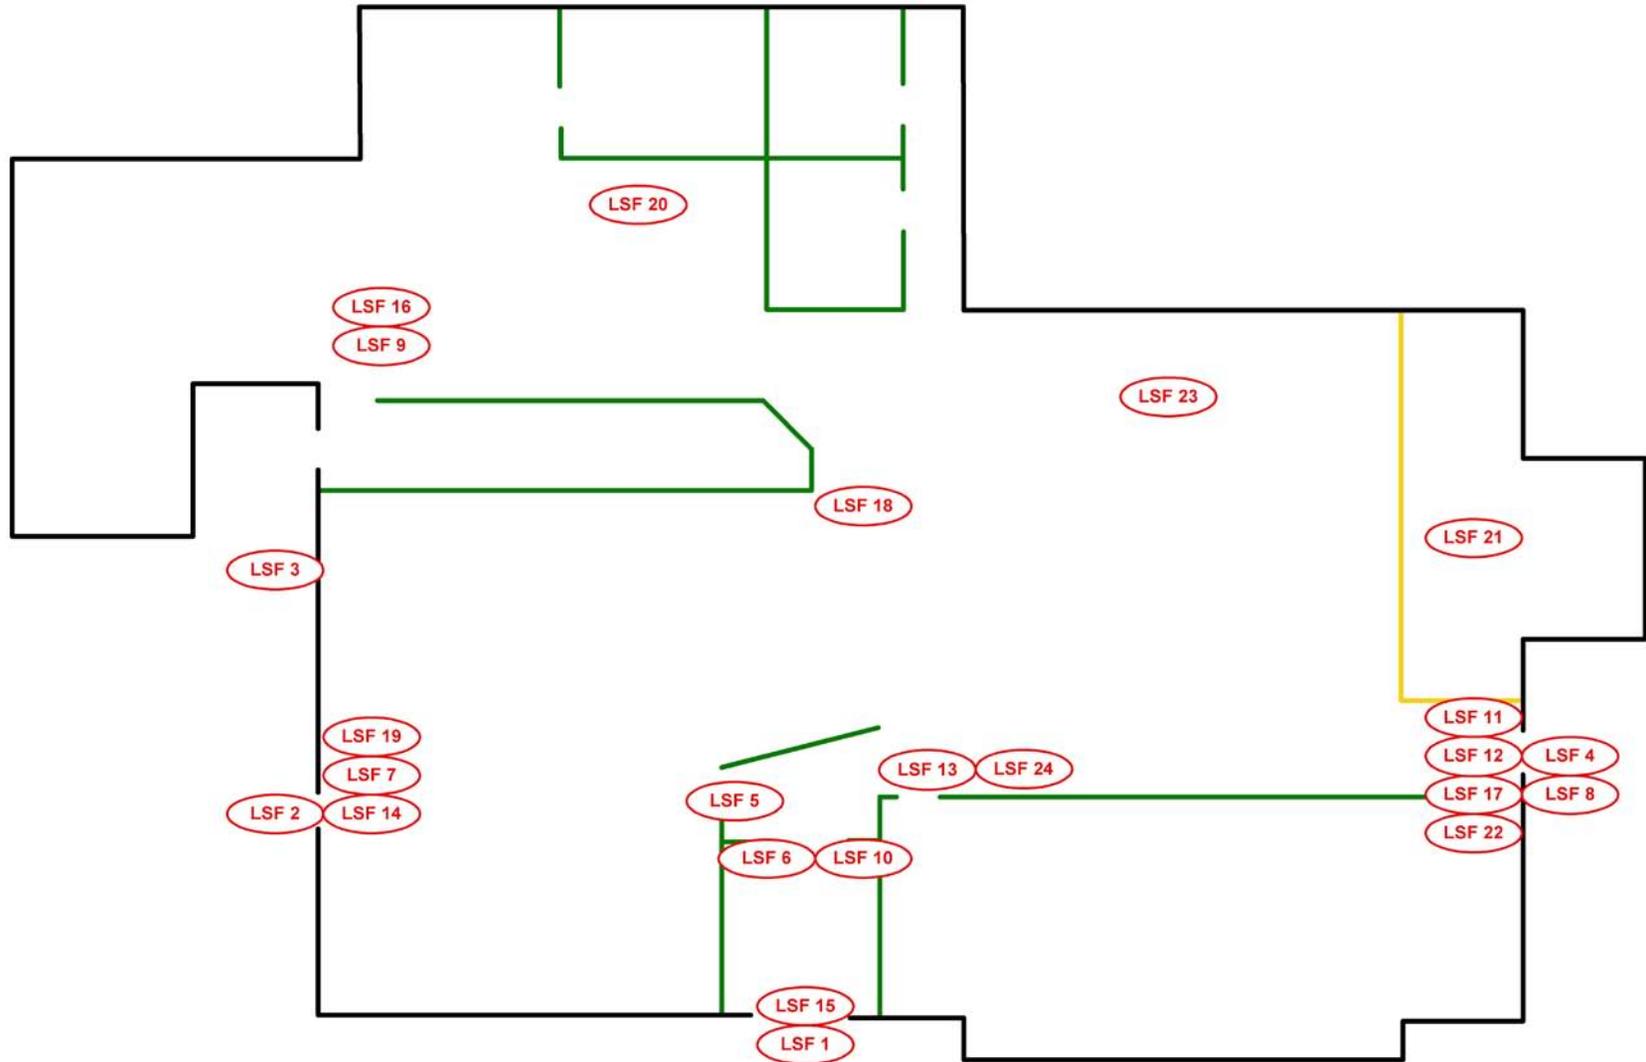
**Figure 6-9. Locations of life safety features listed in Table 6-1.**

Table 6-1 summarizes all identified life safety features within The Station prior to the fire. Refer to Figure 6-9 for the locations of these features within the building. Specific devices and features are shown

LSF 16.	Emergency light located near the rear bar.
LSF 17.	Emergency light above and to the right of the platform exit door.
LSF 18.	Emergency light on the wall adjacent to the kitchen by the main bar facing into the main floor area.
LSF 19.	Emergency light above and to the right of the left side exit door from the main bar area.
LSF 20.	Fire extinguisher located behind the rear bar.
LSF 21.	Detector (heat) located above the lighting grid on the ceiling near the platform.
LSF 22.	Fire alarm strobe adjacent to the exit sign above the platform exit door.
LSF 23.	Fire alarm strobe on the ceiling to the left and in front of the platform.
LSF 24.	Fire alarm strobe on the wall adjacent to the exit sign in the main floor area pointing toward the ticket area.

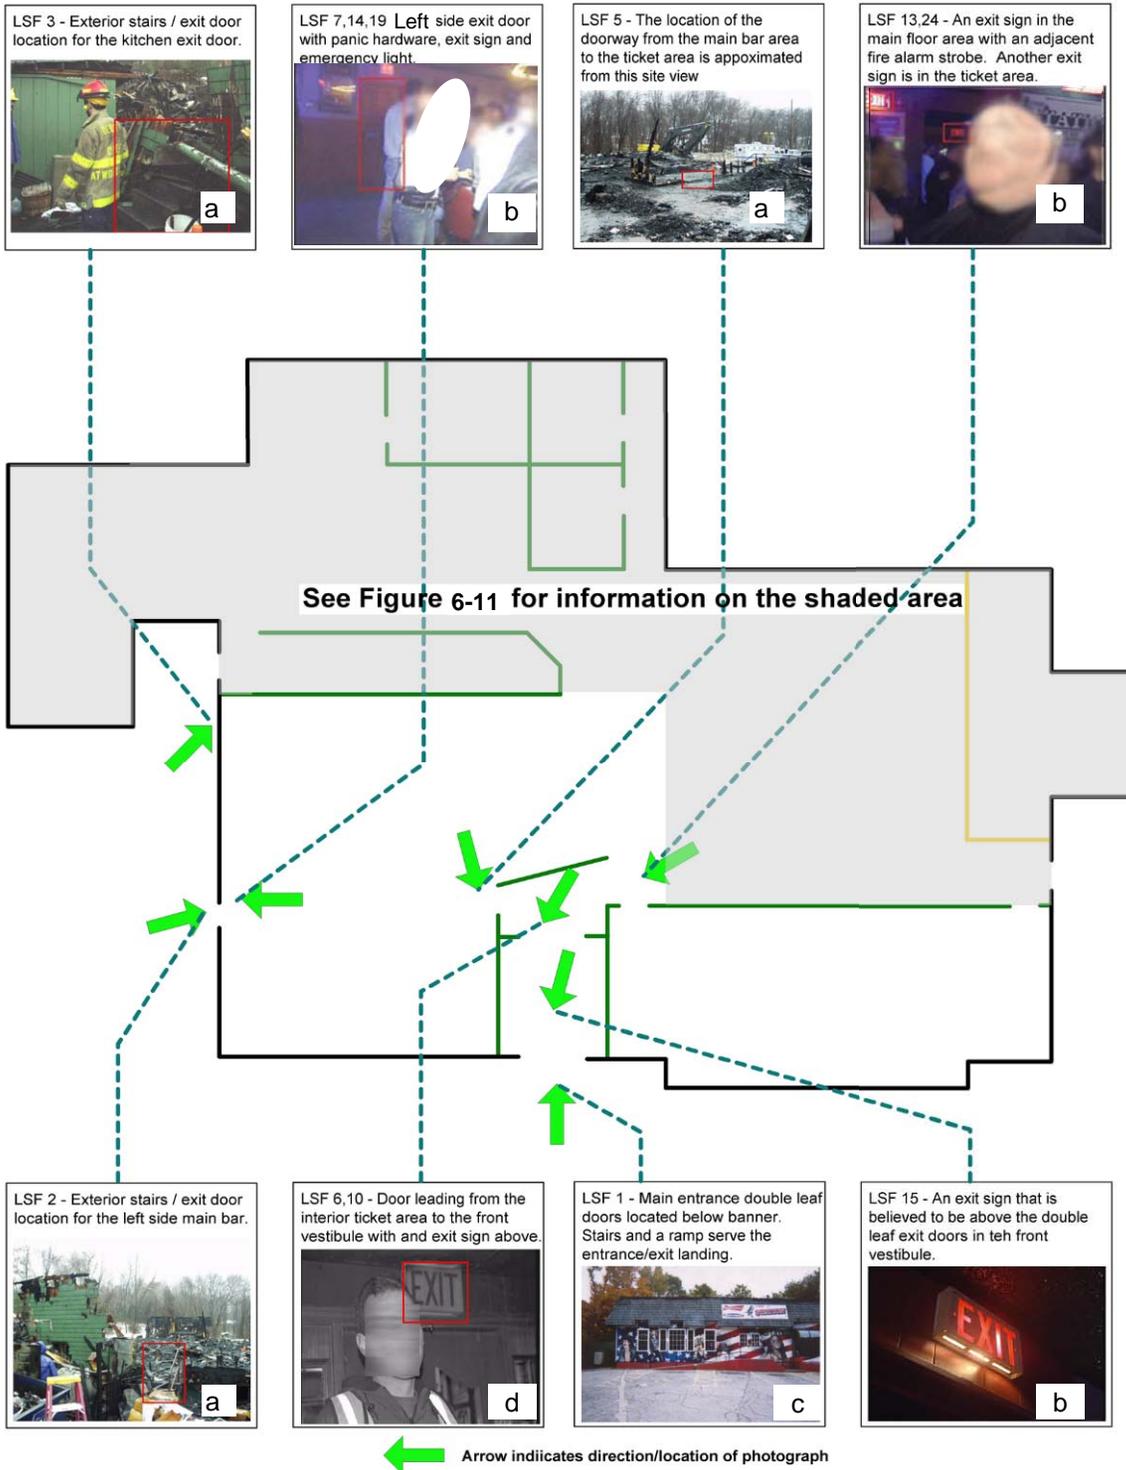
Figure 6-10. Summary of Life Safety Features – Part 1

Egress through the main entrance to the building was limited by a single interior door (LSF 6 in Figure 6-10) not the double doors that could be seen from outside the building.

- Platform exit door swings in the wrong direction;
- Panic hardware on platform door is broken.

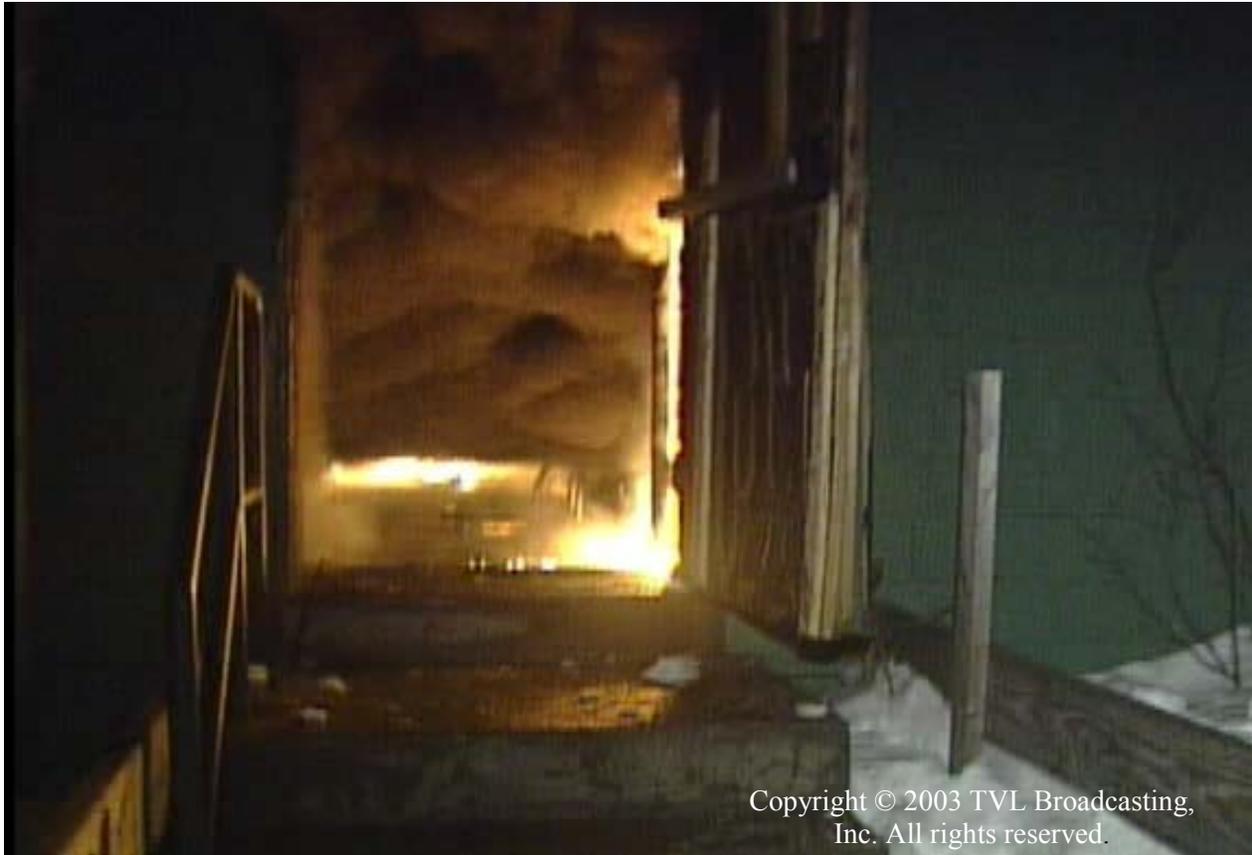
**Figure 6-13. Exit Door Near Platform [2]**

The presence of the interior door is evident from the inward-swinging hinges seen on the doorframe. The edge of this door is visible as well. As can be seen in Figure 6-14 the exterior door was equipped with panic hardware. The hardware installed on the interior door is unclear. Additional examination of this figure reveals what appears to be adhesive on the inside of the exterior door.

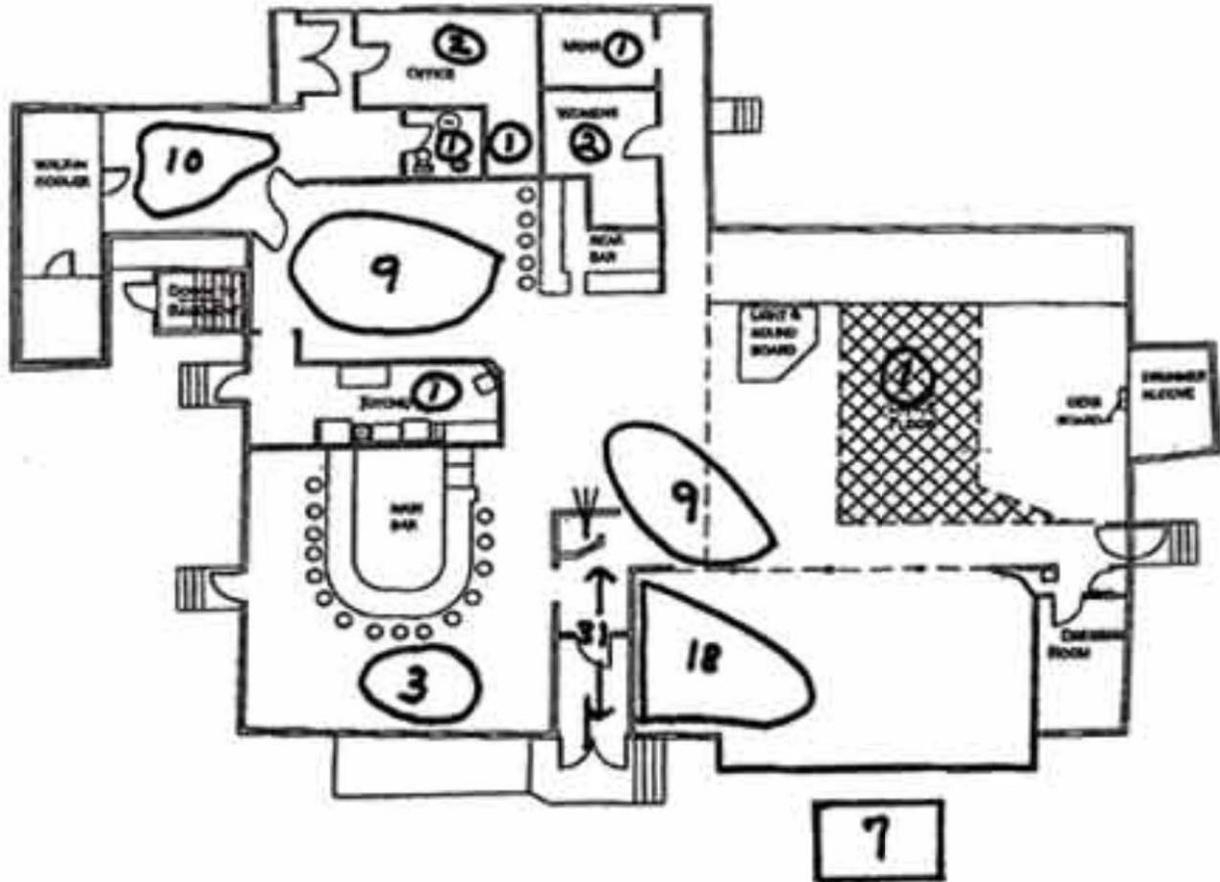
The Rhode Island Attorney General's office released a diagram of the approximate location where the rescuers recovered the 96 people who died at the scene of the fire [36]. (See Figure 6-14.) Based upon interviews with witnesses reported by the *Providence Journal* and the distribution of the victims shown in Figure 6-14, about 2/3 of the occupants appear to have attempted to leave through the main entrance in the front of the building; however, only about 40% of those who successfully evacuated escaped through the main entrance.

Figure 6-14. Location of Recovered People Who Died at Scene [36]

A little over half of all people who successfully escaped via the doors (main entrance plus main bar plus kitchen plus platform door) exited via the main entrance. The windows in the main bar room and the sunroom appear to have become the secondary routes of escape once the main entrance became impassible, and accounted for over 1/3 of the successful evacuations.

The small number of victims found in the main bar room suggests that the main bar room exit door and windows provided open routes to escape for a time period about as long as it took to reach untenable

A significant number of victims were found in the dart room, storage area, and office, suggesting either that they were unfamiliar with the building and hoped to find a safe exit in that region, or that they became disoriented while heading for the side exit of the main bar room (or possibly the kitchen exit). It is unclear whether the seven people identified in Figure 6-14 as being recovered from the front of the building outside of the sunroom died as they escaped or were pulled from the sunroom by rescuers.

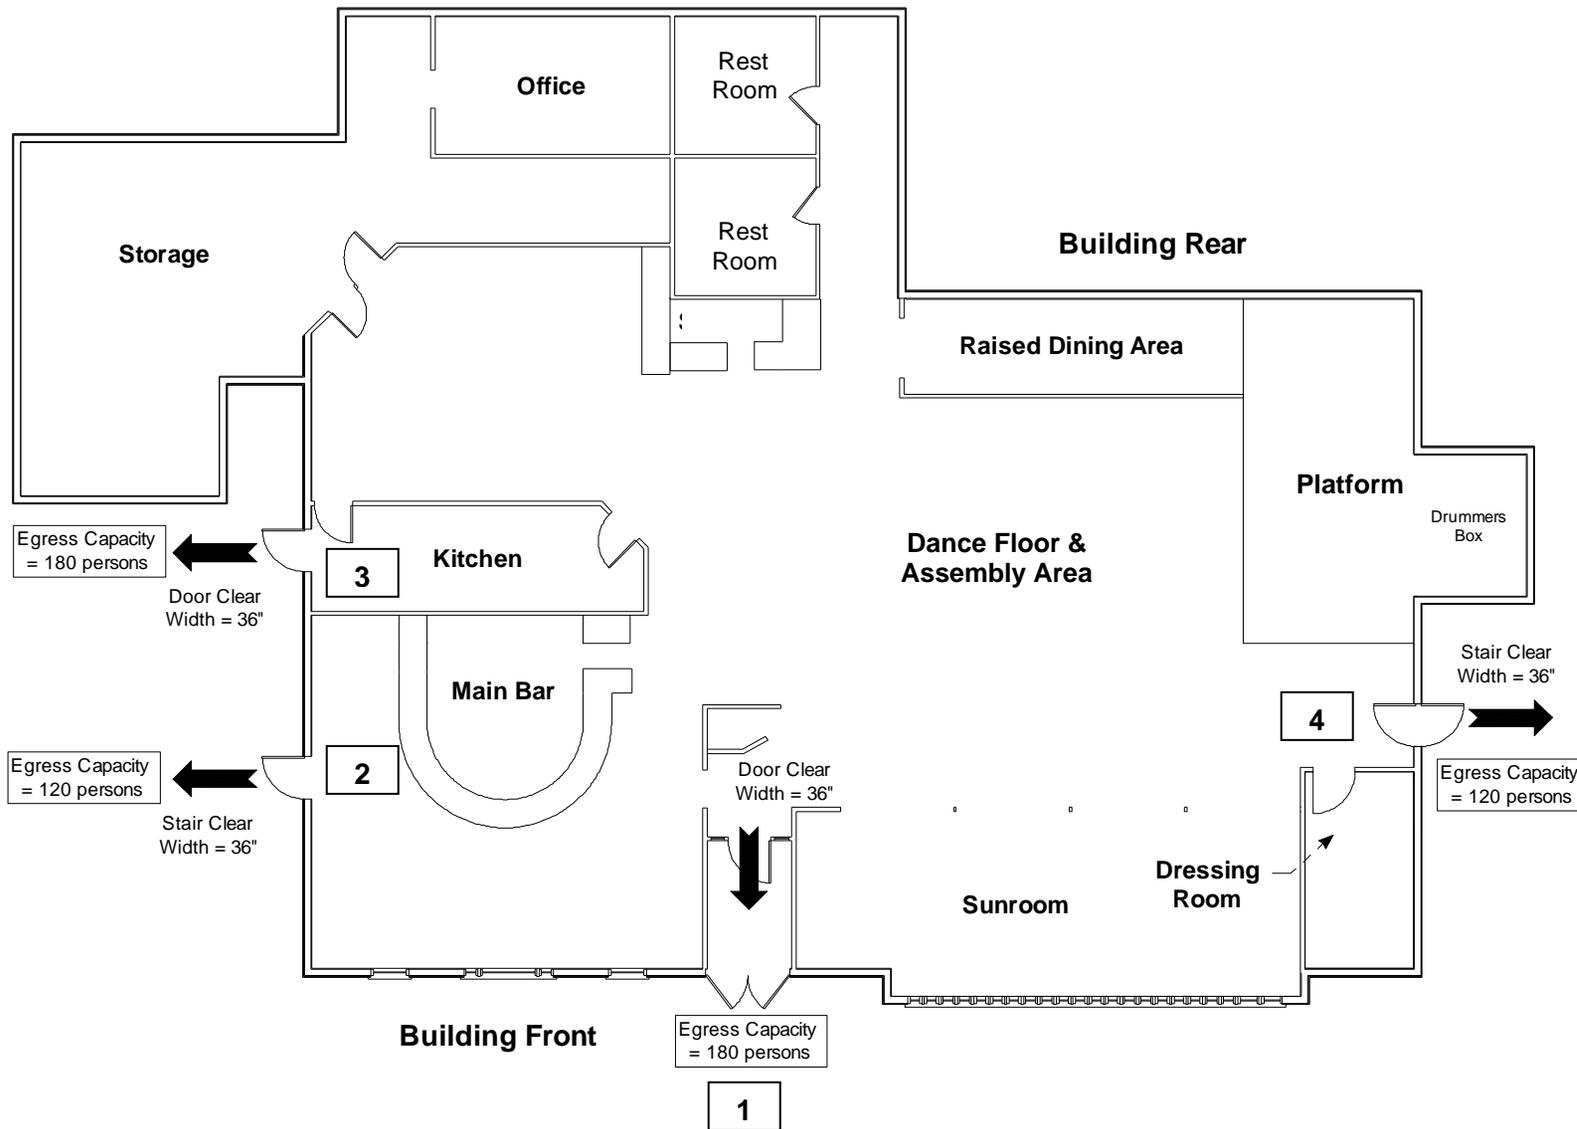
There were four exit routes from the building, as numbered in Figure 7-5: (1) the front main exit, (2) the main bar exit on the side, (3) the kitchen exit, and (4) the platform exit. The model codes govern their number, size, placement, and other details of design, as discussed in this section

**Figure 7-5. Station Nightclub Egress Capacity**

*See Table 7-6 and Figure 7-5 for capacities of each exit. As required by both model codes, the element with the smallest capacity in each path of egress was considered to be the limiting element. The limiting element dictated the capacity of each egress path.*

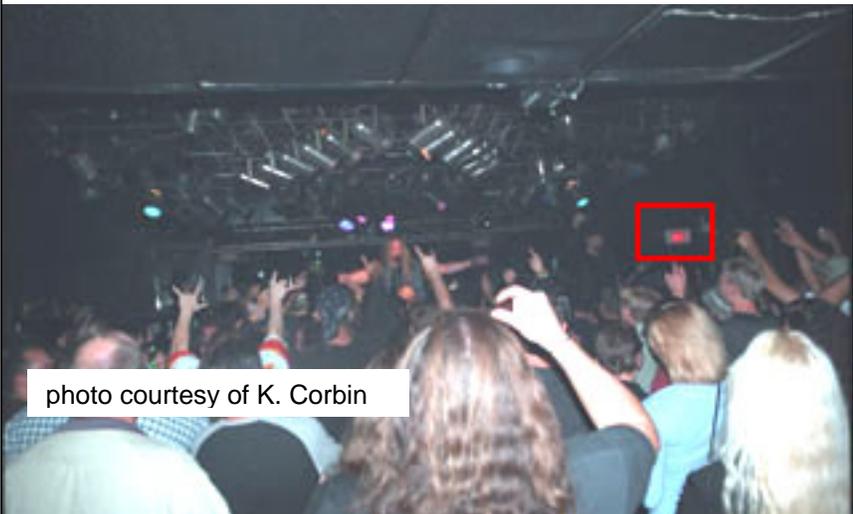
**Figure B.11 Life Safety Feature 11 [4]**

<b>Device Type:</b>	Exit Sign	
<b>Description:</b>	Exit sign above door to the right of the stage. Note that sign is clearly illuminated.

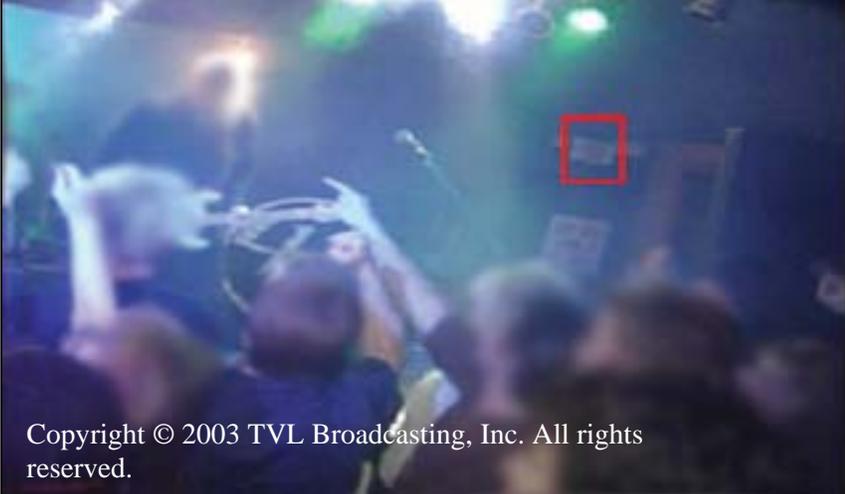
<b>Device Type:</b>	Exit Sign	
<b>Description:</b>	Exit sign above door to the right of the stage. Note that sign does not appear to be illuminated.

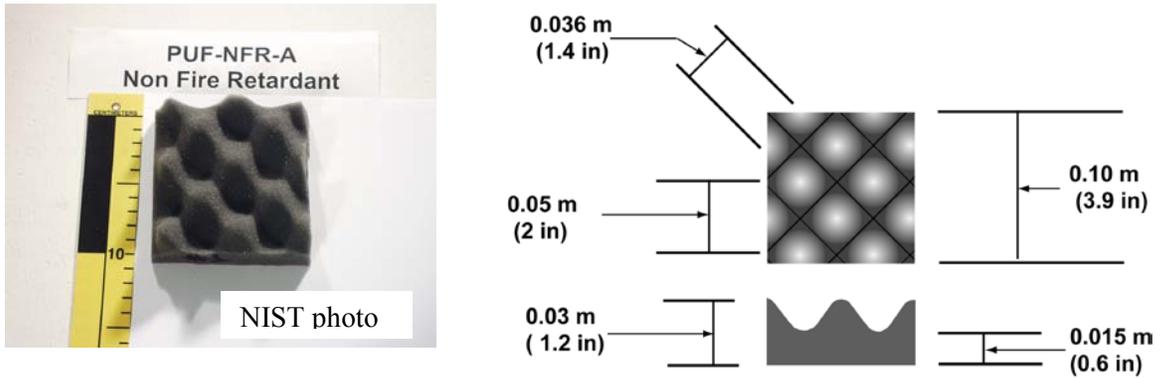
**Figure D-5. Photograph and Dimensioned Diagram of Non Fire Retardant Foam Lot A (PUF-NFR-A).**

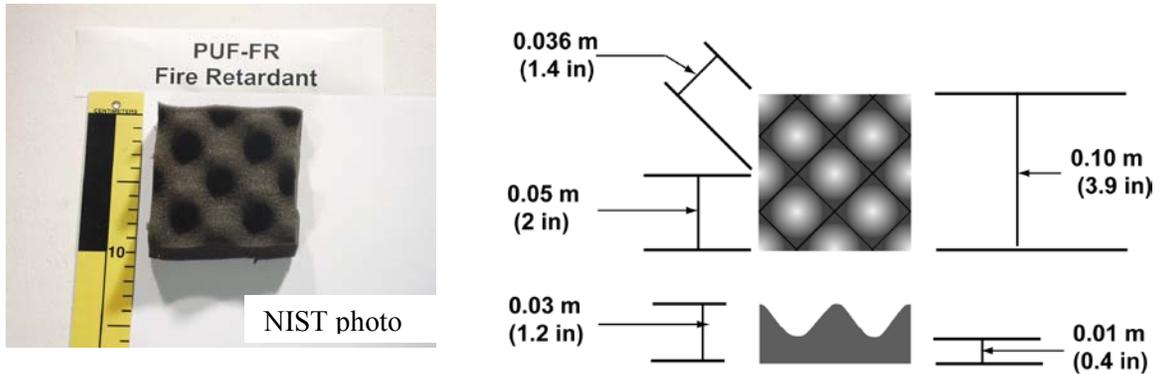
heat release rates than for the non-fire retardant foam samples. It required about twice as long for the fire retardant foam, 13 seconds, to reach sustained ignition as required by the non-fire retardant foam (Table D-3). The time to peak heat release was longer for the fire retardant foam, increasing by about 20 %.

**Figure D-14. Photograph and Dimensioned Diagram of Fire Retardant Foam (PUF-FR).**
