**NIST NCSTAR 2**

# **Draft Report of the Technical Investigation of The Station Nightclub Fire**

March 2005

A fire occurred on the night of Feb. 20, 2003, in The Station nightclub at 211 Cowesett Avenue, West Warwick, Rhode Island. A band that was on the platform that night, during its performance, used pyrotechnics that ignited polyurethane foam insulation lining the walls and ceiling of the platform. The fire spread quickly along the ceiling area over the dance floor. Smoke was visible in the exit doorways in a little more than one minute, and flames were observed breaking through a portion of the roof in less than five minutes. Egress from the nightclub, which was not equipped with sprinklers, was hampered by crowding at the main entrance to the building. One hundred people lost their lives in the fire. On Feb. 27, 2003, under the authority of the National Construction Safety Team (NCST) Act, the National Institute of Standards and Technology (NIST) established a National Construction Safety Team to determine the likely technical cause or causes of the building failure that led to the high number of casualties in that fire. This report documents the procedures, findings, and

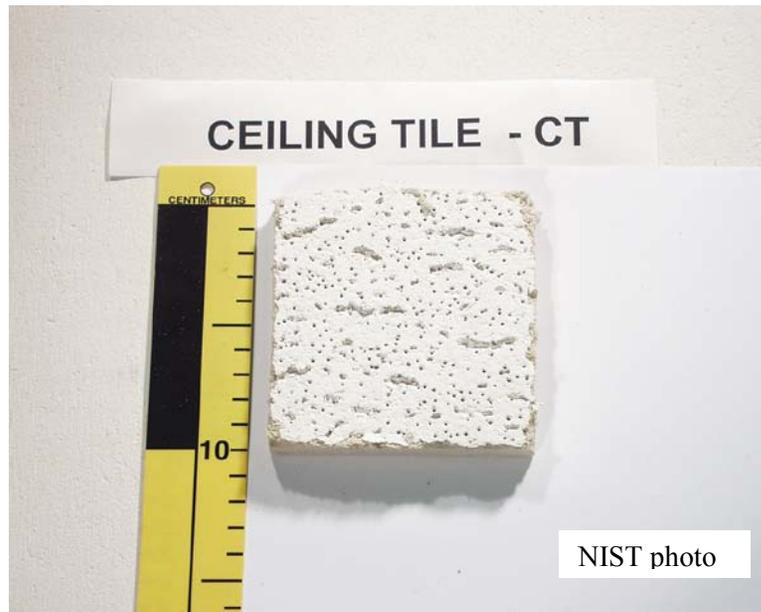
A suspended or dropped ceiling had been installed in the nightclub except for in the sunroom, the raised platform (stage) area, and the dance floor areas (refer to Fig. 4-3). Each 0.61 m (2 ft) x 1.22 m (4 ft) x .016 m (0.625 in) panel had been installed or dropped into a metal grid support system. Photographs of the nightclub interior clearly demonstrate that the ceiling tiles had been painted black. It was not clear from the photographs whether the paint had been applied by brush, roller, or spray can. The surface of the tiles had a glittery appearance that may have been a result of the wet paint being dusted with glitter or sparkle dust. Some of the glitter would have become partially embedded in the wet paint and would have

**Figure D-16. Photograph of Acoustical Tile Showing Factory Painted Surface.**

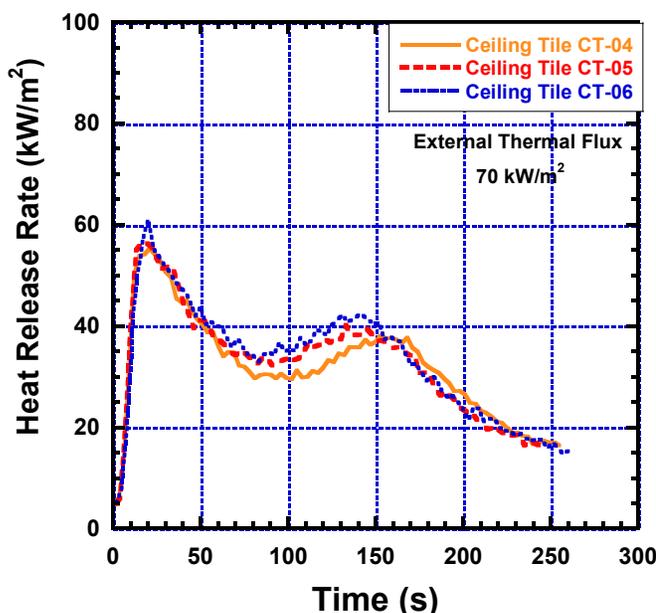
Three test samples were exposed to thermal flux at 35 kW/m<sup>2</sup>. Each test was terminated after 3 min of exposure when none of the three samples ignited (Table D-5). An additional three test samples were exposed to thermal flux at 70 kW/m<sup>2</sup>. The heat release rate for each sample is plotted versus time in Figure D-17. The heat release curves show an initial peak, a period of decline, and then a second peak.

**Figure D-17. Heat Release Rate versus Time for Ceiling Tile Exposed to 70 kW/m<sup>2</sup> of External Heat Flux (PUF-CT). Samples are CT-04, CT-05, and CT06.**

The second peak was observed because as the material initially burns, some of the energy released by the combustion process is lost or conducted away into the unburned portion of the sample. As the test continued, the temperature of the unburned sample gradually increased with the continual heating from either the external flux or the combustion of the fuel itself. Eventually, the temperature of the material increased to the point where much less energy is lost through conduction. At this point, the energy, which was previously being conducted away, became available to increase the pyrolysis and subsequent burning of the fuel. This increase in the pyrolysis and burning resulted in a second peak in the heat release rate. Sometimes, if a sample contained some components that would ignite at a substantially lower temperature, these components would burn first and other components that had a higher ignition temperature would remain. As the sample temperature continued to increase and eventually reached the ignition temperature of the remaining components, even the higher ignition temperature fuel would begin to burn. This additional burning would have caused an increase in the heat release rate at some time after the initial peak due to the burning of the low temperature components.

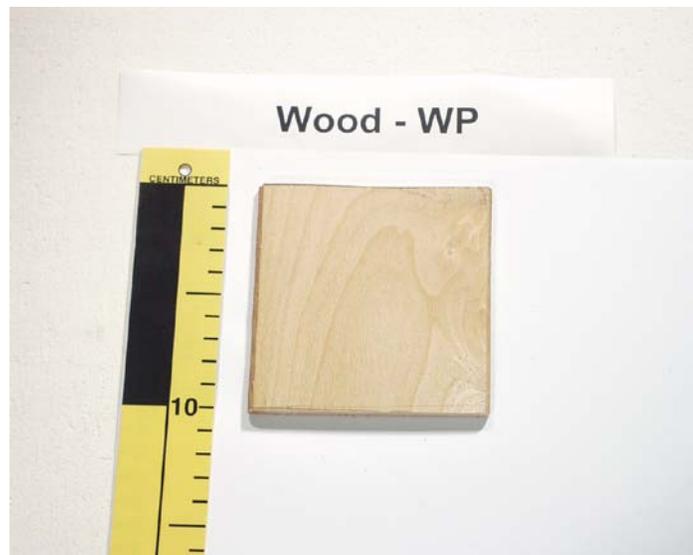
Figure D-18. Photograph of Wood Panel Sample Showing Veneer Surface.

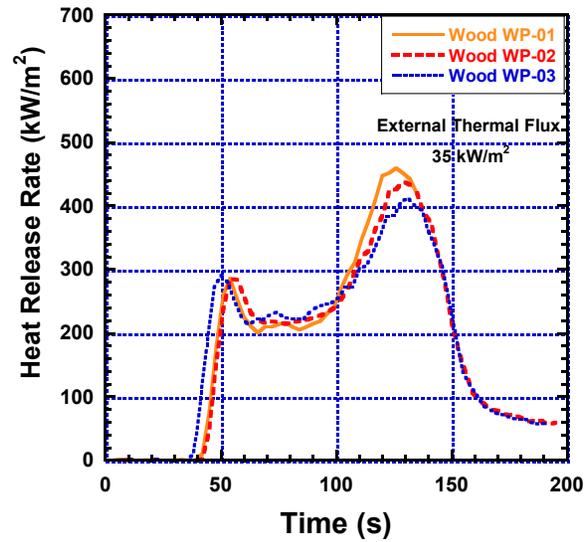
When exposed to 35 kW/m<sup>2</sup> of external heat flux, the wood paneling reached its average peak heat release rate, 440 kW/m<sup>2</sup> in approximately 130 s (Figure D-19). Peak heat release rates for all three wood samples ranged from 413 kW/m<sup>2</sup> to 460 kW/m<sup>2</sup>. At the lower thermal flux, each sample required about 40 seconds to achieve sustained ignition. At the higher flux rate of 70 kW/m<sup>2</sup>, the wood panel samples required much less time, on average 15 seconds, to sustain ignition (Figure D-20). The higher external flux resulted in a higher average peak heat release rate of 530 kW/m<sup>2</sup>, but required substantially less time, 85 seconds, to achieve the peak value.

The heat release curves exhibited a two-peak shape, with the second peak much greater than the first peak. Each wood panel sample charred significantly as it burned and the char represented a greater fraction of the total available fuel than that which was burned early in the test. In the higher thermal flux exposure, the additional flux caused more of the fuel to be burned early in the test, so the two peaks were closer in value.

Figure D-19. Heat Release Rate versus Time for Wood Paneling Exposed to 35 kW/m<sup>2</sup> of External Heat Flux (WP). Samples are WP-01, WP-02, and WP-03.

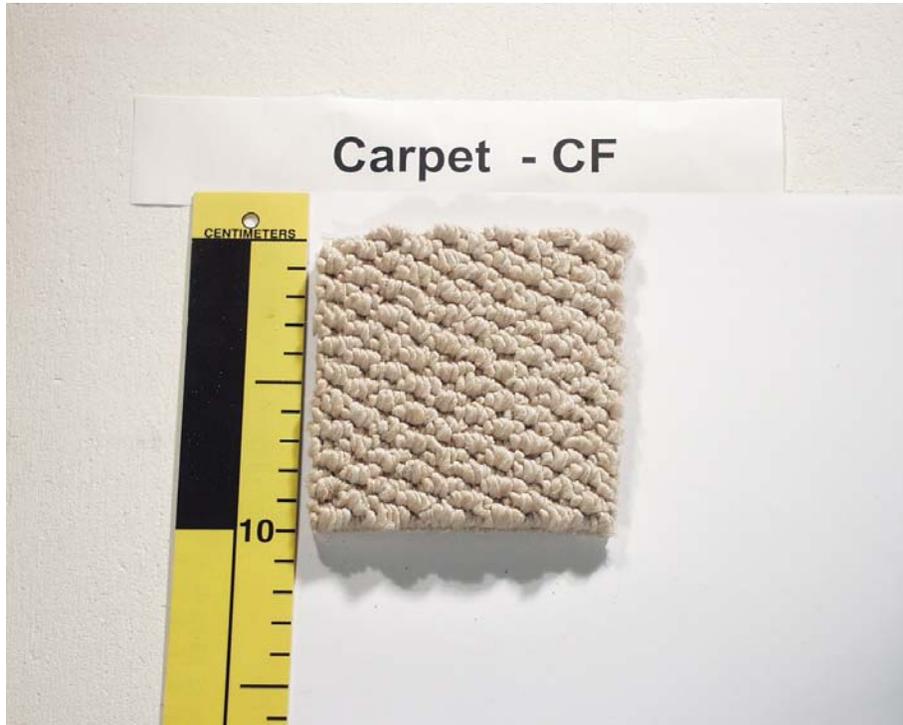
A closed-loop olefin carpet with a binding layer was selected as representing the fuel load contributed by the carpeting. The carpet was purchased from a local supplier in a 3.2 m (12 ft) wide x 15.7 m (50 ft) long continuous roll. The 0.006 m (0.25 in) nylon pile was embedded in a 0.002 m (0.1 in) thick binding layer. Samples that measured 0.1 m x 0.1 m were cut from the roll (Figure D-21). These samples were then stored in a controlled humidity (50 % relative humidity) and temperature (23 °C) room for at least

**Figure D-21. Photograph of Carpet Sample Showing Olefin Pile.**

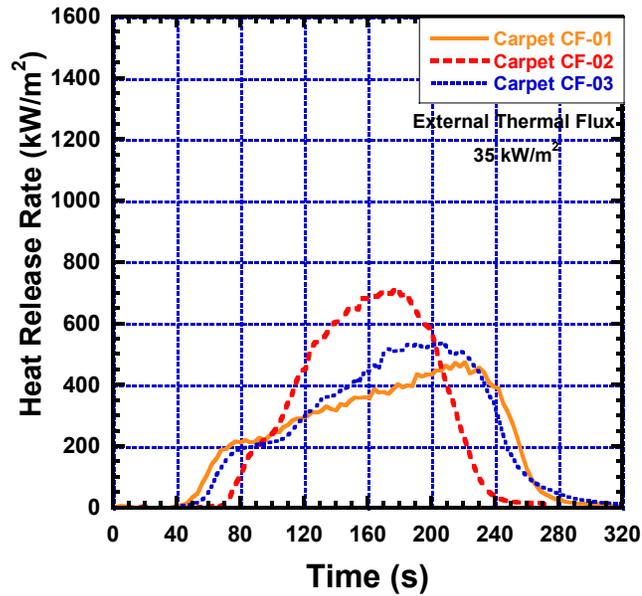
When exposed to  $35 \text{ kW/m}^2$  of external heat flux (Figure D-22), the peak heat release rates for the three carpet samples ranged from  $474 \text{ kW/m}^2$  to  $718 \text{ kW/m}^2$ . The carpet required about 54 seconds, on average, to achieve sustained ignition, and approximately 190 seconds to reach its peak heat release rate (Figure D-22). Three additional test samples were exposed to thermal flux at  $70 \text{ kW/m}^2$  (Figure D-23) when exposed to the higher external heat flux, the carpeting reached its peak heat release rate in about half the time. Peak heat release rates for all three-carpet samples ranged from  $1290 \text{ kW/m}^2$  to  $1450 \text{ kW/m}^2$ , with an average of  $1370 \text{ kW/m}^2$ .

For the lower flux exposure, the heat release curve exhibited a relatively brief step at around  $200 \text{ kW/m}^2$  and then increased gradually to a single broad peak. As the carpet initially began to burn, some of the energy released was conducted into the olefin pile, but instead of producing a char, the polymer melted and formed a more uniform density fuel. As the burning continued, it increased at a relatively steady rate, reached its peak and decreased at a more rapid rate. At the higher flux exposure, the additional energy from the internal heating caused the melting to occur more rapidly, so the initial step seen at the lower flux was not observed.

Figure D-22. Heat Release Rate versus Time for Carpet Sample Exposed to 35 kW/m<sup>2</sup> of External Heat Flux (CF). Samples are CF-01, CF-02, and CF-03.

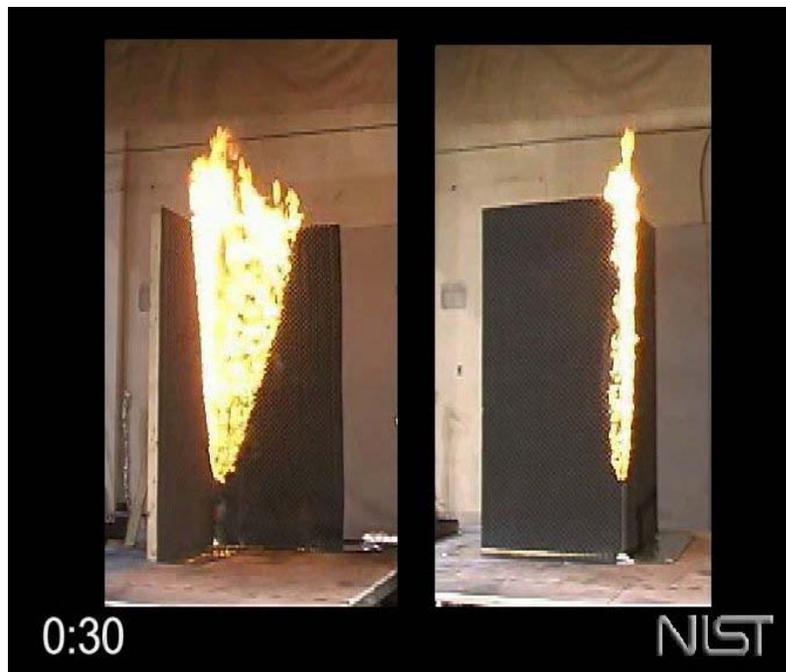
A propane torch was used to ignite the corner of the foam at 0.61 m (24 in) above the floor. While this was lower than the point of ignition in the nightclub, the purpose of these experiments was not to duplicate the fire growth, but to provide a controlled environment in which flame spread measurements (upward, downward, and lateral) could be accurately determined. The fire was videotaped from two directions, and the radiant heat flux and total heat release rate were measured. Figure E-3 includes a video of the external corner burn and internal corner burn, side by side, with a clock.

**Figure E-3. Video of External and Internal Corner Burns**

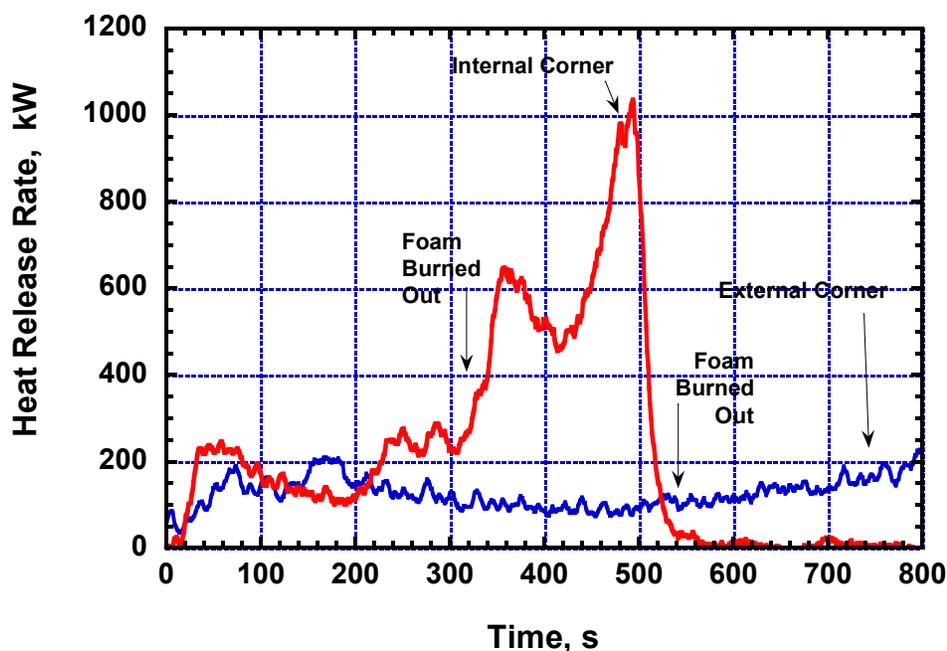
Since the wall panels were burned under an instrumented calorimetry hood, it was possible to utilize oxygen depletion measurements to calculate the heat release rate. The results for the external corner are plotted as the blue line in Fig. E-4. The heat release rate reached a peak value of 200 kW between 160 and 180 seconds after ignition. From the photos in Fig. E-3 taken 120 and 180 seconds into the burn, one can attribute this peak to the pool fire enhanced burning during the third phase of flame spread. The heat release rate included the energy released by all the fuel. Initially, the burning of the foam contributed most of the energy released by the fire while the wood contributed more energy as the foam was consumed. During phase 4, the heat release rate gradually reduces to about half its maximum value until

Figure E-4. Heat release rate versus time for external and internal corner configurations of foam covered wall panels.

almost all of the foam has been consumed at 540 seconds. The increase in heat release rate seen in Fig. E-4 after this point in time is due to the burning of the plywood panel. The irradiation perpendicular to and 2 m from the burning surface mirrors the heat release rate, as shown in Fig. E-6, attaining a value slightly above and below  $1 \text{ kW/m}^2$  from measurements 0.91 m and 1.83 m, respectively, above the bottom of the panel.

The total energy released by the fire can be estimated by integrating the area under the red curve in Fig. E-4. There is a substantial uncertainty in how much of the power to attribute to the foam and how much to the wood for times longer than 300 seconds. If one assumes that that the measured heat release rate between 310 and 410 seconds is due primarily to the liquid fuel at the base of the wood panels, then the total energy released by the foam would be about 106 MJ, which is greater than the 95 MJ of energy

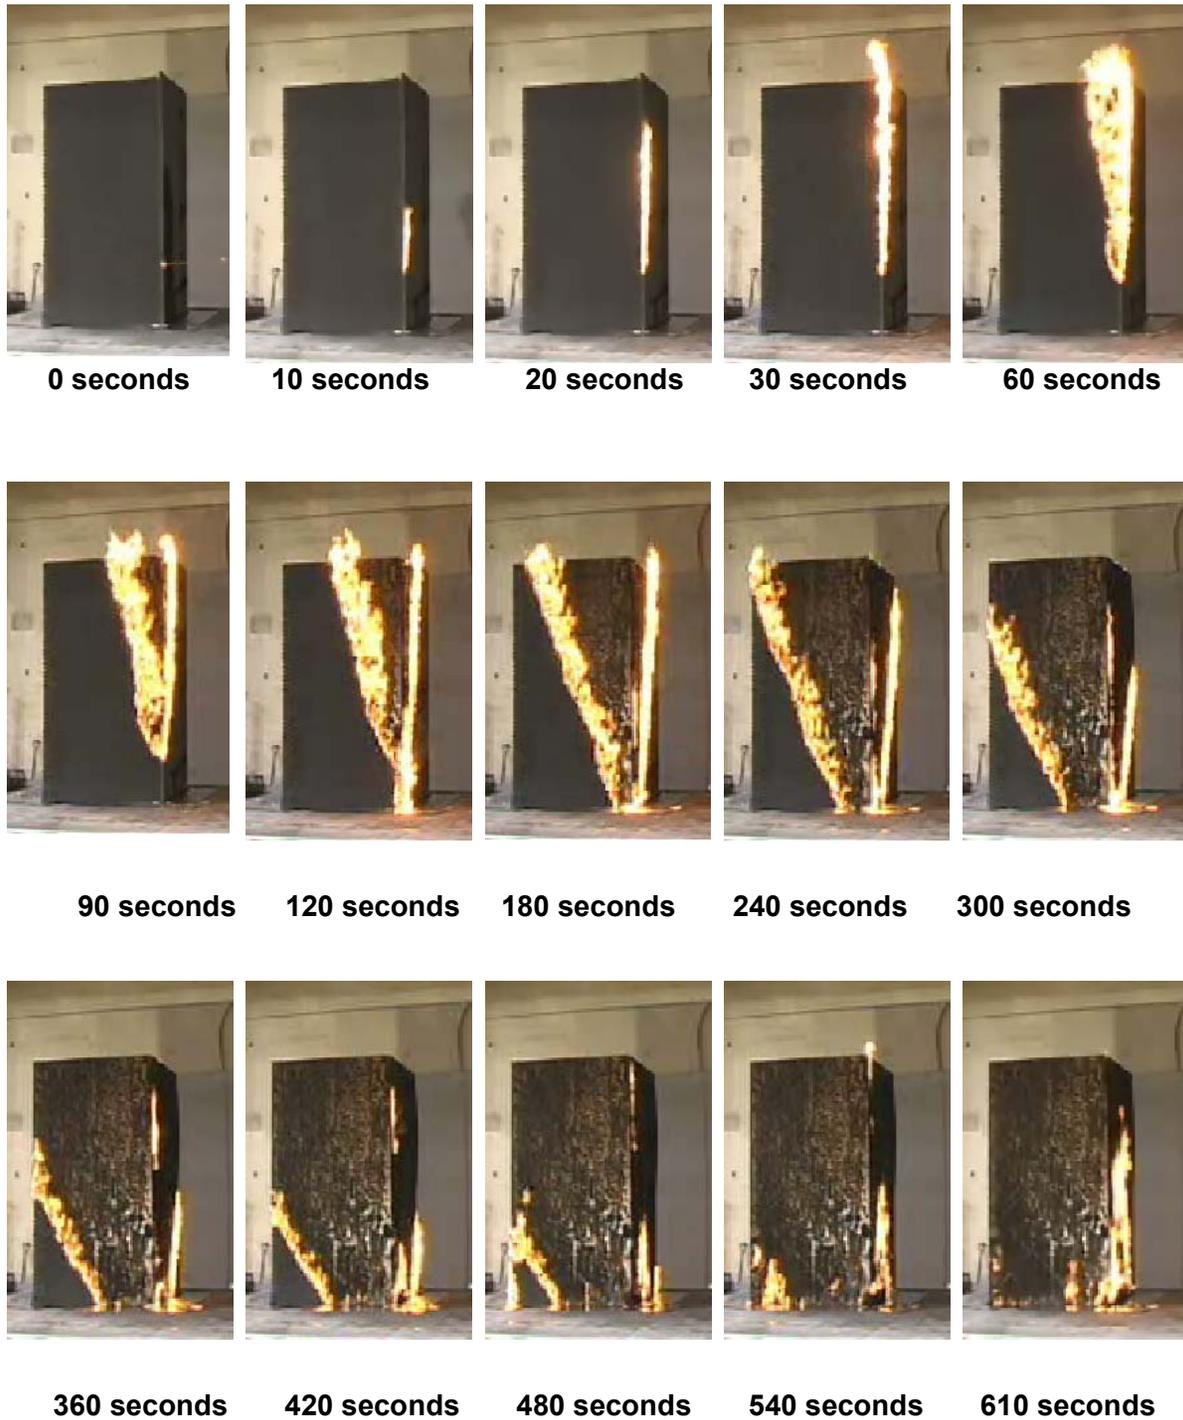
Figures E-3 (right video) and E-5 show the progression of fire in the external corner configuration for the first 610 seconds of the test. The flame spread can be broken into four distinct phases. In the first phase, the fire spreads upward rapidly, with flames reaching the top of the panel before they have had much chance to spread downward or laterally. Once the flames have reached the top of the panel, lateral spread occurs in the second phase, resulting in a vee-shaped flame with the vertex at the corner slightly below the point of ignition. The polyurethane melts and flows down the corner in the third phase, rapidly causing the flame to extend to the ground and to create a small pool fire. In the fourth phase, the flame extends from the floor to the upper edge of the panel, forming a line fire which spread laterally along the bottom and top edges. The flame on the upper horizontal edge reaches the vertical extent of the panel first, at which time the fire spreads downward until all of the foam is consumed. By the end of the test, the plywood backing can be seen to be burning near the initial point of ignition.

**Figure E-5. Flame spread over polyurethane foam covered panels, external corner configuration.**

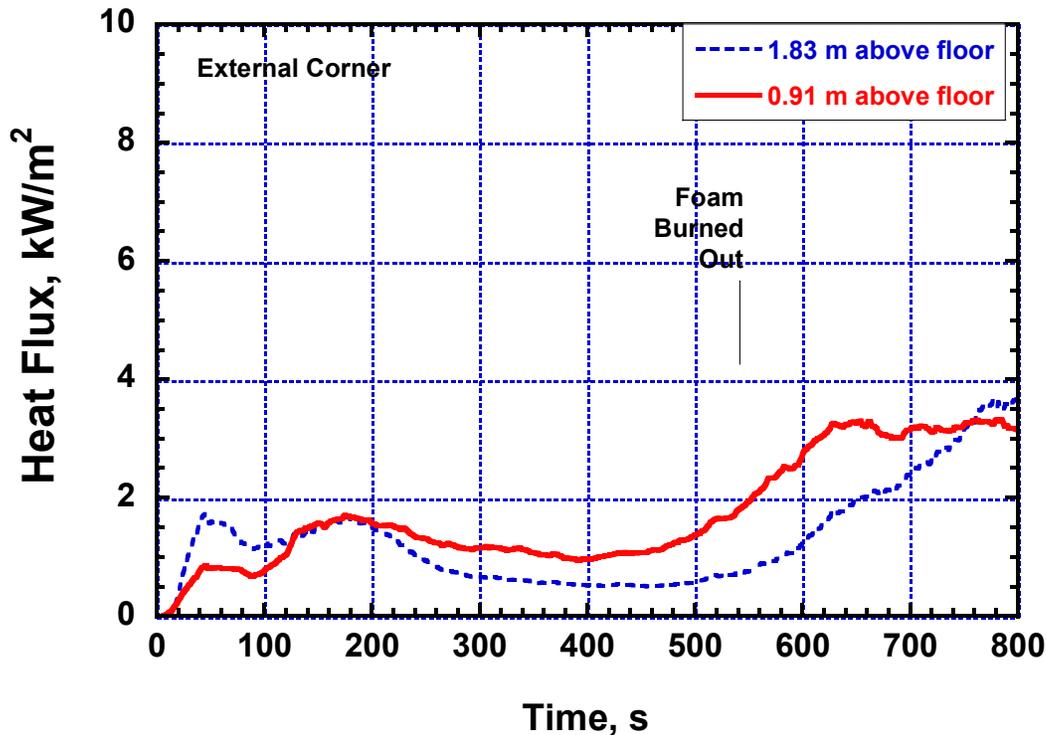
Figure E-6. Heat flux versus time for external corner burn.

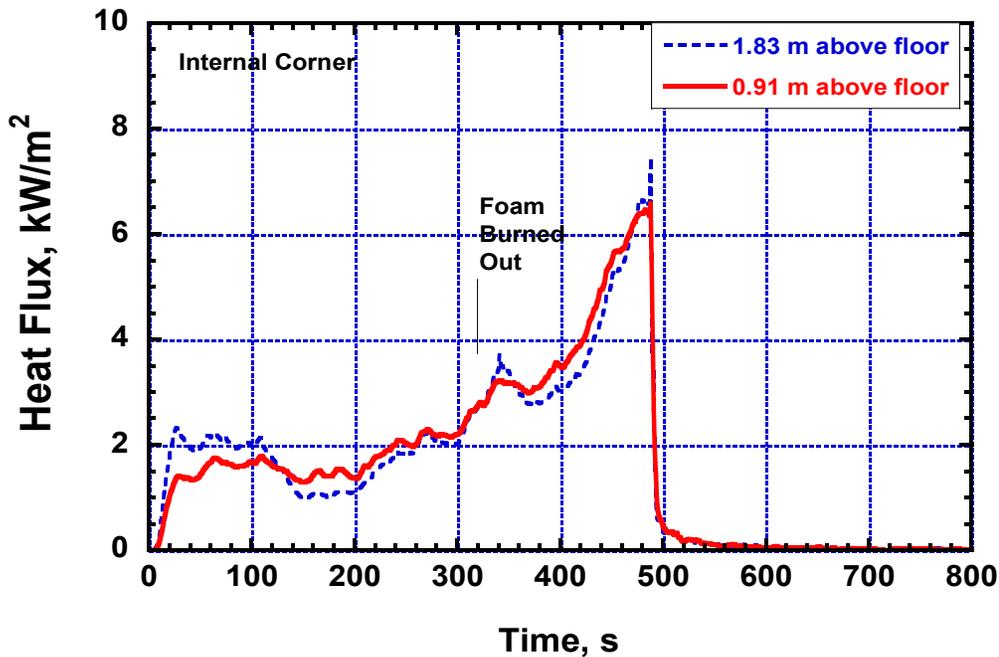
The heat release rate from the internal corner test is plotted as the red line in Fig. E-4. The irradiation measured perpendicular to and 2 m away from the panel is plotted in Fig. E-7. The shapes of the first 200 seconds for both plots are similar to what was found during the first 500 seconds of the external corner test, although the magnitudes are larger for the internal corner fire; that is, a peak heat release rate in excess of 200 kW, corresponding to the phase 3 burning, occurs early, followed by a gradual decrease to about half the peak heat release rate, and the heat flux from the surface during this period is a bit over 1 kW/m<sup>2</sup>. The Beyond 200 seconds, the internal corner test undergoes a more complicated behavior, as the pool fire at the base of the panel grows. The vertical arrow at 310 seconds marks the time when no more foam was visible on the wall panels. The pool fire from the melted foam reached a maximum heat release rate of 650 kW about 360 seconds into the burn. The increase in the fire size after 420 seconds is caused by the burning plywood along the vertical corner. The fire was extinguished at 490 seconds. [Note that while the shape of the flame seen in Fig. E-8 at 400 seconds is reminiscent of the M-shaped pyrolysis region reported by Qian et al.[1], inspection of the panels following their extinguishment revealed that the dark region seen in the photo along the vertical corner was due to complete burnout of the thin plywood panel.]

**Figure E-7. Heat flux versus time for external corner burn.**

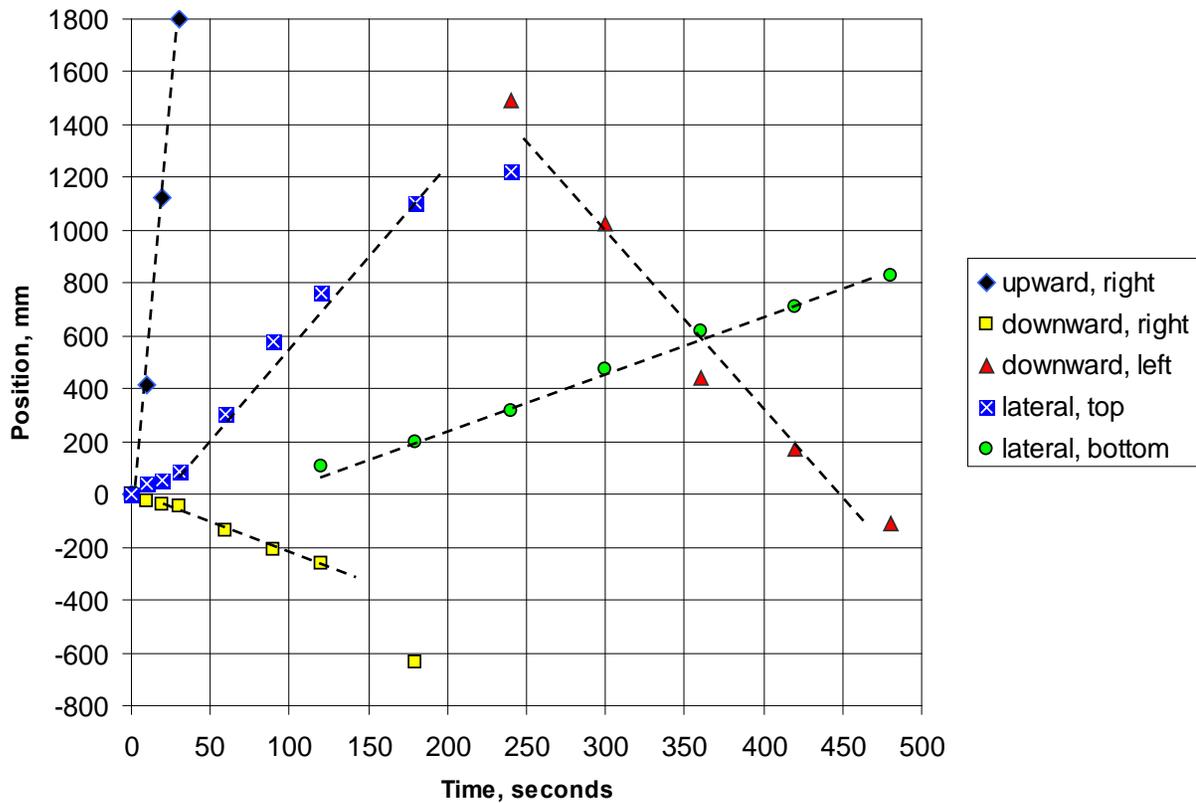
Figure E-9 is a plot of the position of the flame along the boundaries of the panel as a function of time, showing the upward, downward (initially on the right of the panel, and later along the left edge), and lateral flame spread (along the top and bottom, respectively) as a function of time and position. The dotted lines in the figure are drawn to represent the approximately steady region of flame spread, and their

Figure E9. Flame position relative to ignition point on external corner configuration

slopes correspond to the respective spread rates. Table E-1 provides a summary of the estimated spread rates for the external corner configuration. The last row is the normal flame speed (the vector sum of the horizontal and vertical components) during the later phases of burning. The flame speed decreases from a maximum of 63 mm/s in the upward direction to just over 2 mm/s in the downward and lateral direction along the bottom edge of the panel. The normal flames speed during the steady burning period is 7.2 to 7.3 mm/s.

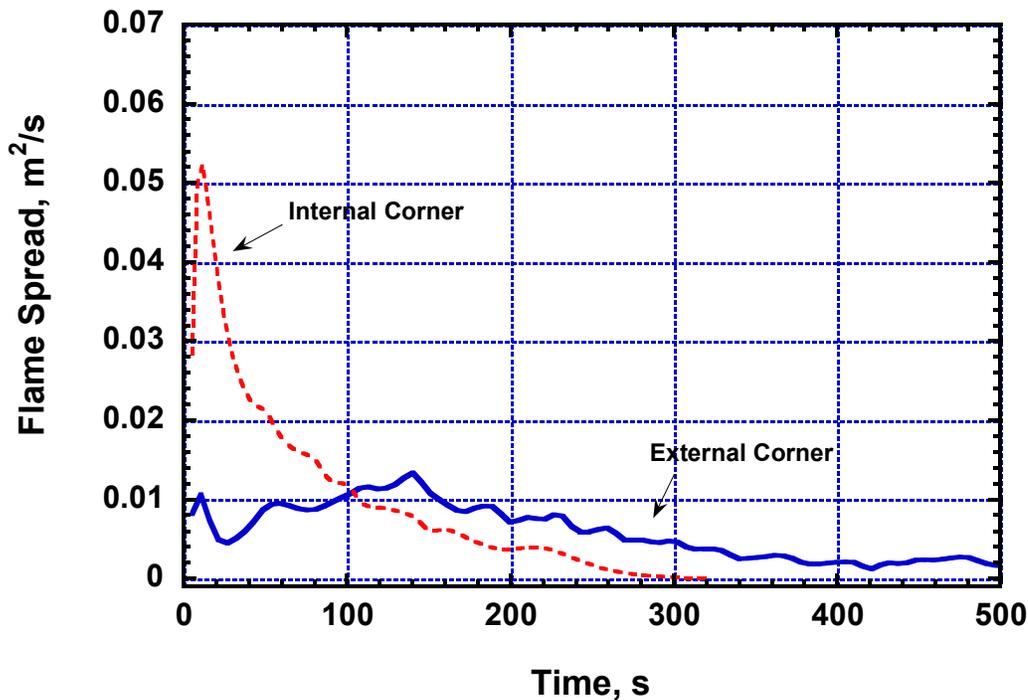
**Figure E-10. Flame spread across foam covered wall panel (m<sup>2</sup>/s).**

The video images were processed to track the unburned portion of the panel not covered by flames to provide an estimate of the surface area burning rate. The result is shown as the blue line in Fig. E-10. Following a small spurt during the initial rapid upward flame spread, the area burning rate drops and then slowly increases in the second and third phases to reach a peak of 0.013 m<sup>2</sup>/s about 140 seconds into the fire. The area burning rate gradually declines over the phase 4 period as the line of fire shortens about linearly with time. From the estimated downward and lateral flame speeds listed in Table E-1 and assuming the shape of the unburned foam remains approximately congruent to a triangle formed by the edges and diagonal of the panel, the area burning rate can be expressed as  $(X_0 v_y + Y_0 v_x)/2 - v_x v_y (t - t_0)$ , where  $X_0$  and  $Y_0$  are the lengths of the sides of the panel,  $v_x$  and  $v_y$  are the components of the normal flame velocity, and  $t_0$  is the time when the flame begins moving downward along the outer edge of the panel. Using this formulation the area burning rate diminishes from 0.0070 m<sup>2</sup>/s at 200 seconds to 0.0024 m<sup>2</sup>/s at 500 seconds, consistent with the more accurate calculation represented by Fig. E-10.

The red line in Fig. E-10 is a plot of the area burning rate determine by processing the video images such as those seen in Fig. E-3 and E-8. The initial peak exceeds 0.05 m<sup>2</sup>/s, which undoubtedly is an over estimate since the quickly growing flames conceal a portion of the foam panel that has not had time to be completely consumed. Applying the same formulation  $[(X_0 v_y + Y_0 v_x)/2 - v_x v_y (t - t_0)]$  developed in section E.3.1 for the area burning rate, a lateral flame speed of 4.4 m/s, and a downward flame speed of 14 mm/s, the flame spread can be estimated to decrease from 0.014 m<sup>2</sup>/s at 90 seconds to 0.001 m<sup>2</sup>/s at 300 seconds, again consistent with Fig. E-10.

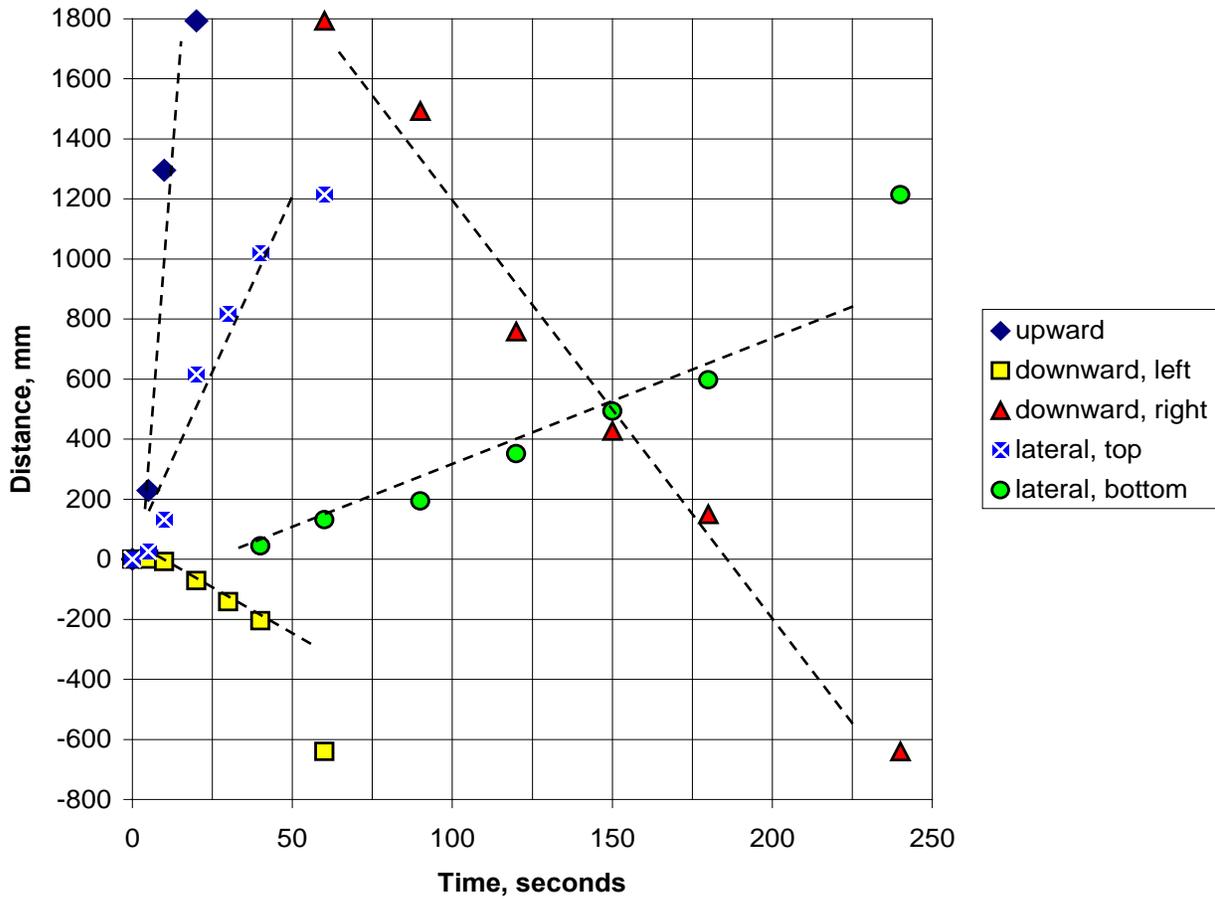
**Figure E-11. Flame position relative to ignition point on internal corner configuration**

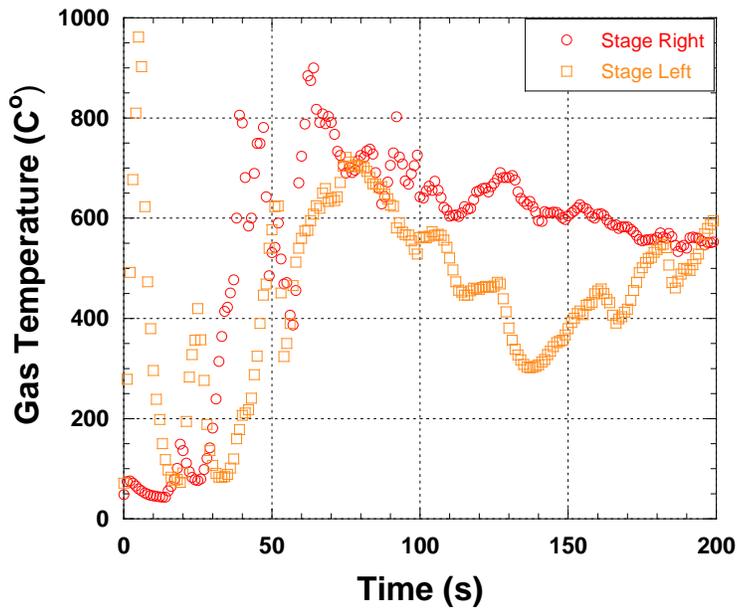
Thermocouples were installed near the ignition points on both sides of the alcove opening, 1.8 m above the floor of the platform. As shown in Figure G-3, in the unsprinklered compartment burn, the temperatures near the ignition point stage-left began to increase rapidly in less than 10 seconds and it then dropped to about 100 °C. After about 30 seconds, both stage-right and stage-left thermocouples began to increase to temperatures in excess of 600 °C. The initial peak and subsequent drop and then rapid increase were probably due to movement of the flame sheet or thermal plume. If the thin flame sheet was near the thermocouple bead, a high temperature would be recorded, but if the plume of hot gases moved and caused the bead to be in the fuel rich interior of the plume, lower temperatures could have been recorded.

Figure G-3. Temperatures versus Time for Unsprinklered Mockup Test. Thermocouples positioned on right and left side of alcove opening 1.8 m (5.1 ft) above platform floor at ignition points.

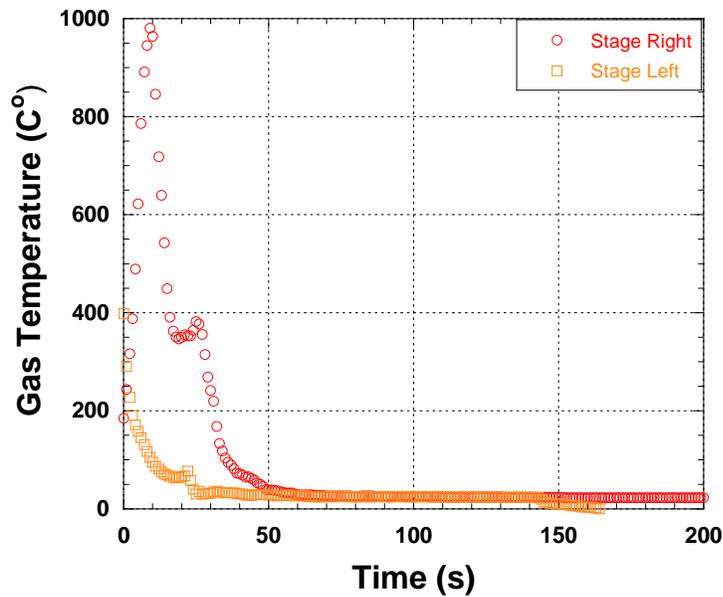
Slightly different temperature behavior was recorded in the sprinklered test (Figure G-4). Initially both stage-left and stage-right temperatures increased rapidly as the stage-left thermocouple had in the unsprinklered test, but as sprinklered burn temperatures dropped back to about 100 °C, the sprinklers activated and caused the temperatures to decrease to near ambient temperatures.

Figure G-4. Temperatures versus Time for Sprinklered Mockup Test. Thermocouples positioned on right and left side of alcove opening 1.8 m (5.5 ft) above platform floor at ignition points.

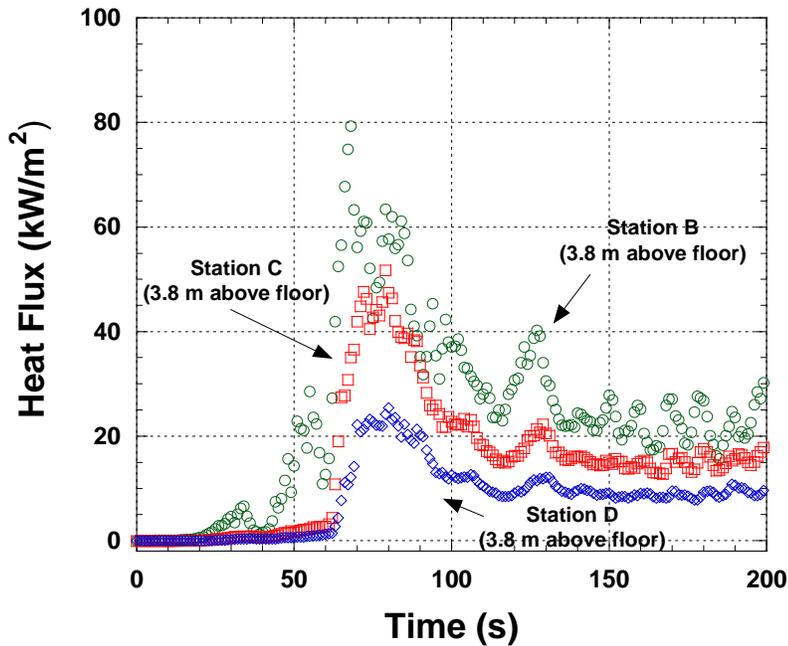
The three radiometers were plotted together in Figure G-15. As the distance between the radiometer and the fire source increased, the peak radiation flux decreased. For Locations B, C, and D, peak radiation levels were approximately 60 kW/m<sup>2</sup>, 50 kW/m<sup>2</sup>, and 20 kW/m<sup>2</sup>, respectively.

Figure G-15. Radiation fluxes versus time for un-sprinklered mockup test. Gauges positioned flush with ceiling (3.8 m above floor) at locations B, C, and D.

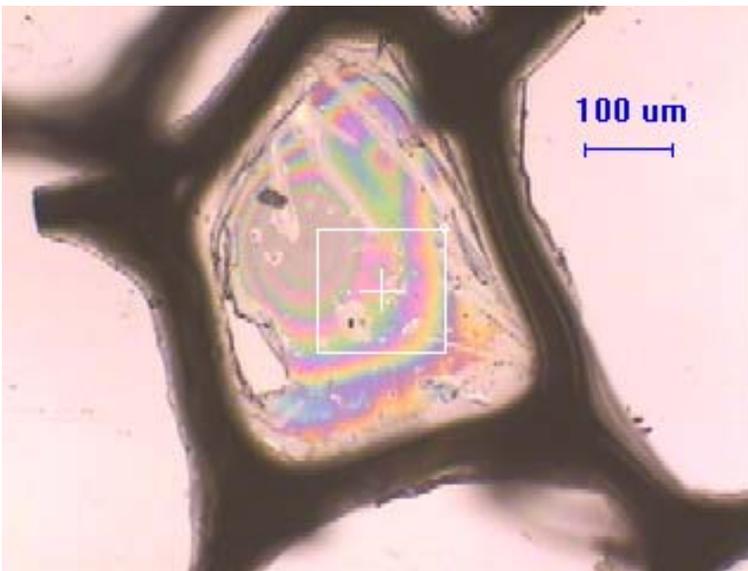
6. The picture of a foam cell in Figure 2 shows that each cell is covered with a thick oily liquid. This liquid is not visible to the naked eye as shown in the picture in Figure 1. Identification of this liquid is essential as it is a significant component of the foam. The spectrum produced by the liquid (Figure 5.) closely matched polypropylene glycol (Figure 6.).

Figure 2. Microscope picture of sample 0310027-01 unburned foam at 100X magnification. This is a picture of one foam cell. All of the foam cells outer edges are covered in a thick clear liquid. This cell has the liquid actually spanning the open area of the cell.

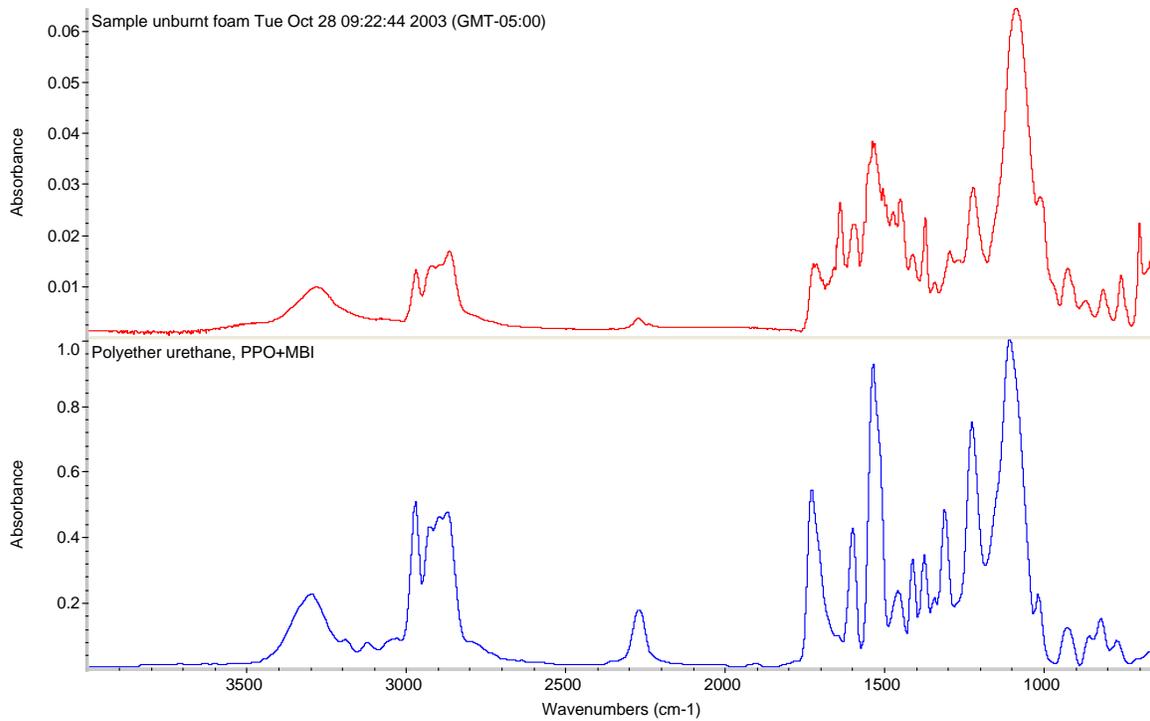
5. Identification of the foam type was performed by running the infrared spectrum of the unburned foam sample 0310027-01 (Figures 1 and 2). The spectrum produced (Figure 3.) closely matched polyester urethane foam (Figure 4.). Since foam is a polymer product made with various monomers in various ratios an exact match is not possible. This match shows the basic components that make up the bulk of the material. This foam is therefore a polyester urethane co-polymer product.

Figure 4. Infrared spectrum of sample unburned gray foam (top), best library match polyester urethane foam (bottom).

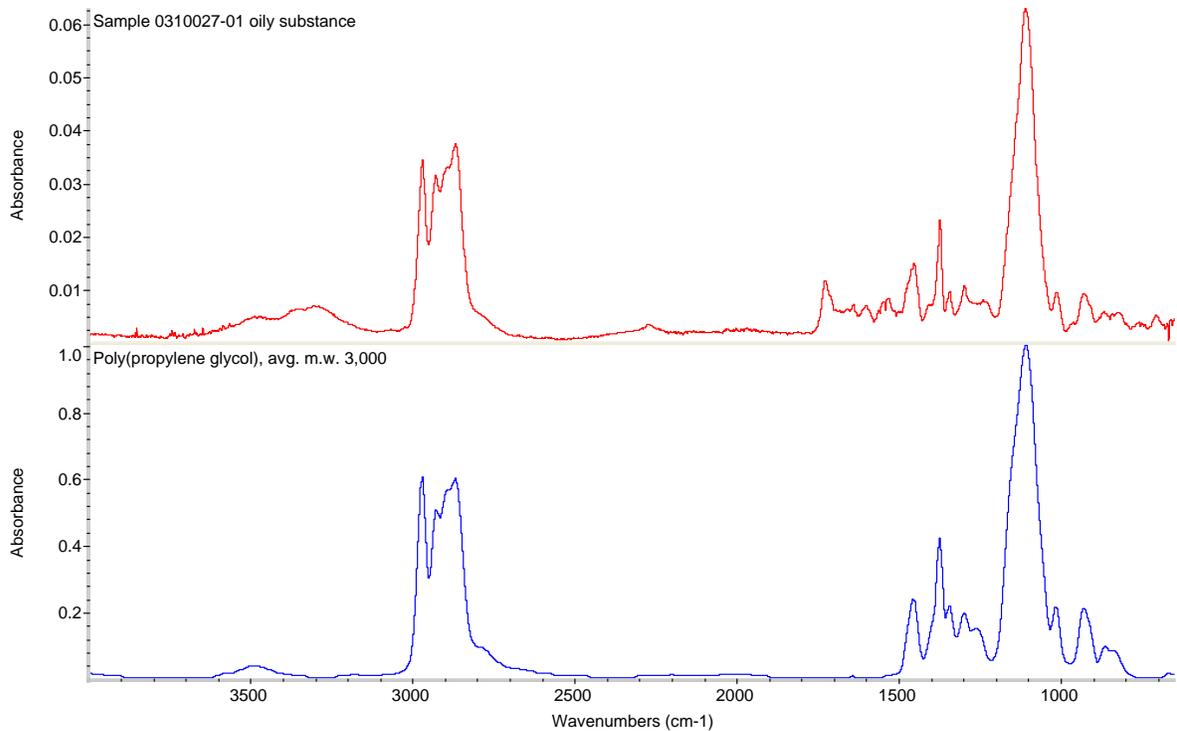
Figure 6. Infrared spectrum of sample oil on unburned gray foam (top), best library match polypropylene glycol (bottom).

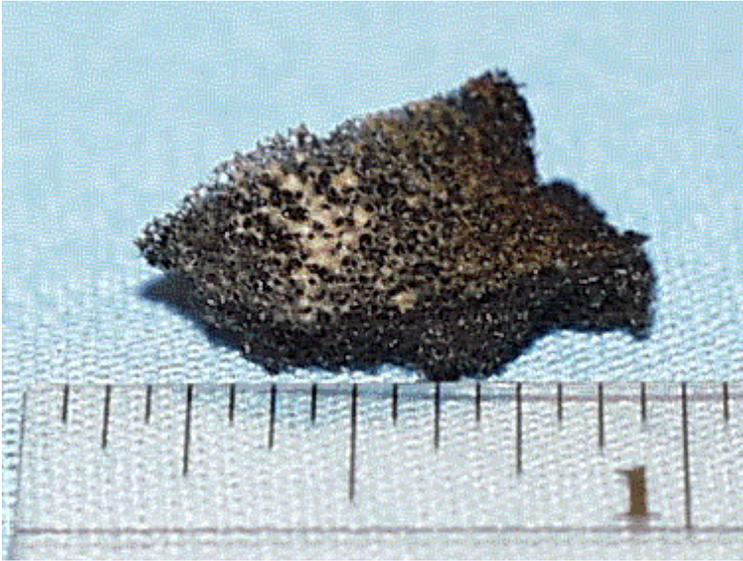
7. Figure 7 is a picture of the burned foam sample 0310027-02 with adhesive on the outer surface. The adhesive side of the foam was positioned against the ATR accessory and the infrared spectrum acquired (Figure 8). The library search produced the match seen in Figure 9. The best match is a latex rubber based mineral filled adhesive. A second library search was performed against a library of minerals and the library match shown in figure 10 was produced. The mineral filling in the adhesive is a silicate class compound similar to the natural mineral Kaolinite (see information with Figure 10).

Figure 7. Sample 0310027-02 piece1 foam with adhesive.

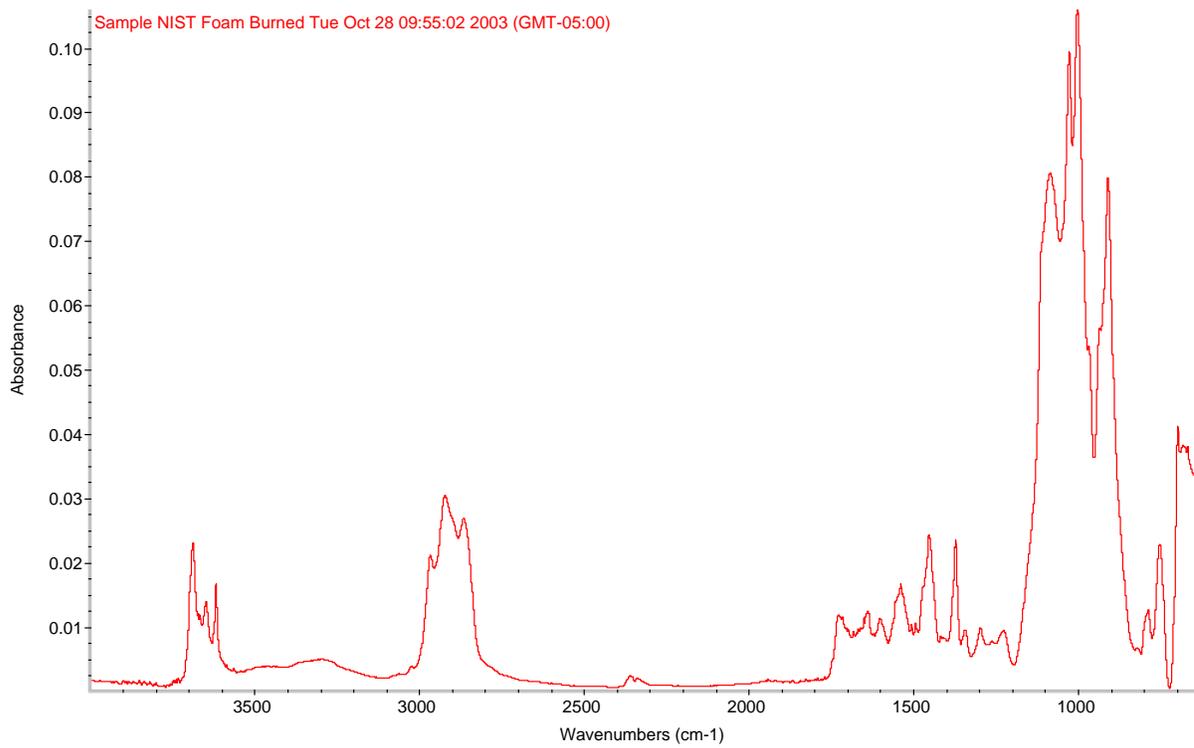
Figure 8. Infrared spectrum of sample foam adhesive.

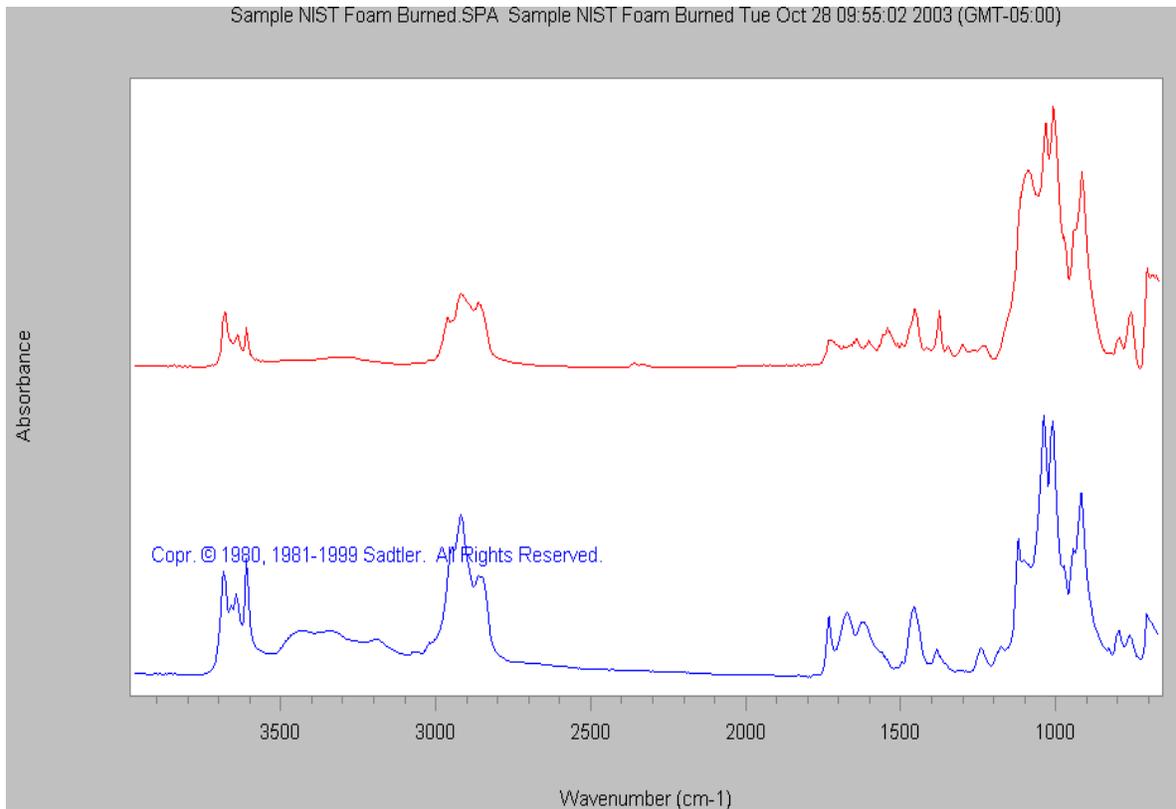
Figure 9. Infrared spectrum of foam adhesive (top), best library match a mineral filled latex based adhesive (bottom).

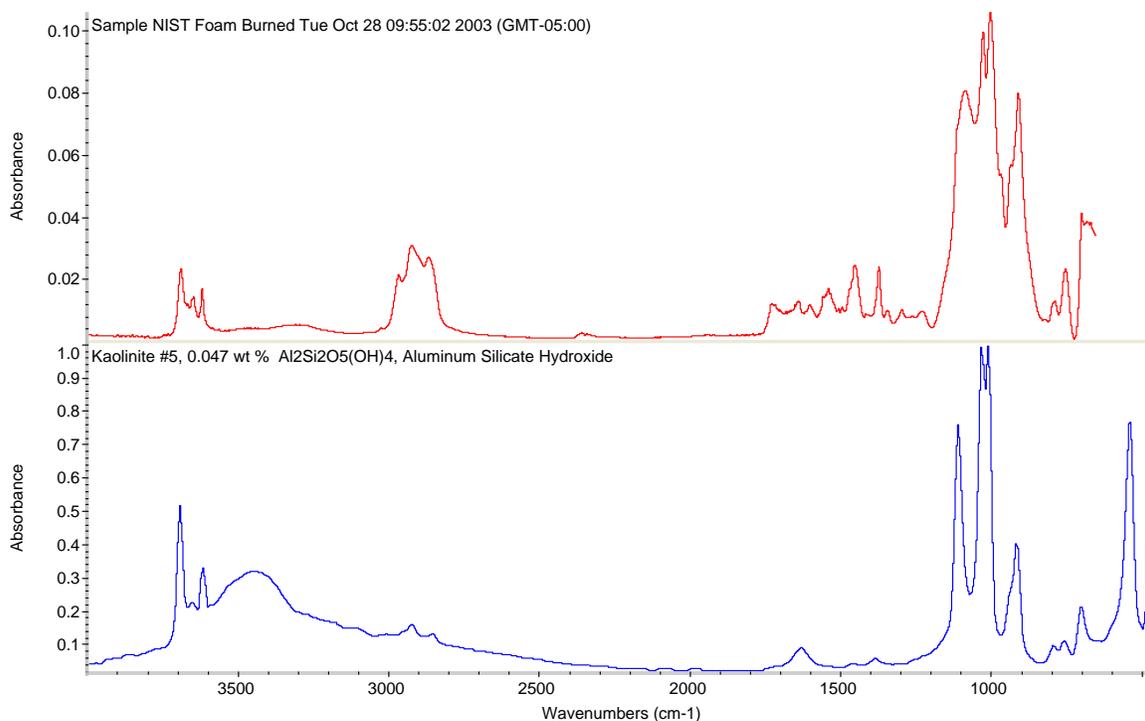
Figure 10. Infrared spectrum of sample foam adhesive (top), best library match of the mineral filler kaolinite  $\text{Al}_2\text{Si}_2\text{O}_5(\text{OH})_4$ , (bottom).
