**NIST NCSTAR 2**

# **Draft Report of the Technical Investigation of The Station Nightclub Fire**

March 2005

A fire occurred on the night of Feb. 20, 2003, in The Station nightclub at 211 Cowesett Avenue, West Warwick, Rhode Island. A band that was on the platform that night, during its performance, used pyrotechnics that ignited polyurethane foam insulation lining the walls and ceiling of the platform. The fire spread quickly along the ceiling area over the dance floor. Smoke was visible in the exit doorways in a little more than one minute, and flames were observed breaking through a portion of the roof in less than five minutes. Egress from the nightclub, which was not equipped with sprinklers, was hampered by crowding at the main entrance to the building. One hundred people lost their lives in the fire. On Feb. 27, 2003, under the authority of the National Construction Safety Team (NCST) Act, the National Institute of Standards and Technology (NIST) established a National Construction Safety Team to determine the likely technical cause or causes of the building failure that led to the high number of casualties in that fire. This report documents the procedures, findings, and

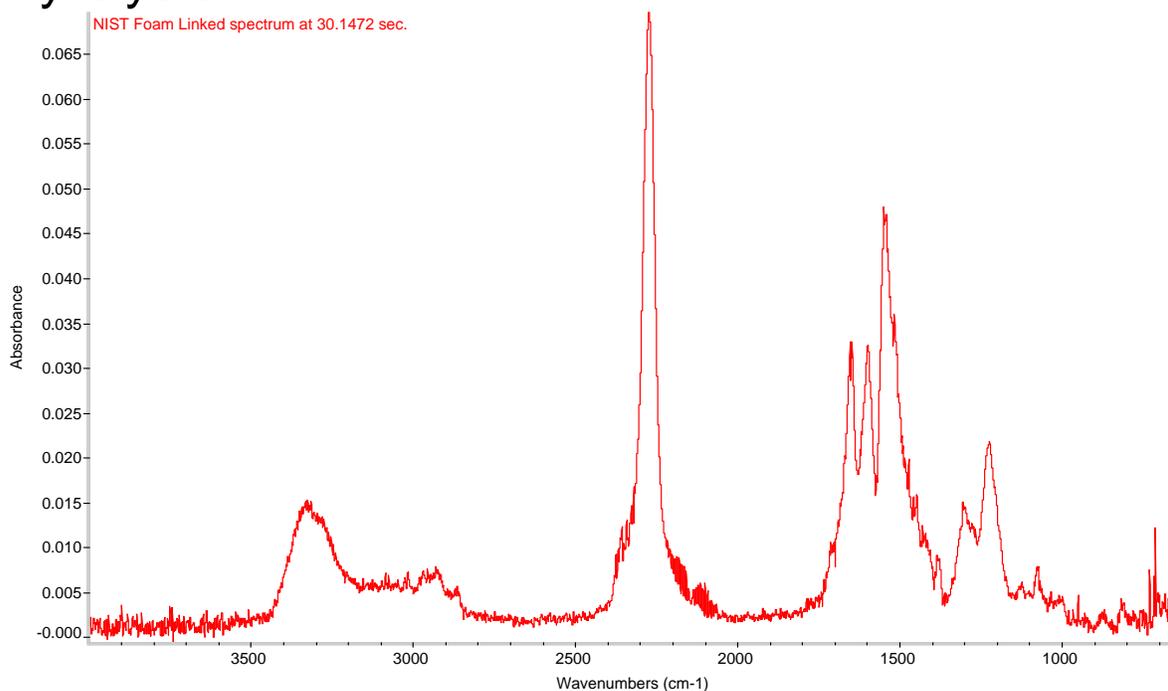
11. The pyrolysis of foam is shown in Figures 11 to 14. The fully pyrolyzed foam is displayed in figure 11. A large absorption at  $\sim 2270\text{ cm}^{-1}$  is produced in this spectrum. The best library match; methyl isocyanate, is shown in figure 12. Figure 13 is the infrared spectrum of the pyrolyzed foam with all of the major absorption peaks labeled. Note that due to a lack of oxygen the amounts of carbon dioxide and carbon monoxide are low.

Figure 11. Infrared spectrum of Foam Pyrolysis. The isocyanate peak  $2270\text{ cm}^{-1}$  is from a class of compounds with the general formula  $\text{H}_x\text{C}_x\text{HNO}$ . These compounds are very toxic.

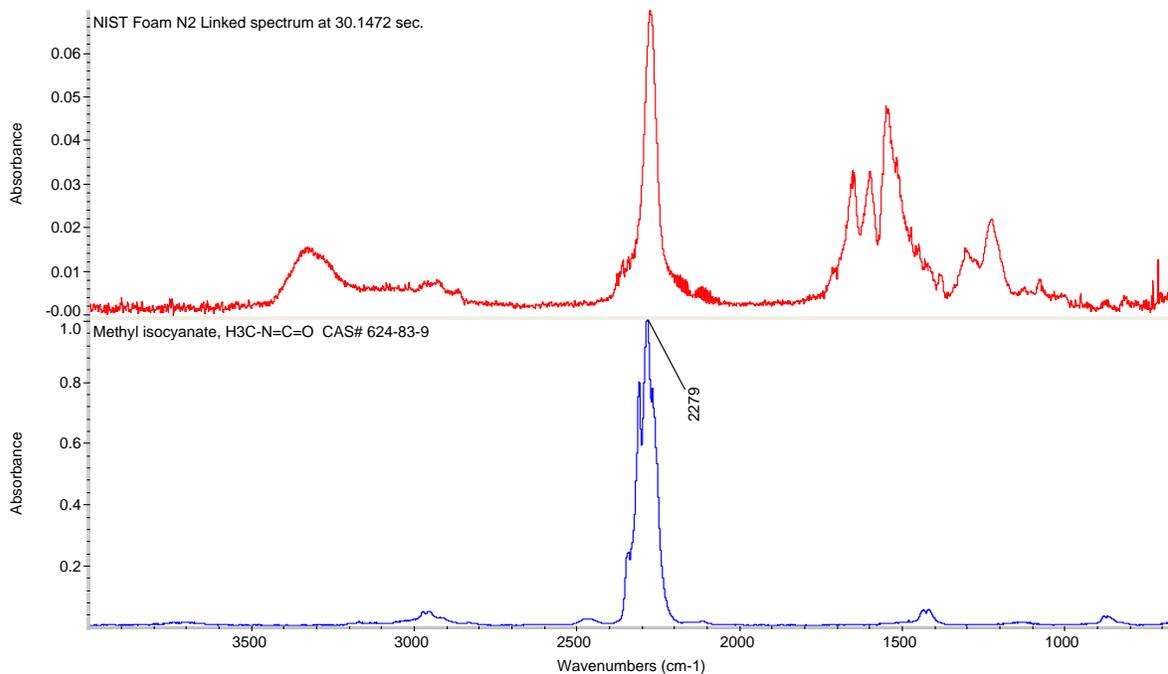
Figure 12. Infrared spectrum of sample pyrolyzed foam (top). Best library match is methyl isocyanate (peak  $\sim 2270\text{ cm}^{-1}$ ). This is a match to a class of isocyanate compounds. Methyl, Propyl, and even Butyl isocyanate have spectra that cannot be distinguished at this resolution.

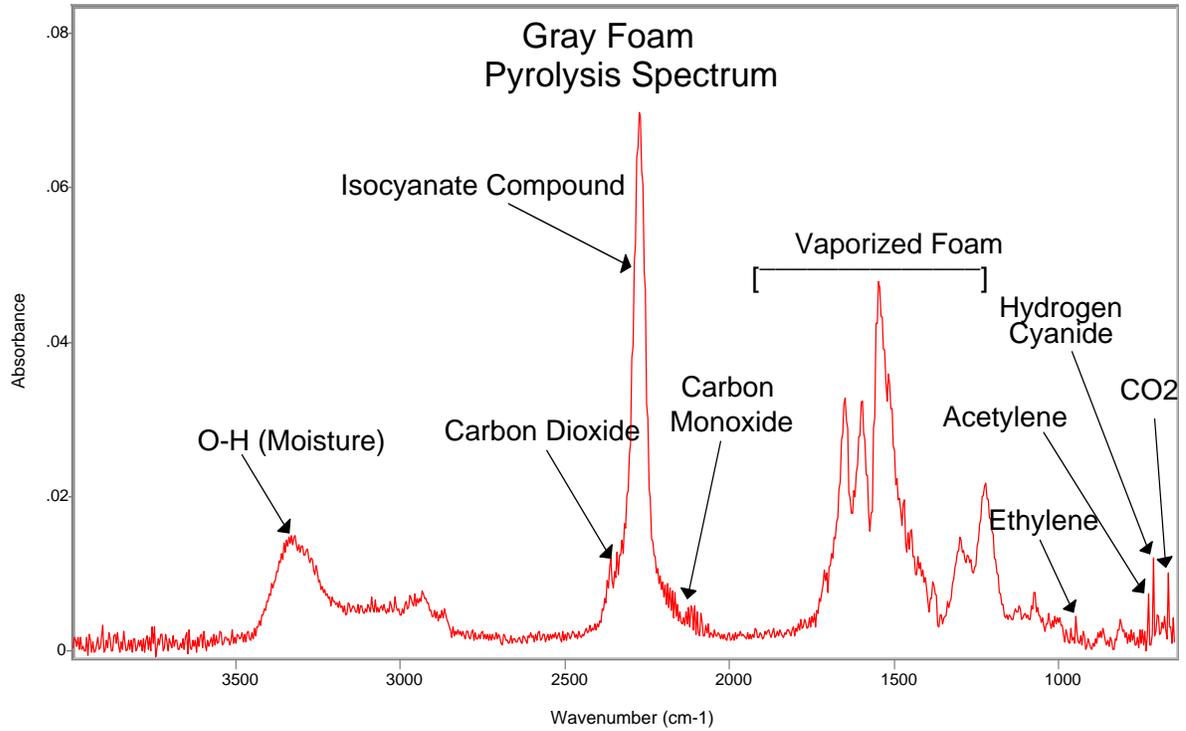
Figure 13. Infrared spectrum of gray foam pyrolysis with gases labeled. The more oxygen starved the combustion the more the final products will be similar to the pyrolysis products.

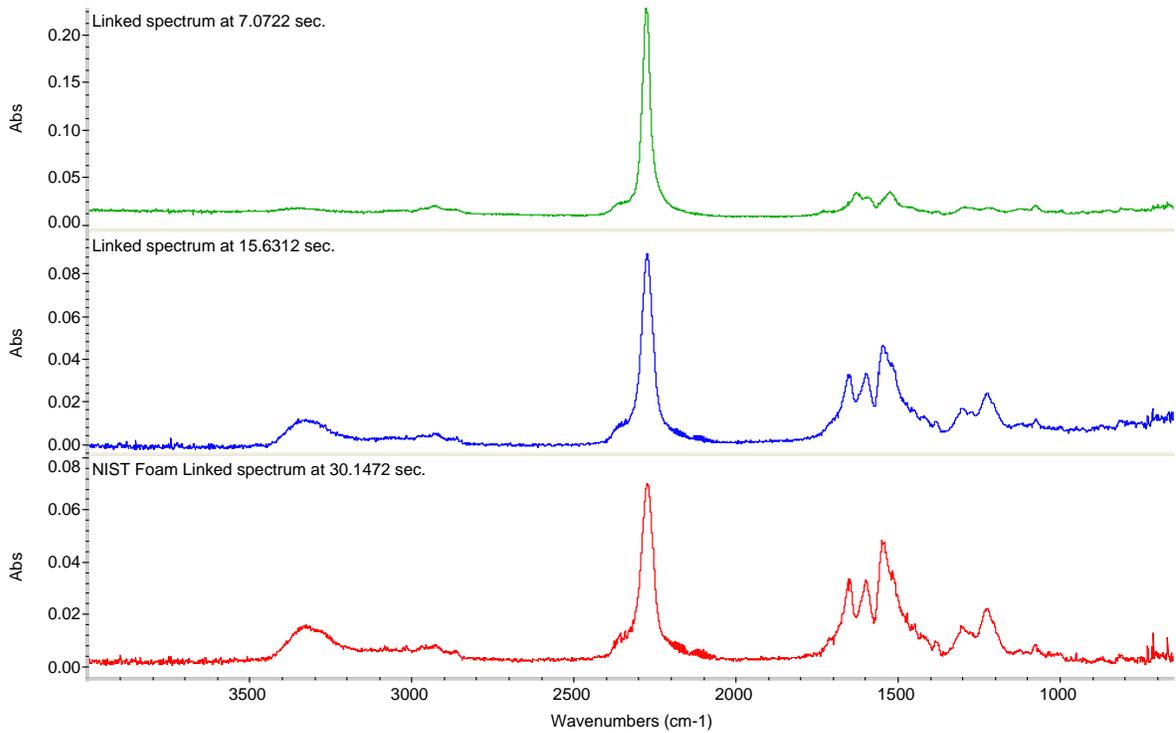
12. Figure 14 shows the foam pyrolysis progression. Initially the isocyanate compound (which is thought to be a mixture of C1 to C4 isocyanates) and foam vapor is detected, next carbon monoxide and carbon dioxide are formed from the foam vapor. The final pyrolysis products are an Isocyanate Compound ( $\text{H}_y\text{C}_x\text{NCO}$ ), and much lesser quantities of Carbon Dioxide ( $\text{CO}_2$ ), Carbon Monoxide ( $\text{CO}$ ), Ethylene ( $\text{C}_2\text{H}_4$ ), Acetylene ( $\text{C}_2\text{H}_2$ ), Hydrogen Cyanide ( $\text{HCN}$ ) and Vaporized Foam. The more oxygen starved the combustion of foam the more the gases produced will favor the final pyrolysis products. Not all of the foam is consumed in this pyrolysis. See Enclosure 4 for more information on the reaction mechanism and isocyanate compounds.

Figure 14. Infrared spectrum of Foam pyrolysis progression.

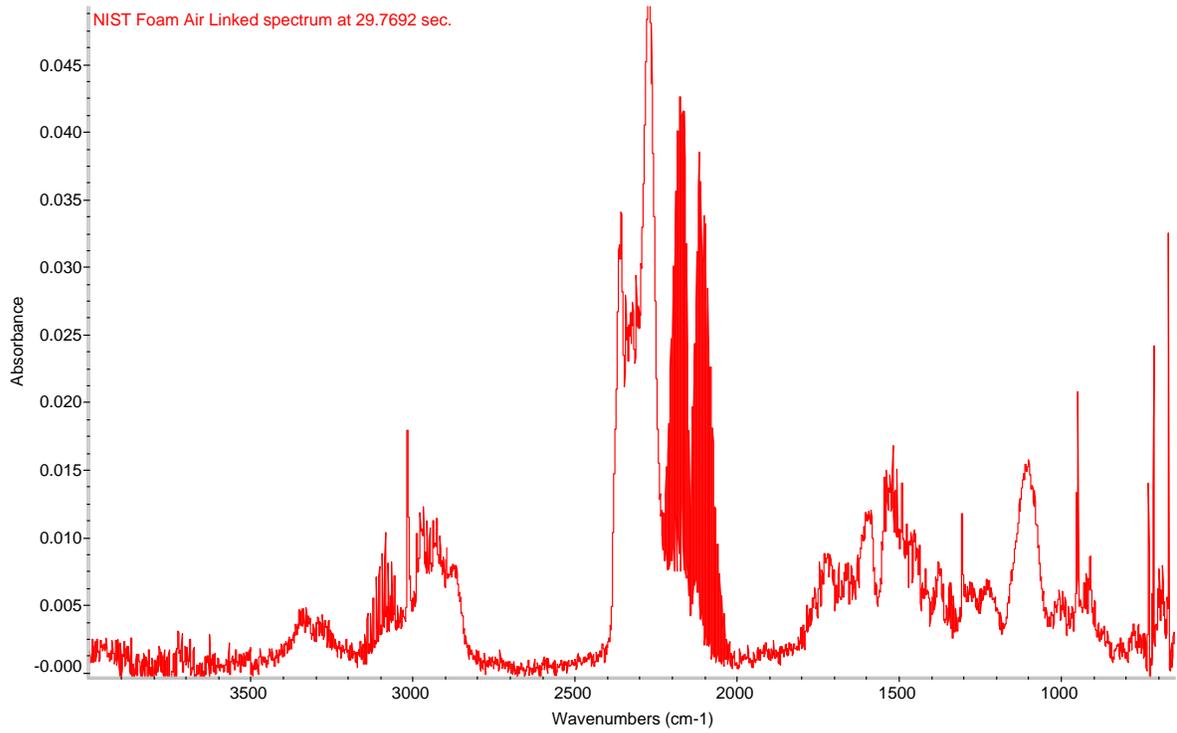
14. The combustion of the foam is shown in Figures 15 through 18. The fully combusted foam is displayed in figure 15. A large absorption at  $\sim 2270\text{ cm}^{-1}$  is produced in this spectrum. The best library match; an isocyanate compound, is shown in figure 16 along with the major gases that are produced in this combustion. Figure 17 is the infrared spectrum of the pyrolyzed foam with all of the major absorption peaks labeled.

Figure 15. Infrared spectrum of Foam Combustion in air.

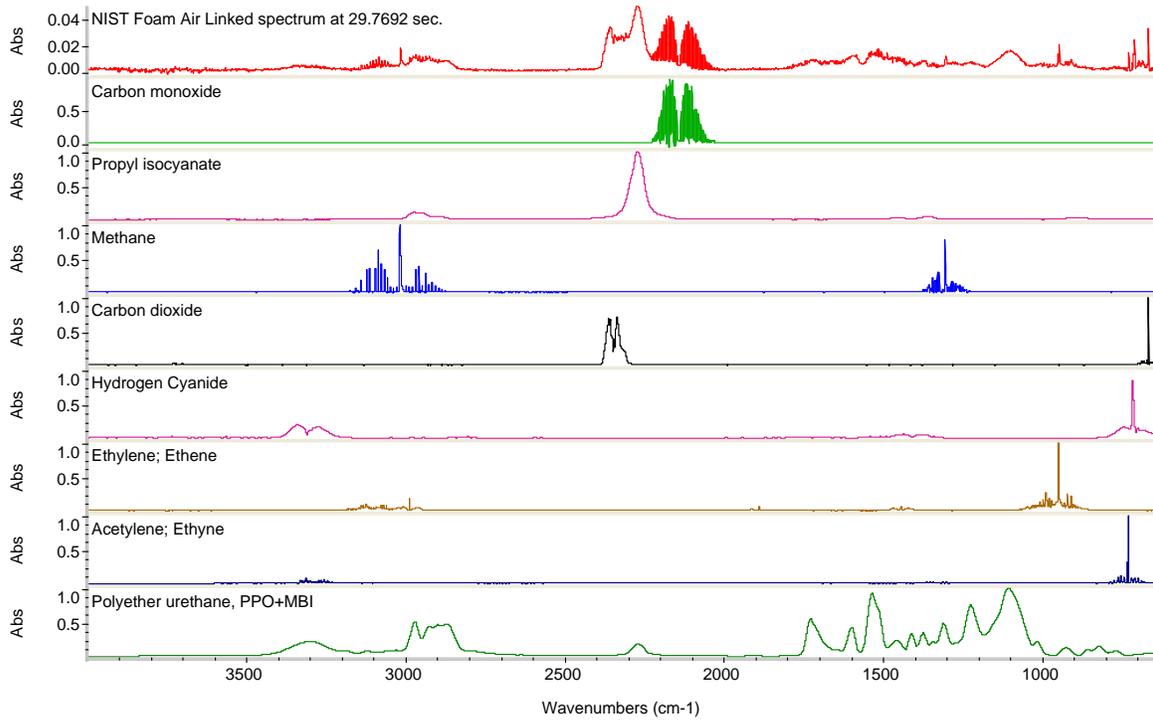
Figure 16. Infrared spectrum of Foam Combustion (top) and identified gases below.

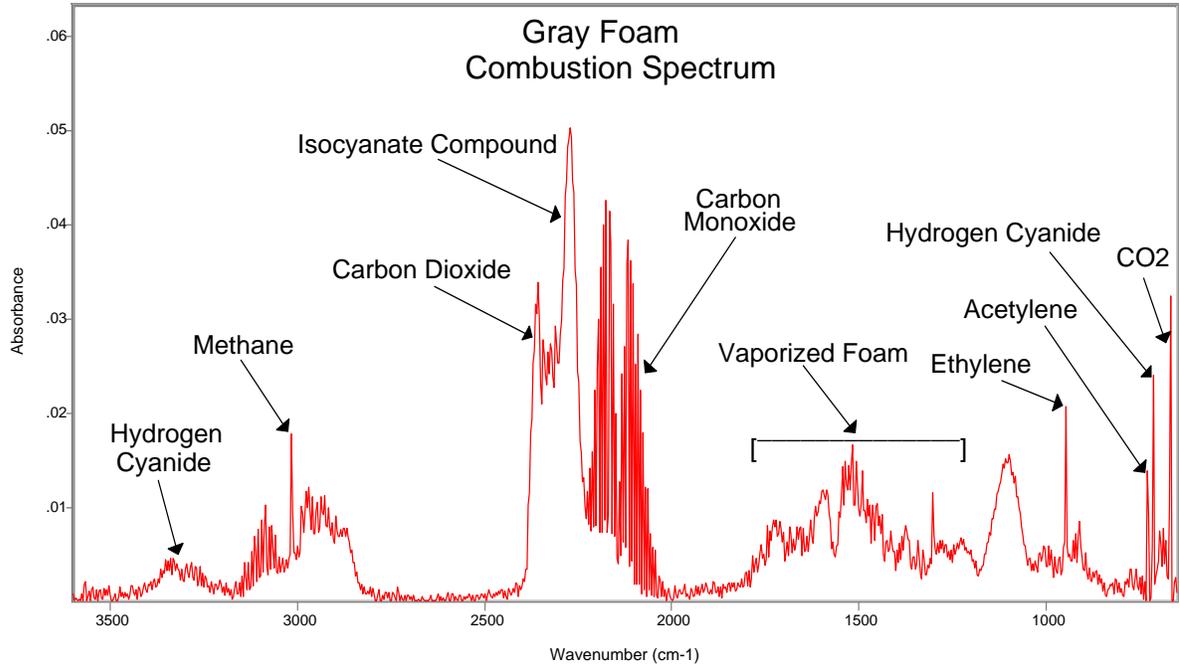
Figure 17. Infrared spectrum of Gray foam combustion with combustion gases labeled

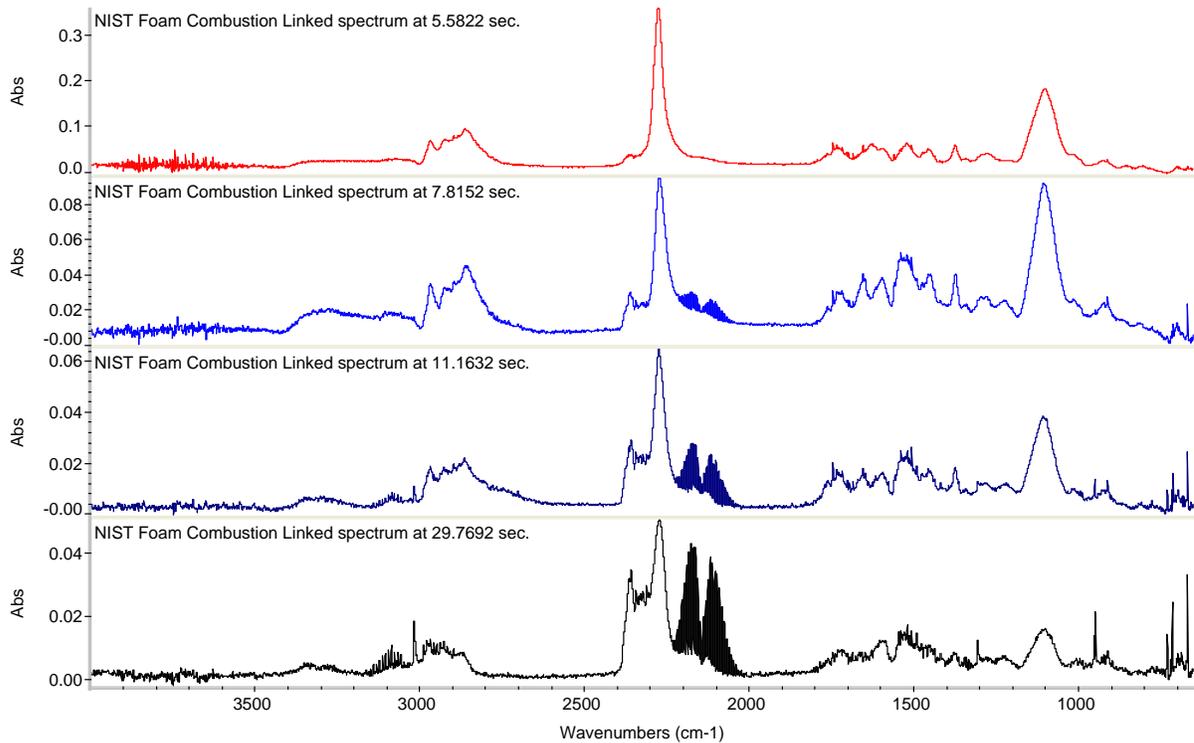
15. Figure 18 shows the foam combustion progression. The initial combustion products are the isocyanate compound (which is thought to be a mixture of C1 to C4 isocyanates) and foam vapor. At this point (about 6 seconds into the combustion) the products are the same as pyrolysis. As the combustion progresses (see middle and lower spectra on Figure 18.) large quantities of carbon dioxide and carbon monoxide are produced. The final products are the Isocyanate Compound ( $H_yC_xNCO$ ), Carbon Dioxide ( $CO_2$ ), Carbon Monoxide (CO), Methane ( $CH_4$ ), Ethylene ( $C_2H_4$ ), Acetylene ( $C_2H_2$ ), Hydrogen Cyanide (HCN), and Vaporized Foam. Combustion is incomplete as evidenced by the presents of carbon monoxide and foam vapor. See Enclosure 4 for more information on the reaction mechanism and isocyanate compounds.

Figure 18. Infrared spectrum of Foam Combustion progression. Note the growth of the carbon monoxide peak (centered at  $2150\text{ cm}^{-1}$ ) as the combustion progresses from 5 to 30 seconds. The isocyanate compound peak ( $\sim 2270\text{ cm}^{-1}$ ) dominates each spectrum. The polypropylene peak ( $\sim 1100\text{ cm}^{-1}$ ) is decreasing showing that the oily polypropylene (glycol?) compound is being consumed as the combustion progresses.

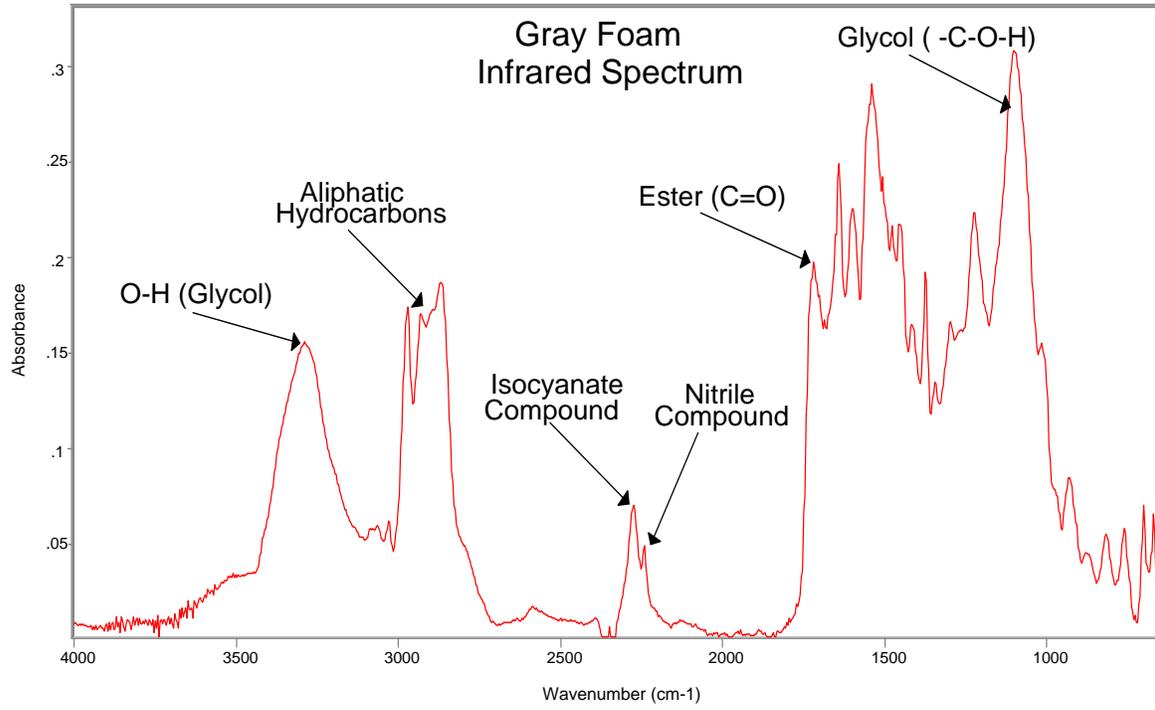
16. Figure 19 is included to show some of the major functional chemical groups in the original foam. The aliphatic hydrocarbons produce Methane ( $CH_4$ ), Ethylene ( $C_2H_4$ ), Acetylene ( $C_2H_2$ ), as they break down into smaller molecules during combustion. As these smaller molecules are oxidized (combusted) they form Carbon Dioxide ( $CO_2$ ) and Carbon Monoxide (CO). The isocyanate compound is released from the polymer backbone by the heat of combustion and forms the mixture of C1 to C4 isocyanates. The nitrile compound is the most likely source of the hydrogen cyanide. The ester and urethane (not labeled) parts of the foam also form isocyanates (see enclosure 4 explanation of thermal degradation mechanisms). All other parts on the foam contribute to the Carbon Dioxide ( $CO_2$ ) and Carbon Monoxide (CO) seen in the combustion spectra.

Figure 19. Infrared spectrum of gray polyether urethane foam with major structures labeled.

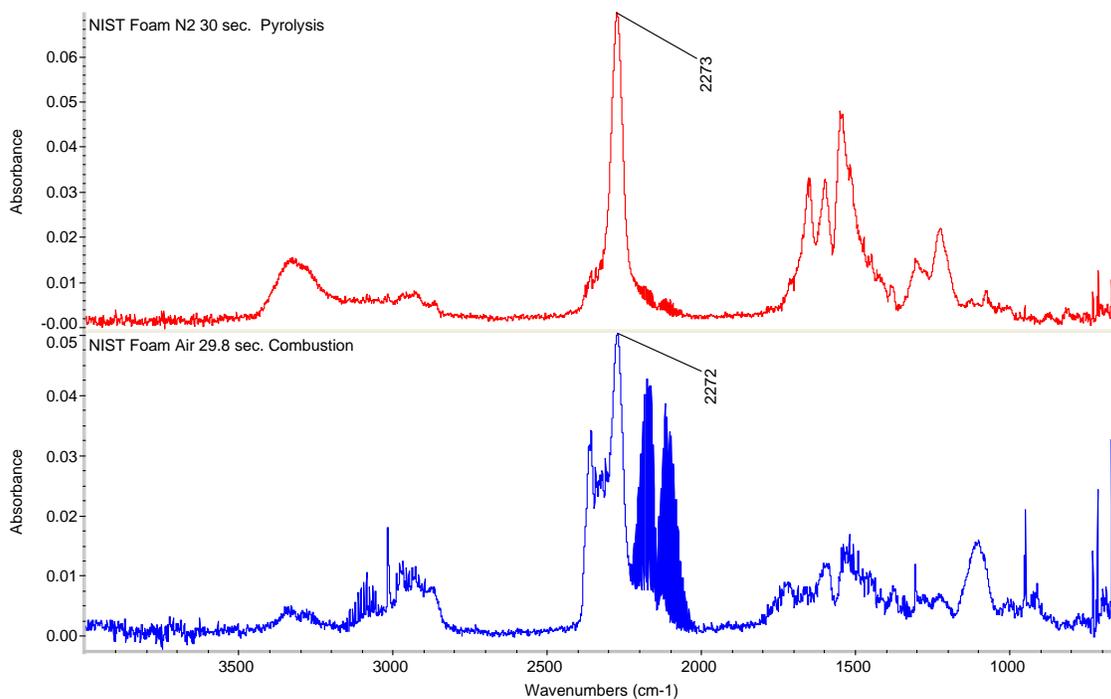
From the referenced combustion mechanism above pathway 1 which produces isocyanates must be the dominant combustion pathway. The large isocyanate peak in both the pyrolysis and combustion spectra of Figure 2 support this.

Figure 2. Infrared spectrum of foam pyrolysis gases (top) and combustion gases (bottom). The dominate peak in each spectrum is the peak at  $\sim 2270 \text{ cm}^{-1}$ . This peak most closely matches isocyanate compounds (see figure 3). The related isocyanide compounds are not a good match (see figure 4) because their absorbance is too far from  $2270 \text{ cm}^{-1}$ .

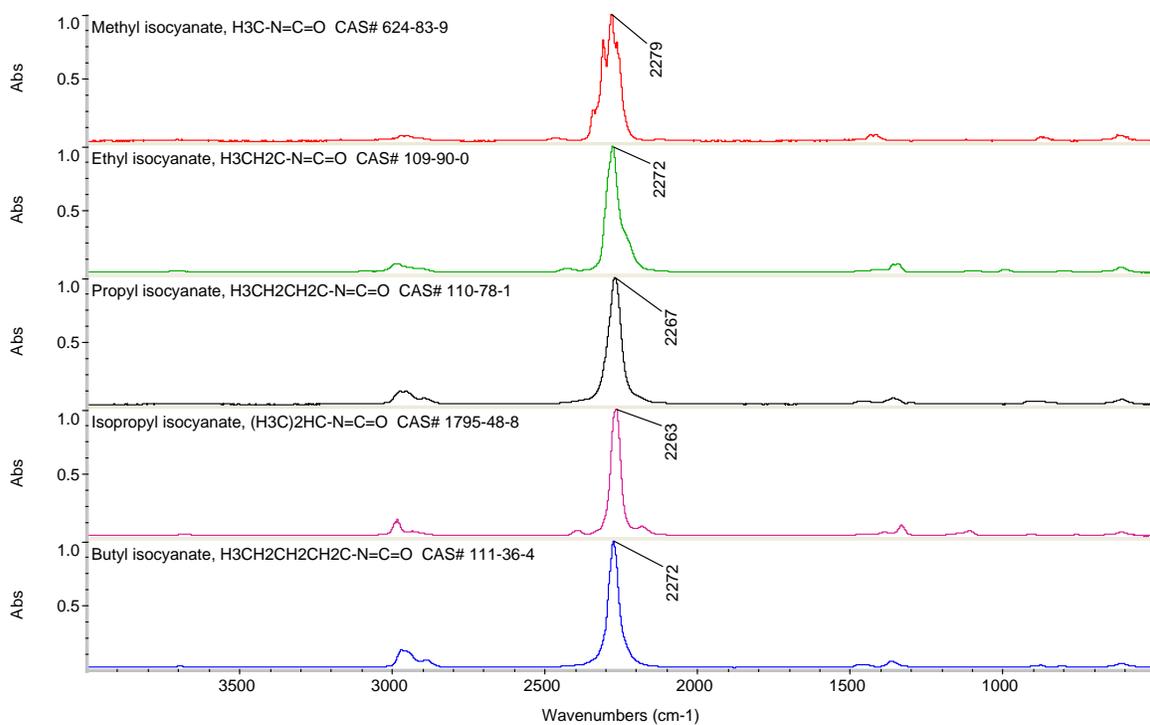
Figure 3. Infrared spectra of selected isocyanate compounds all with absorbance's in the 2270 +/- 9 cm<sup>-1</sup> range. These are some of the most likely compounds to match the 2270 cm<sup>-1</sup> peak in the pyrolysis and combustion spectra (Figure 2.).

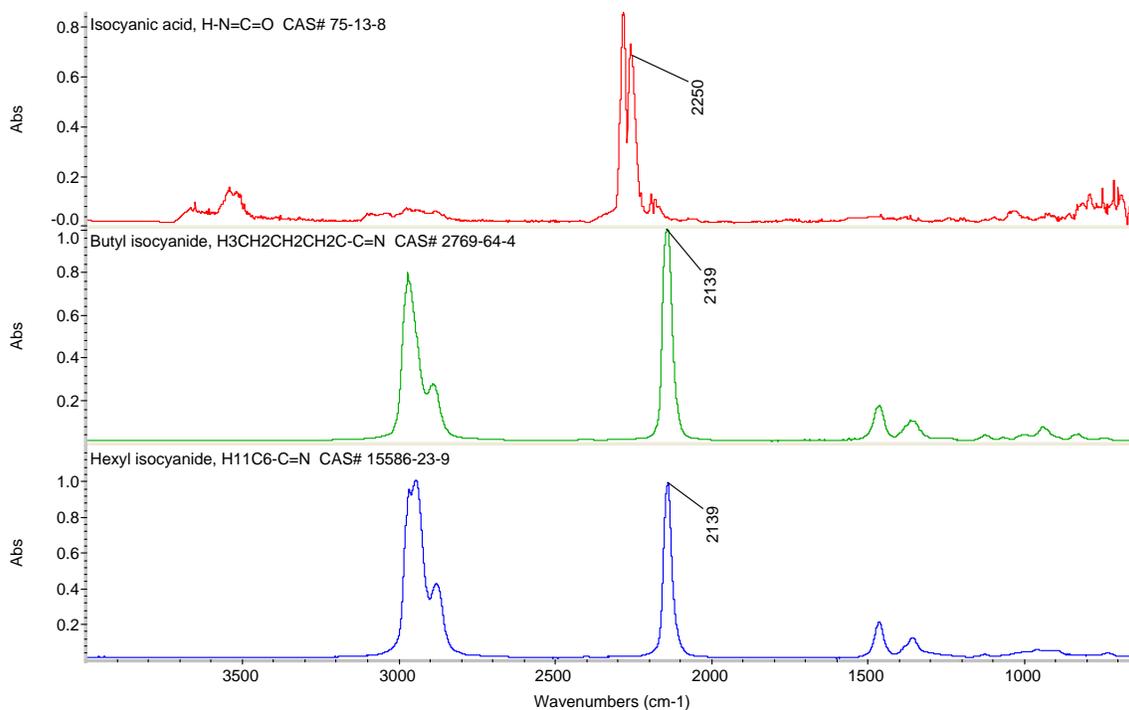
Figure 4. Infrared spectra of selected isocyanide compounds. These have a slightly different structure than the isocyanate compounds in Figure 3. These do not match the 2270 cm<sup>-1</sup> peak in the pyrolysis and combustion spectra (Figure 2.).

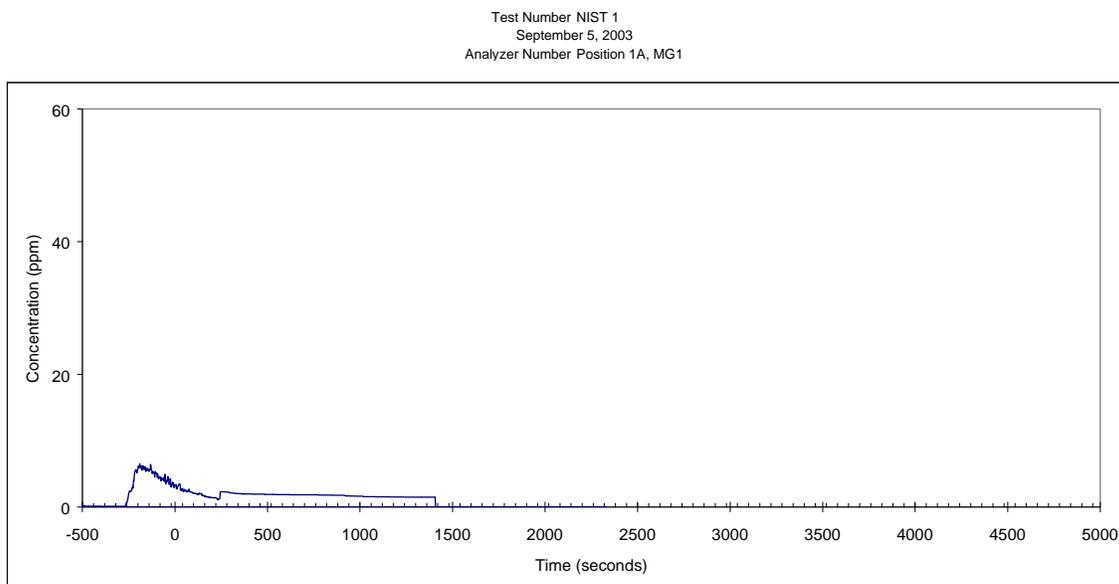
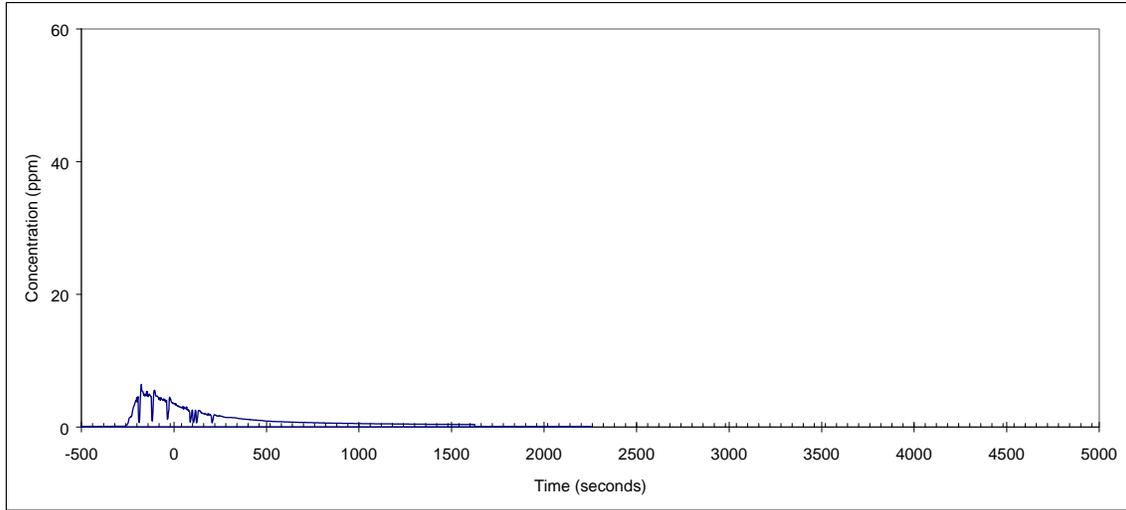
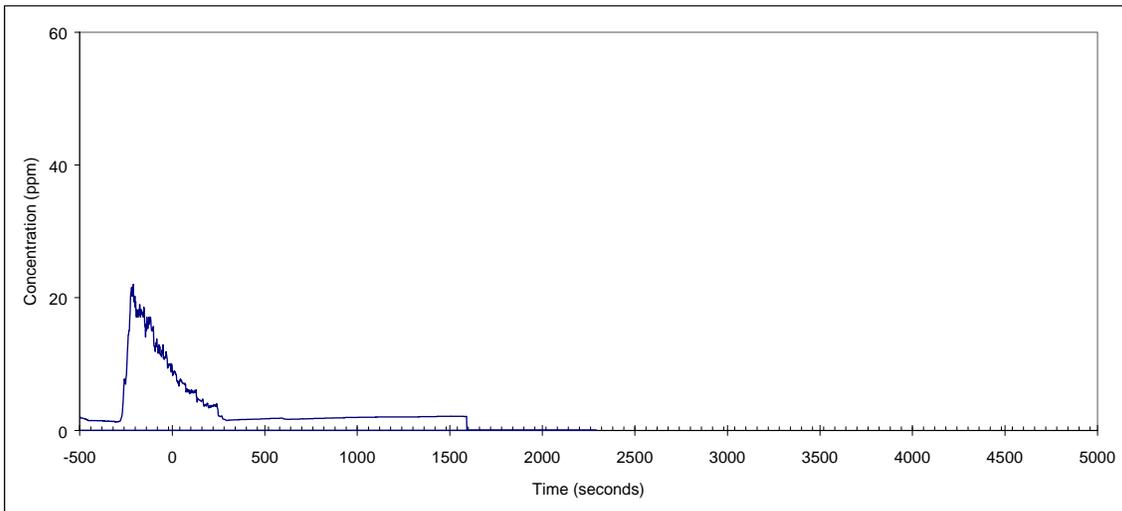
Figures J-3 to J-5 show real-time results from the three HCN gas analyzers used for test 1 conducted on 5 Sept 03. The automatic sprinkler system activated at about 25 sec.; therefore, there was very little HCN produced.

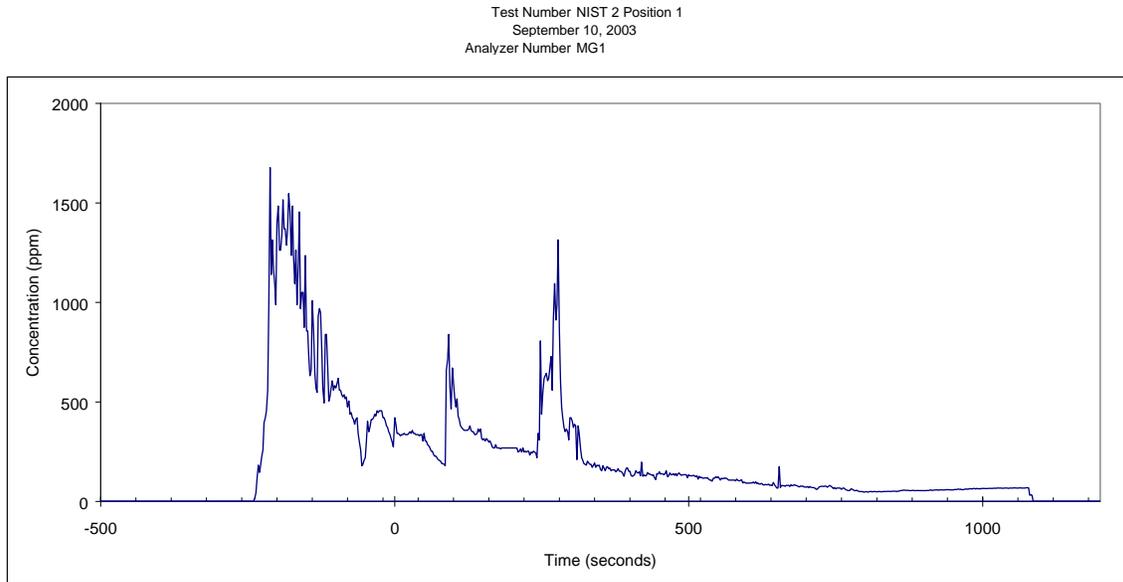
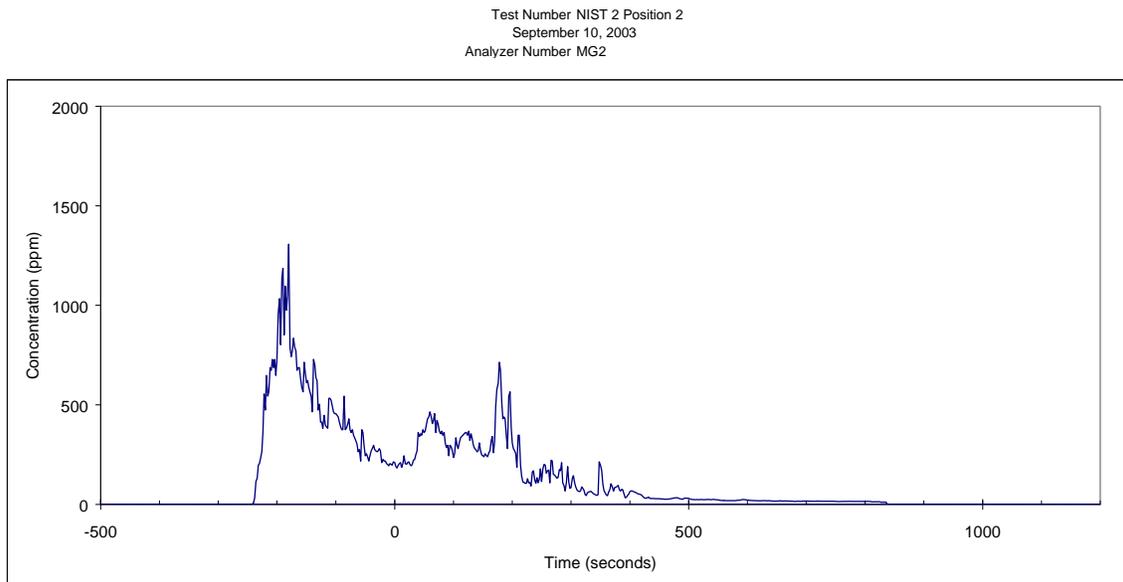
Figures J-6 and J-7 show real-time results from the two mini gas HCN analyzers used for test 2 conducted on 10 Sept 03. This fire burned much longer and as indicated by the response produced much higher values of HCN.

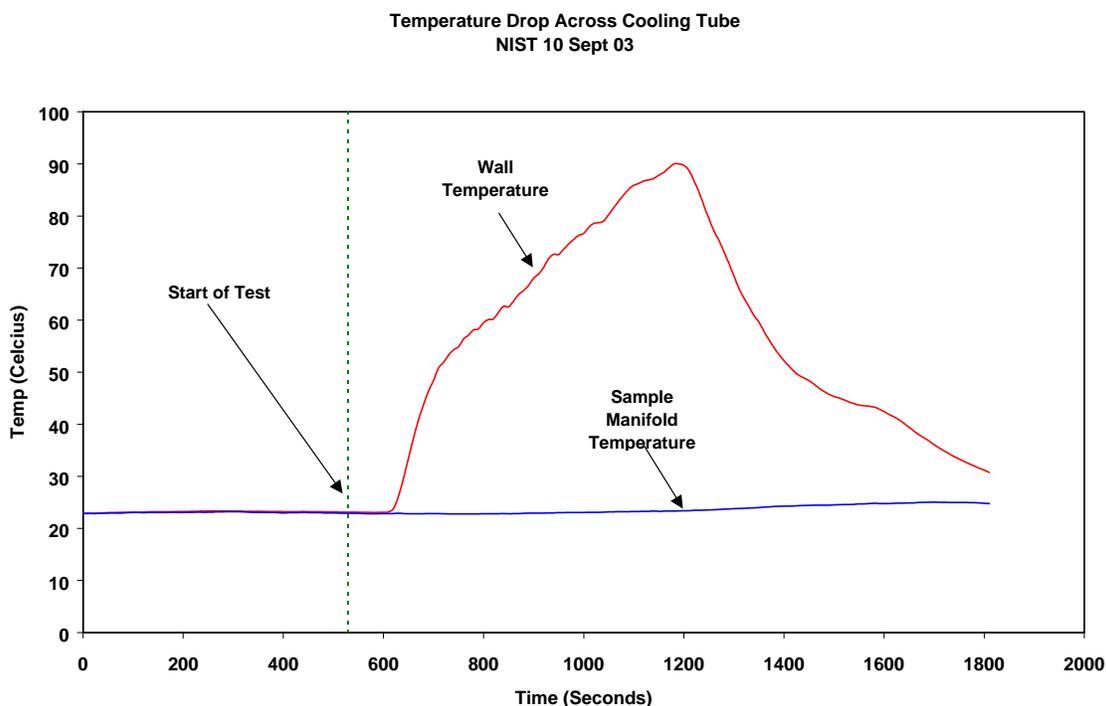
The data from the two thermocouples was recorded at 10-sec. intervals. The figure below shows that the 3-ft. extension successfully cooled the sample gases prior to entering any of the sampling devices.
