**NIST NCSTAR 1-5D (Draft)**

**Federal Building and Fire Safety Investigation of the  
World Trade Center Disaster**

# **Reaction of Ceiling Tile Systems to Shocks (Draft)**

September 2005

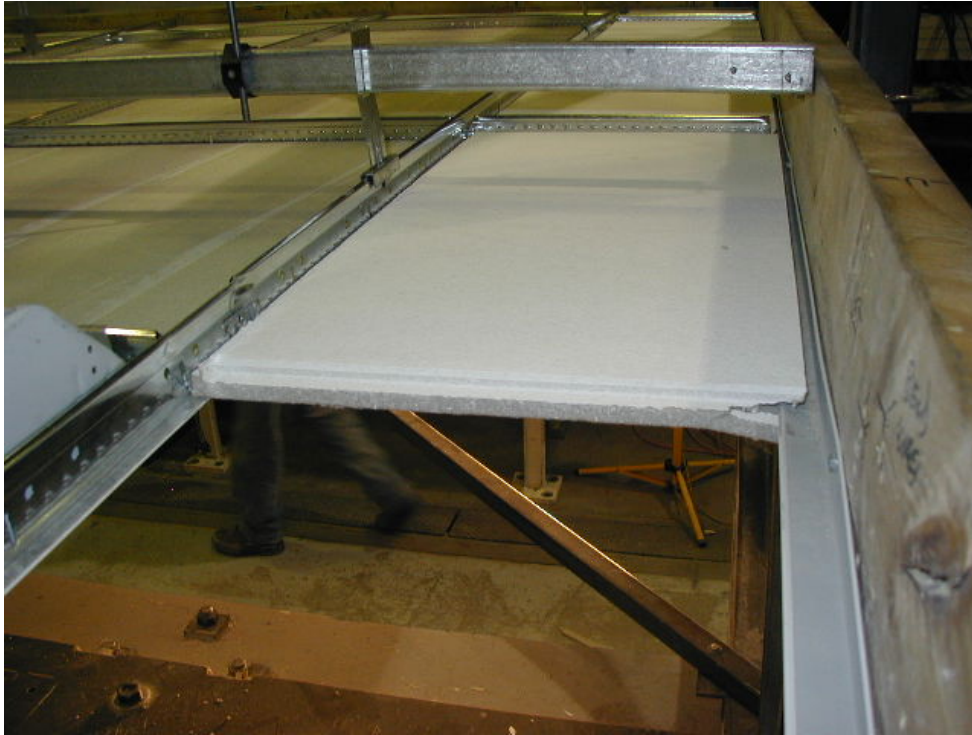
1.75	Entire north perimeter fell. Significant damage to south perimeter. See Figs. 3–14 and 3–15.

**Figure 3–15. Damage to south perimeter of ceiling system CS4 after 1.75g earthquake excitation.**
