# Firebrands Generated in Shurijo Castle Fire on October 30th, 2019

Sayaka Suzuki <sup>(b)</sup>\*, National Research Institute of Fire and Disaster (NRIFD), 4-35-3 Jindaiji-Higashimachi, Chofu, Tokyo 182-0012, Japan
Samuel L. Manzello <sup>(b)</sup>, National Institute of Standards and Technology (NIST), 100 Bureau Drive, Gaithersburg, MD 20899, USA

*Abstract.* A fire started in Shurijo Seiden, or the main hall of Shurijo Castle, Nahacity, Okinawa, Japan on the morning of October 30th, 2019. The fire resulted in loss of 8 structures and many important Okinawan cultural assets. The original Shurijo Castle was destroyed many years ago and a replica was constructed and rebuilt to be as close as possible to the original building. The replica was fabricated mainly from wood (*Chamaecyparis taiwanensis*). Firebrands were reported during the fire. In this study, firebrands from Shurijo Castle was collected and analyzed. The data was compared with those from other investigation as well as experimental data.

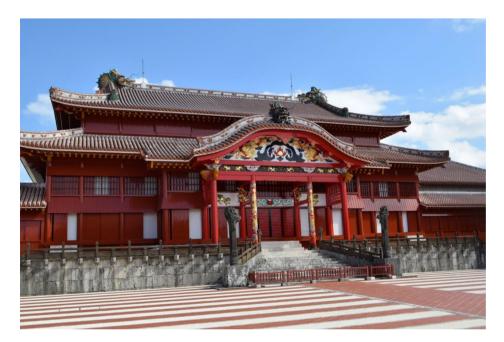
Figure 1. Image of Shurijo Castle (Seiden) (before the 2019 fire) where a fire started. The height of Shurijo Seiden is 18 m.

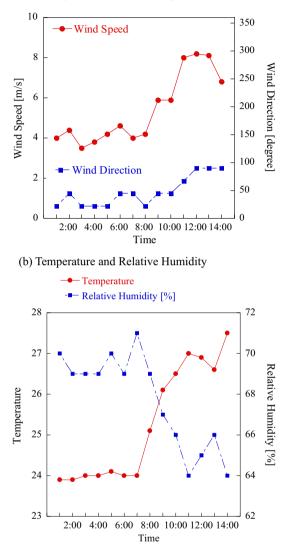
On the day of disaster, the weather was clear and wind speeds during the fire was around 5 m/s to 6 m/s from NNE (22.5 degree), then increased to 8 m/s with wind from ENE (67.5 degree) then East later that day, shown in Fig. 3 (a) [19]. As shown in Fig. 3 (b), the temperature was constantly around 24 °C until 7 AM, then increased during the day and the relative humidity was around 70% until 7 AM and decreased to 64% afterwards. The location of weather observatory is shown in Fig. 4.

Figure 3. Weather information during the fire. a Wind speed and direction. O degree indicate North. b Temperature and Relative Humidity.

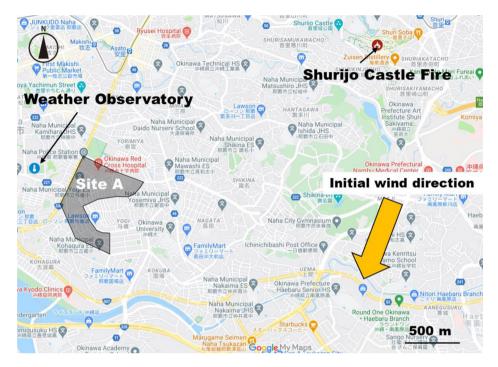
Figure 4. Location of Shurijo Castle and Weather Observatory in Naha-city, Okinawa, Japan. Site A indicates an area where firebrands were provided.
