Experimental Study on Fire Resistance of a Full-Scale Composite Floor Assembly in a Two-Story Steel Framed Building

National Institute of Standards and Technology, Gaithersburg, Maryland, USA

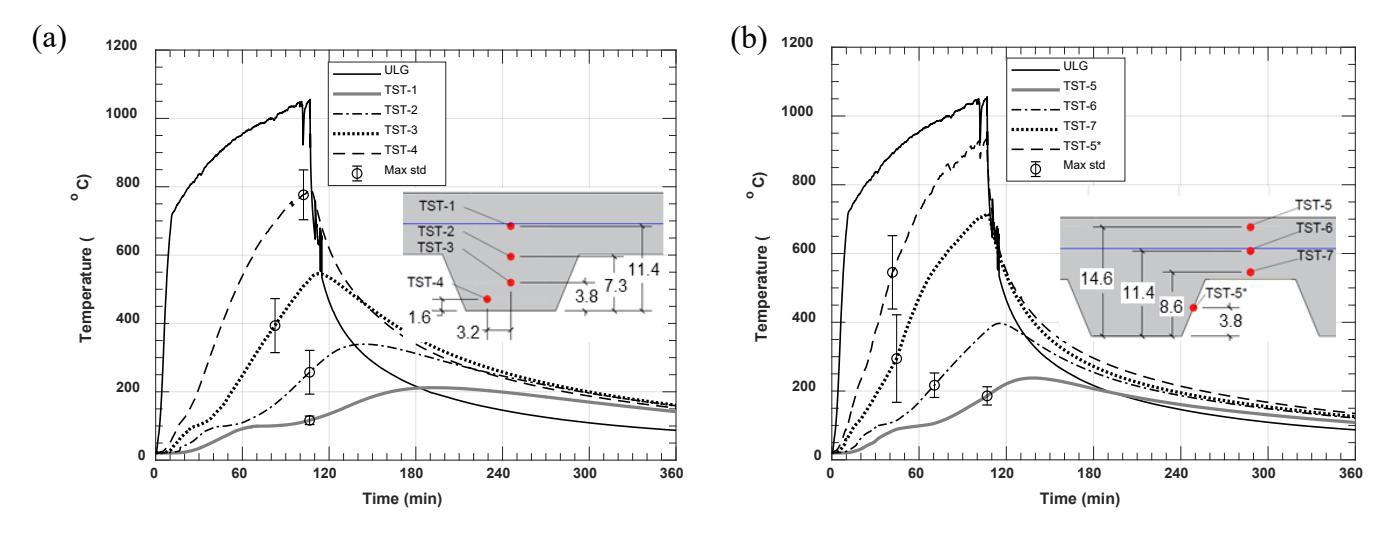
Figure 8 – Measured temperatures of (a) deep section and (b) shallow section of the concrete floor slab. Plotted with the average values of six deep sections or four shallow sections across the test floor; thermocouple locations are in cm

A total of thirty-six thermocouples were mounted on the 9.1 m by 6.1 m test floor slab at various locations that were not thermally shaded by the steel framing underneath. Figure 8 shows the average concrete temperature in the 159 mm thick or 83 mm thick sections of the concrete slab. Thermocouples installed at the steel decking (TST-5*) measured the hottest temperature, reaching nearly 900 °C during fire loading. The peak temperature of the concrete near the bottom rib of the steel decking (TST-4) was about 100 °C higher than the concrete temperature near the top rib (TST-7). However, the spatial temperature variation of TST-5*

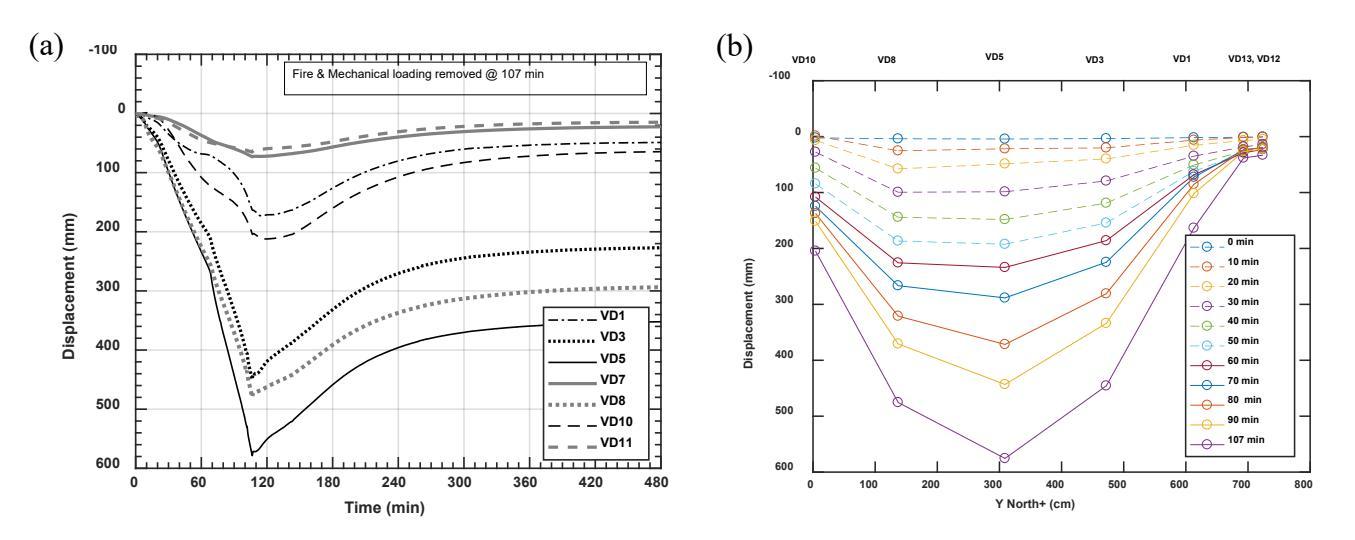
Figure 10 – (a) Vertical displacements after the burner ignition at 0 min; (b) Vertical displacement profile varying with fire exposure time

As shown in Figure 10, the vertical displacement of the test floor assembly continued to increase during heating and partly recovered during cooling; however, collapse did not occur. It is noteworthy that the actuator loads on the heated floor were removed immediately after the burners were switched off at 107 min, and therefore the test floor assembly supported the weight of loading frames (approx. 0.45 kPa) during the cooling phase. Until 60 min after ignition the values of VD5 and VD8 were similar. However, after the test floor slab began to breach (wide longitudinal crack) around 70 min, VD5 surpassed VD8 and reached 460 mm at 92 min. This displacement was approximately equal to the ratio of L/20 where L is the eastwest span of 9.1 m. While VD5 finally reached the L/16 ratio at 107 min, there was no indication of 'runaway' deformation. Conversely, the vertical displacements of the perimeter steel members (VD1, VD7, VD10, and VD11) were relatively small, ranging from 65 mm to 210 mm. Also, VD7 and VD11 appeared to be less affected by the longitudinal concrete fractures. These perimeter members exhibited some degree of twisting and lateral deformations discovered during the post-test inspections.

heating. Hence, the headed stud anchors welded atop the east and west girders were ineffective to induce tension in the concrete in the east-west direction as the heated floor slab continued to deflect downward. In contrast, the north edge crack formed 370 mm or less north of the north primary beam (i.e., outside of the test-bay column grid) and thereby the headed stud anchors on all three 9.1 m long beams appeared to provide anchorage of the concrete and steel decking against tension developing in the north-south direction. As the vertical displacement of the test floor increased in fire, the excessive tension would develop more effectively in the north-south direction than in the east-west direction until welded wire reinforcement finally ruptured at critical locations. This welded wire reinforcement rupture would happen in the concrete where the vertical displacements were greater, i.e., south of the secondary beam (VD8) as shown in Figure 10(b).

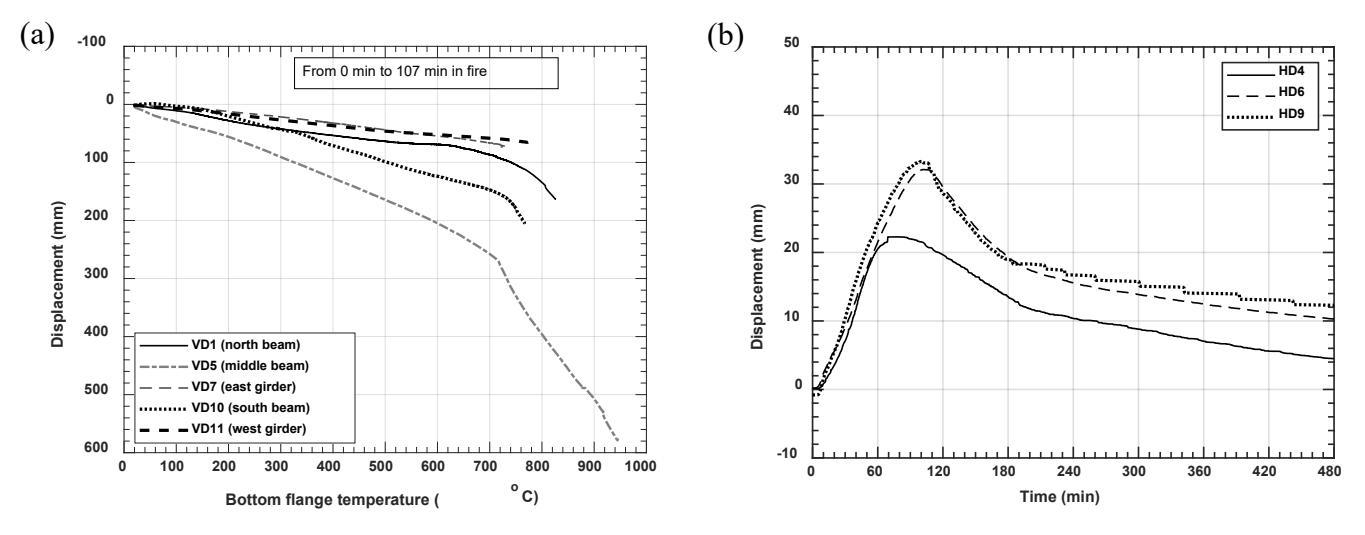
Figure 11 – (a) Vertical displacement data as a function of bottom flange temperatures during heating; (b) Horizonal displacements measured at 15 cm above the test floor slab during heating (until 107 min) and cooling

Figure 11(a) shows the midspan vertical displacements of the protected steel beams and girders as a function of the bottom flange temperatures. When the bottom flange temperature exceeded 700 °C, the vertical displacement of the secondary beam (VD5) increased much more rapidly from 0.4 mm/°C to 1.4 mm/°C. This change could be caused by several factors, such as initiation of a longitudinal breach of the test floor slab and continuous degradation of flexural strength and stiffness of support beams at higher temperatures. In the early stage of a test fire, on the other hand, the increase in displacements of the east and west girders (VD7 and VD11, respectively) was affected by smaller applied load ratios than the secondary beam.

The horizontal (axial) displacements of the test assembly were measured using the lateral displacements of the columns at the first-story level. Figure 11(b) shows the time-varying horizontal displacement of the north primary beam (HD4) and the east girder (HD6) of the test assembly as well as the lateral displacement of the southeast column of the test bay. The positive values in this figure represent the displacements due to thermal expansion of the heated test assembly. The values of HD6 and HD9 were similar throughout the test, indicating that the east girder expanded in one direction, i.e., toward the south due to a much larger restraint provided by the north surrounding frame. These displacements increased continuously to a peak value ranging from 32 mm to 34 mm until the fire test was terminated. The value of HD4 increased at a similar rate but began to decrease after 70 min when the longitudinal fracture of concrete occurred. The maximum axial displacement due to thermal expansion in the east-west direction was approximately 22 mm.

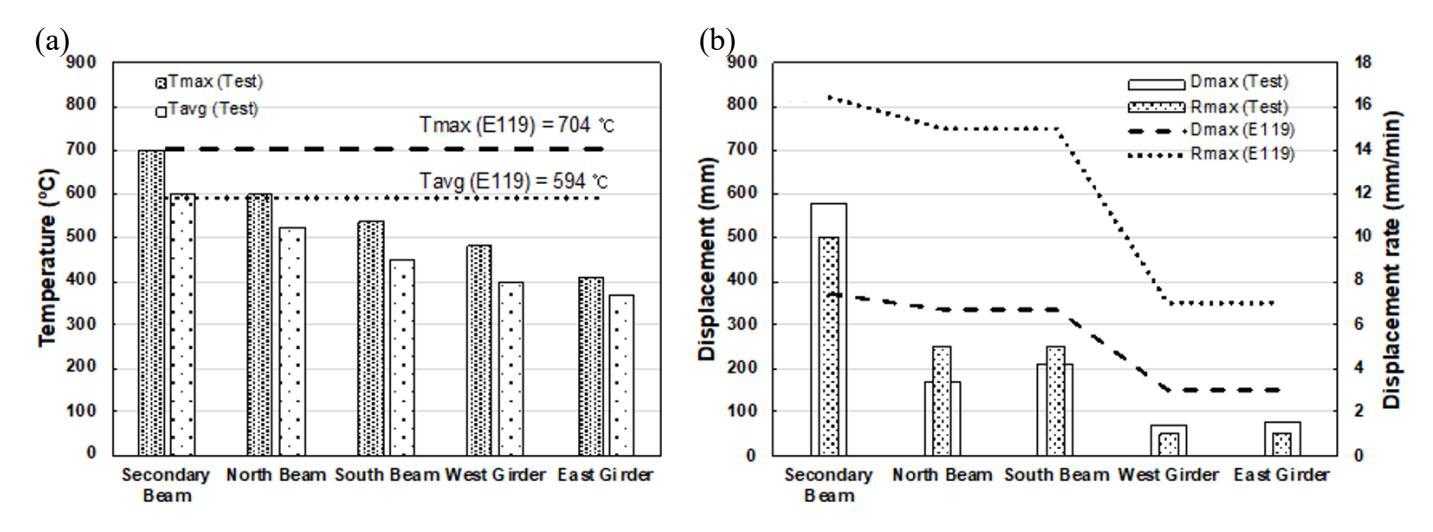
Figure 14 – Comparisons of the test results with (a) limiting temperatures and (b) limiting displacements and displacement rates, where Dmax = maximum displacement and Rmax = maximum displacement rate

Figure 14 summarizes the test results in comparison with ASTM E119 acceptance criteria. For the 2-hour restrained fire resistance rating, the test specimen must meet a specified combination of the following conditions: (i) sustaining the applied loads with no ignition of cotton waste placed on the top of the heated concrete slab during the full rating period, (ii) the average temperature on unexposed surface less than 139 °C above its initial temperature during the first hour, (iii) a peak temperature of structural steel members below 704 °C during the first hour, and (iv) the average temperature at any section of structural steel members below 593 °C during the first hour, and (v) the maximum total displacement less than the value of $Lc^2/400d$ where Lc = beam clear span, d = depth of composite beam, and the corresponding displacement rate less than the value of $Lc^{2}/9000d$. As shown in Figure 14, the protected individual W16×31 beams and W18×35 girders of the test assembly successfully met the limiting temperature and displacement criteria. The average concrete surface temperature measured by eight thermocouples distributed across the test assembly was approximately 120 °C prior to extinguishment of the fire. Although the maximum total displacement of the secondary beam exceeded the ASTM E119 displacement limit, the measured displacement rate of this beam was 40 % less than its specified value. It is important to note that this load condition was determined from the ASCE 7 load combination of $1.2 \times \text{dead load} + 0.5 \times \text{live load}$, only on the order of 30 % of the load prescribed in the ASTM E119 standard for the same assembly. If the ASTM E119 load was used instead, then the test floor assembly might have achieved the limiting displacement and displacement rate much sooner.
