NIST Technical Note 2203

**Fire Resilience of a Steel-Concrete
Composite Floor System: Full-Scale
Experimental Evaluation for Influence
of Slab Reinforcement (Test #2)**

Test #2 investigates the influence of the slab reinforcement on the structural integrity of the 9.1 m × 6.1 m steel-concrete composite floor subjected to combined mechanical loads and compartment fire exposure. The fire test bay was situated on the ground floor in the middle edge bay of the two-story test building. The floor slab in the test bay was reinforced with 9.5 mm diameter deformed bars placed 30 cm on center (230 mm²/m). The test floor was hydraulically loaded to 2.7 kPa to mimic the code-prescribed gravity loads for fire conditions. Natural gas burners created a peak gas temperature exceeding 1100 °C below the test floor. The test fire lasted about 131 min, but the hydraulic loading was not removed until the test floor cooled down over 2 hours after the fire was extinguished. This experiment confirmed that the steel reinforcement played a vital role in maintaining the integrity of the composite floor under prolonged compartment fire exposure. The mid-panel vertical displacement increased at a rate less

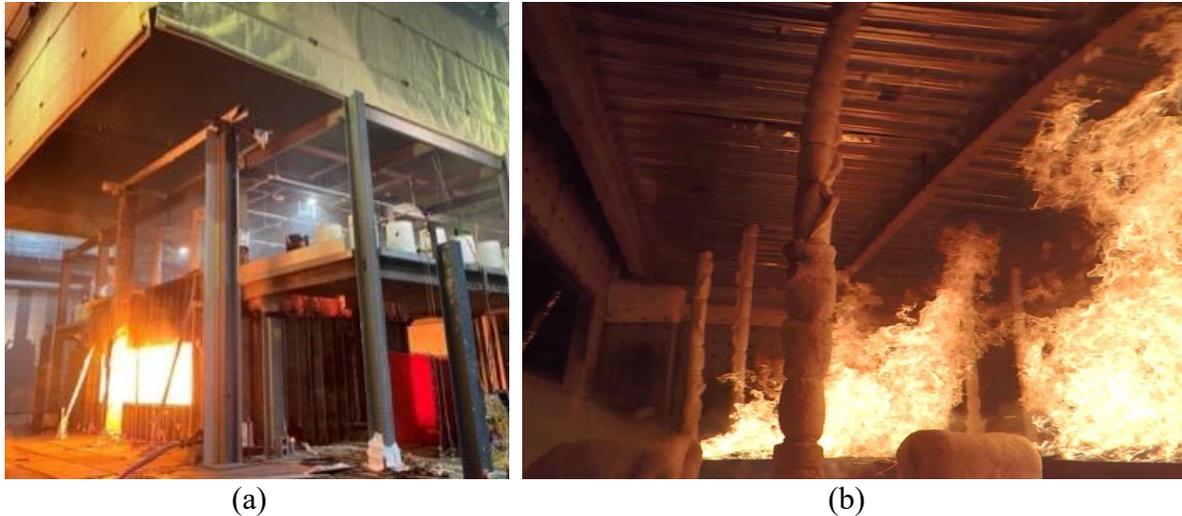
Fig. 1. (a) Compartment fire test in the south middle bay of the two-story building under 20 MW exhaust hood; (b) Composite floor soffit exposed to natural gas fueled compartment fire.

The natural gas fueled compartment fire produced the upper layer gas temperature (below the composite floor) closely following the temperature-time relationship used in standard fire testing. The peak gas temperature of 1060 °C was recorded when both the test fire and hydraulic loading was removed at 107 min. Temperatures of the protected steel beams in the test bay reached a peak value of 800 °C. The peak heat release rate and total heat energy was measured 10.8 MW and 63.5 GJ, respectively.

During fire, the heated composite floor (with imposed mechanical loads on top) continuously sagged, reaching the peak vertical displacement of 60 cm at 107 min. The 9.1 m long floor beams (W16×31) buckled at their ends due to large compressive forces induced by the restraint to thermal elongation. The exterior columns (W12×106) bent outward due to thermal expansion of the heated floor assembly, resulting in partial shear ruptures in some bolts connected to those columns.

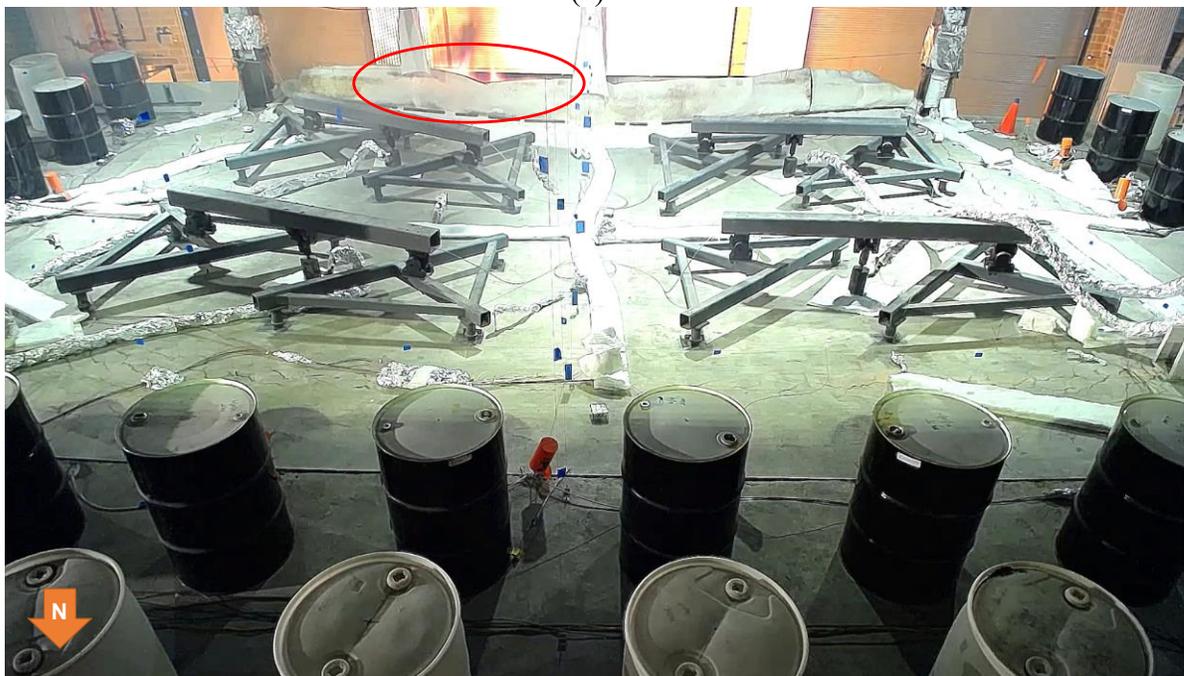
Clock Time	Fire Exposure Time	Description
10:36 AM		Hydraulic loads of actuators began to ramp up
11:25 AM	0 min	The burner ignition was confirmed; See Fig. 14a.
12:45 PM	100 min	A breach became visible along the south wall above the test floor level allowing flame extension; See red circle in Fig. 14b.
1:36 PM	131 min	The burners were switched off
3:38 PM		Hydraulic pressure was released

Fig. 14. Snapshots from the test video showing (a) inside the test compartment at ignition of the burners and (b) top of the test floor specimen at 120 min after the burner ignition.

As shown in Fig. 28, the vertical displacement of the secondary beam at midspan (VD5) increased to 455 mm (equivalent to the ratio $L/20$ where $L = 9.1$ m) at 131 min, finally reaching its peak value of 475 mm at 145 min (i.e., about 14 min into cooling). The maximum displacements of the north beam (VD1), the east girder (VD7), and the west girder (VD11) were 200 mm, 115 mm, and 125 mm, respectively. The vertical displacements of the south edge beam at midspan (VD10) became invalid after 130 min because Kaowool strips placed along the south wall were flipped over a measurement string of this displacement sensor as the south wall significantly bent toward the south (Refer to Fig. 14b).

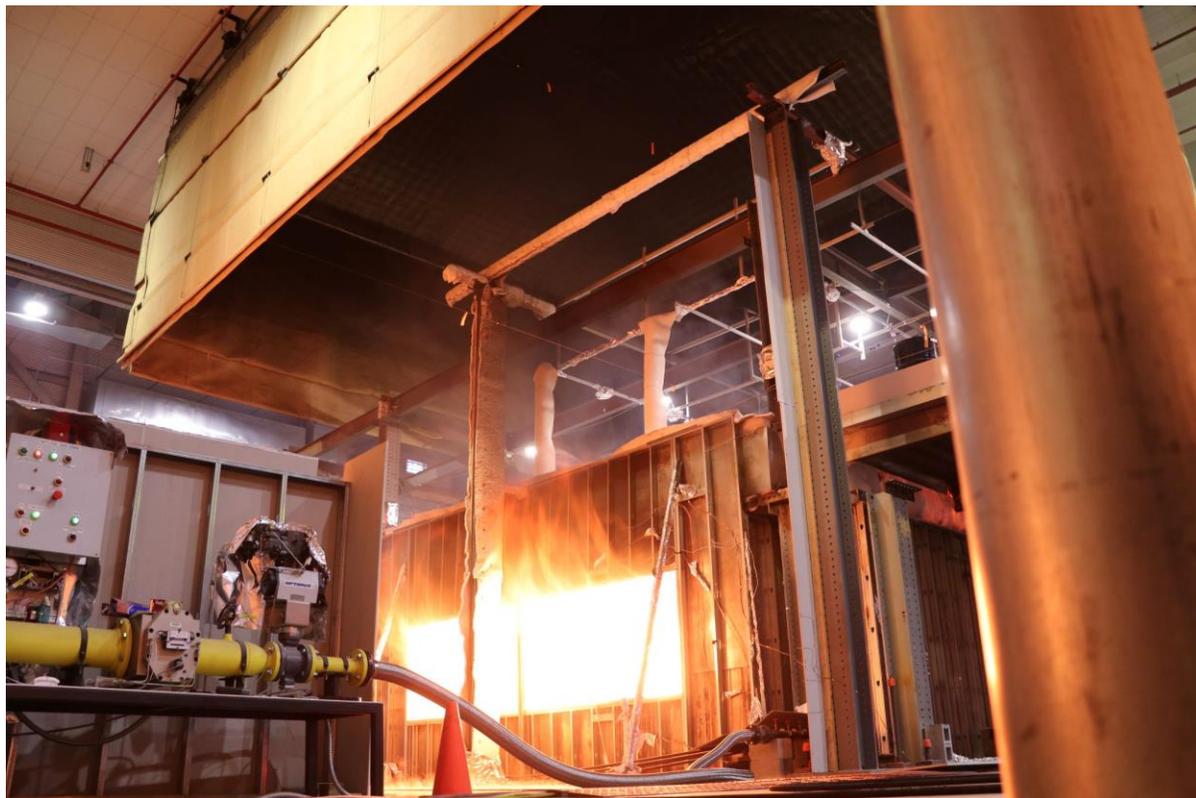
Fig. 18. Front view of the main vent opening of the fire test compartment during Test #2.

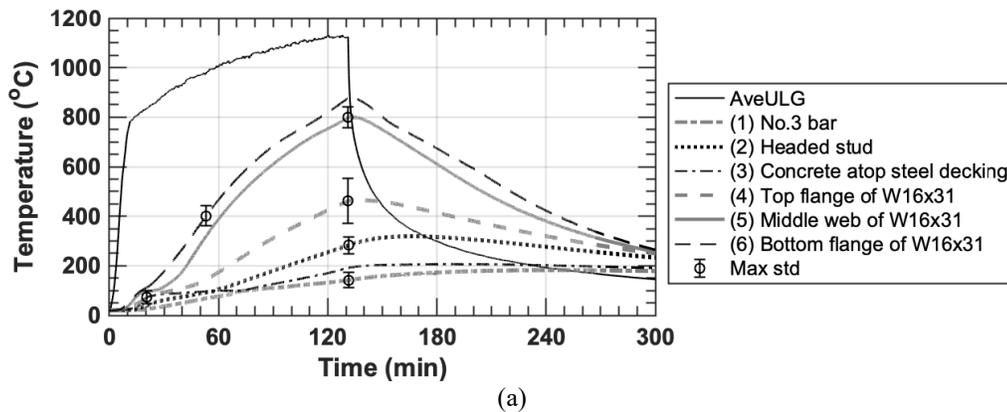
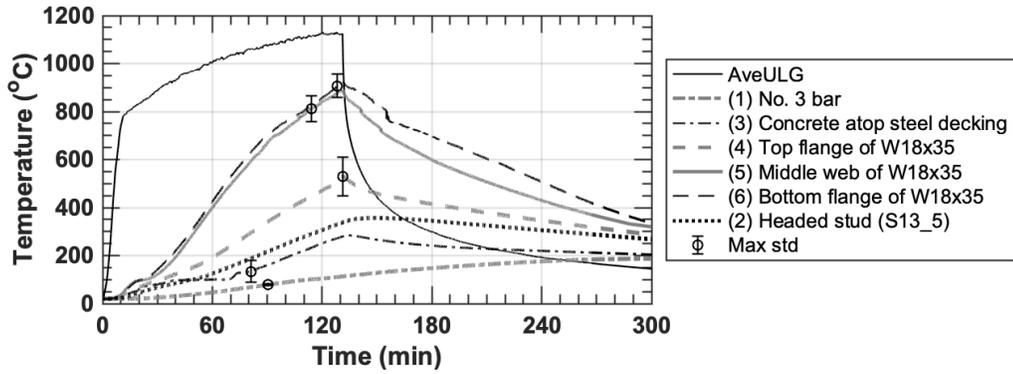
The typical temperature change across the composite beam sections is presented in Fig. 23. The 9.1 m composite beam temperatures (Fig. 23a) are the average values of temperature readings of the north, south, and secondary beams at midspan. Similarly, the composite girder temperatures in Fig. 23b are the average temperature values of the east and west girders at midspan. As shown, during the fire exposure, temperatures of the SFRM-applied steel shapes reached a peak value of 850 °C at the bottom flanges and 500 °C at the top flanges on average. Temperatures of the embedded No. 3 reinforcing bars over the beams or girders increased to a peak value of 200 °C after the test fire was extinguished. The greater temperature variation (as large as 20 %) was observed at the top flange or within the concrete slab.

Fig. 23. Average temperatures of (a) 9.1 m composite beam and (b) 6.1 m composite girder at midspan. The error bars indicate the maximum standard deviation of temperature readings at different sections.

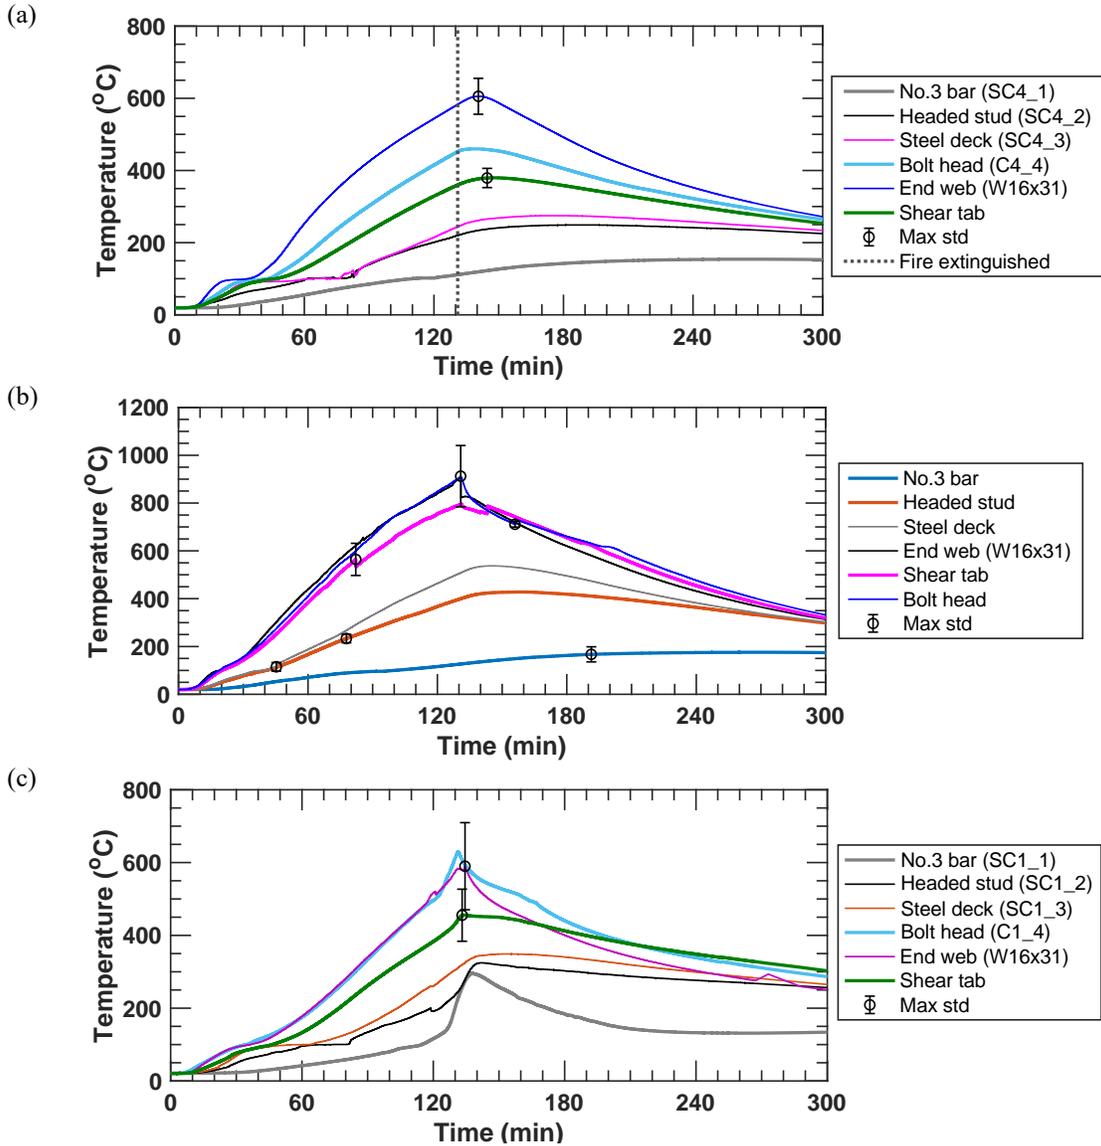
As shown in Fig. 25, the beam-to-girder connection region was heated more rapidly due to its proximity to the burners and a thinner layer of SFRM. The shear-tab connection temperature exceeded 800 °C on average during the fire exposure. Temperatures of the same connection at the north and south beam ends remained below 600 °C. The No.3 reinforcing bar over the connection remained below 200 °C for the north and secondary beams. However, the No. 3 bar temperature at the south beam ends sharply increased after 120 min, indicating concrete cracks.

Fig. 25. Average temperatures of the beam-end connections of (a) north edge beam, (b) secondary beam, and (c) south edge beam with W16x31 shapes. Error bars indicate a maximum value of standard deviation of temperatures measured at multiple locations.

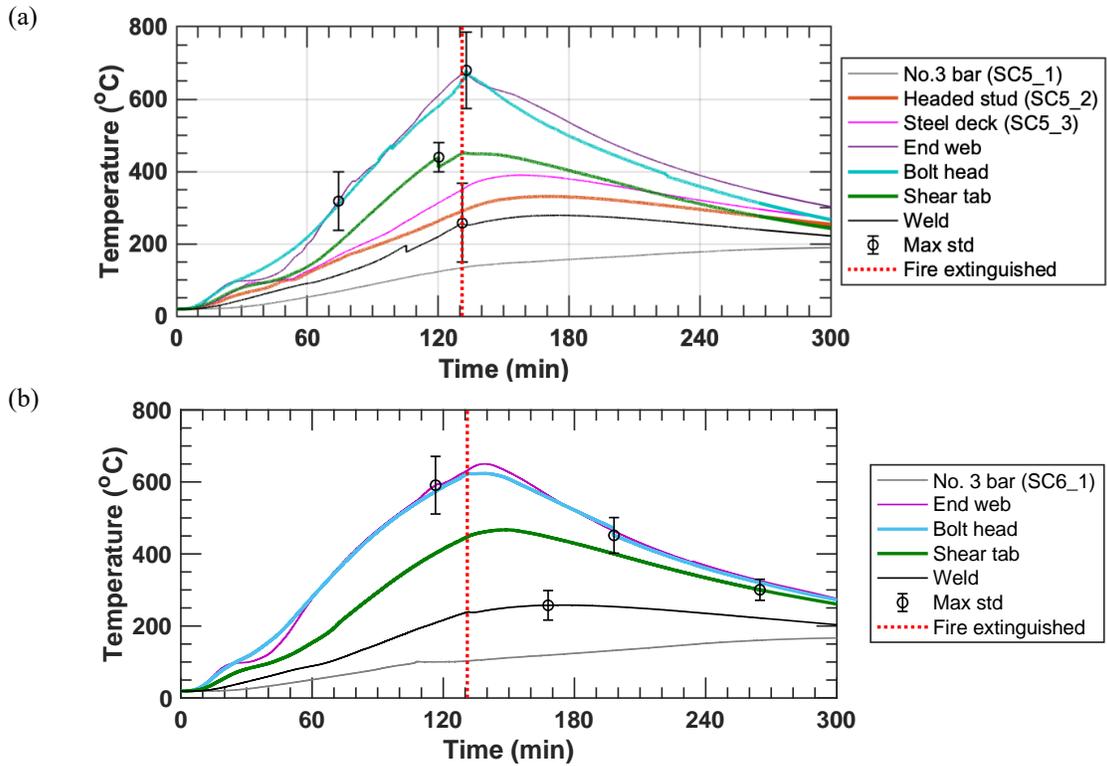
The girder end-connection regions indicated a similar change in temperatures (Fig. 26). The beam end web and bolt head reached over 600 °C on average. However, temperatures of the extended shear tabs and welded joints were approximately 200 °C and 400 °C lower, respectively, because thermocouples in those regions were shaded by the column flanges. The No.3 bar temperature was considerably low with a peak value of 200 °C during cooling.

The temperature variation in the beam or girder end webs as well as bolt heads was as large as 25 %. This might be caused by local buckling of the end web leading to physical damages (fissures, debonding, or both) to applied SFRM where thermocouples were installed.

Fig. 26. Average temperature of (a) east girder end connection and (b) west girder end connection attached to W18x35 shapes. Error bars indicate a maximum value of standard deviation in temperatures measured at multiple locations.

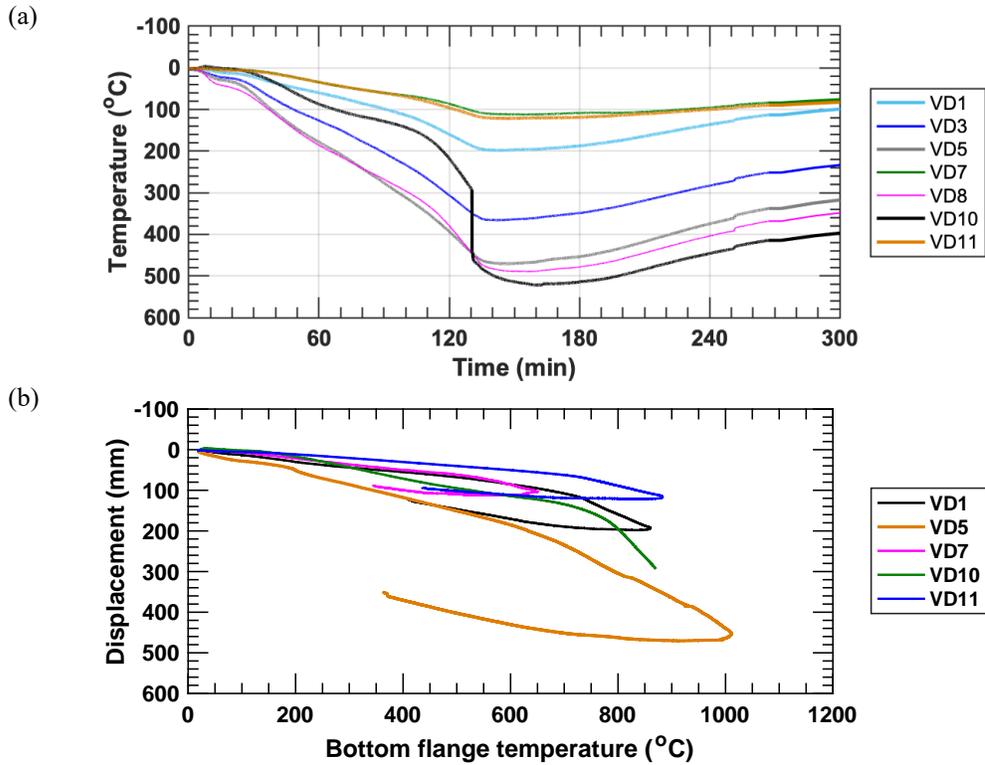
The mid-panel vertical displacement (VD5) increased at an approximate rate of $0.4 \text{ mm}/^\circ\text{C}$ until the bottom flange temperature of the secondary beam reached $700 \text{ }^\circ\text{C}$. The increase in the VD5 value became approximately $0.7 \text{ mm}/^\circ\text{C}$ afterward. The vertical displacement of the south (exterior) edge beam (VD10) increased more rapidly than other edge beams (VD1,

Fig. 28. Measured vertical displacements as a function of (a) fire exposure time and (b) bottom flange temperatures of the floor beams.

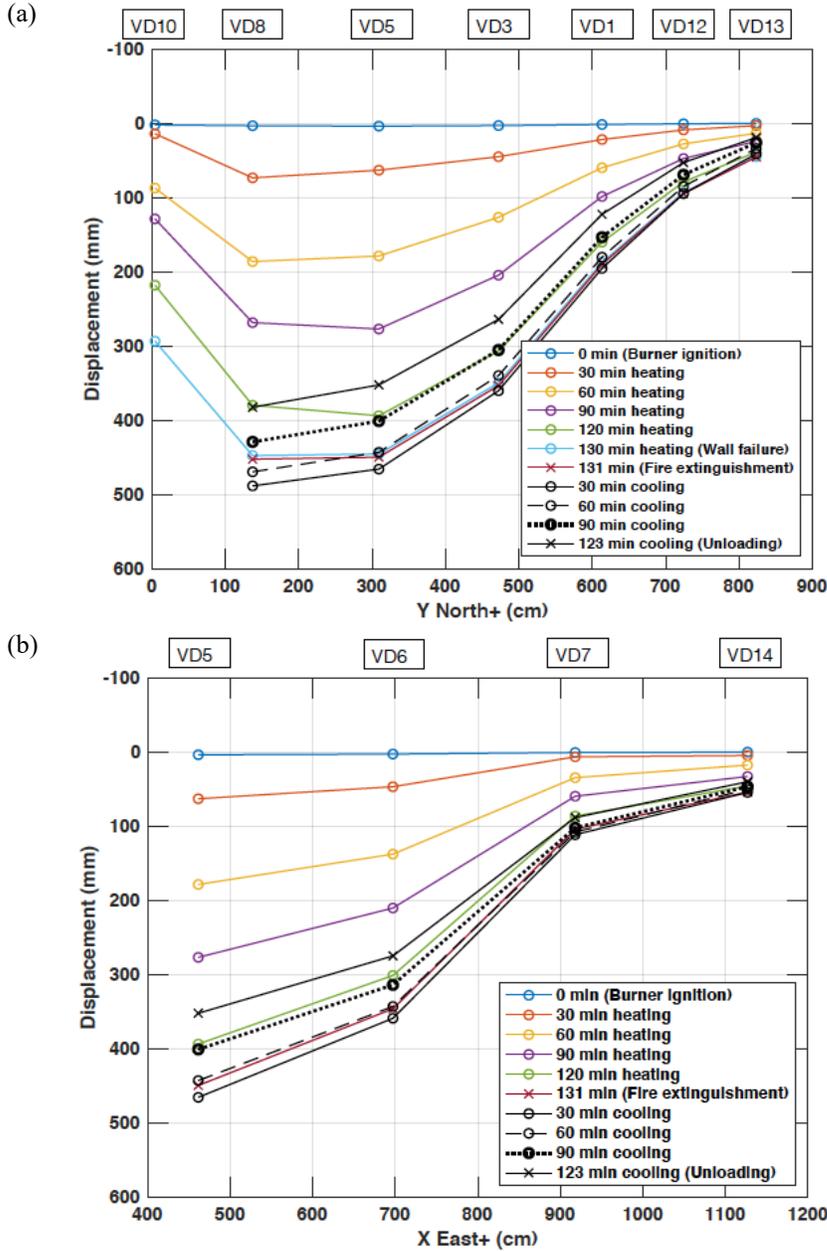
The temporal change in the vertical displacement measured along the centerlines of the test bay is illustrated in Fig. 30. The south half of the floor specimen deflected more than its north half since the No. 3 deformed bars placed perpendicular to the north edge beam provided some degree of rotational restraints, maintaining a good continuity with the steel reinforcement placed in the north surrounding bay which remained cool during fire loading.

Fig. 30. Vertical displacement profile of the test floor assembly at (a) the north-south centerline and (b) the east-west centerline. The upper horizontal axes indicate the corresponding position of each vertical displacement sensors.

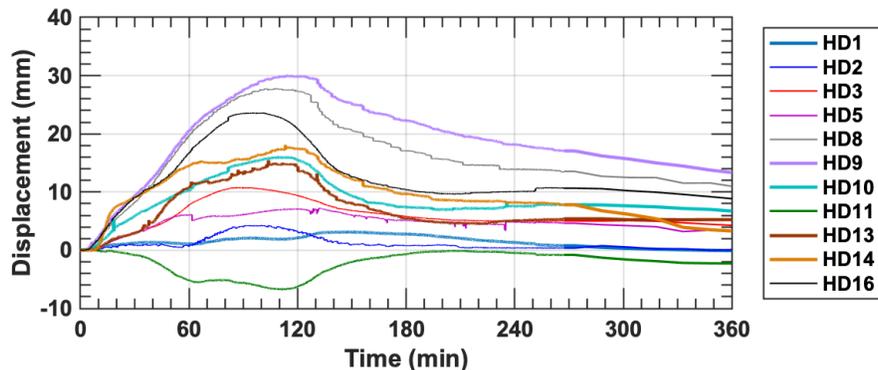
Some horizontal (lateral) displacements of the exterior columns at the test floor level are illustrated in Fig. 32. Other displacements not presented in this figure are reported in Appendix A.8. As shown, approx. 5 min into fire loading, the displacements began to increase in the east or west direction due to thermal expansion of the test floor assembly. Simultaneously, the lateral displacement of the north column (HD11) at the second-story level increased toward south since this column was pulled together with the south columns deflecting toward the south during heating. The peak values of each displacement sensor occurred between 80 min and 120 min after the burner ignition. For instance, from 80 min to 95 min into heating, thermal expansion of the north edge beam (HD3) and the south edge beam (HD16) came to a halt, which suggests that local buckling could be initiated near the ends of these beams.

Fig. 32. Measured lateral displacements of the exterior columns.

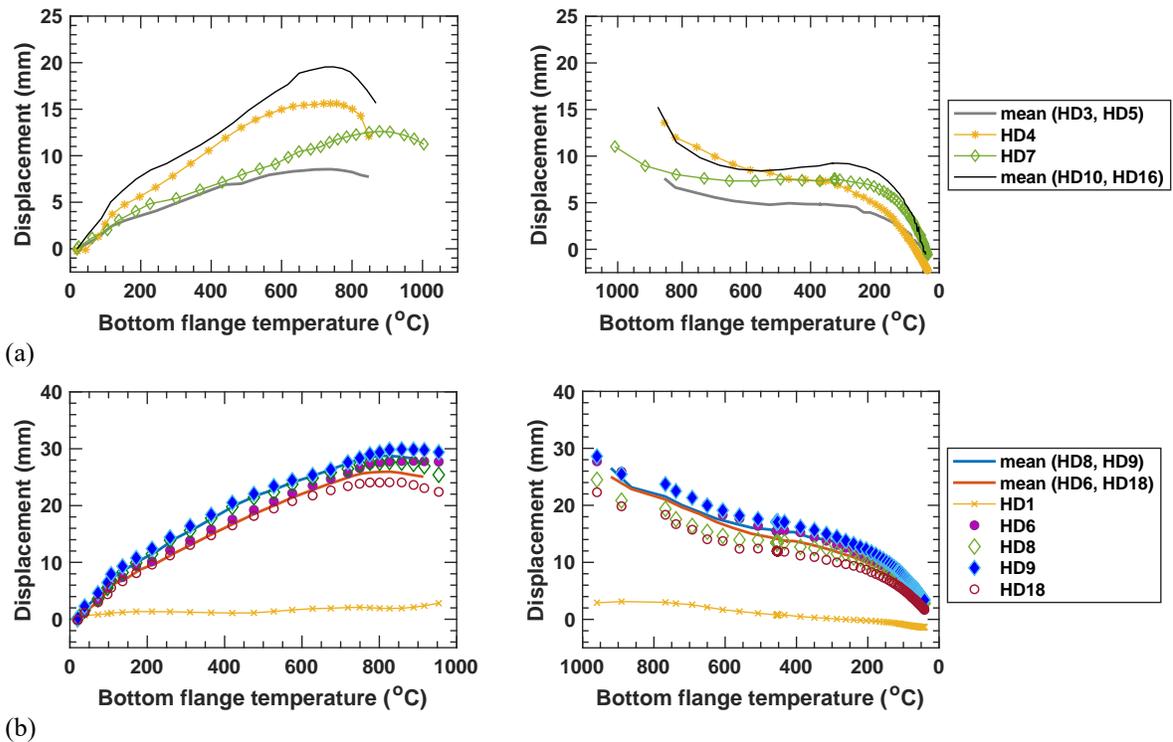
Thermal elongation along the north edge of the test assembly (HD4) was approximately equal to two times the average displacement of the east and west exterior columns (HD3 and HD5), as shown in Fig. 33a. The change in the displacement values became less sensitive to the temperature beyond 600 °C. Thermal elongation along the longitudinal centerline (HD7) continued until the bottom flange temperature of the secondary beam reached to 870 °C, followed by a descending trend afterward. Thermal elongation along the south edge of the test assembly (HD10) continued until the bottom flange temperature of the south edge beam reached to 720 °C, followed by a descending trend afterward.

With the presence of the north surrounding bay, the east and west edges of the test assembly thermally elongated mostly toward the south. As shown in Fig. 33b, the average thermal elongation of the east and west edges (HD6 and HD18, respectively) were very similar to the average lateral displacement of the southeast and southwest column of the test bay (HD9 and HD8, respectively). Beyond 800 °C, those displacements stopped increasing and began to slowly decrease until the test fire was removed.

Fig. 33. Measured horizontal displacements as a function of bottom flange temperatures; (a) thermal elongation and contraction in the east-west direction and (b) thermal elongation and contraction in the north-south direction.

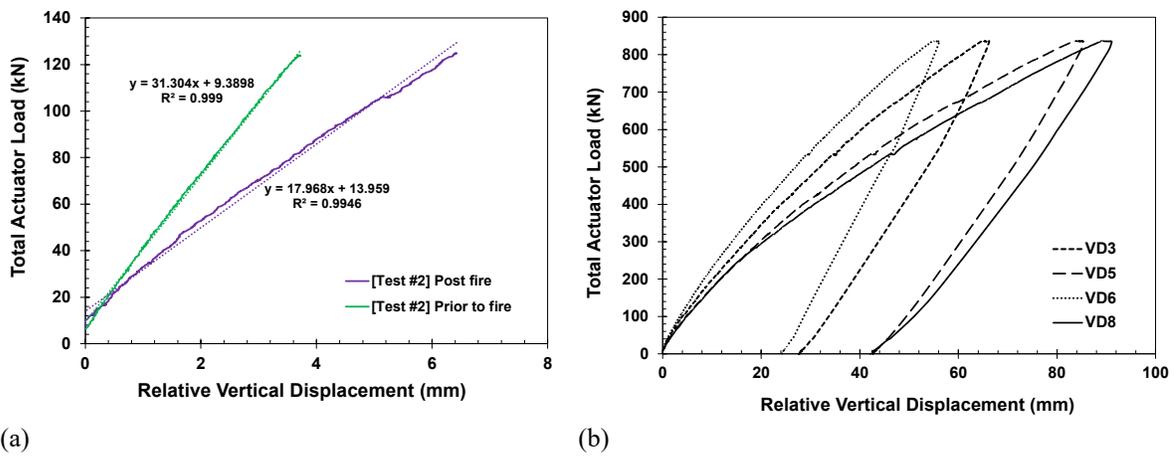
After cooldown, the test floor assembly was loaded again using the same hydraulic actuators used in the fire testing to examine its post-fire flexural behavior at ambient temperature. Locations of the loading points on the test floor remained unchanged (Refer to Fig. 4b). For this test, the mechanical loading was applied at an approximate rate of 9 kN/min until the hydraulic actuator system maxed out its load limit (836 kN). The bending stiffness of the test floor before and after the fire test is compared in Fig. 34a. As shown, the fire-damaged test floor retained approximately 42 % of its normal bending stiffness prior to fire exposure.

The total actuator load versus vertical displacement relationship is plotted in Fig. 34b. At a maximum load of 836 kN, the mid-span vertical displacement of the secondary beam (VD5) was about 85 mm, and the vertical displacement of the south middle slab (VD8) was about 91 mm, relative to the permanent displacement measured after cooldown from fire loading. The maximum gravity load was approximately 17.8 kPa (370 psf), which was estimated including self-weight of the test floor assembly prior to fire exposure and that of loading frames.

It is noteworthy that the test floor assembly still retained very large flexural strength (after cooldown) at least two times greater than the ASCE 7 load demand (9 kPa) for normal conditions determined from the load combination of 1.2 times dead load plus 1.6 times live load. A collapse mechanism was not developed even though the total floor load reached almost 90 % of the ambient-temperature moment capacity (21 kPa) of the as-designed secondary composite beam calculated in accordance with the AISC 360 specification [15] but with measured mechanical properties of steel and concrete at ambient temperature (Refer to Table 2 and Table 8, respectively).

Fig. 34. (a) Initial bending stiffness and (b) load-displacement relationship during the post-fire loading test.

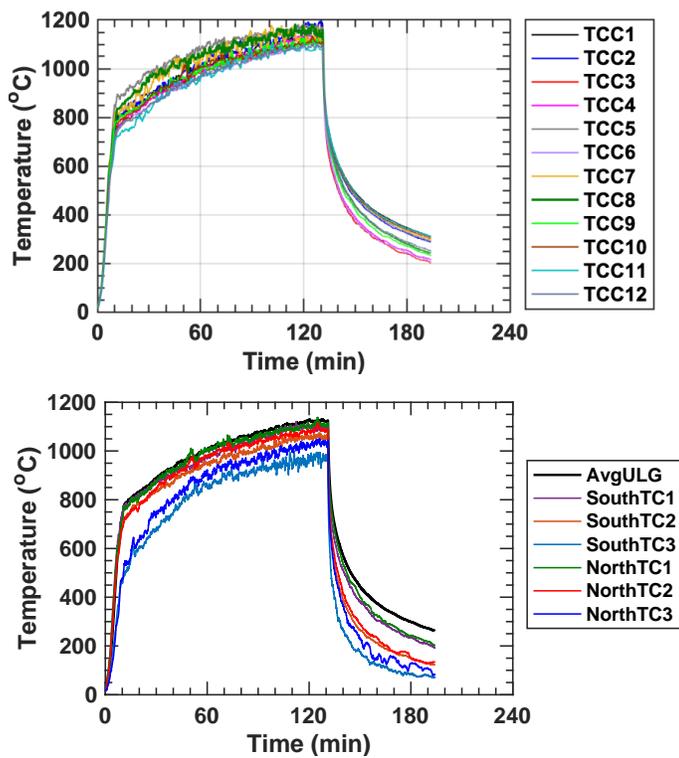
The hottest spot was measured at TCC5 which was approximately 50 °C above the average upper layer gas temperature. TCC11 indicated the lowest temperature, about 50 °C below the average value. During cooling, temperatures of TCC6 decreased much quicker than TCC11.

In addition, during the first 15 min of heating, the gas temperatures measured at the north and south trees differed by a maximum of 100 °C, due to air intake through the south ventilation opening. However, this temperature variability also became smaller as the test fire continued longer than an hour.

Fig. 45. Gas temperatures inside the test compartment. Fire was extinguished at 131 min.

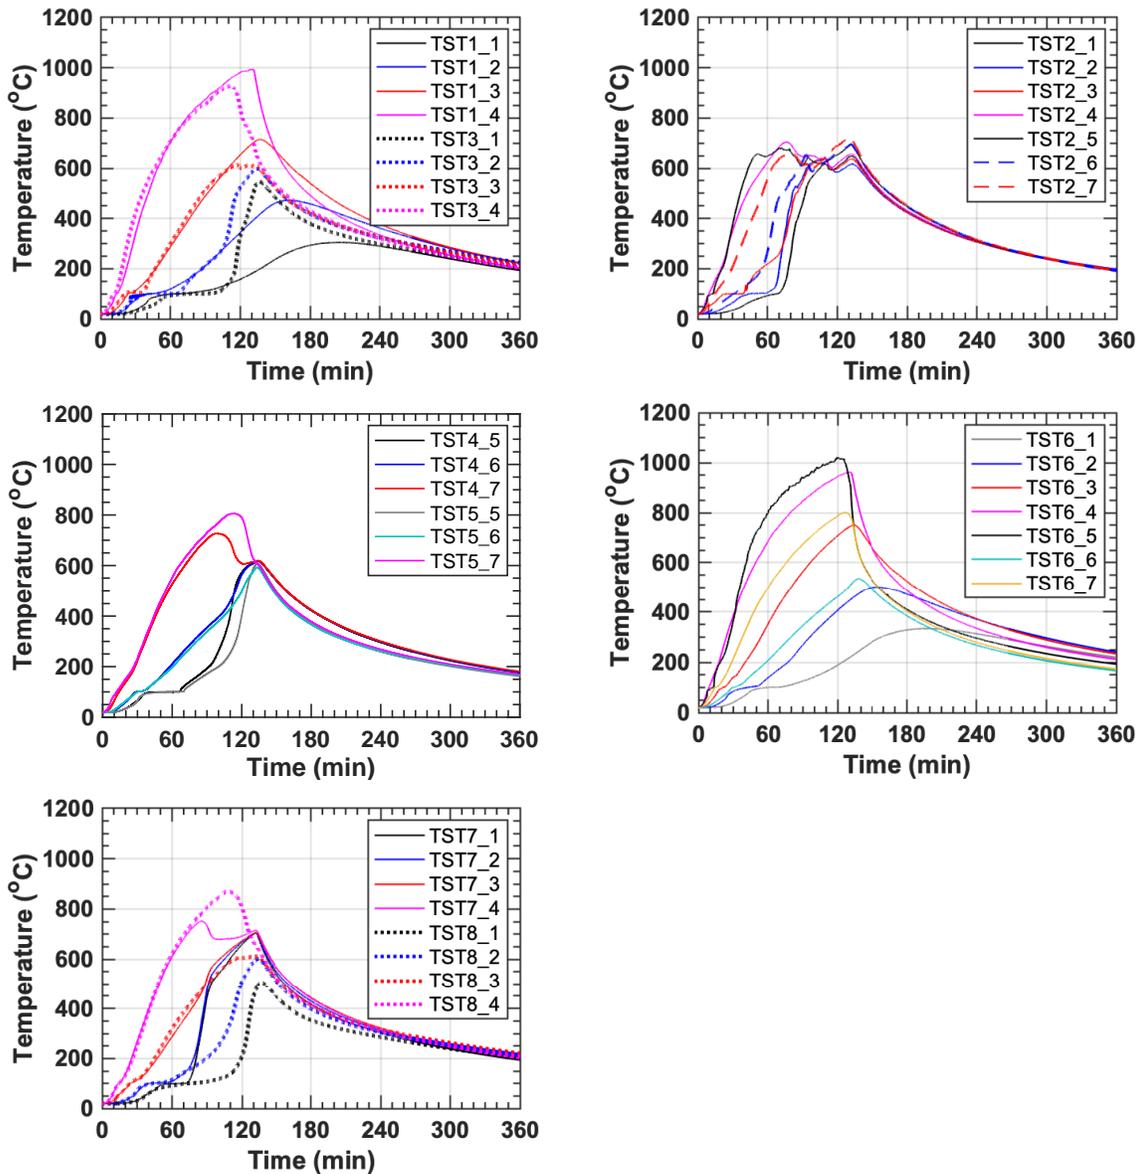
Table 12 shows the list of thermocouple probes used to estimate the average temperatures at specific depths which are plotted in Fig. 20. For this estimation, locations 1 and 2 only included TST1 and TST6 thermocouples only because thermocouples at other TST locations appeared to be significantly affected by concrete damage. With the same reason, locations 6 and 7 only included TST 4 through TST6 thermocouples. All raw data are plotted in Fig. 47, where some temperature readings (e.g., TST2_1, TST2_2, TST3_1, and TST3_2) started increasing rapidly after 60 min to 70 min into heating.

Fig. 47. Concrete temperatures through the depth of the test floor slab. Fire was extinguished at 131 min.

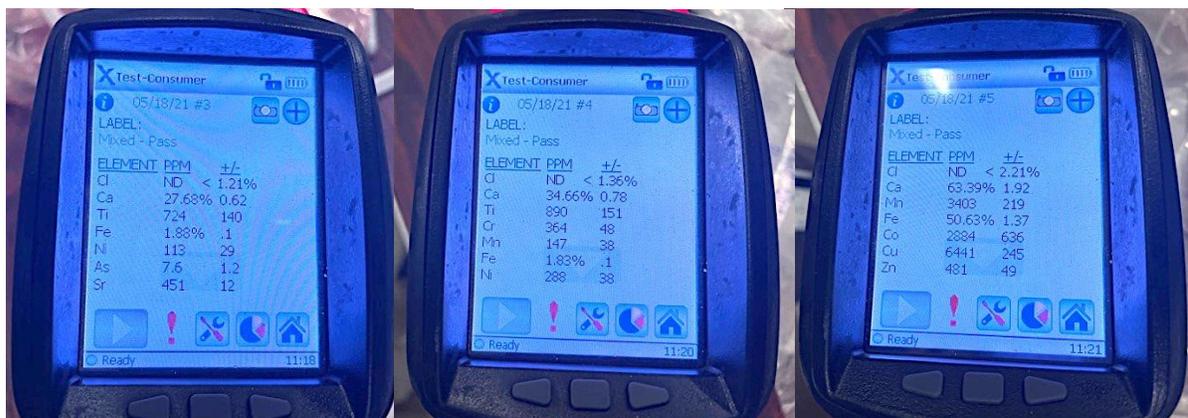
Fig. 77. Samples of fire exposed SFRM applied on the support steel beam framing.

After the fire testing, there were two spots toward the ends of the secondary beam where the fire exposed SFRM turned black and charcoal color as shown in Fig. 77. Those locations were directly above the east and west burners. A handheld XRF (X-ray fluorescence) analyzer manufactured by Olympus [37] was utilized to measure chemical compositions of the samples collected from the secondary beam at two different locations (the west end and midspan) after cooling. A comparison of some scanned results is shown in Fig. 78, along with the unused SFRM powder. Although a further study is needed, this SFRM discoloration was likely caused by high-temperature oxidation or phase change of the steel heated beyond 1000 °C. Refer to TB5 and TB7 temperatures in Sect. A.6. The charcoal-colored sample contained about 51 % iron by mass, whereas the unused sample or other exposed sample contained about 2 %.

Southwest Type 5MD Powder
(Color: Tan)

SFRM Sample @ Midspan
(Color: Beige)
