## Real fire performance of partition assemblies<sup>‡,§</sup>

### SUMMARY

A series of real-scale compartment tests was performed to provide information on the phenomenology of partition response and failure, to guide model development. Two partition assemblies of 2.44 m × 2.44 m were exposed to two intense fires from the time of ignition to beyond flashover. The assemblies were constructed using type X gypsum panels. The stud spacing and stud dimensions were fixed for both assemblies. Heat flux gauges provided time histories of the energy incident on the partitions, while thermocouples provided data on the propagation of heat through the partitions and on the progress toward perforation. Visual and infrared cameras were used to image partition behavior during the fire exposure. The results obtained from these experiments are discussed. Published in 2005 by John Wiley & Sons, Ltd.

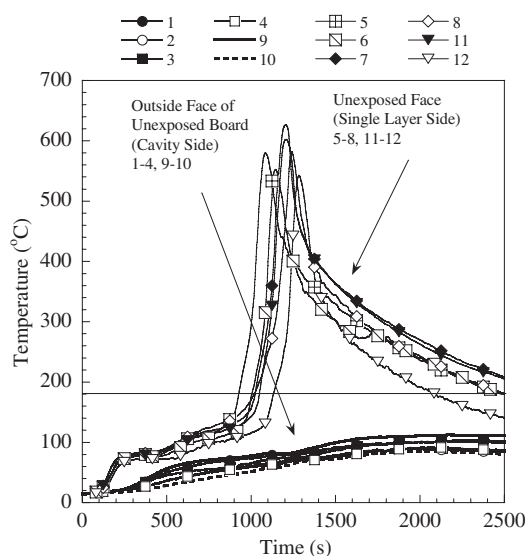
Figure 9. Temporal evolution of the unexposed face temperature measurements for Assembly Two as a function of location.

The outside face temperatures of the unexposed board were measured for Assembly Two and are displayed in Figure 9. From the data it is apparent that the temperature rise on the outside face of the unexposed board was minimal. In fact, the temperature rise was insufficient to result in failure under the insulation criterion of ASTM E119 [1]. For the side with the single layer, the temperature rise was significant. The insulation failure criterion [1] was reached at 900 s after ignition. Based upon the total heat flux and exposed face temperature measurements, it is not surprising that the temperature at location 5 rose the quickest. Similar to Assembly One, differences in the maximum temperatures measured on the unexposed surface were observed.

Similar to Assembly One, the timeline of events from the video-graphic records agreed with the magnitude of the unexposed face temperature measurements. Locations where the most severe flaming was observed (5, 7 and 11) produced the highest measured temperature. The lower portion of section 1, near thermocouple location 12, produced the lowest temperatures since flaming was not observed at this location.
