Margin Failures in Crown-Like Brittle Structures: Off-Axis Loading

Abstract: The effect of off-axis loading of compliant indenters on the initiation of cracks at the margins of dental crown-like dome structures consisting of glass shells back-filled with an epoxy resin is examined. As in previous studies on similar structures but with strictly axial loading, cracks can be made to initiate and propagate from the margins around the dome faces into a “semi-lunar” fracture pattern characteristic of some all-ceramic crown failures. In this study, balsa wood and teflon disk indenters are used to provide the off-axis loading, at 45° to the dome axis. The soft indenters, considered representative of food bolus, spread the contact at the top surface, suppressing otherwise dominant radial cracks that ordinarily initiate at the dome undersurface directly along the load axis beneath harder indenters. Finite element modeling is used to show that off-axis loading dramatically increases the tensile stresses at the near-side dome margin, strongly diminishing the loads required to generate the lunar fracture mode. © 2007 Wiley Periodicals, Inc. * J Biomed Mater Res Part B: Appl Biomater 85B: 23–28

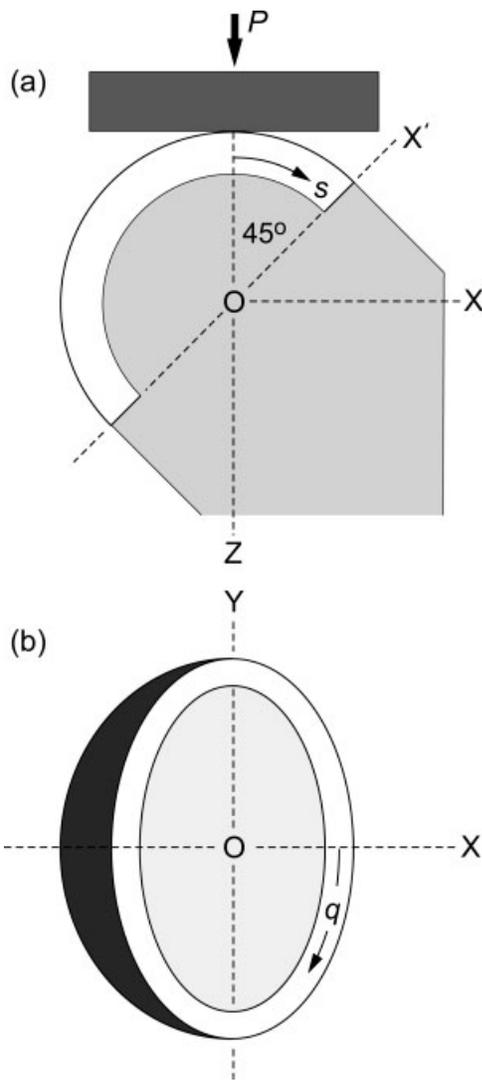
Figure 1. Schematic showing indentation with flat disk on crown-like structure consisting of a brittle hemispherical shell supported by polymeric dentin-like base: (a) side-on view (along OY); (b) undersurface view (along OZ), without substrate. Load is 45° to dome base OX' .

Dome glass/epoxy bilayer structures were fabricated as previously outlined.^{1,8-10} A schematic of the configuration is shown in Figure 1, showing side-on and undersurface views.

A finite element algorithm described earlier was adapted to the configuration in Figure 1 to determine the stress distributions.⁹⁻¹¹ Meshing in the critical region between the contact and dome edge was refined, as before, until the stress solutions attained convergence. The deformation was assumed to be elastic everywhere over the load ranges covered. Values

of Young's modulus and Poisson's ratio used in the calculations are listed in Table I. Maximum principal stresses and their directions of action within the dome structures were calculated at each load step, with special attention to distributions along the inner dome surface as a function of longitudinal and latitudinal coordinates s and q in Figure 1.

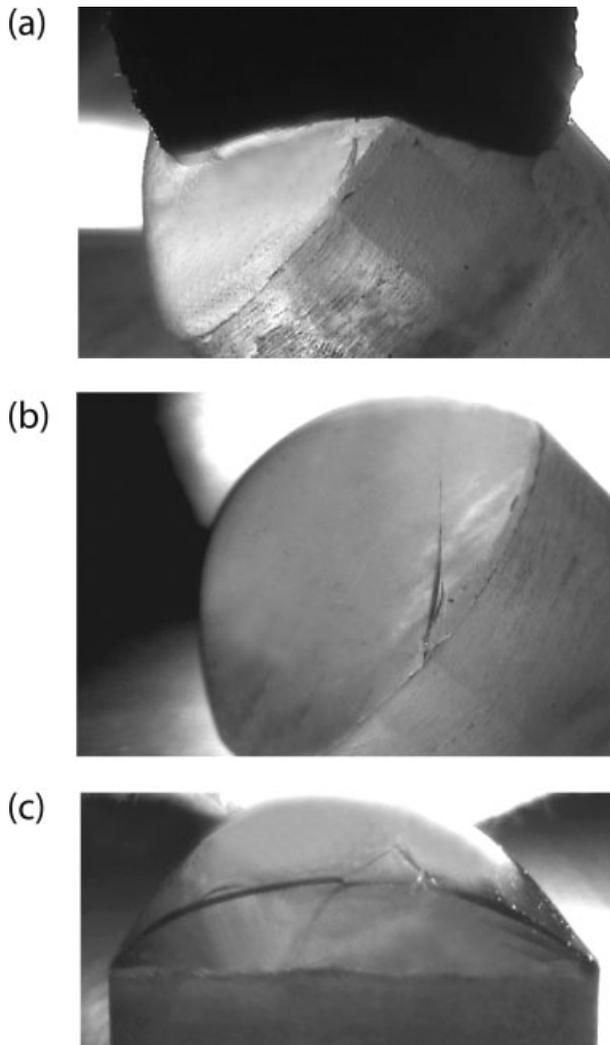
Figure 2. Contact fracture of epoxy-filled glass domes of inner radius 8 mm and thickness 1 mm on epoxy base, indented with balsa wood disk at loads (a) 1000 N (viewed along OY, Figure 1), (b) 1500 N (along OY) and (c) 1800 N (along OX'). Views in (b) and (c) taken after interrupting test. Note how cracks initiate at margin and propagate around side of dome to link up and form 'semi-lunar' chip.

Figure 2 shows margin crack patterns produced in glass domes using off-axis loading with balsa wood disks, as depicted in Figure 1. The photographs are from interrupted tests, at loads (a) 500 N (viewed along OY in Figure 1), (b) 1500 N (same view), and (c) 1800 N (along OX'). In these tests the crack was difficult to follow *in situ*, owing to

engulfment of the contact zone by the soft balsa [Figure 2(a)]. Nevertheless, interrupted views [Figs. 2(b,c)] are sufficient to determine the essence of the evolution. Prior to loading, no cracking was evident in the specimen, including at the margins. During loading, a small crack was observed to pop in from the margin on the near side of the specimen, Figure 2(a). A similar, symmetrically disposed small crack was observed on the back side of the specimen [not visible in Figure 2(a)]. On increasing the load, the cracks propagated upward further toward the contact center, Figure 2(b). Still further load increase caused the cracks on opposite sides of the specimen to link up to form a closed fracture, as seen front-on in Figure 2(c). This is the lunar fracture pattern previously described for axial loading,¹ but now formed without the need for a precursor crack.

This raises the issue of surface finish. Material strengths may be severely compromised by the introduction of especially large flaws in finishing and preparation operations (e.g. by sandblasting¹³), especially in the margin regions. Such strength loss can lead to a reduction in the corresponding critical load to initiate cracks. This further highlights the need for dental practitioners to avoid such damage in edge preparation of all-ceramic crowns. In the event of a totally uniform distribution of flaws, the favored location for initiation of margin cracks is that of the symmetry position $q = 0$ in Figure 7. However, the presence of larger flaws elsewhere along the margin may shift the initiation site around the circumference, consistent with the observations in Figures 2 and 3. Such lateral shifts may also be caused by nonlinearity in the elastic response of balsa at higher loads,¹ in which case the contact compression zones may be considerably larger than evident in Figures 5 and 6, possibly even extending to the dome edge at very high loads. This could result in suppression of the maxima at $q = 0$ in Figure 7. This could explain why margin cracks tend to initiate nearly symmetrically on opposite side faces, as seen in Figures 2(c) and 3(b).

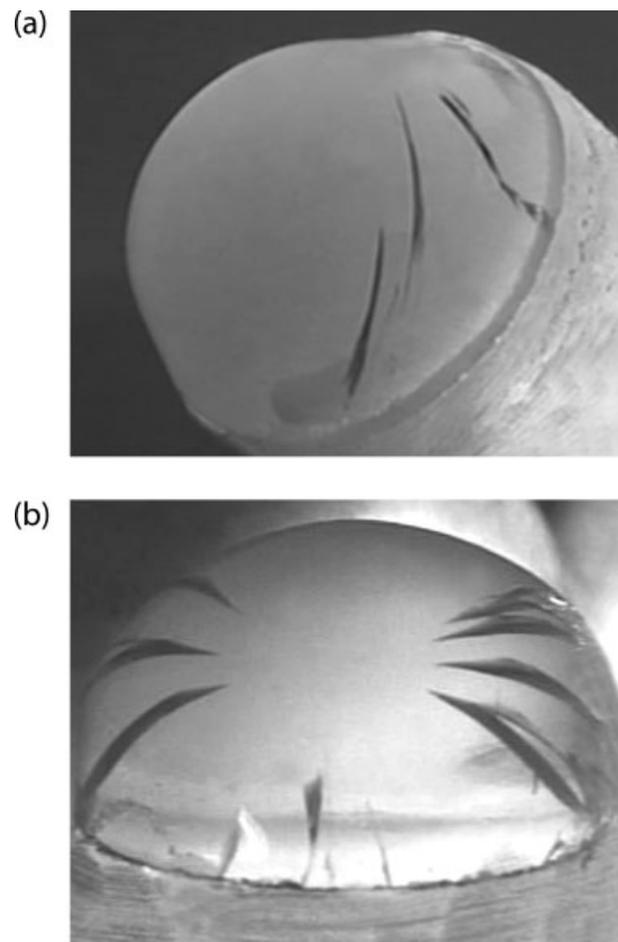
Figure 3. Contact fracture of epoxy-filled glass domes of inner radius 8 mm and thickness 1 mm on epoxy base, indented with (a) balsa disk at load 1000 N (viewed along OY) and (b) teflon disk at 2000 N (closely along OX'). Views taken after interrupting test. Note how margin cracks initiate propagate around side of dome toward contact center.

Figure 3 shows further examples of margin cracking from off-axis indentation with (a) a balsa disk at load 1000 N (viewed along OY in Figure 1) and (b) a teflon disk at 2000 N (viewed closely parallel to OY). In both cases the cracks have initiated at the edges and have propagated toward the

contact center. It is of interest that these cracks tended to initiate more or less symmetrically on opposite sides of the dome base. The location of such cracks varied from test to test, sometimes closer to the mirror symmetry plane of the loaded dome, but always on the same side face as the contact center. Multiple cracking occurred at higher loads, for example Figure 3(b) relative to Figure 3(a).

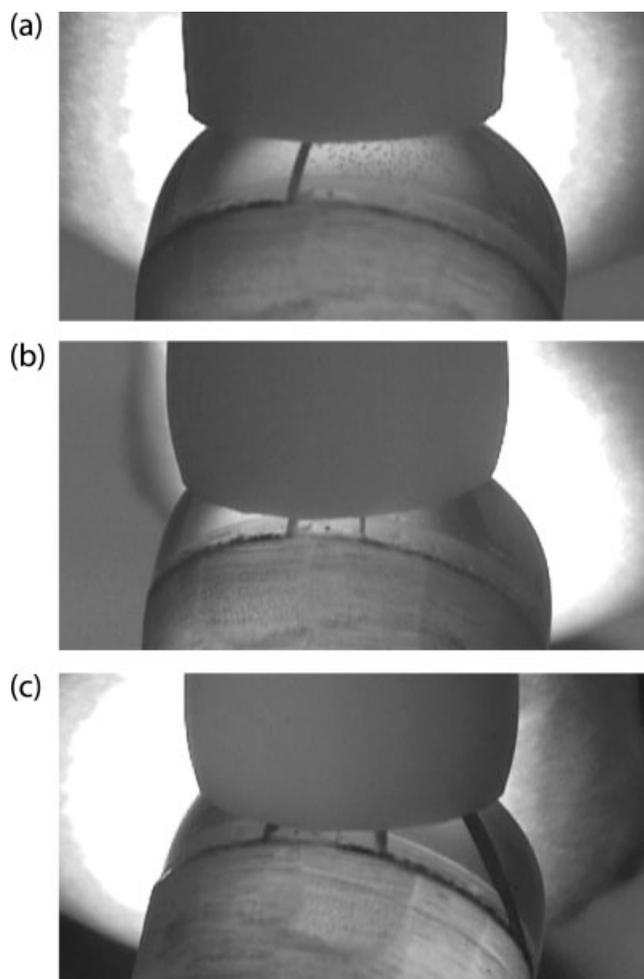
Figure 4. Contact fracture of epoxy-filled glass domes of inner radius 6 mm and thickness 1 mm on epoxy base, indented with teflon disk at loads (a) 630 N, (b) 1360 N, and (c) 1440 N. Views taken *in situ* during loading (closely along OX). Multiple margin cracks are observed.

A sequence of photographs in Figure 4 shows near-front-on views (closely parallel to OX) of fracture evolution in a teflon-loaded dome at off-axis loads (a) 630 N, (b) 1360 N, and (c) 2000 N. Here the comparatively stiffer teflon indenter (i.e., relative to balsa) allows direct visualization of the cracks during loading, despite heavy deformation of the indenter at the higher loads. In this case the first crack has initiated from the near edge close to the symmetry plane [Figure 4(a)], followed subsequently by two other, symmetrically disposed cracks [Figure 4(b)], and finally additional side cracks [Figure 4(c)].

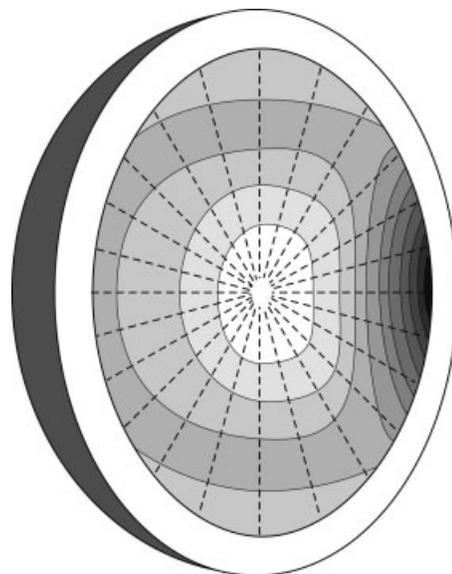
Figure 5. Finite element modeling of principal stresses at inner surface of epoxy-filled glass domes of inner radius 6 mm and thickness 1 mm indented with balsa disk, shown here for load 1000 N. Solid lines are contours of maximum principal stresses σ_1 . Light region indicates compression, dark region tension, each contour is increment of 10 MPa. Dashed lines are trajectories of minimum principal stresses σ_3 . Undersurface view along OZ as in Figure 1(b).

Trajectories (directions of action of stress components) and contours of principal stresses were calculated at specified off-axis loads on the dome inner surface. These stresses have been previously demonstrated to be substantially higher on the inner than the outer surface.¹ The stresses of interest are σ_1 (most tensile) and σ_3 (most compressive). (The intermediate stress σ_2 lies near-normal to the plane of the dome surface, and so is near-zero everywhere.) An example is shown in Figure 5 for indentation on an epoxy-filled glass dome with a balsa disk at 1000 N, viewed from below along the load axis (OZ). The solid lines are contours of the σ_1 principal stress. The first contour indicates zero stress, so that the white central region denotes a compression zone beneath the engulfing indenter. Each contour represents a tensile increment of 10 MPa, amounting to a maximum stress of about 100 MPa at the right margin. The concentration of contours on the right side of the inner surface confirms a strong transfer of stress to the near-side extremities. Note the way these contours extend around the dome base, suggesting that crack initiation could occur anywhere in this region, depending on the availability of starting flaws. Also included in Figure 5 are trajectories of the σ_3 stress component, with an intersection point close to the center of load-

ing. Normals to these trajectories indicate the directions of maximum tensile stresses σ_1 , and so indicate approximate crack paths.¹² Note the close correspondence between these trajectories and the crack paths in Figures 2–4.

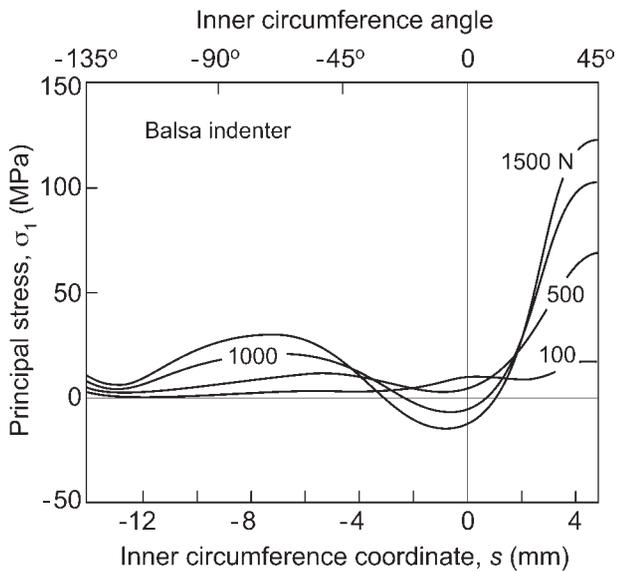
Figure 6. FEM calculations of maximum principal stress σ_1 as function of longitudinal coordinate s measured from contact axis along inner surface, for epoxy-filled glass domes of inner radius 6 mm and thickness 1 mm. Indentation with balsa disk at loads P specified. Note strong buildup of σ_1 in region $s > 0$, and expanding compression zone with load in this region.

More detailed stress distributions around the inner surface of the same dome structure are shown in Figures 6 and 7, with σ_1 plotted as a function of longitudinal and latitudinal coordinates s and q , respectively, around the inner dome cir-

cumference (Figure 1), for loads incrementing to 1500 N. Considering the variation with s along the symmetry longitude (i.e., at $q = 0$) in Figure 6 first, we see that the maximum value of σ_1 is at the margin at $s = 45^\circ$, in accordance with Figure 5. This maximum value increases steadily with load but, toward 1000 N, begins to saturate as the compressive engulfment zone spreads across the dome surface. This increasing engulfment is also reflected in the progressive switch in sign of σ_1 at the inner dome surface from tensile to compressive along the contact axis at $s = 0$.

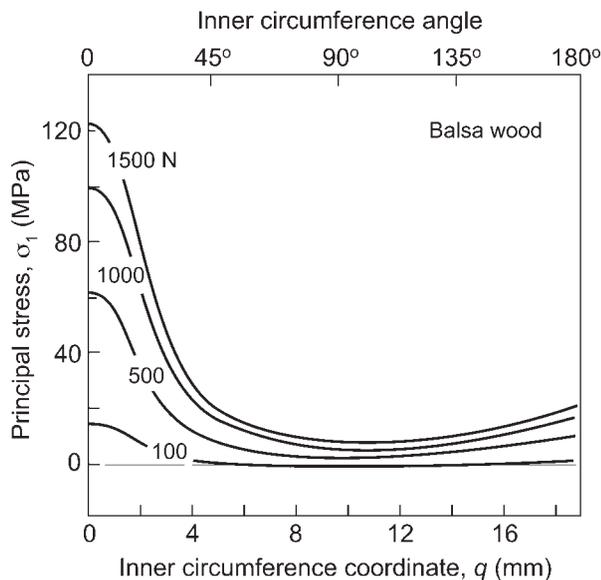
Figure 7. FEM calculations of maximum principal stress σ_1 as function of latitudinal coordinate q measured along inner surface (Fig. 1b), for epoxy-filled glass domes of inner radius 6 mm and thickness 1 mm. Indentation with balsa disk at loads P specified. Note $q = 0$ in this plot corresponds to $s = 45^\circ$ in Figure 6.

The plot in Figure 7 indicates the distribution of σ_1 with latitude coordinate q around the margin, with $q = 0$ corresponding to $s = 45^\circ$ in Figure 6 and $q = 180^\circ$ likewise corresponding to $s = -135^\circ$. In this case the stress intensities rise steadily with load, and remain tensile around the entire circumference. Note that the stress remains positive with increasing q , consistent with the spread-out contours in Figure 5, so that crack initiation may occur at any point around the margin where uncommonly large starting flaws reside.

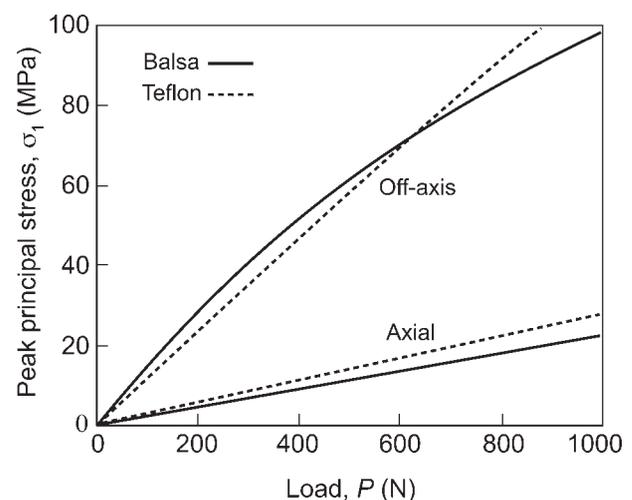
Figure 8. FEM calculations of peak principal stress σ_1 at symmetry margins (i.e., $s = 45^\circ$, $q = 0$) for epoxy-filled glass domes of inner radius 6 mm and thickness 1 mm indented with balsa. Comparing present off-axis data with corresponding data for axial loading from preceding study, for indenters made from balsa (solid curves) and teflon (dashed curves).

Figure 8 plots peak values of σ_1 at the margin $s = 45^\circ$, $q = 0$ as a function of load for the dome system under study here, for off-axis and axial loading using both balsa (solid curves) and teflon (dashed curves) indenters. Note the nonlinearity in the stress/force response for off-axis loading with balsa indenters, attributable to an encroachment of the contact compression zone toward the margins at high loads. Notwithstanding this nonlinearity, the magnifying effect of off-axis loading is clearly evident. The differences in margin stresses between the two indenter materials is not large, suggesting that margin cracks may be initiated by any kind of soft indenter. However, as pointed out earlier, the softer balsa is more effective in suppressing radial cracking in the near-contact zone.¹
