NIST GCR 97-724-2

APPENDICES: Development of Procedures to Enhance the Performance of Rehabilitated URM Buildings

Bret Lizundia, William T. Holmes, Margaret Longstreth, and Alan Kren
Rutherford & Chekene
303 Second Street, Suite 800 North
San Francisco, California 94107

APPENDIX A

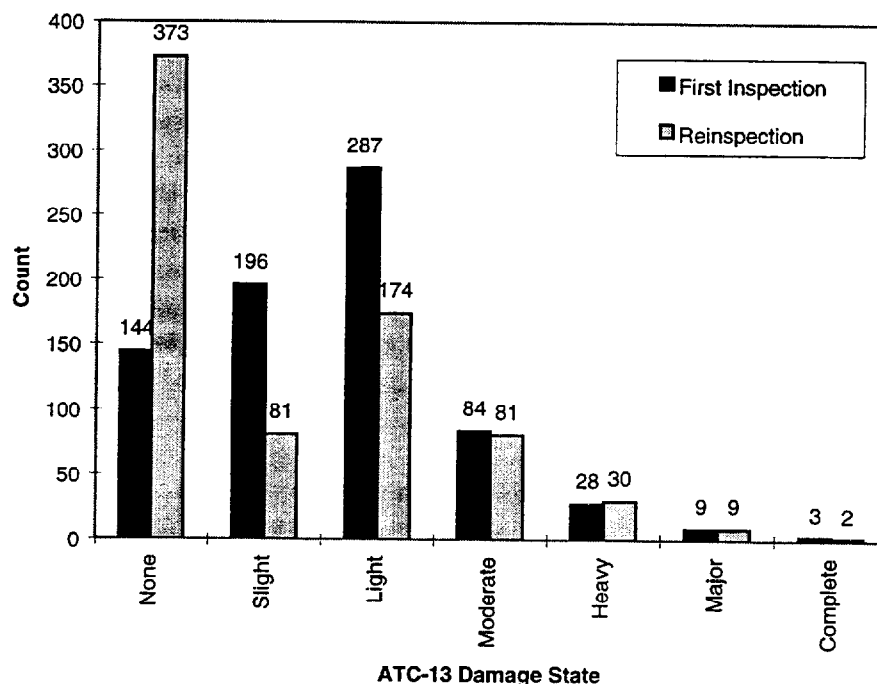
Figure A-6: Comparison of ATC-13 Damage State for First Inspection Damage Estimate and Reinspection Damage

The revised damage estimate data was sorted to determine the effect of the damage revisions on the database. Of the 751 retrofitted buildings, 115 buildings had their original damage estimates revised upward and 336 downward; the remaining 300 did not change. The average percentage of damage for the 115 upward revisions increased from 6% to 19% whereas the average percentage of damage for the 336 downward revisions decreased from 11% to 2%. Since there is no consistent way to create a revised “first inspection” damage estimate which will not bias the data, the initial and re-inspection data are evaluated separately. The overall inventory is compared in Figure A-6. It is apparent from this figure that the reinspection damage estimates are biased towards lower damage. Assignment to ATC-13 (1985) damage state was made per the groupings in Table A-7. Further, the average percentage of damage decreases from 7.9% for the first inspection data to 5.3% for the reinspected data.

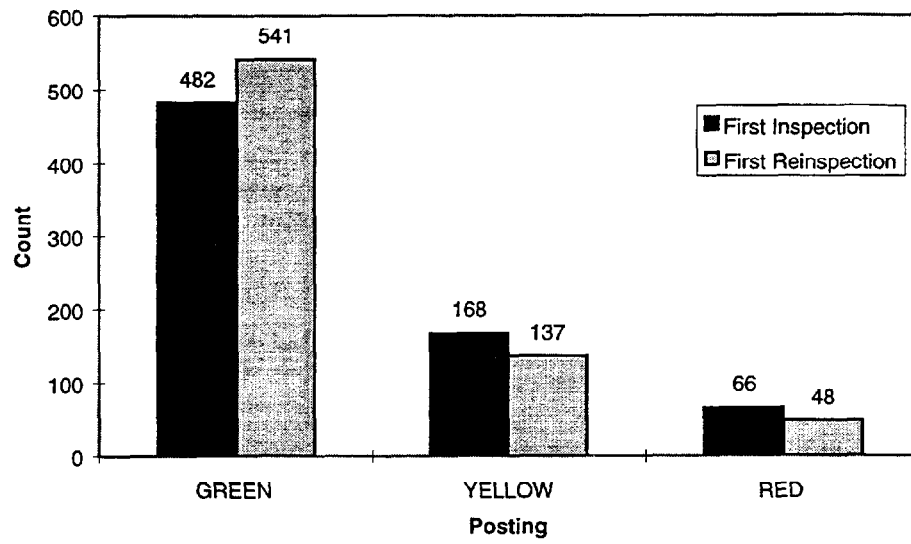
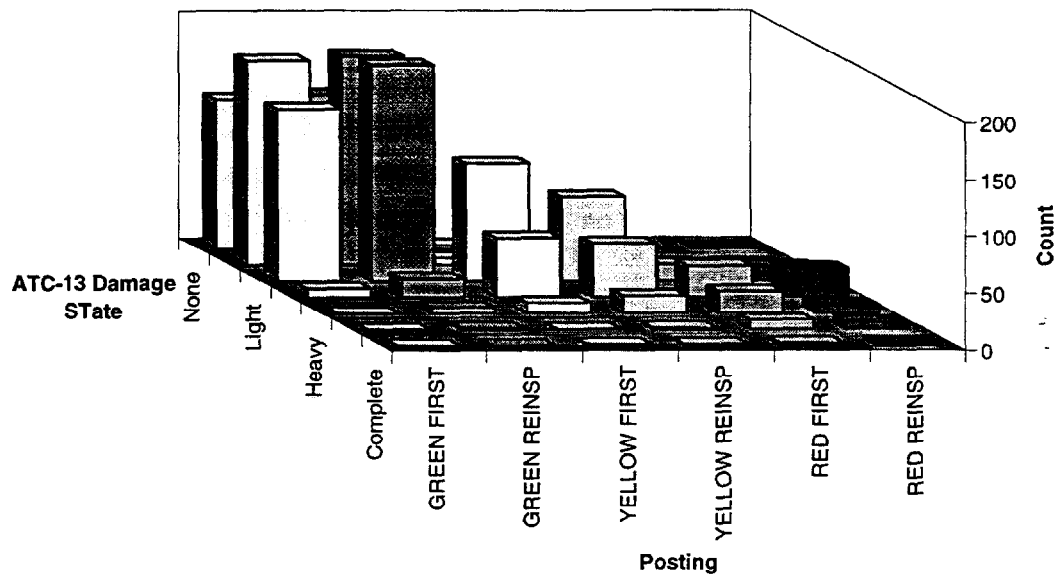
(a)

(b)

Figure A-7: Comparison of First Inspection Posting and First Reinspection Posting

Finally, by comparison, of the 751 buildings in the RFI Database, there were 66 red tags, 168 yellow tags, and 482 green tags. The remaining 35 did not receive a posting. In the reinspection dataset, there were 48 red tags, 137 yellow tags, and 541 green tags. The remaining 25 did not receive a posting. The first inspection posting and first reinspection posting are compared in Figure A-7(a). ATC-13 (1985) damage states are compared in Figure A-7(b).

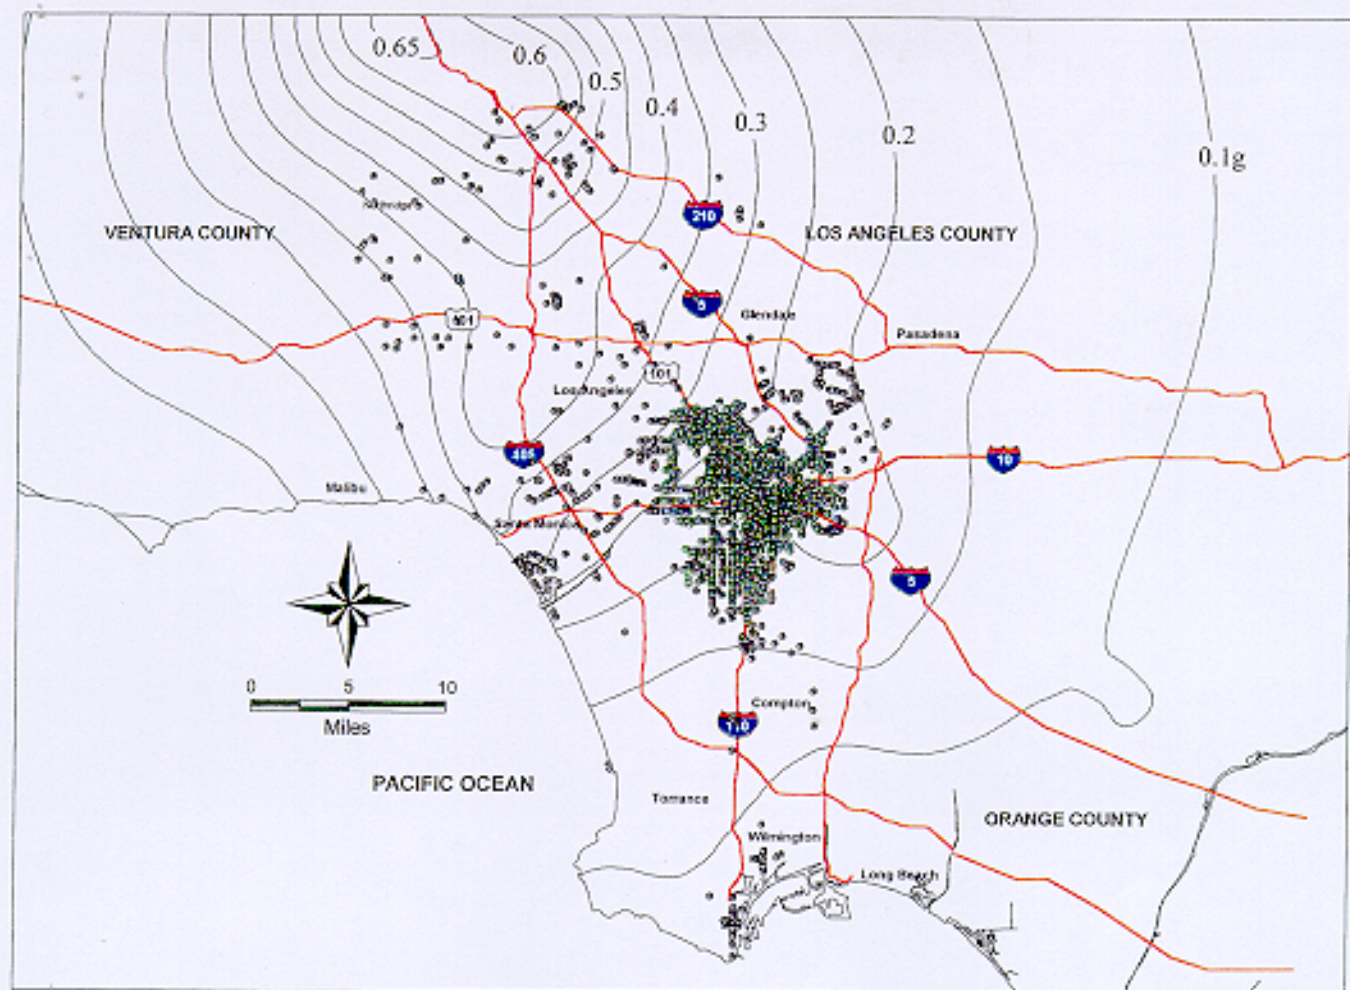
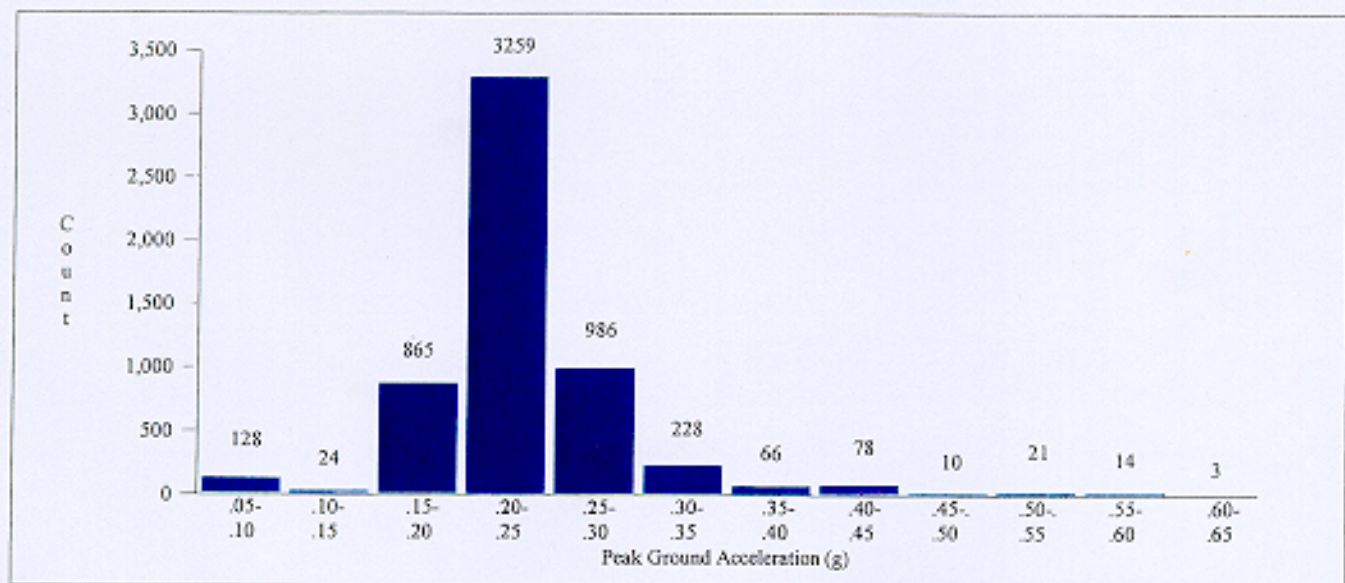
Figure A-8: Total Retrofitted Inventory vs. Peak Ground Acceleration (g)

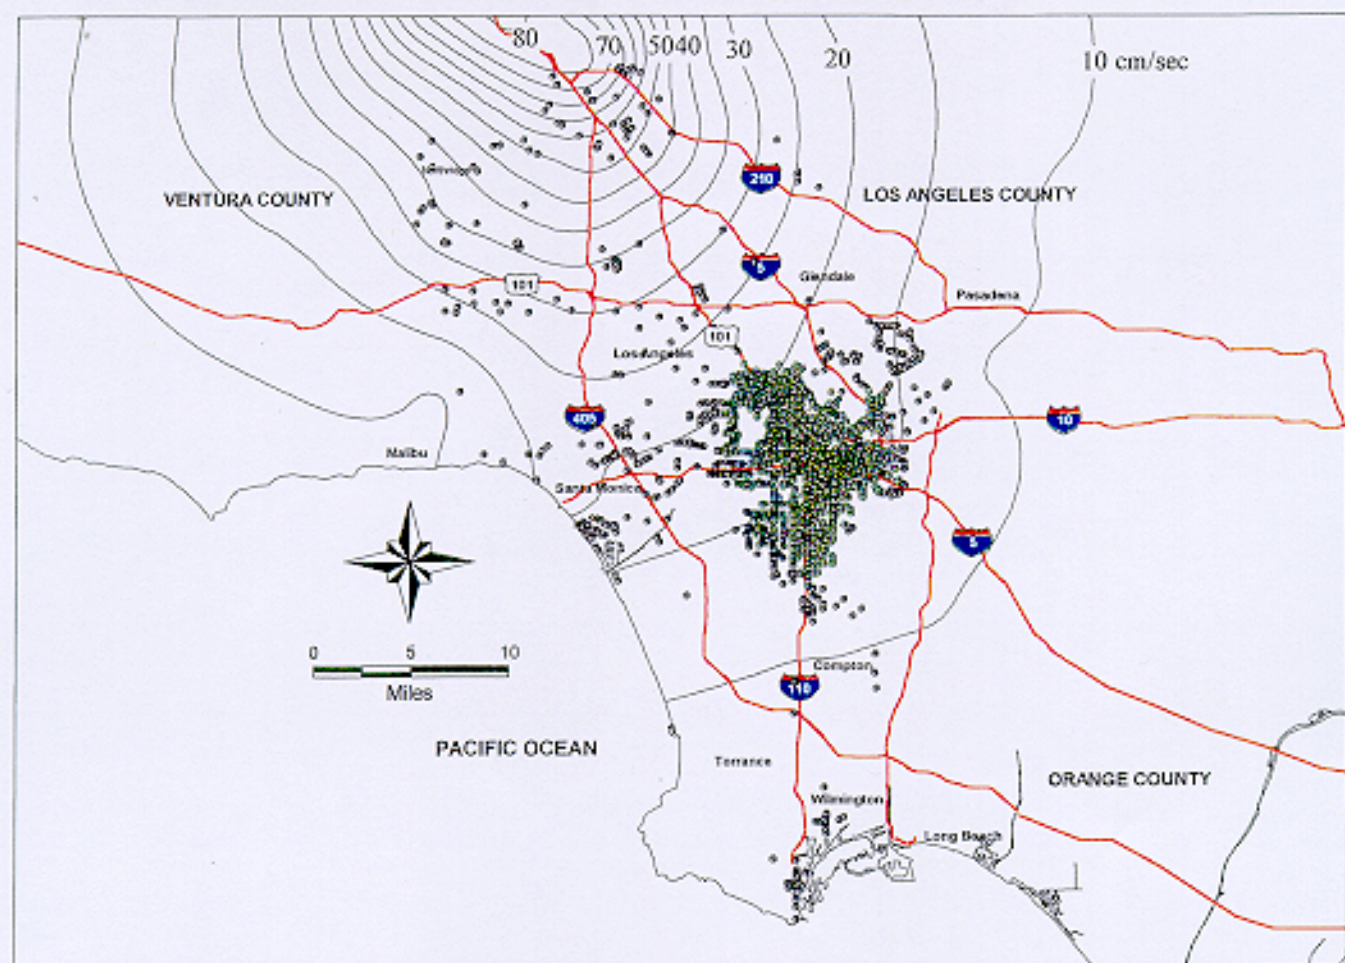
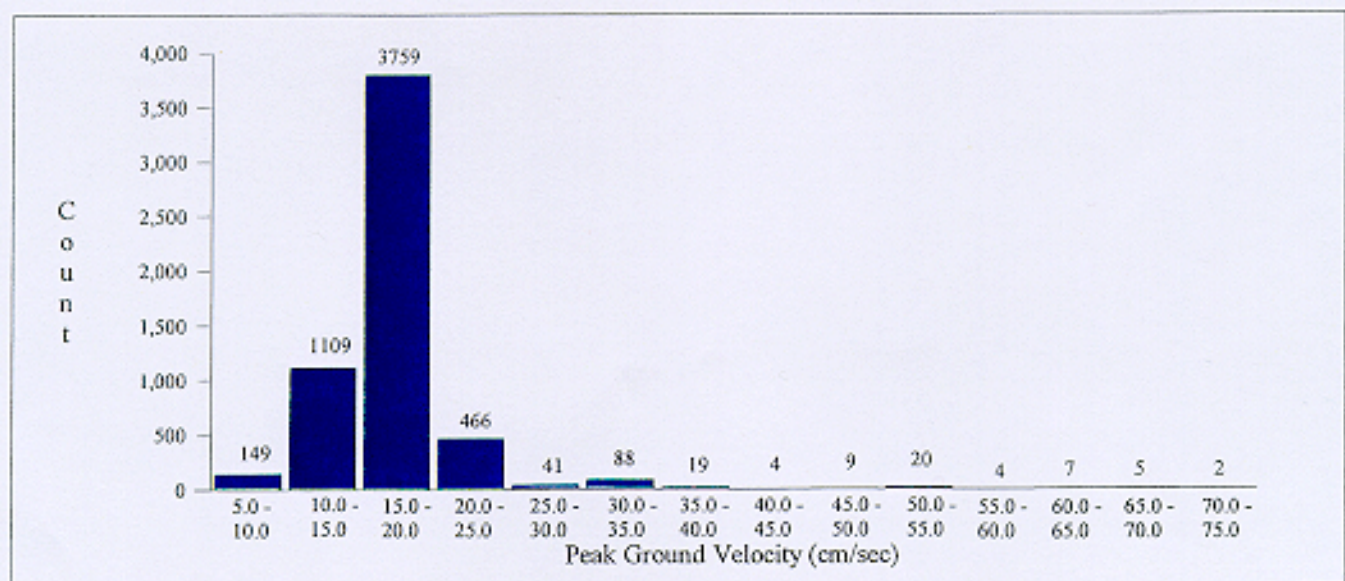
Figure A-9: Total Retrofitted Inventory vs. Peak Ground Velocity (cm/sec)

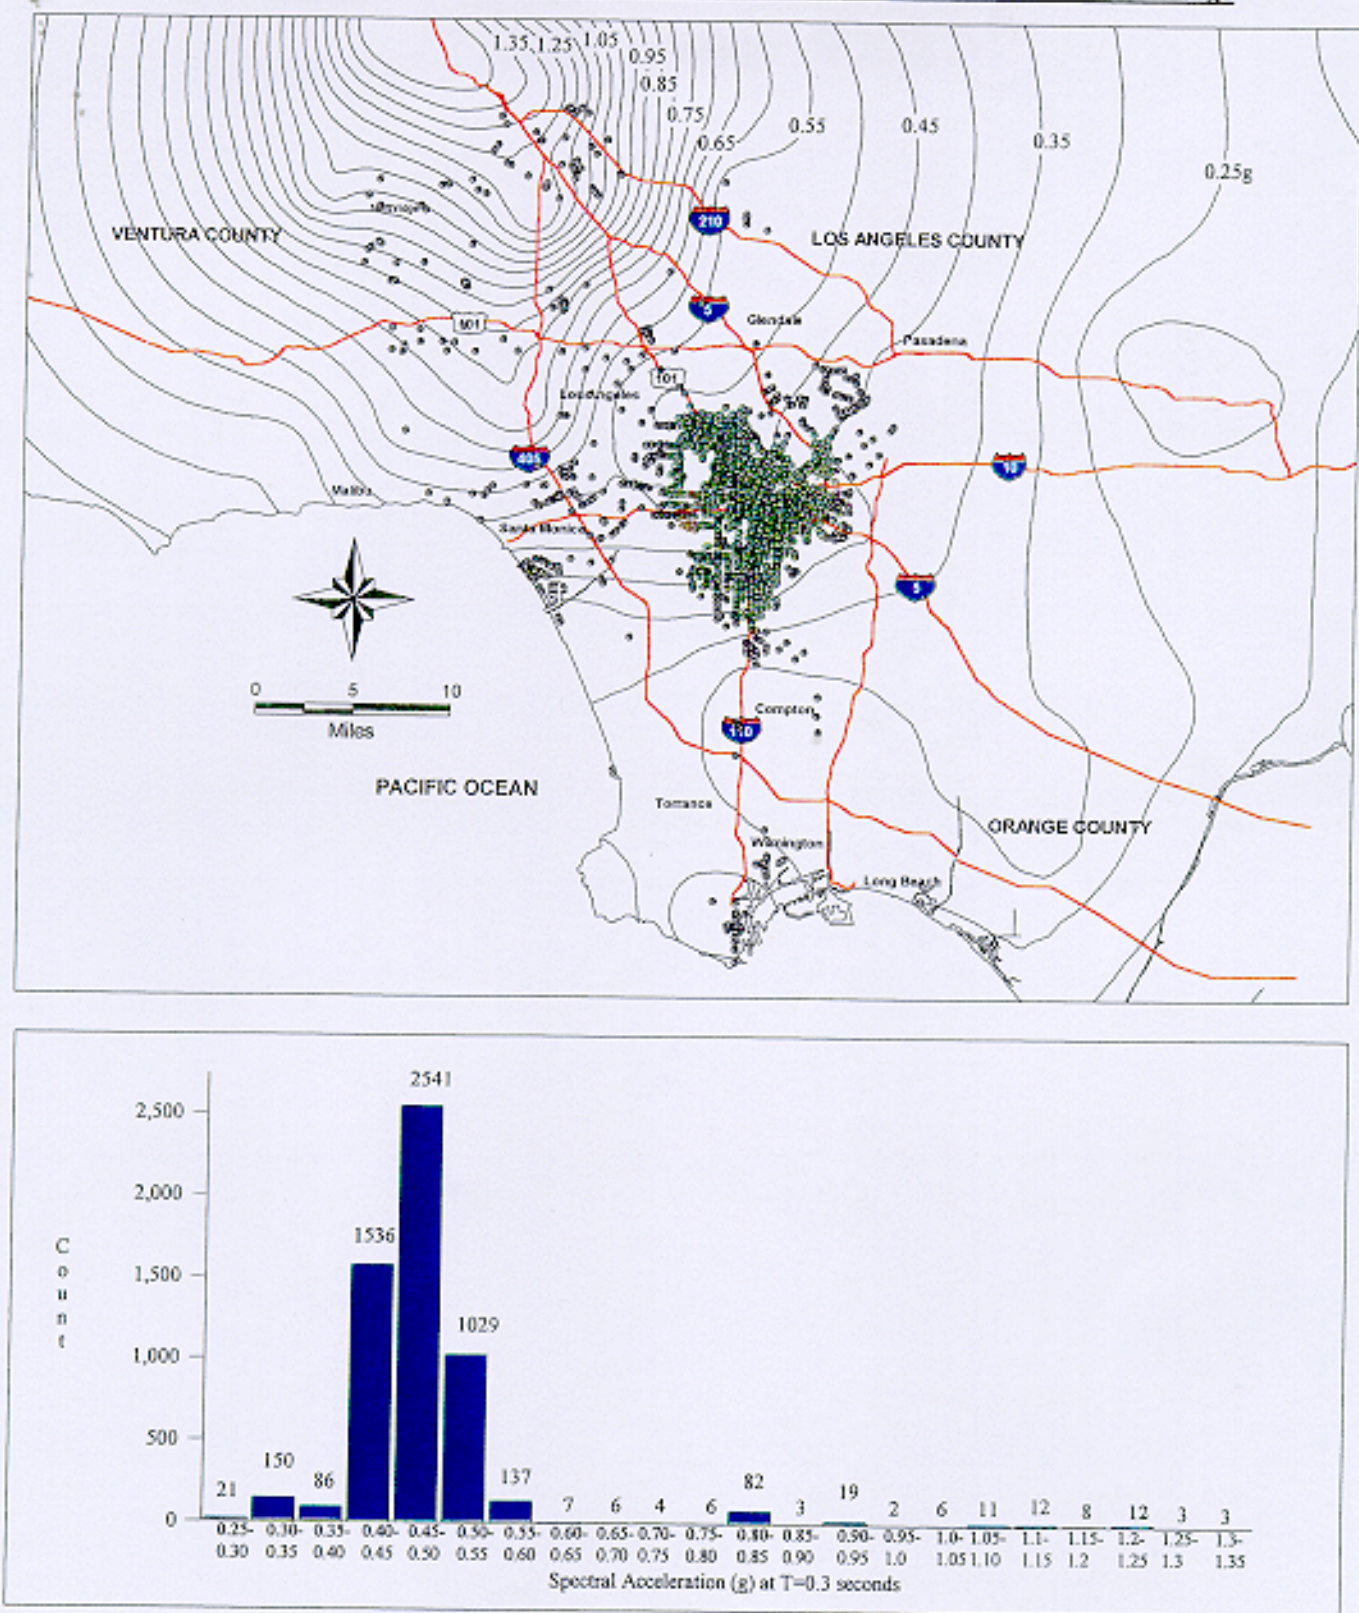
Figure A-10: Total Retrofitted Inventory vs. Spectral Acceleration (g) taken at T=0.3 seconds

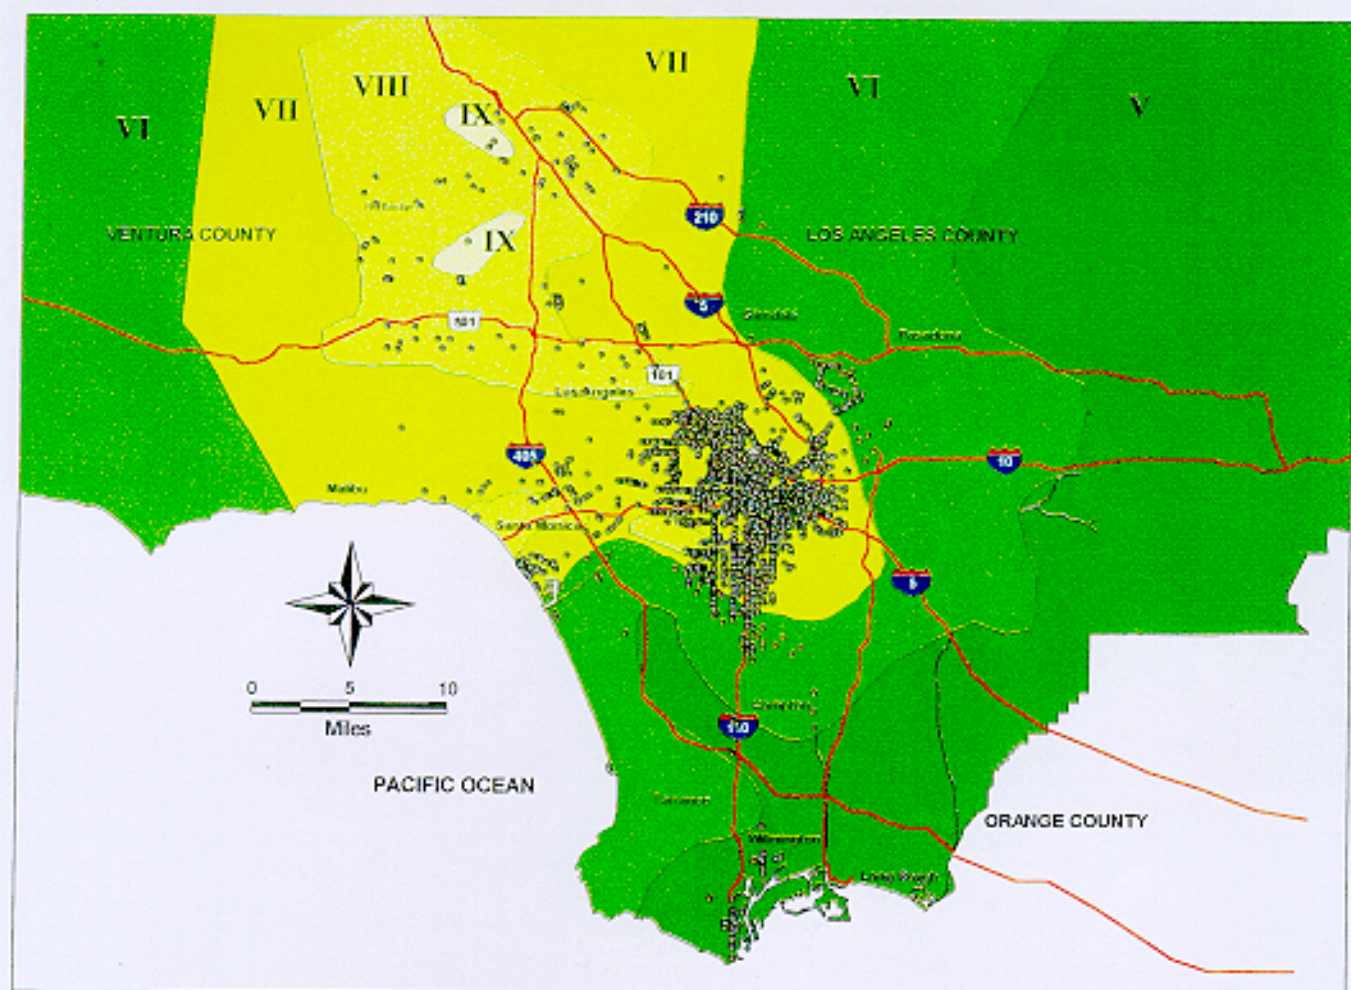
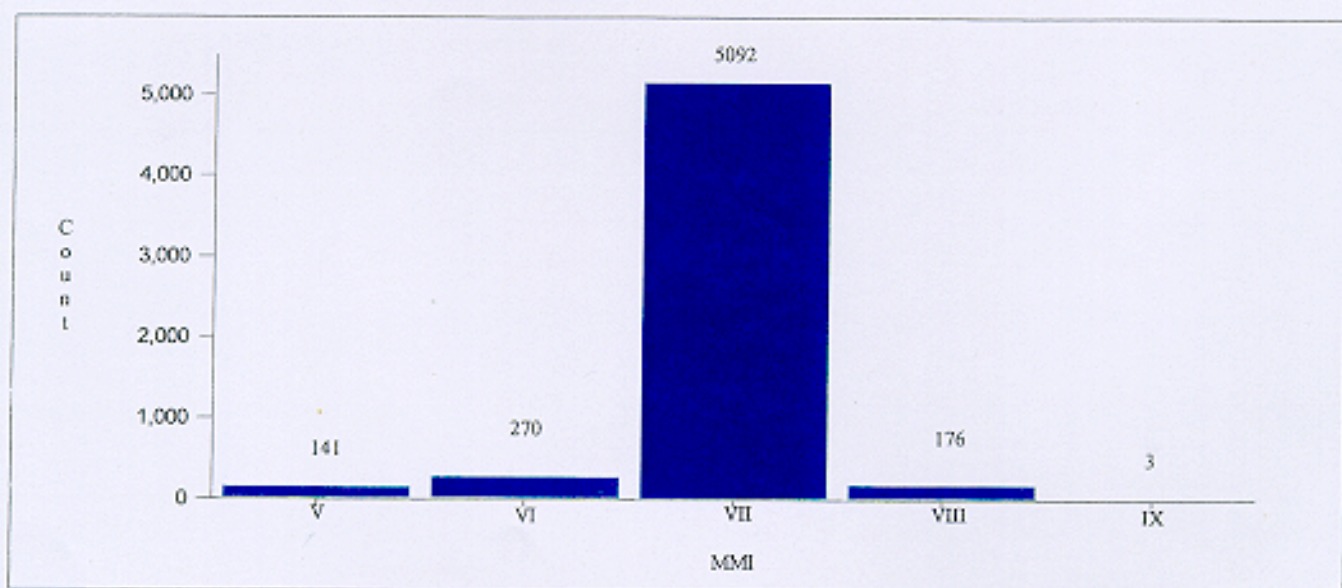
Figure A-12: Total Retrofitted Inventory vs. MMI

A map of isoseismal lines and point observations of Modified Mercalli Intensity (MMI) was developed by Dewey, et al. (1995). A detailed explanation of the creation of this map is contained therein. MMI contours, overlain by the retrofitted URM inventory, are shown in Figure A-12. The bulk of the inventory is in the moderate intensity (VII) contour. Intensity VII is bounded by Glendale to the northeast, Torrance and Compton to the south, and extends as far west as Fillmore. Reports of IX were limited to the immediate vicinity of the epicenter and to isolated pockets in the San Fernando and Santa Clarita Valleys, Santa Monica, and south-central Los Angeles.

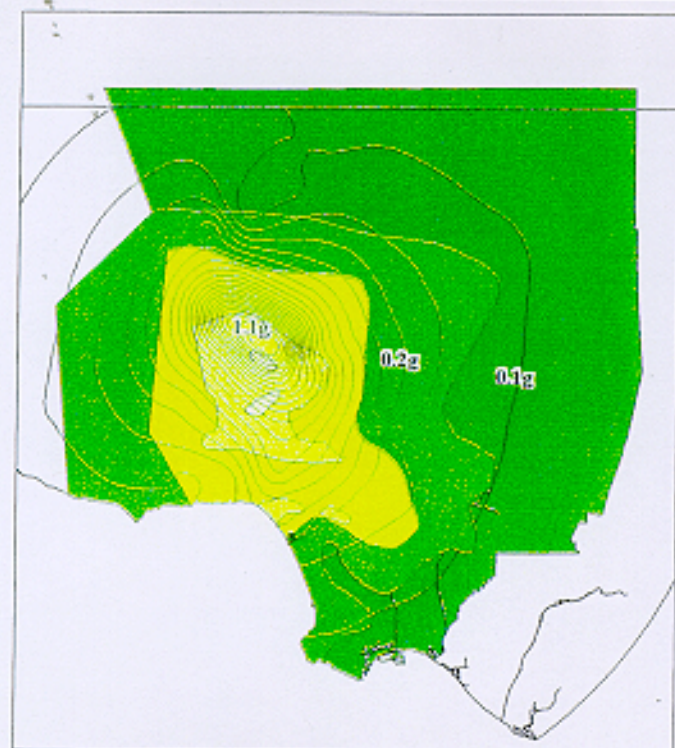
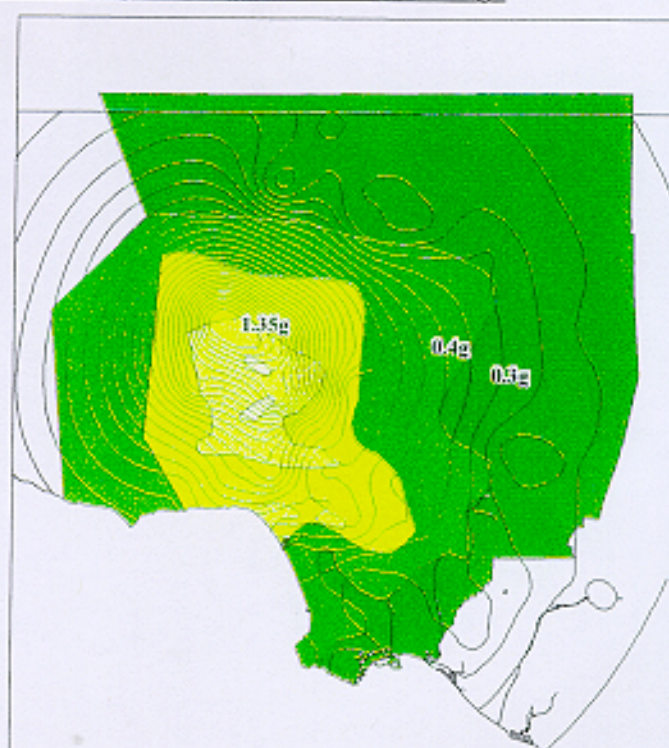
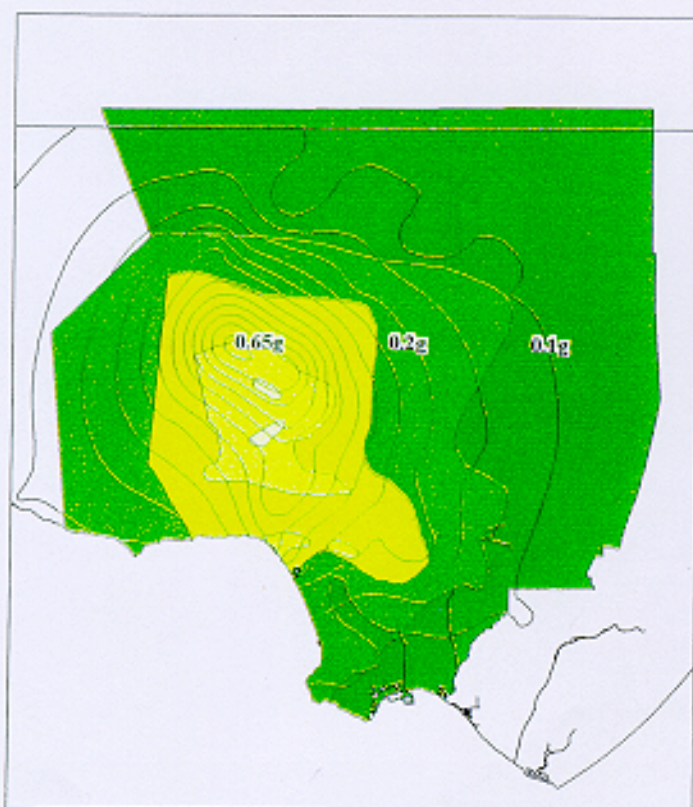
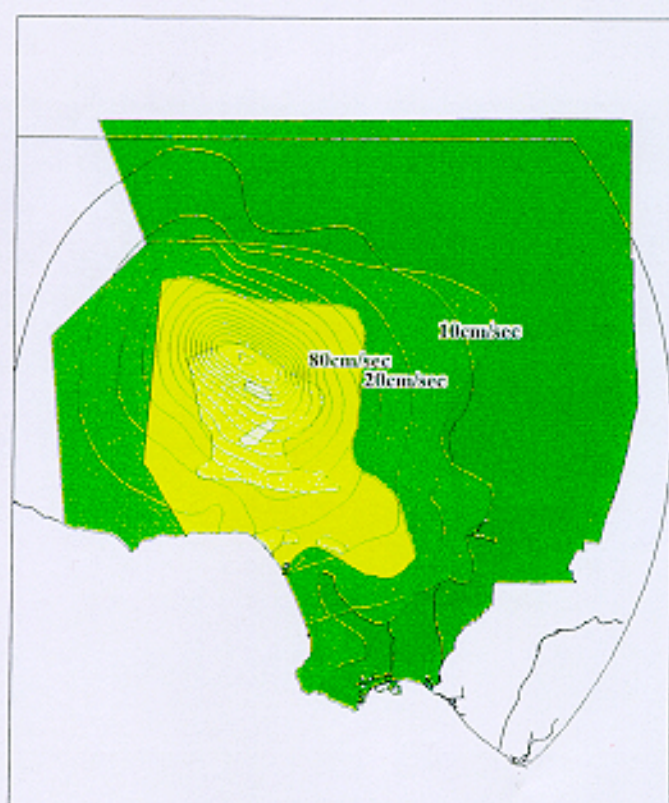
(a) MMI vs $S_a(1.0)$ (g)

(b) MMI vs $S_a(0.3)$ (g)

(c) MMI vs PGA (g)

(d) MMI vs PGV (cm/sec)

Figure A-13: Comparison of MMI Contours and other Ground Motion Contours

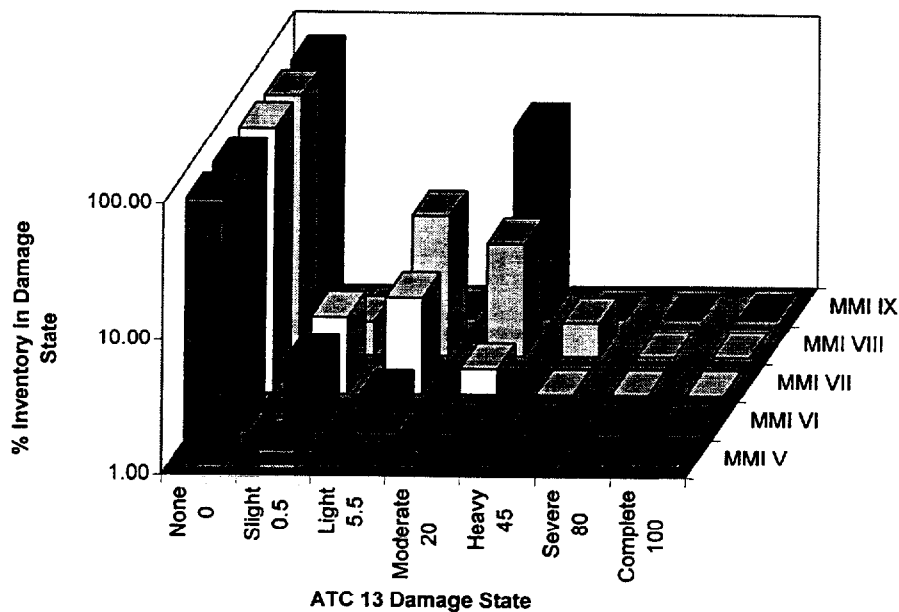
Figure A-14a: Percentage of Total Retrofitted Building Inventory vs. ATC-13 Damage State (Uninspected Buildings Assumed to Have No Damage)

Accompanying the table is a bar chart representation of the percent of inventory in each ATC-13 damage state for each MMI (Figure A-14). A similar bar chart showing the percent inventory in each damage state vs. MMI is shown in Figure A-15 for data aggregated using the EERI damage scale. In both Figure A-14(a) and A-15, the uninspected buildings are assumed to have no damage. Though the scales are defined differently, similar trends emerge as the MMI increases.

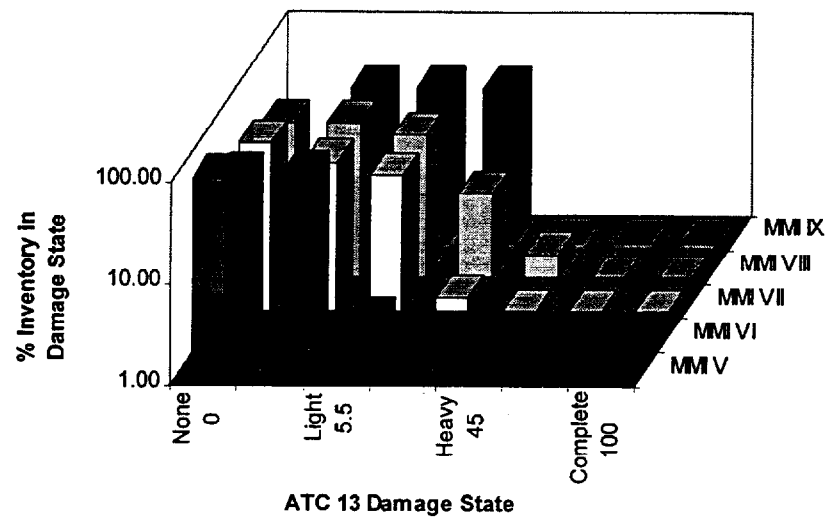
Figure A-14b: Percentage of Total Retrofitted Building Inventory vs. ATC-13 Damage State (Uninspected Buildings Assumed to Have Some Damage)

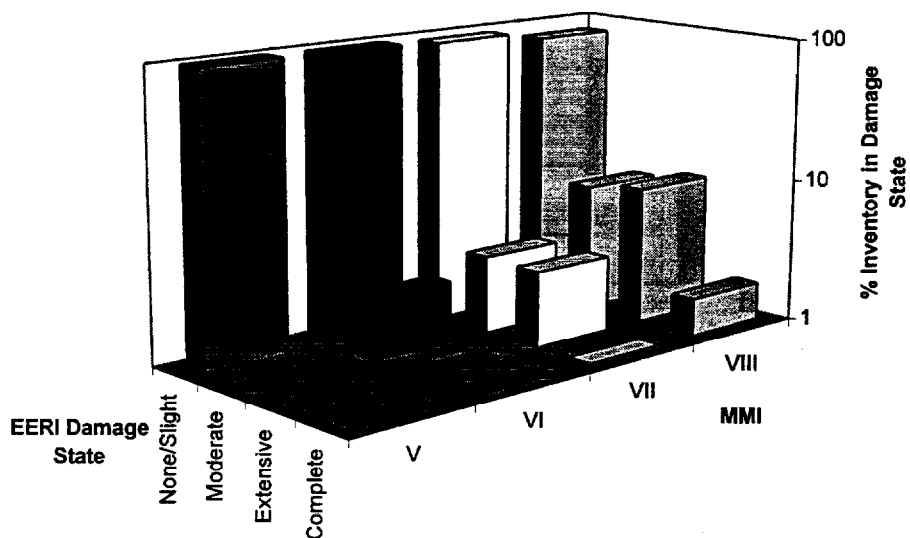
Figure A-15: Percentage of Total Retrofitted Building Inventory in Each EERI Damage State for MMI V, VI, VII, and VIII

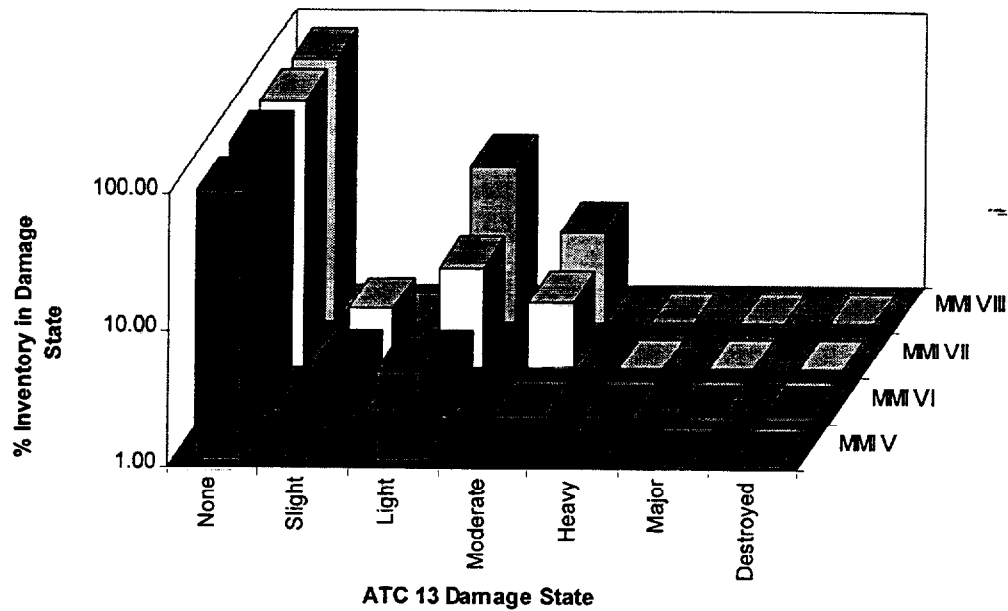
Figure A-16: Percentage of Total Unretrofitted Building Inventory vs. ATC-13 Damage State

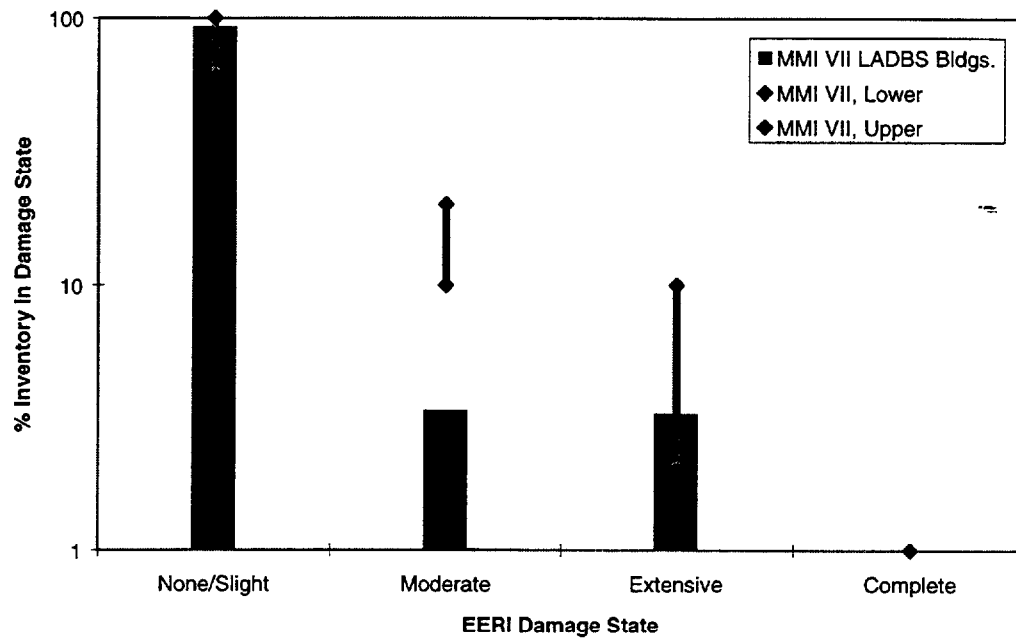
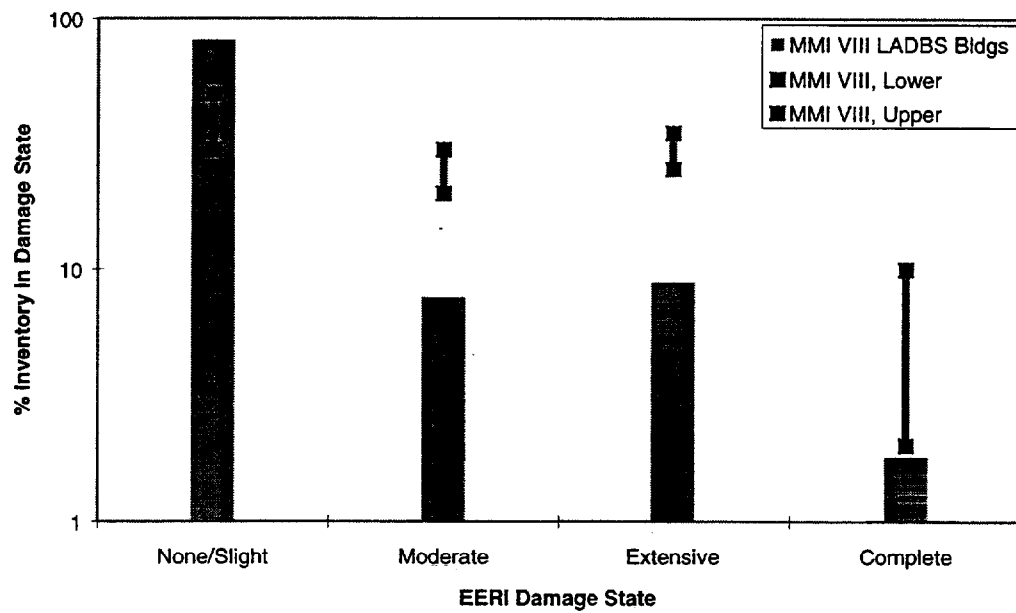
(a) MMI VII

(b) MMI VIII

Figure A-17: Percentage of Total Retrofitted Inventory in Each EERI Damage State vs. EERI Expected Performance Range

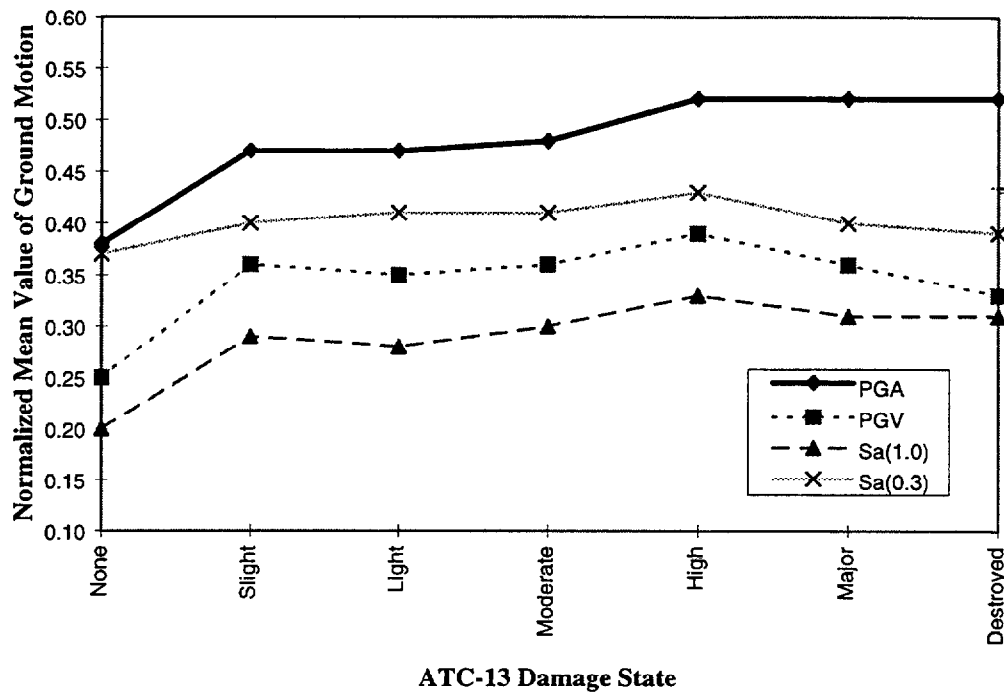
Figure A-18: Comparison of Normalized Ground Motion Parameters and Mean Damage Factor

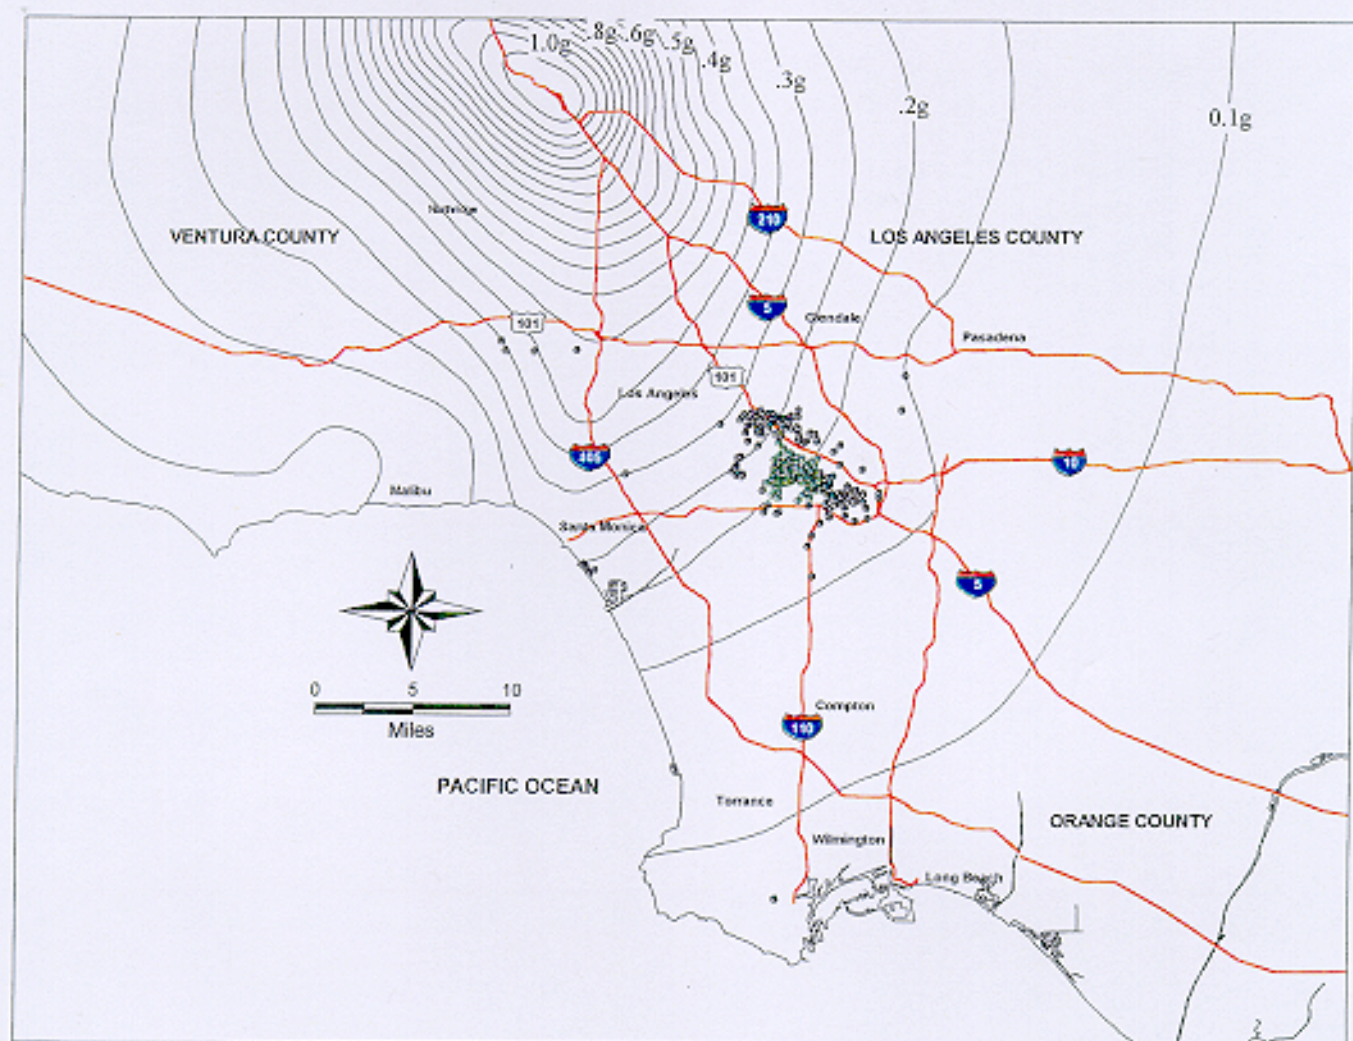
Figure A-19: Location of Midrise Inventory Overlain on Spectral Acceleration (g) taken at T=1.0 sec

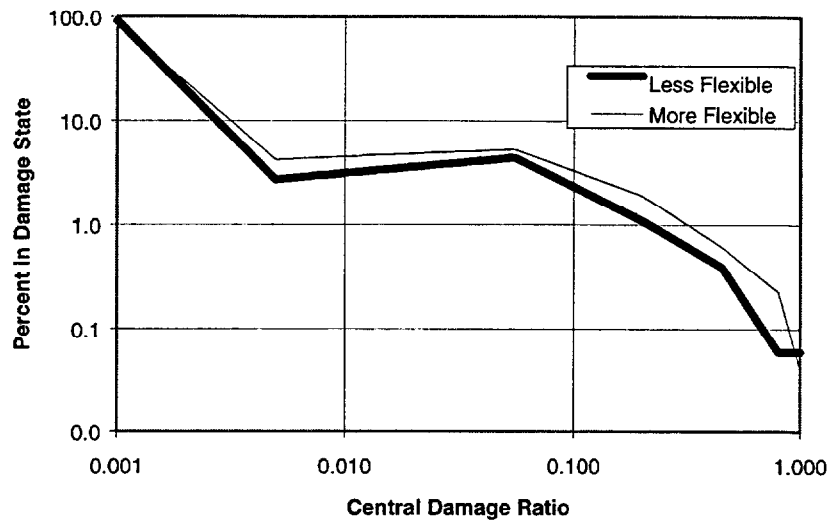
Figure A-20: Comparison of Central Damage Ratio for Less Flexible and More Flexible Horizontal Aspect Ratio

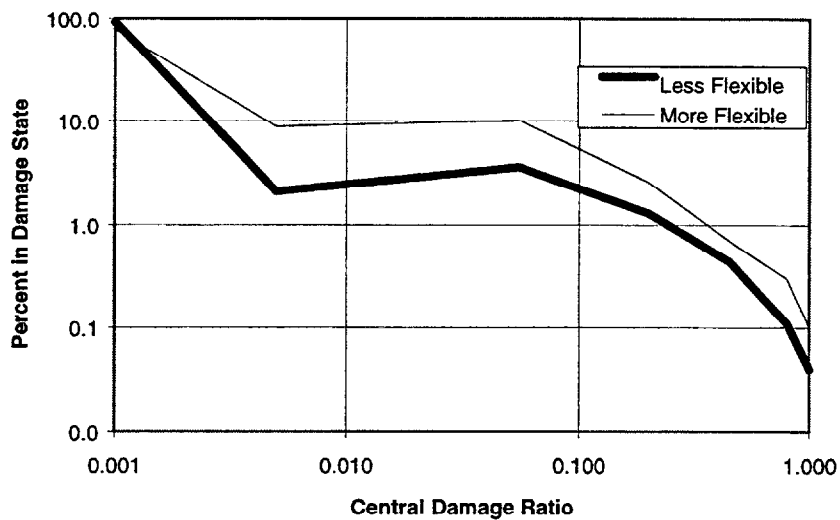
Figure A-21: Comparison of Central Damage Ratio for Less Flexible and More Flexible Vertical Aspect Ratio

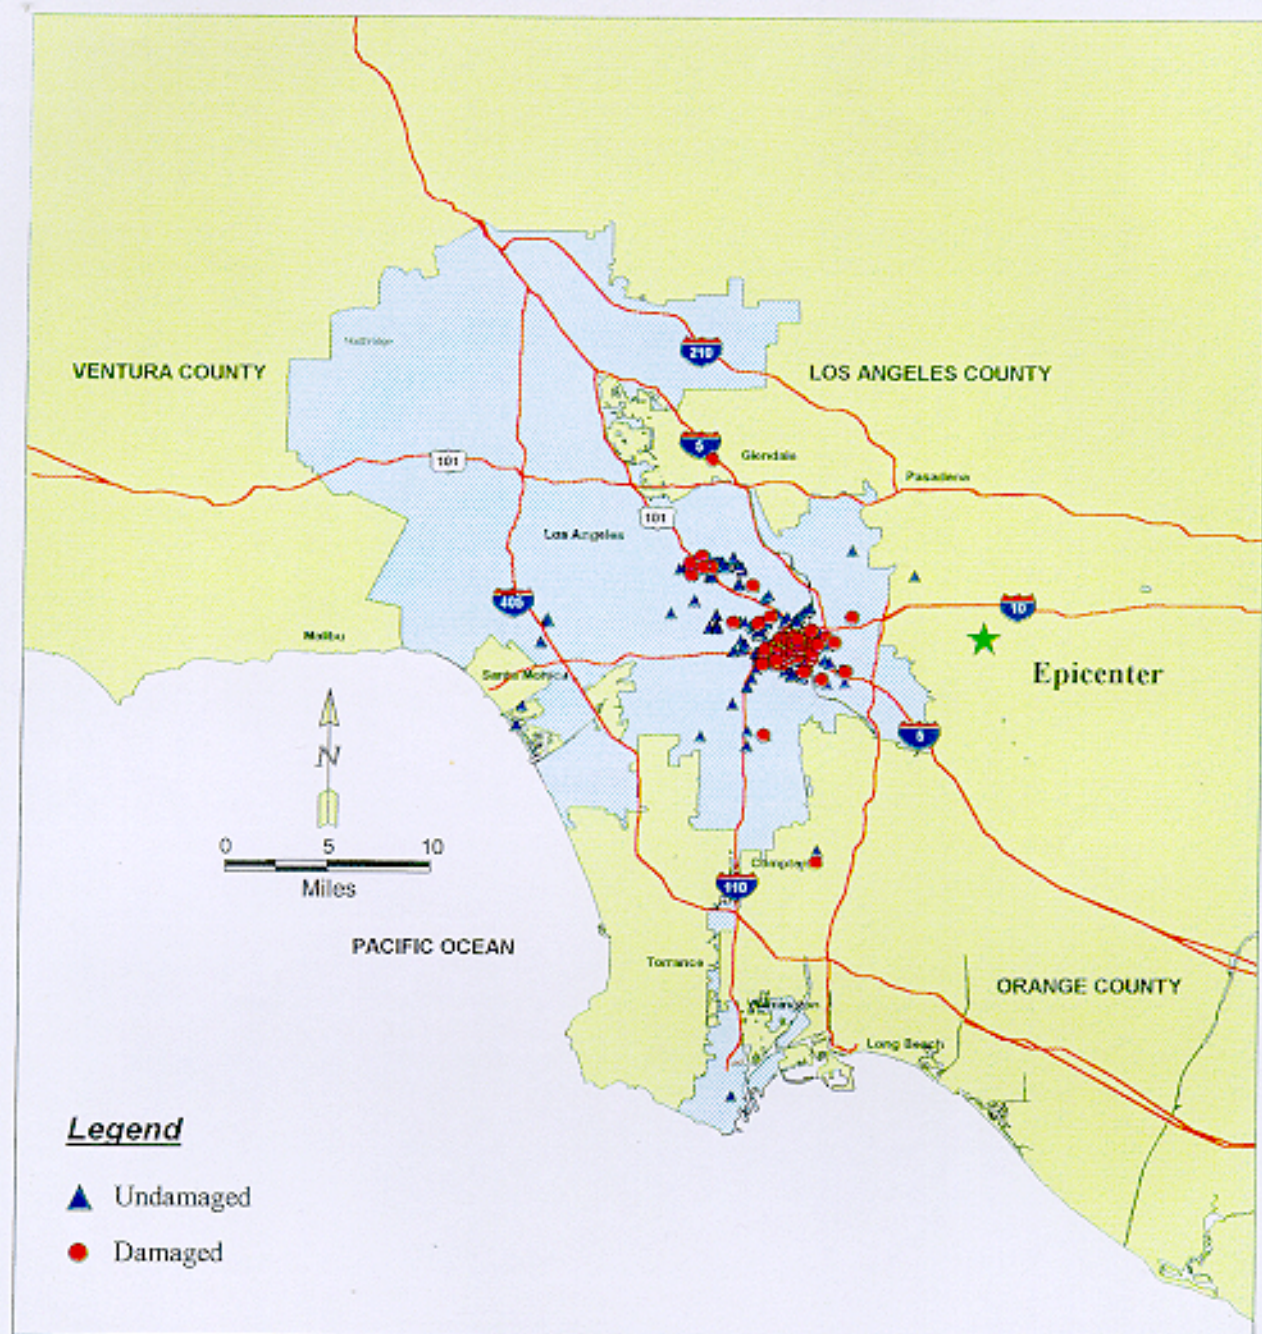
Figure A-22: Retrofitted URM Inventory, Whittier Narrows Earthquake

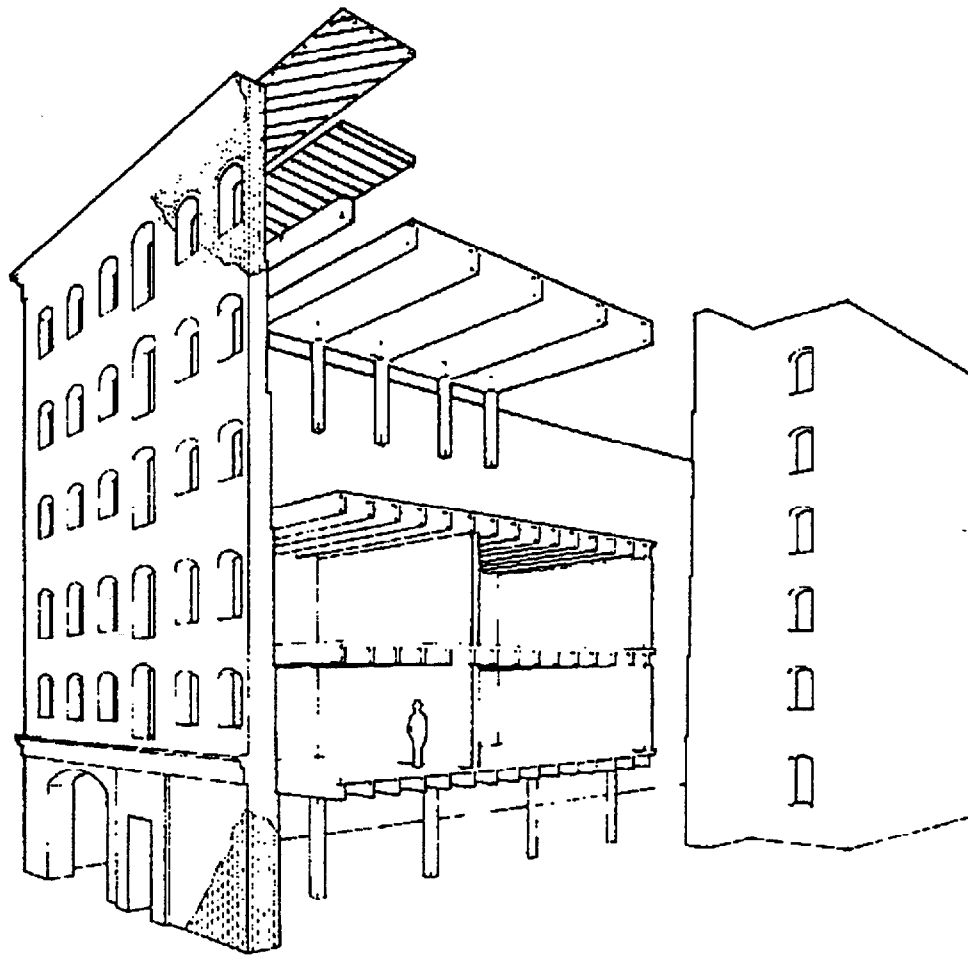
Typical roof/floor span system

Wood joists

Large openings for ground floor shops

Figure B-1: Typical URM Bearing Wall Building For Which California-Type Retrofit Schemes Were Developed (Adapted from Wong, 1987)
