NIST GCR 97-724-2

APPENDICES: Development of Procedures to Enhance the Performance of Rehabilitated URM Buildings

Bret Lizundia, William T. Holmes, Margaret Longstreth, and Alan Kren
Rutherford & Chekene
303 Second Street, Suite 800 North
San Francisco, California 94107

APPENDIX A

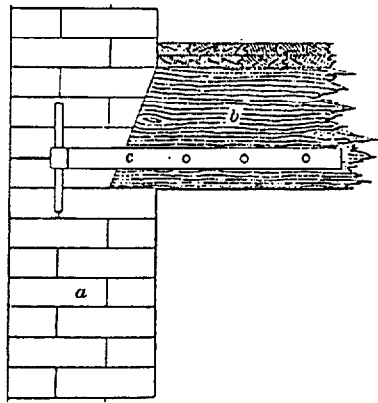
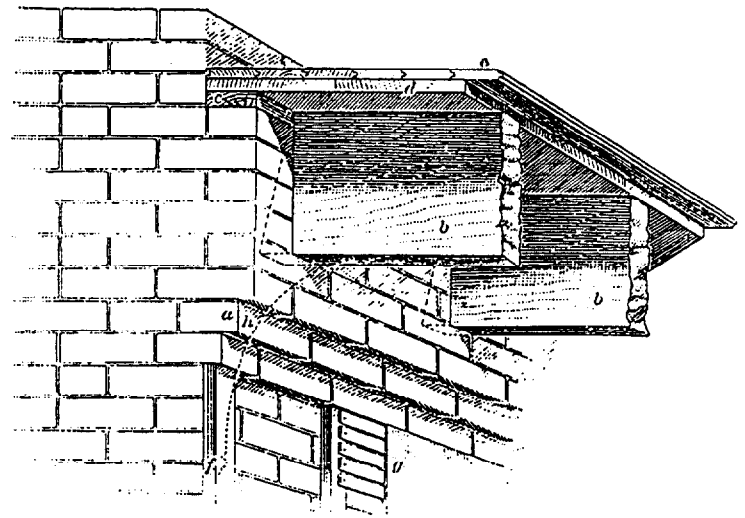
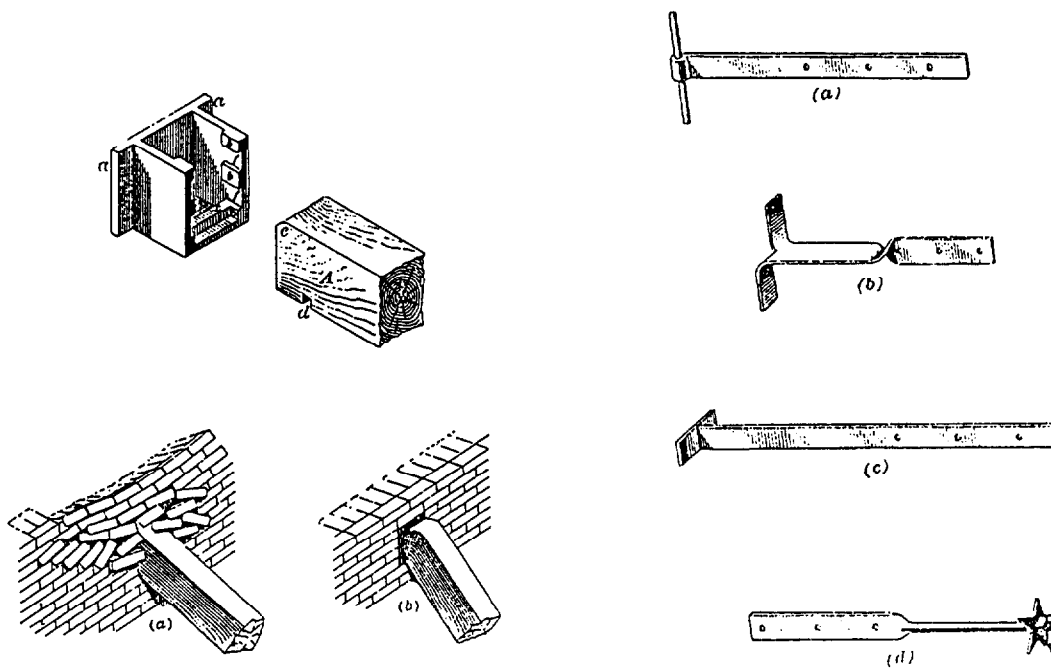
(a) Typical Joist Anchor

(b) Corbel

(c) Typical Anchorage Hardware

**Figure B-2: Typical Joist Anchorage Details and Hardware, Circa 1900
(Lavicka, 1980)**

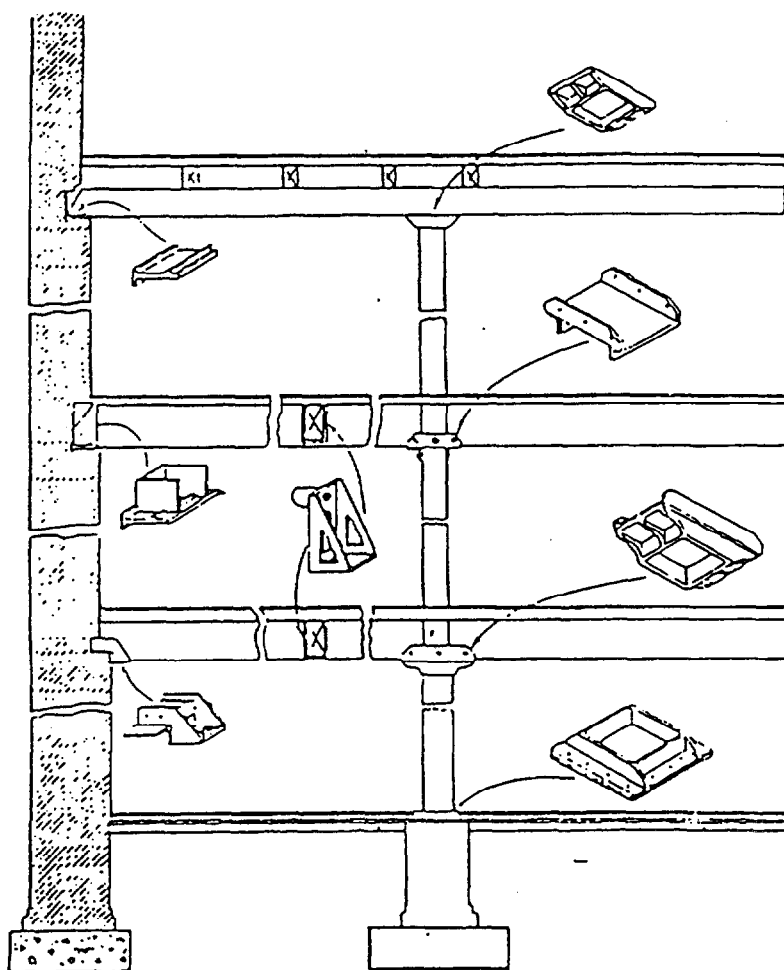
Fig. 29. Mill-construction. Combination Post-caps, etc.

Figure B-3: Mill Construction Circa 1890. Steel I-beam Floor Framing and Cast-Iron Interior Column (Kidder, 1916)

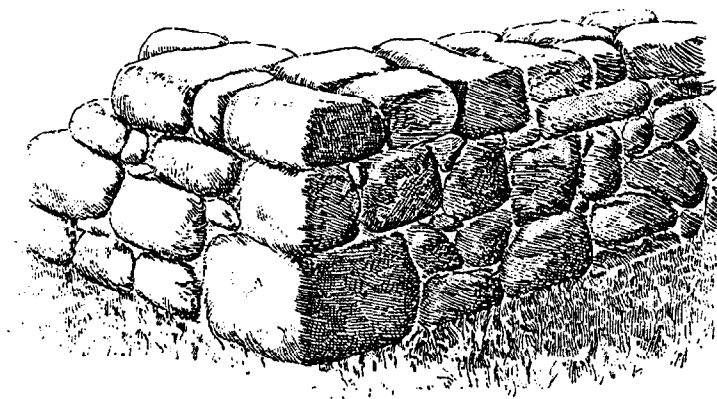
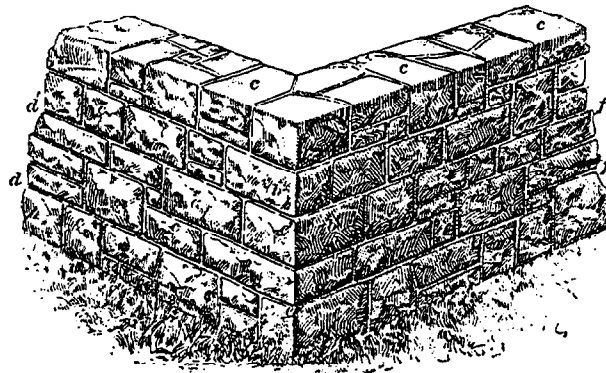
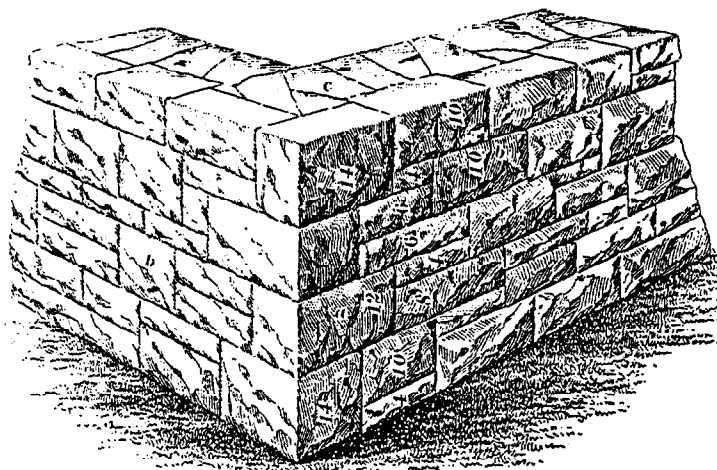
(a) Stone

(b) Coursed Rubble

(c) Broken Ashlar

Figure B-4: Stone, Coursed Rubble, and Broken Ashlar Walls (Lavicka, 1980)

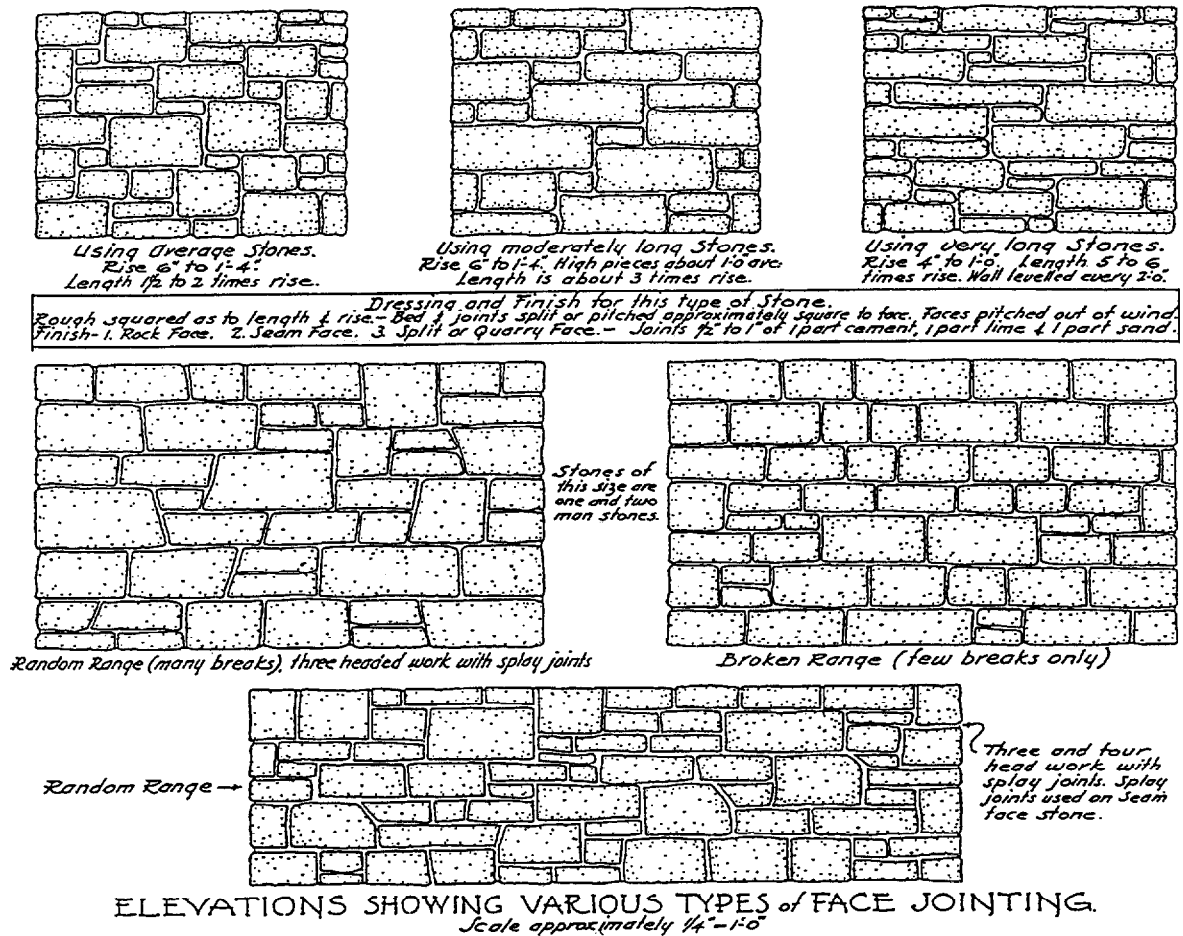
Figure B-5: Elevations Showing Various Types of Face Jointing
(Belle, et al., 1991)

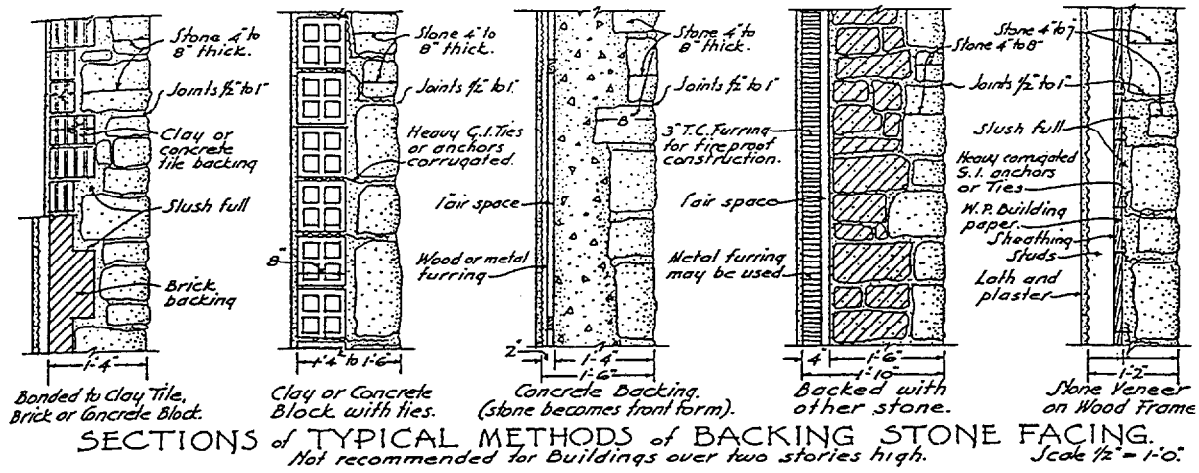
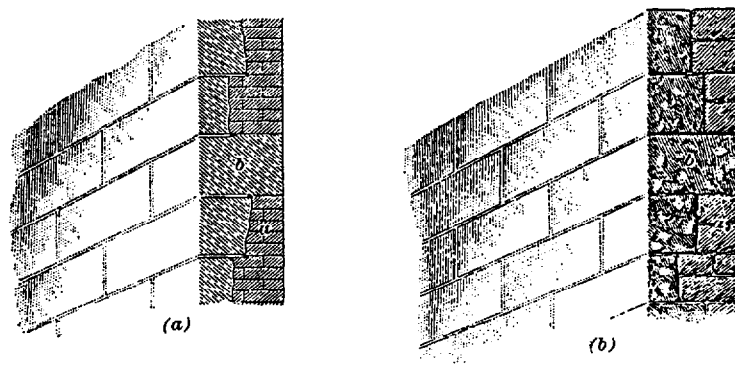
(a) Backing Stone Facing (Belle, et. al., 1991)

(b) Ashlar Facing with Brick and Stone Backing (Lavicka, 1980)

Figure B-6: Sections of Typical Methods of Backing

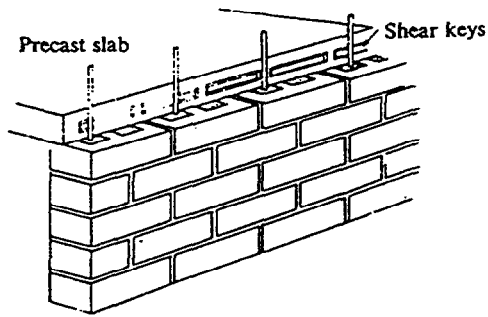
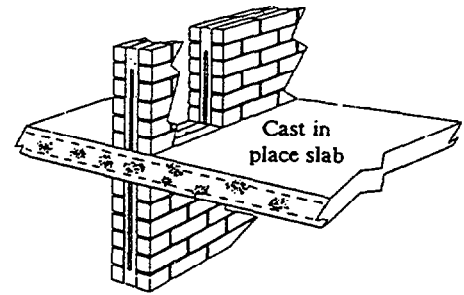
(a) Concrete Slab

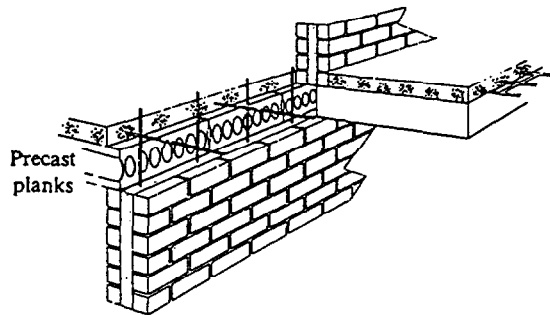
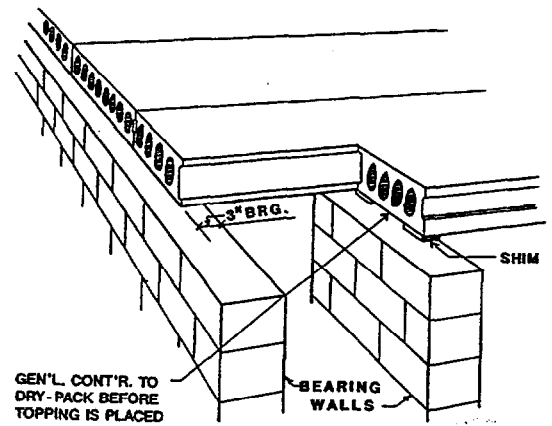
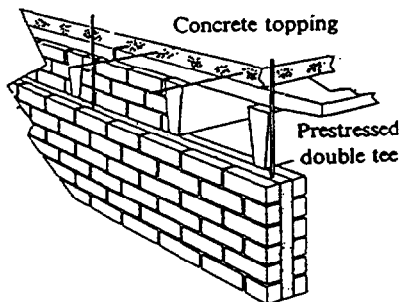
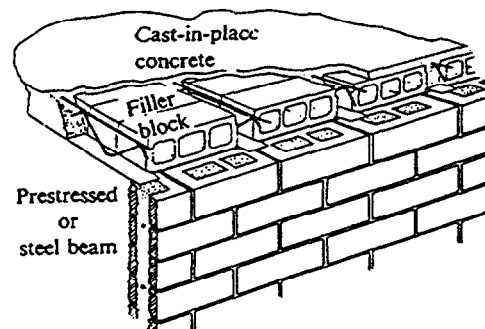
(b) Hollow Plank

(c) Precast Joists

Figure B-7: Concrete Diaphragms (Amrhein, 1983)

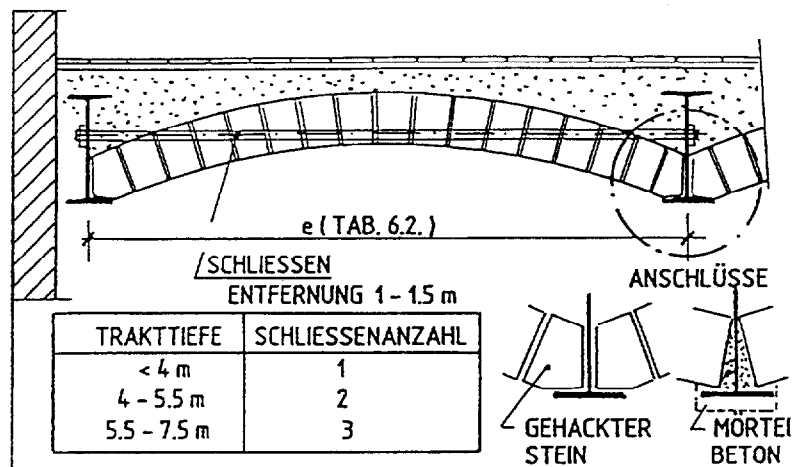
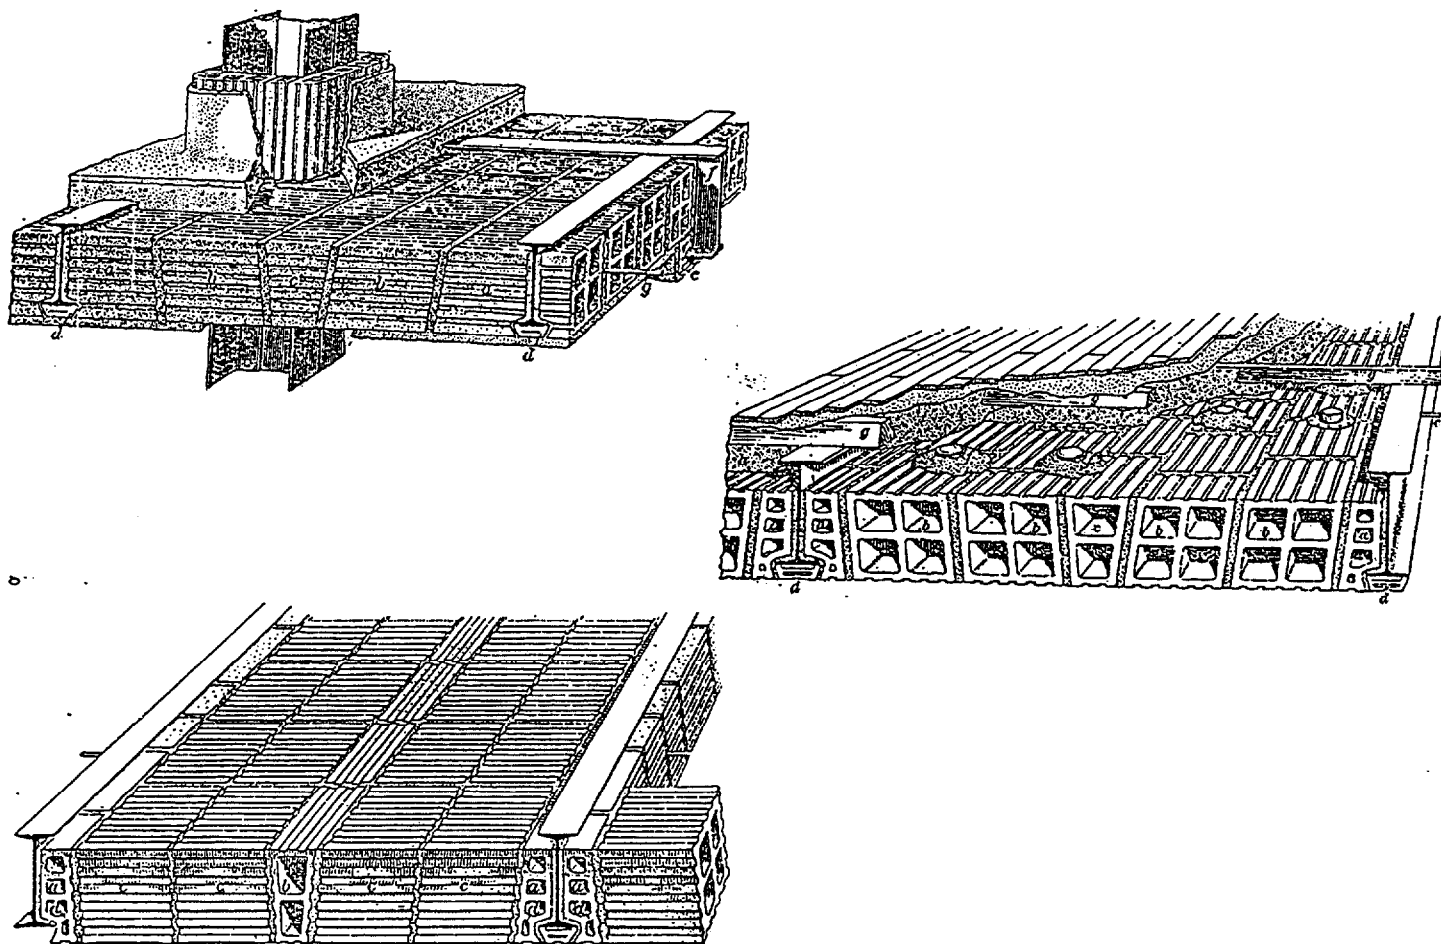
(a) Brick arch spanning between steel I-beams (Kolbitsch, 1989)

(b) Hollow clay tile flat arch spanning between steel I-beams (Lavicka, 1980)

Figure B-8: Masonry Diaphragms

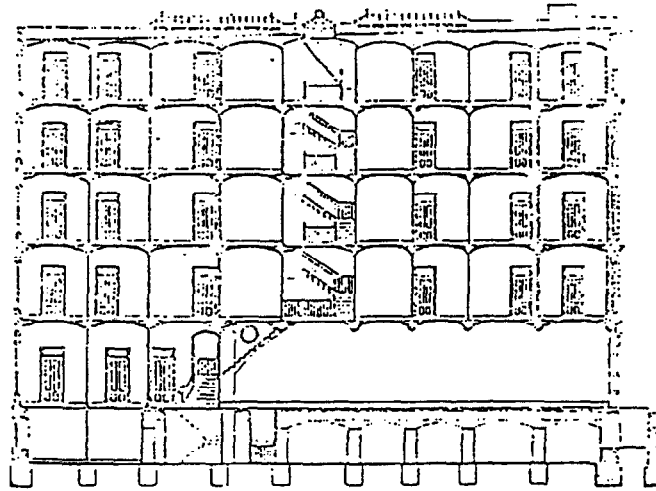
(a) Section

(b) Floor Detail

Figure B-9: Longitudinal Section through Manhattan Apartment Circa 1880 with Tile Arches from Cellar to Roof (Brickbuilder, 1901)

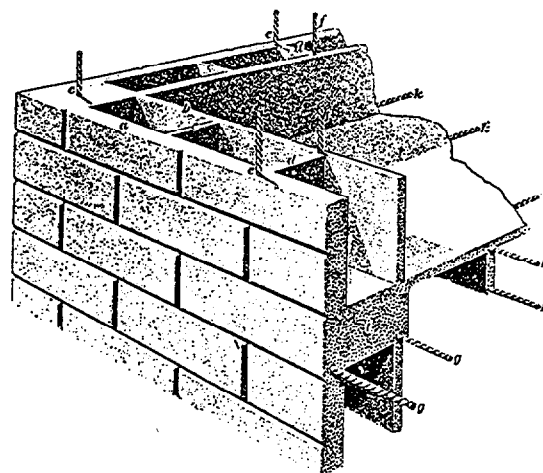
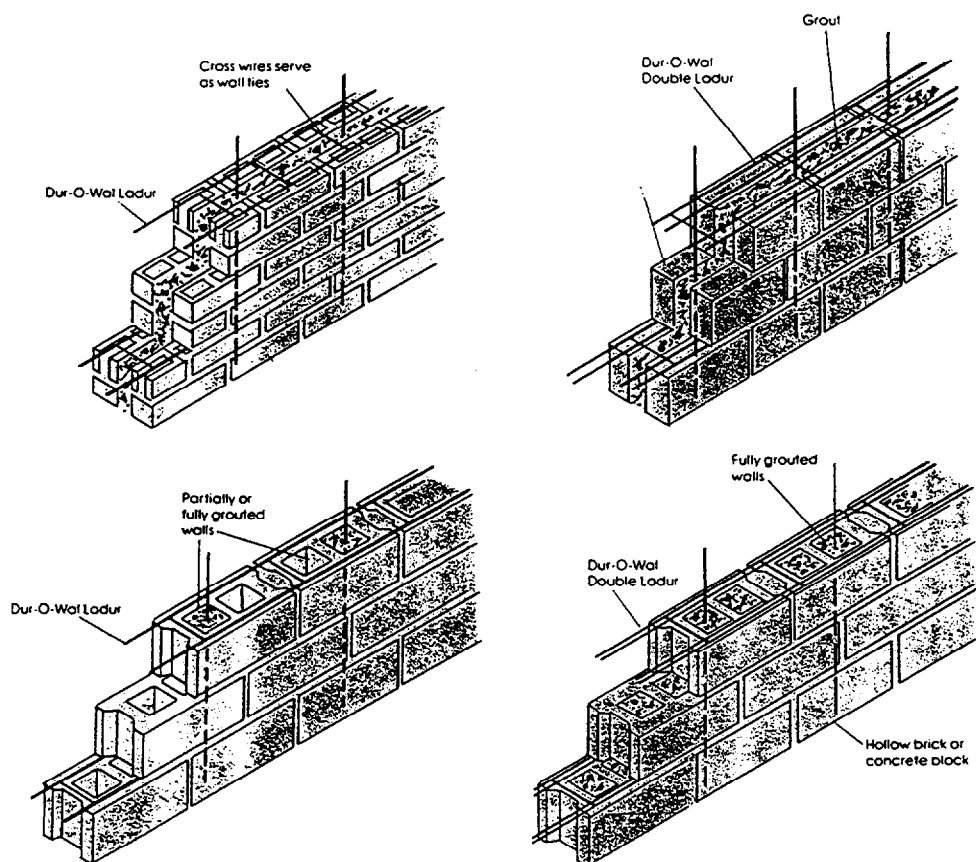
(a) Circa 1900

(b) Dur-O-Wal Construction, Present

Figure B-10: Hollow Concrete Wall Construction

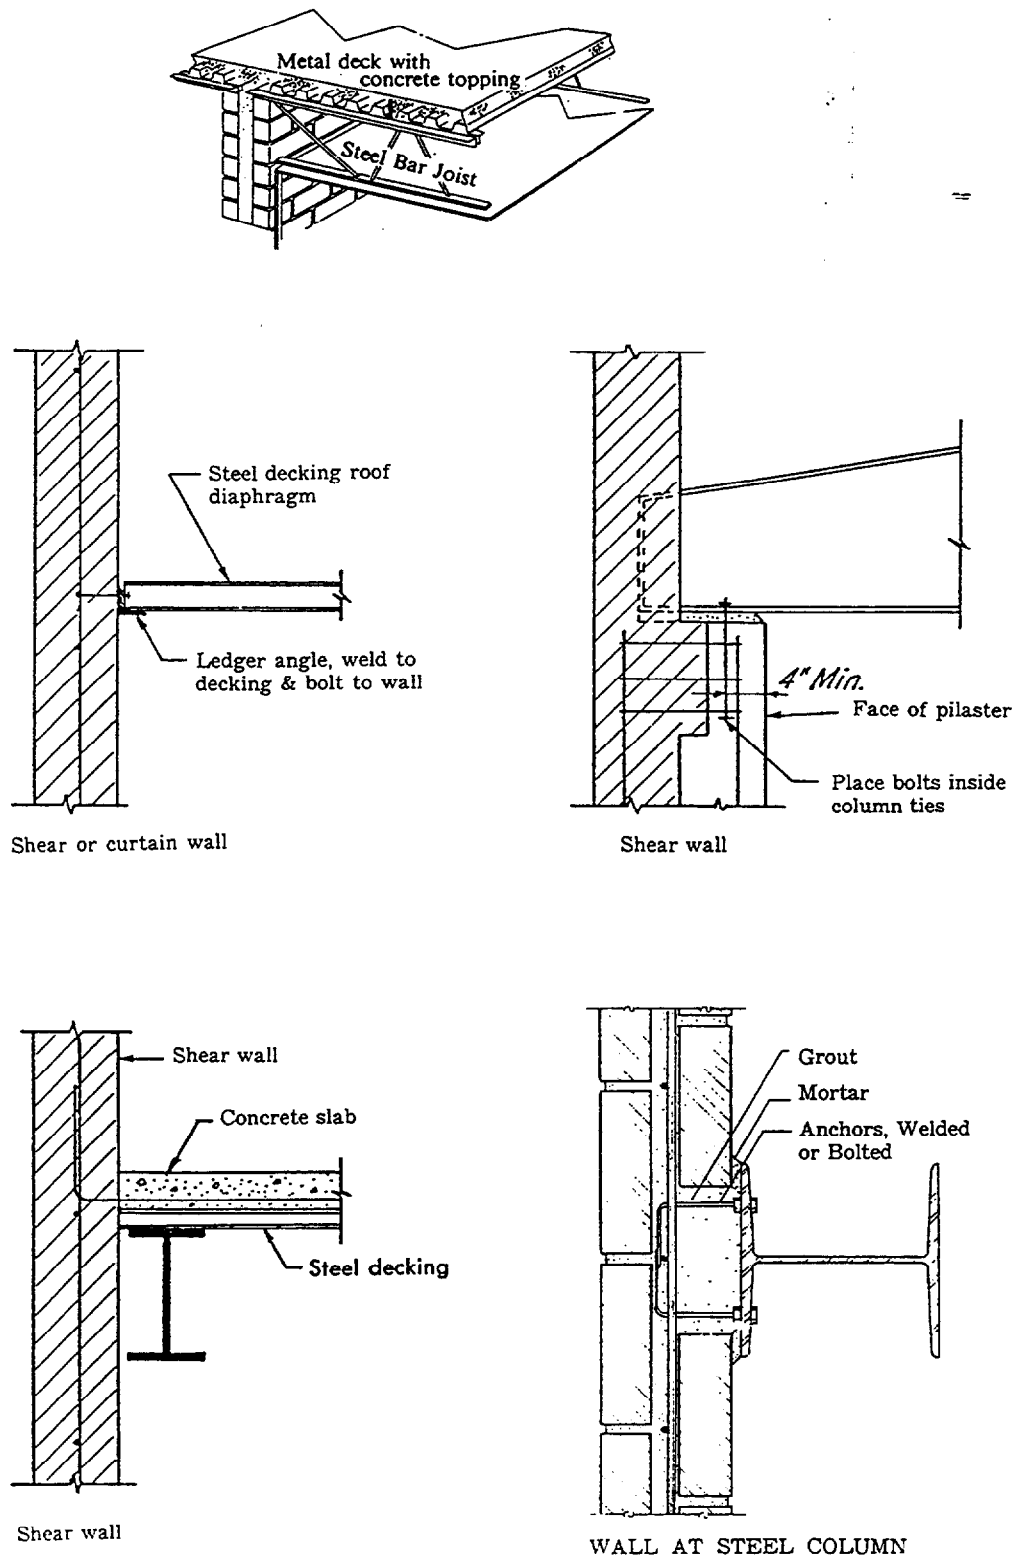
Figure B-11: Metal Deck Diaphragm Details (Amrhein, 1983)

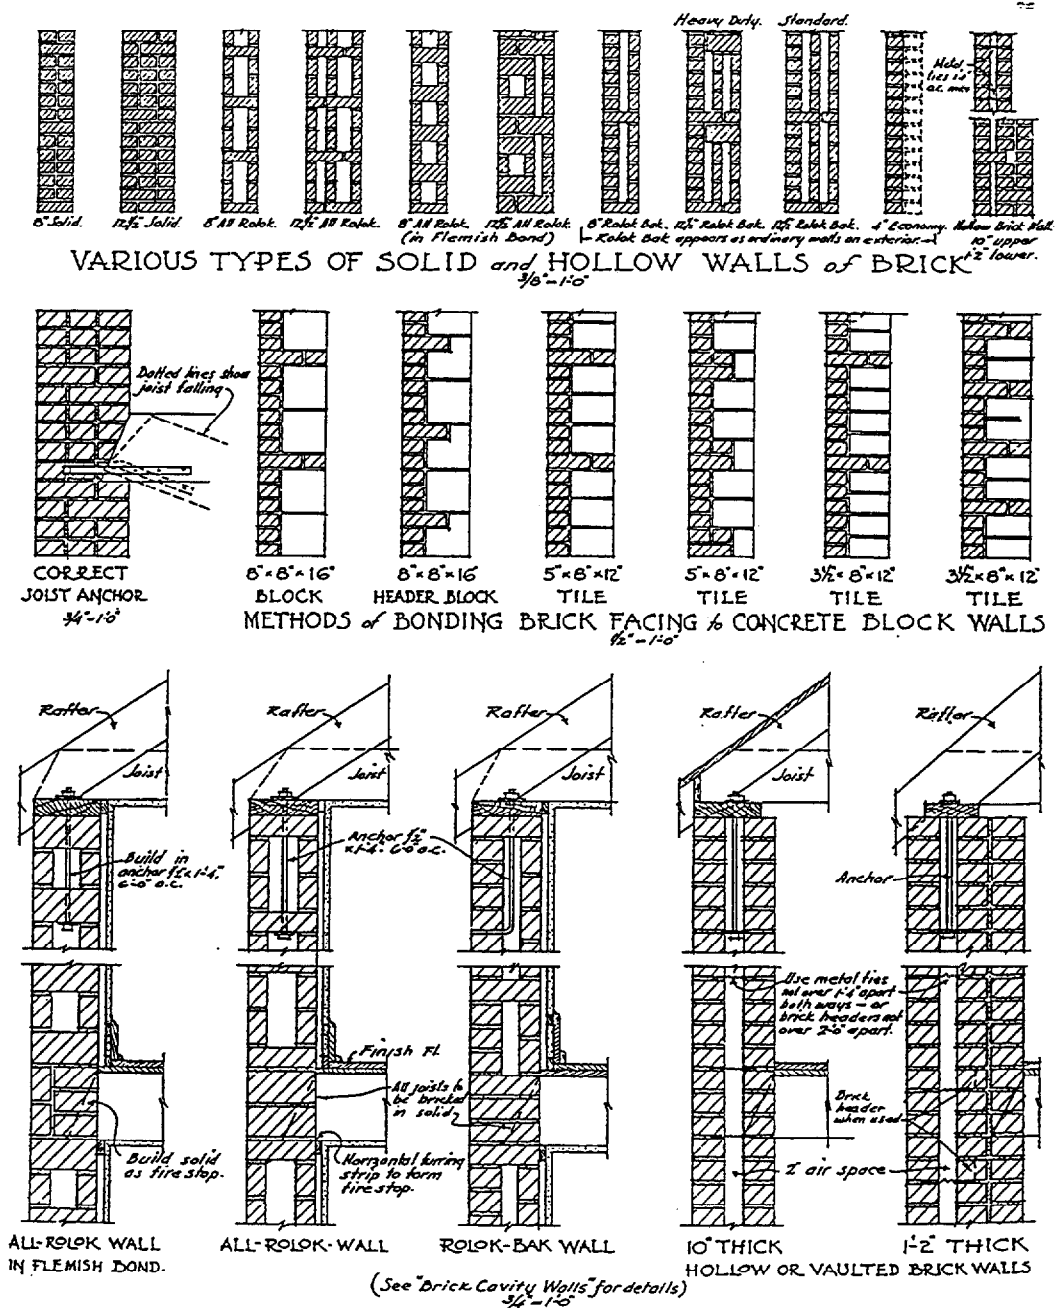
Figure B-12: Various Types of Solid and Hollow Walls of Brick (Belle, et al., 1991)

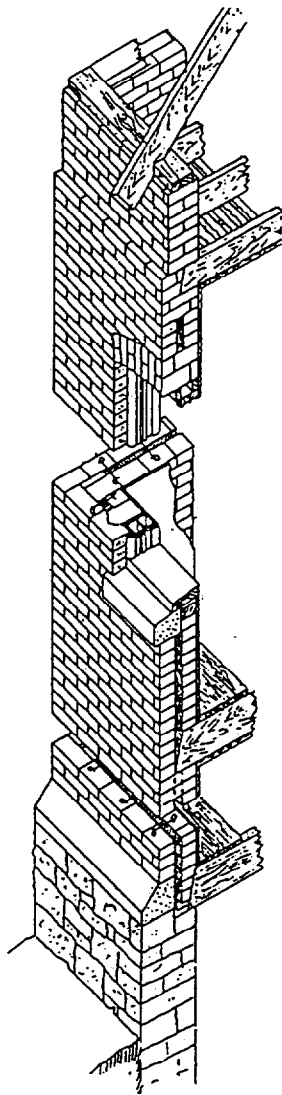
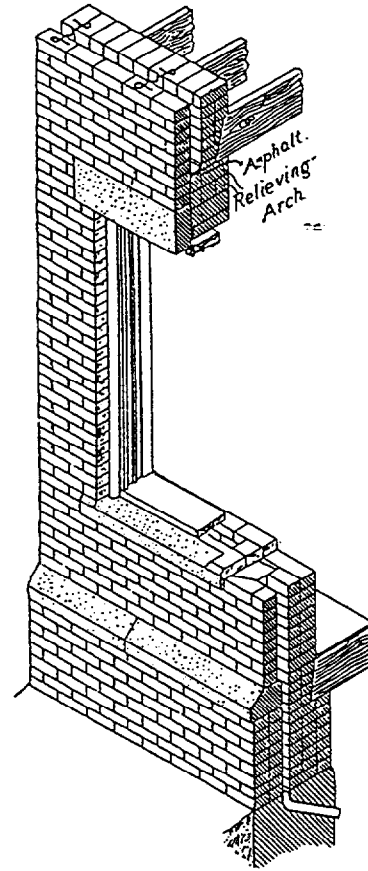
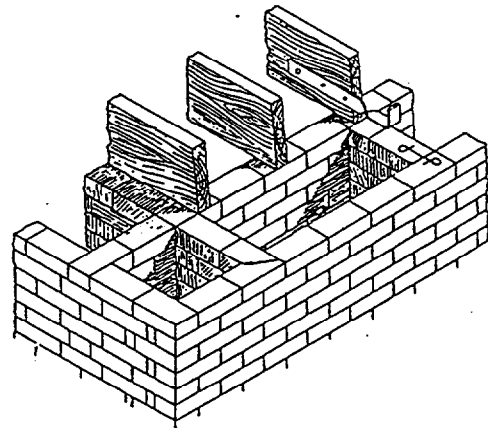
(a) Brick Cavity Wall Construction for Inexpensive Cottage Construction

(b) Brick Cavity Wall Construction for Two-Story Buildings

(c) Brick Cavity Wall Construction. Congress Hall, Saratoga, N.Y.

Figure B-13: Brick Hollow Wall Construction Types (Lavicka, 1980)

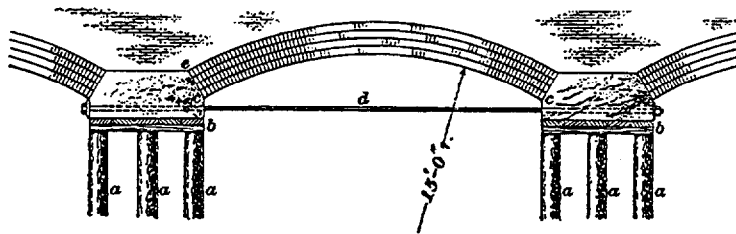
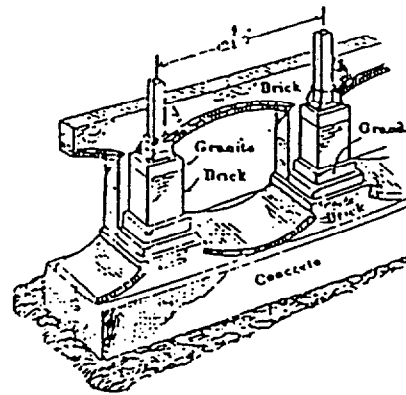
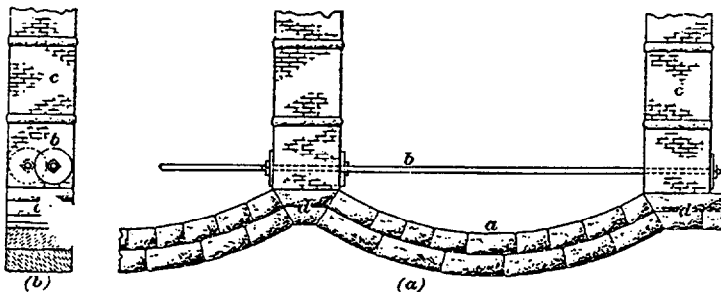
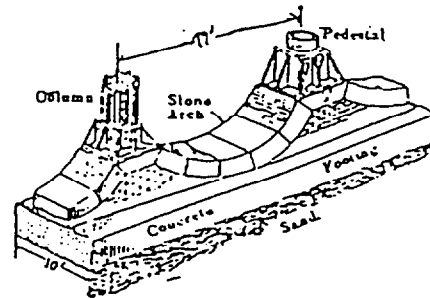
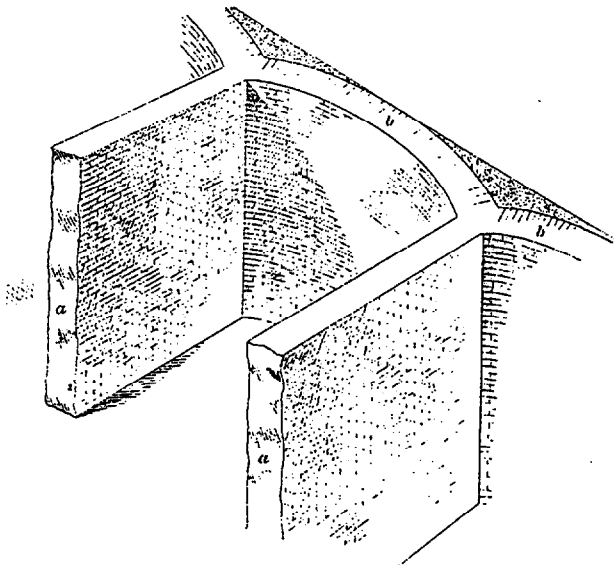
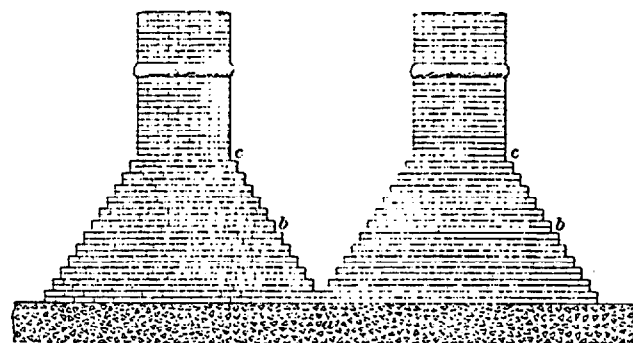
(a) Cluster Piles with Brick Anchors

(b) Inverted-arch Footing
World Building, New York

(c) Inverted Stone Arch

(d) Inverted-arch Footing, Drexel
Building, Philadelphia

(e) Brick Vaults

(f) Stepped Footing

Figure B-14: Masonry Footings (Lavicka, 1980)

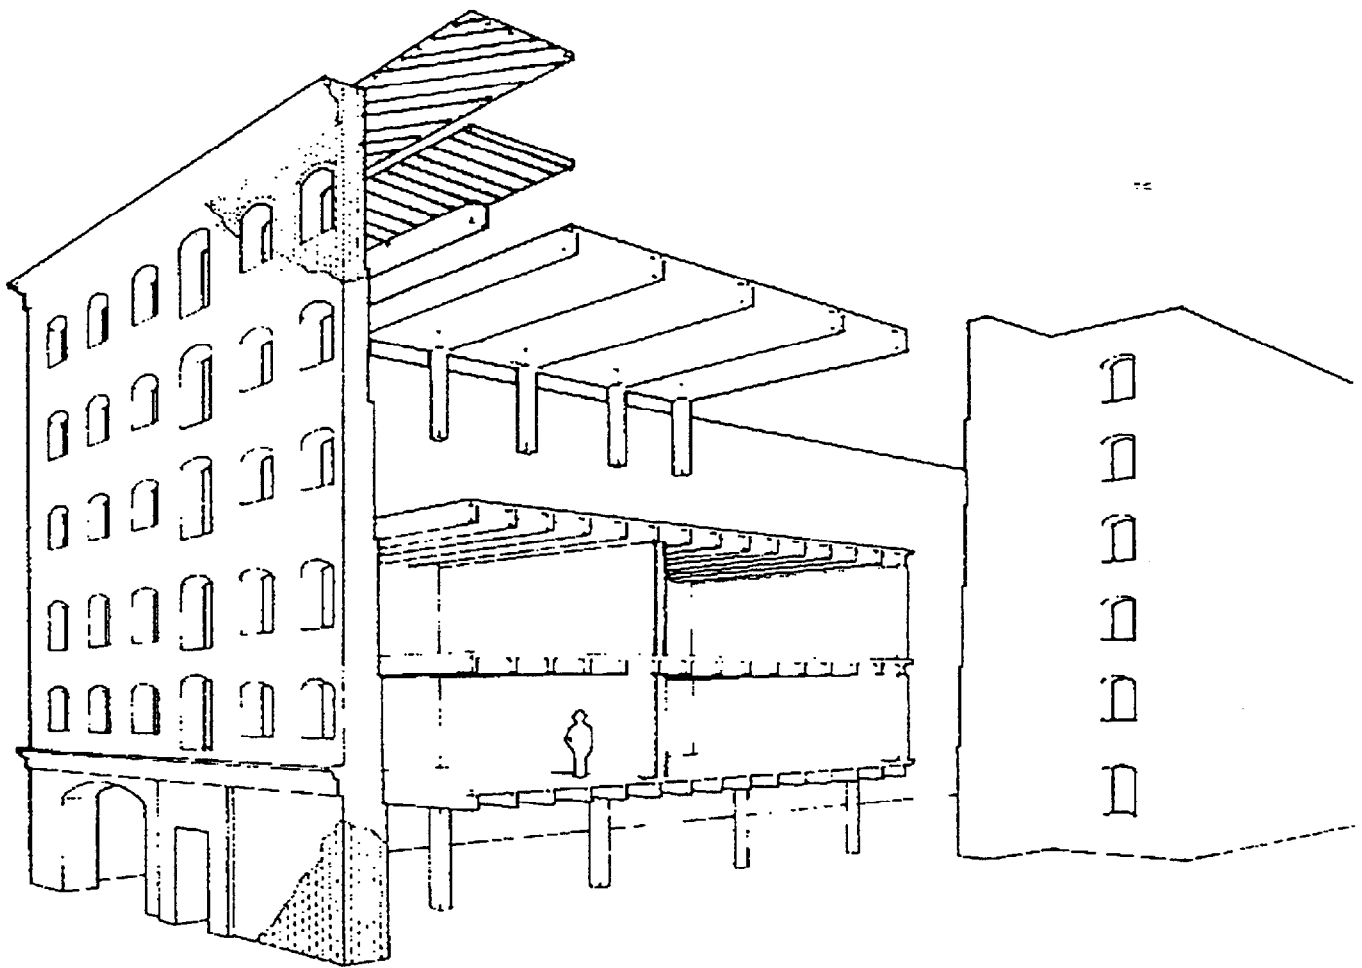
Typical Unreinforced Masonry Bearing Wall Building for which California-type Retrofit Schemes Developed

Typical roof/floor span system

Attached is a short questionnaire which I would like you to fill out at your convenience. The first page shows an isometric view and details of typical California UMB construction; the next shows the many variations of the prototypical URM building found in San Francisco. The two page questionnaire which follows solicits basic data on URM building types found in your local inventory which you consider to be exceptions to the typical URM building. Please return the questionnaire to me at the above address at your earliest convenience.

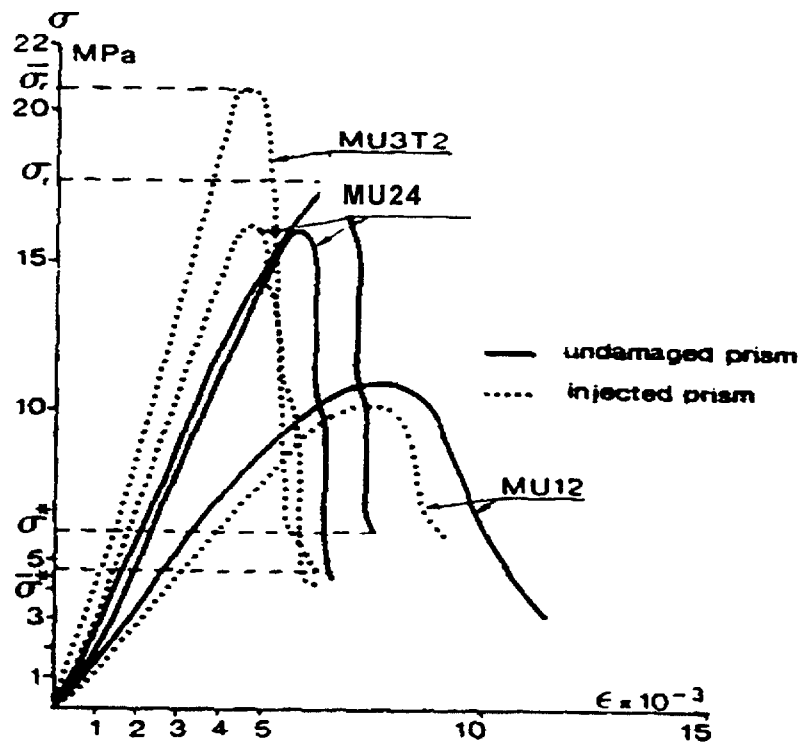
Figure 1: Measured Stress-Strain Curves for Test Prisms

A total of 25 test prisms were made with solid clay bricks and three types of mortar (M1, M2, M3). Prisms were nominally 25 x 52 x 60 cm. Some of the test prisms were subjected to crystallization to simulate decay. All of the prisms were tested in compression.

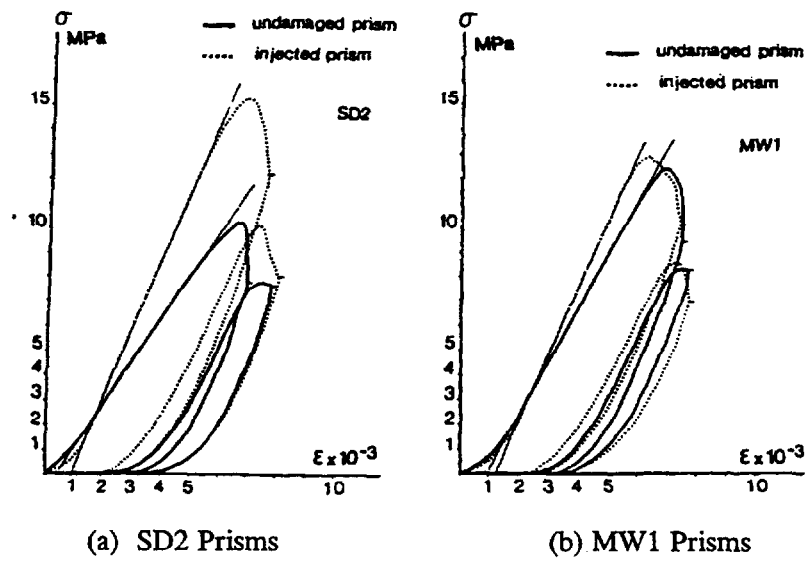
Figure 2: Typical Stress-Strain Curve for Type S Resin Injection

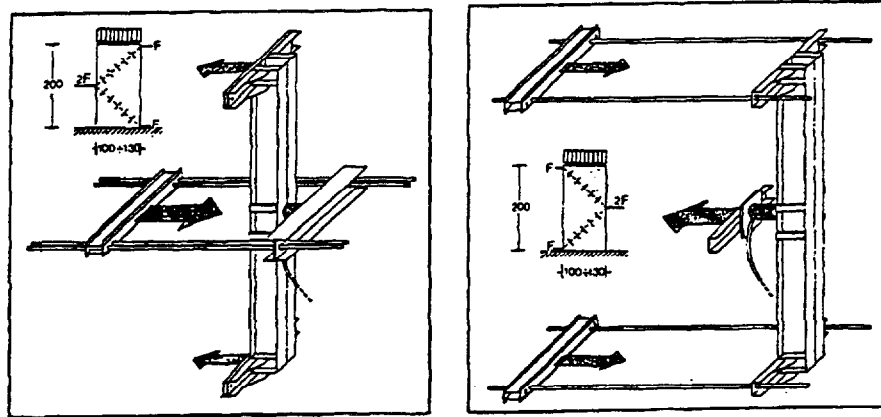
Figure 1 : Testing Apparatus for In-situ Shear Tests

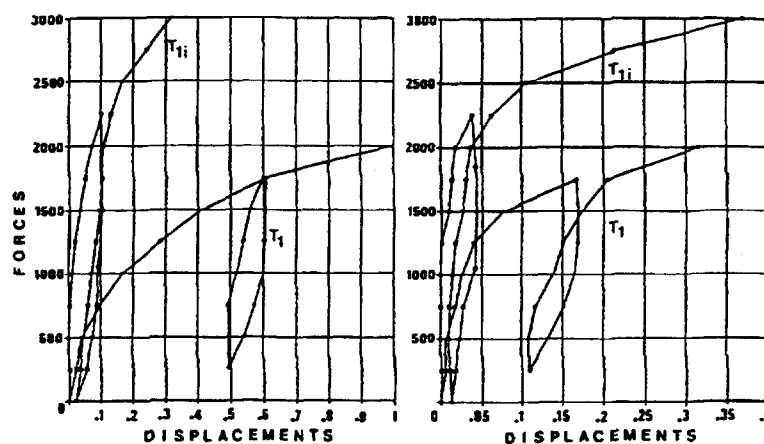
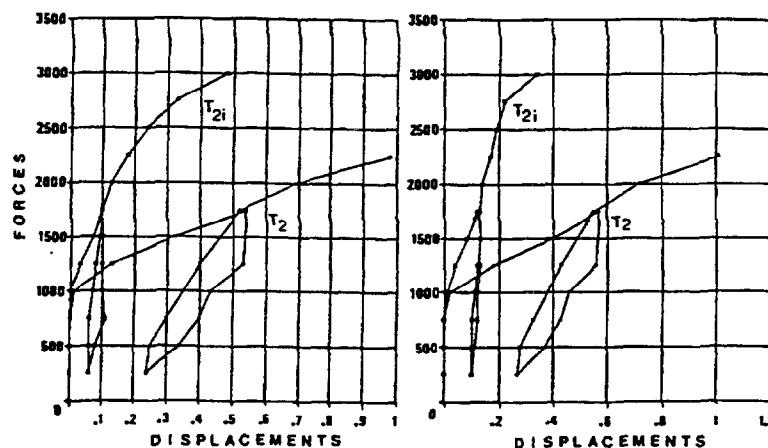
(a) Test Type 1: Transducers 3/8 (compression) and 4/7 (tension)

(b) Test Type 2: Transducers 3 (tension) and 4 (compression)

Figure 2: Sample Force-Deflection Curves from In-situ Shear Tests

The injection technique was effective for restoring, or improving, the original strength and stiffness of damaged walls.

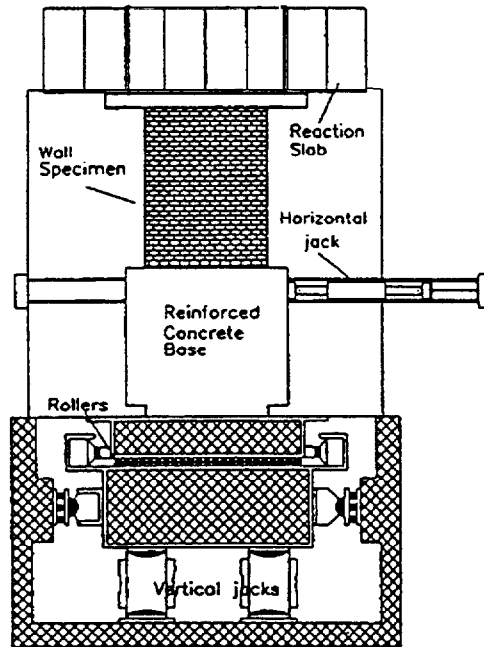
Figure 1: Testing Apparatus

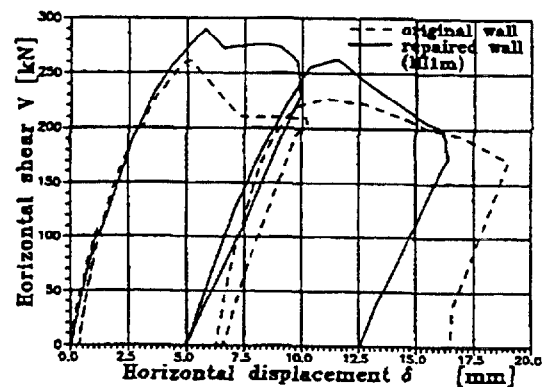
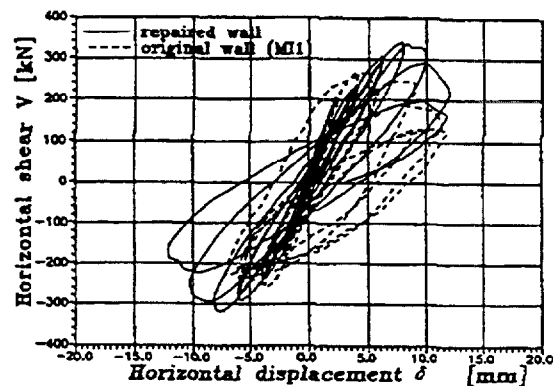
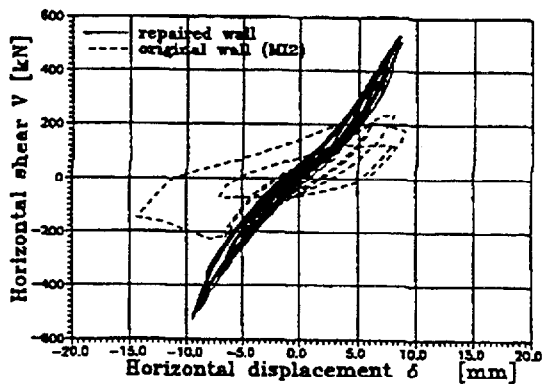
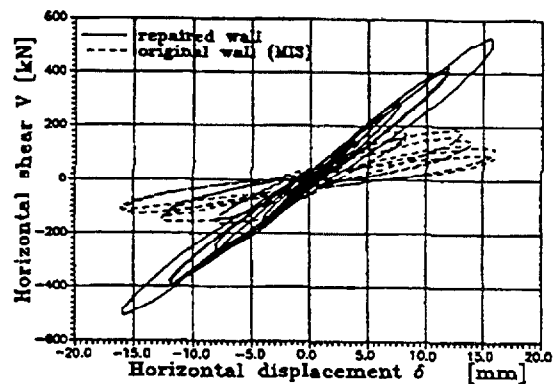
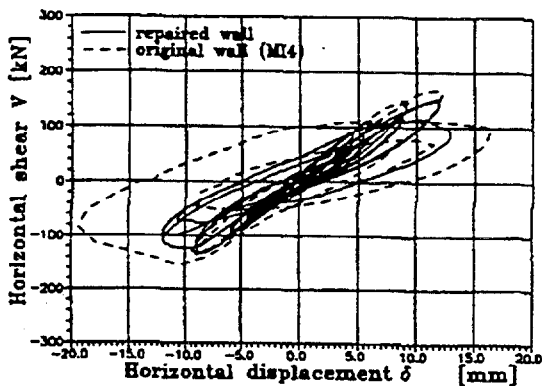
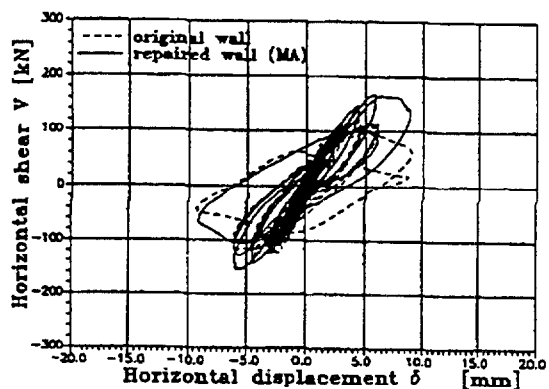
(a) Test Wall MI1m

(b) Test Wall MI1

(c) Test Wall MI2

(d) Test Wall MI3

(e) Test Wall MI4

(f) Test Wall MA

Figure 2: Measured Force-Deflection Curves

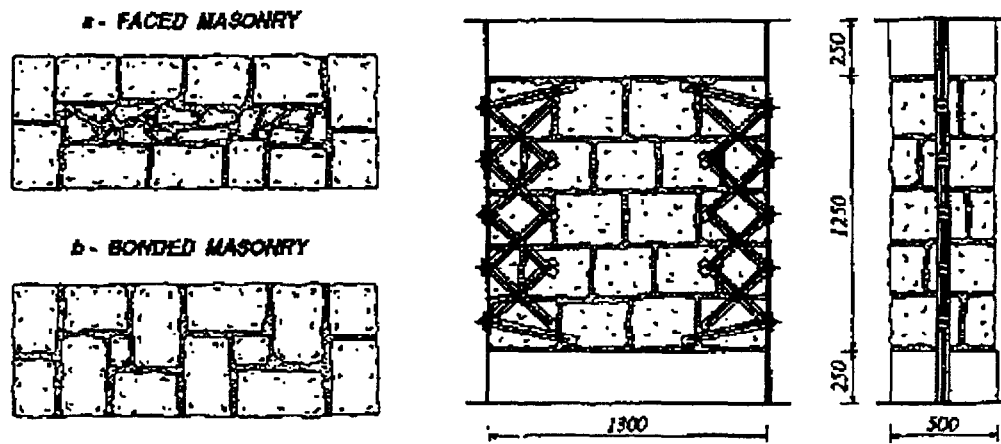
Figure 1: Masonry Types and Arrangement of Reinforcement

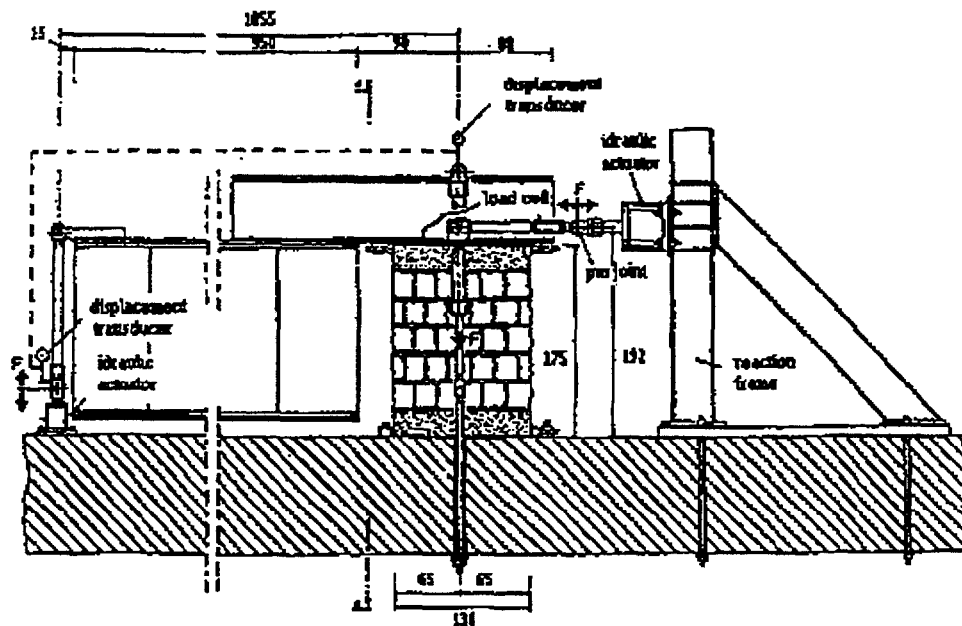
Figure 2: Testing Apparatus

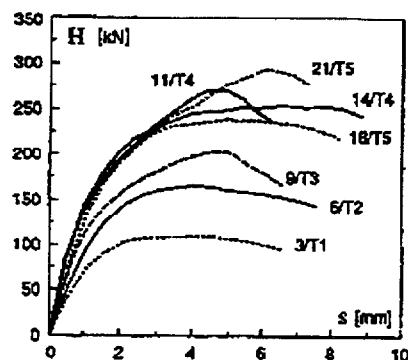
Figure 3: Measured Force-Deflection Relations for Test Walls

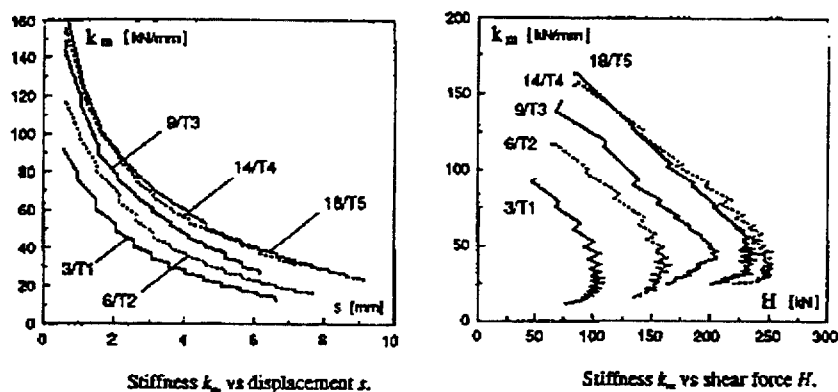
Figure 4: Lateral Stiffness of Test Walls vs. Displacement and Force

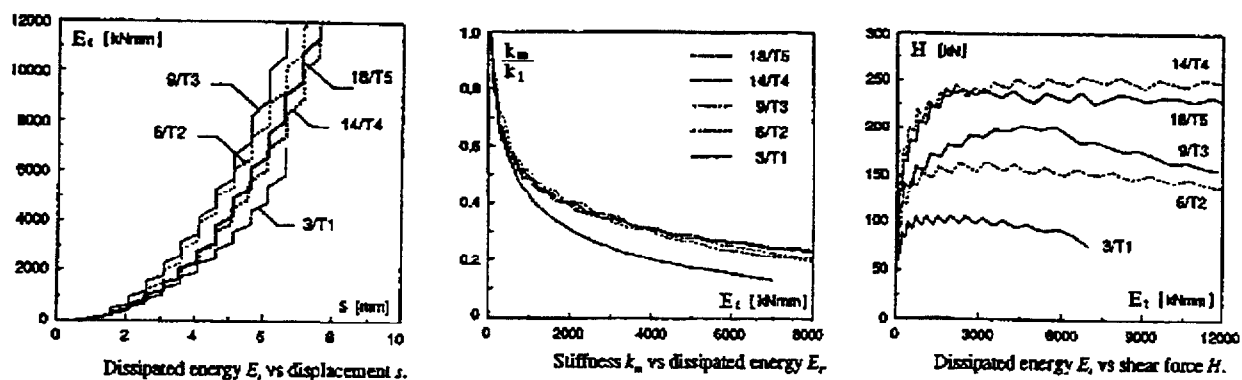
Figure 5: Dissipated Energy of Test Walls vs. Displacement, Stiffness and Force

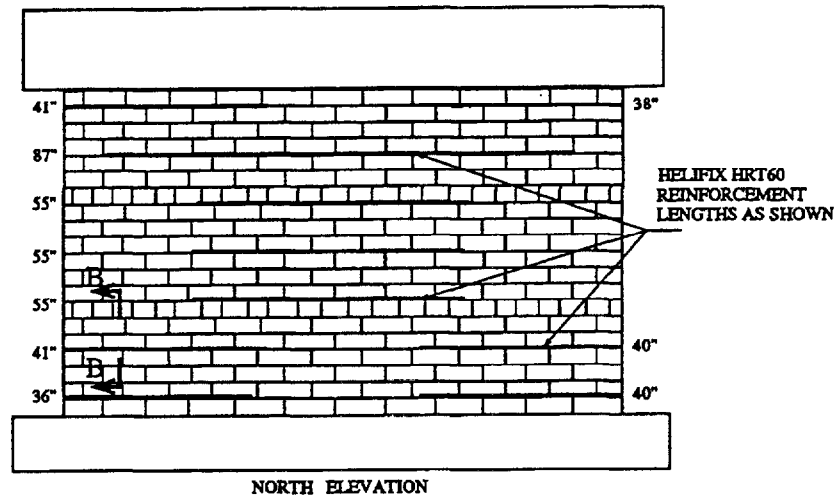
Figure 1: Placement of Horizontal Helifix Ties (Wall #3)

Measured force-deflection behavior of test wall #3 (Figure 5a) demonstrated the effectiveness of adding horizontal reinforcing ties in the bed joints. Comparison of behavior of wall #4 (Figure 5b) revealed that the added horizontal and vertical reinforcement suppressed the formation of diagonal tension cracks and base sliding. The reinforcement tended to keep the masonry intact and thus resulted in less inelastic action, less hysteretic energy dissipation and less damage.
