NIST GCR 97-724-2

APPENDICES: Development of Procedures to Enhance the Performance of Rehabilitated URM Buildings

Bret Lizundia, William T. Holmes, Margaret Longstreth, and Alan Kren
Rutherford & Chekene
303 Second Street, Suite 800 North
San Francisco, California 94107

APPENDIX A

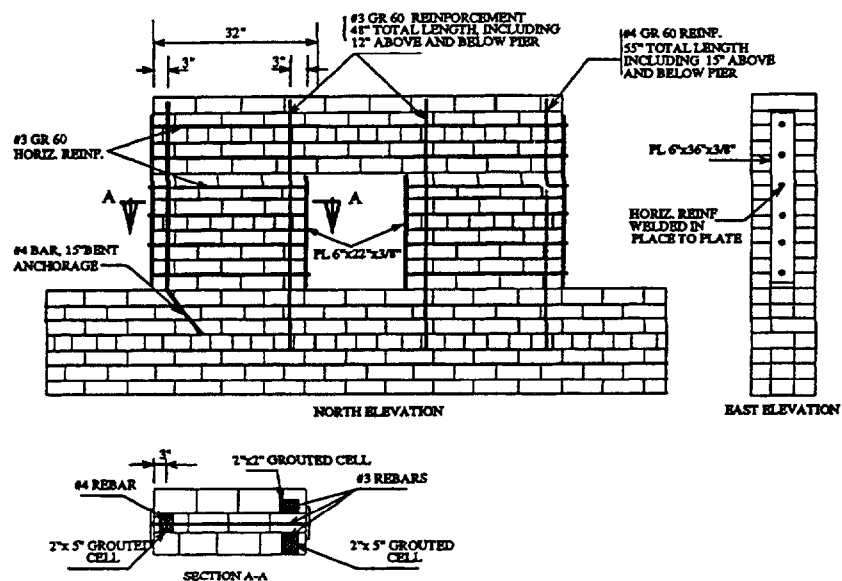
Figure 2: Placement of Horizontal and Vertical Reinforcement (Wall #4)

Measured force-deflection behavior of test wall #3 (Figure 5a) demonstrated the effectiveness of adding horizontal reinforcing ties in the bed joints. Comparison of behavior of wall #4 (Figure 5b) revealed that the added horizontal and vertical reinforcement suppressed the formation of diagonal tension cracks and base sliding. The reinforcement tended to keep the masonry intact and thus resulted in less inelastic action, less hysteretic energy dissipation and less damage.

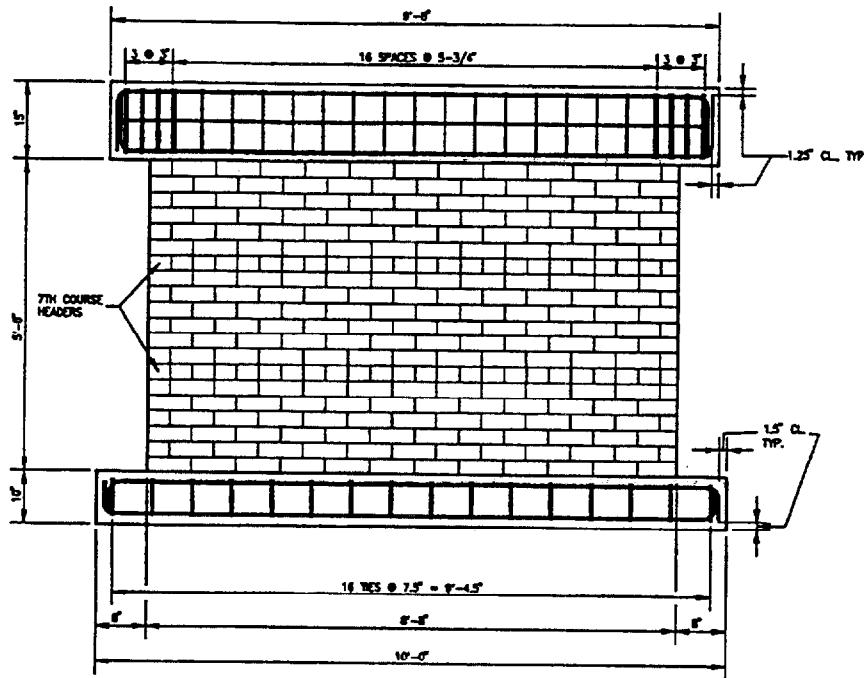
Figure 3: Description of Test Walls #1 - #3

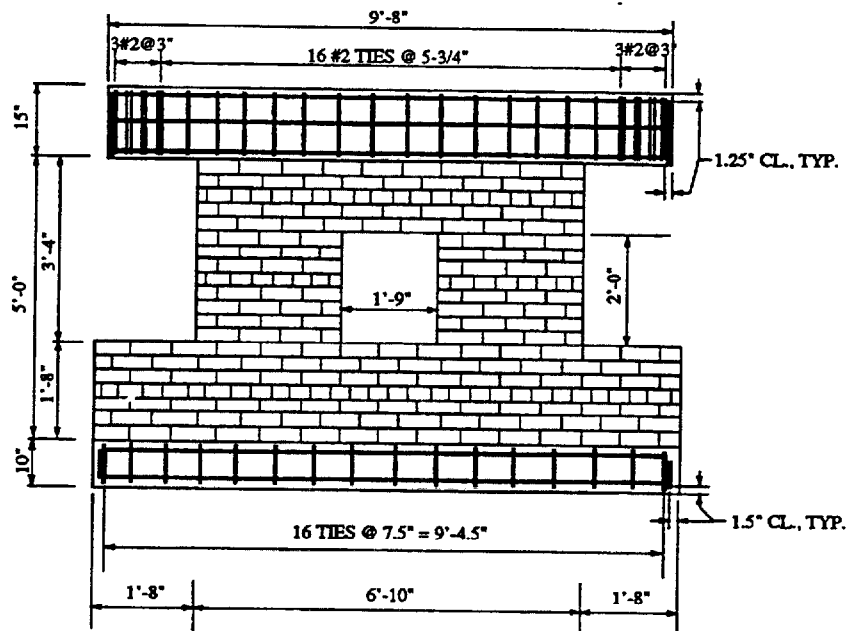
Figure 4: Description of Test Wall #4

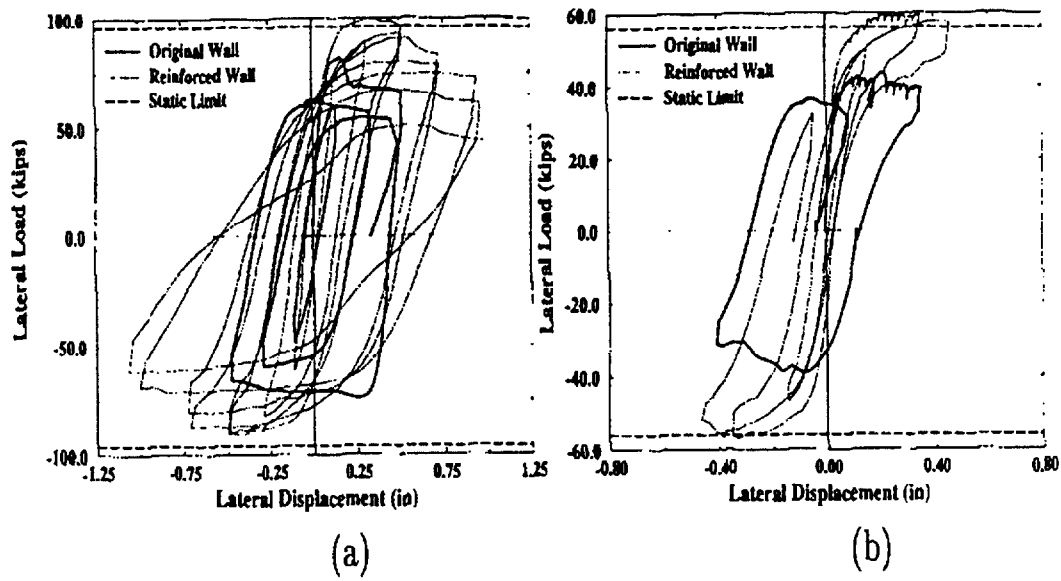
Figure 5: Measured Force-Deflection Relations for Walls #3 and #4

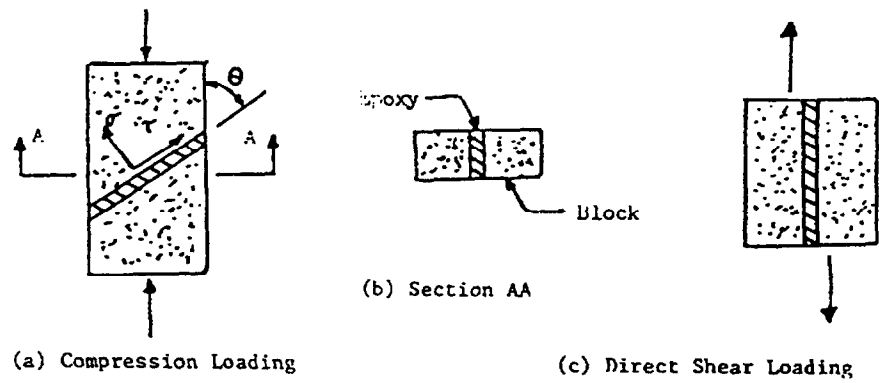
Figure 1: Control Block Rib Specimens

Block test specimens (10 cm x 15 cm) were saw cut from standard 6 in. concrete masonry units. Grout specimens (15 cm x 25 cm x 10 cm) were constructed to approximate the cross sectional area of the cavity of the 6 in. standard block. Cracked grout specimens were immediately repaired with epoxy.

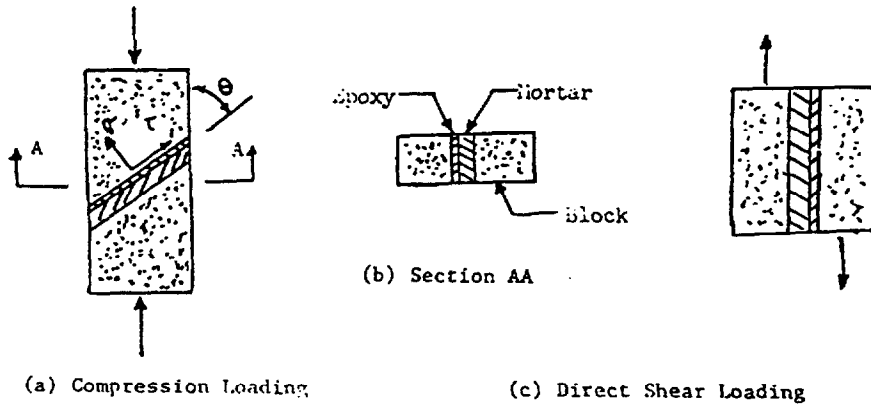
Figure 2: Masonry Epoxy Joint Specimens

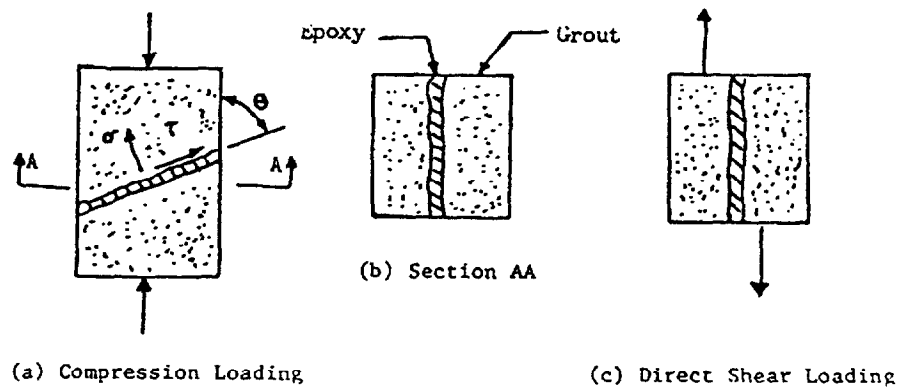
Figure 3: Epoxy Joined Grout Specimens

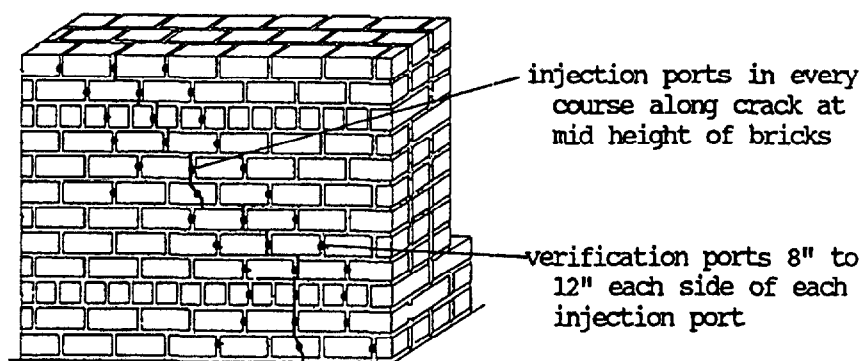
Figure 1: Pattern of Injection and Verification Ports

Before injection, loose mortar and mortar easily debonded are removed from the open joint. The crack is then cleaned by flushing with water, and filled with mortar to a depth of about 1/2 inch. The mortar is tooled to match the adjacent joints. Bricks that can be removed by hand are removed from the wall and reset in new mortar. Then, holes for injection and for verification of flow are drilled into and adjacent to the crack (see Figure 1). The holes are drilled from one side of the wall to the depth of the near face of the far wythe. The crack and holes are flushed with water to clean and saturate the wall. Each injection hole and verification hole are flushed until water runs clean from adjacent holes. Flushing is repeated.

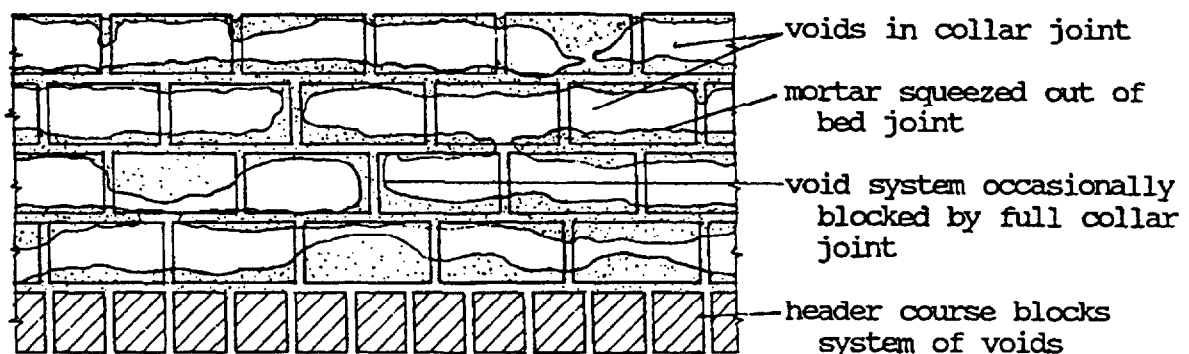
Figure 2: Condition of Mortar in Collar Joint

The injection process forces fluid grout into the crack and into the interconnected system of voids in the collar (Figure 2) and head joints. Generally, the voids in the collar and head joints allow grout to flow well beyond the crack and to make contact with the adjacent bricks. The hardened

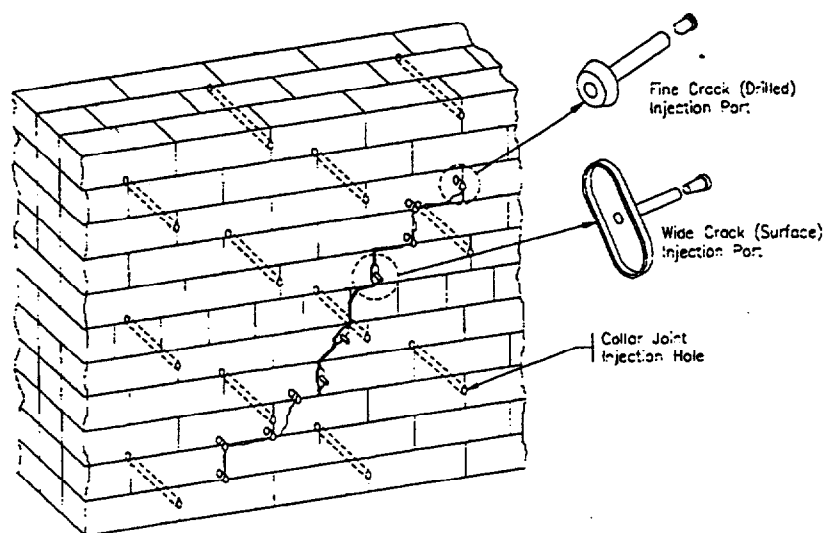
Figure 1: Placement of Grout through Ports

Grout is injected into fine cracks through either drilled injection ports or surface mounts. The spacing and placement of these ports is dependent on the width and roughness of the crack as noted in Figure 1. For cracks less than 1 mm wide, drilled ports are recommended. For cracks larger than 1 mm wide, surface mounted ports placed over the crack are recommended. For injection of collar joints, ports are inserted into a drilled hole and sealed with silicone or epoxy.

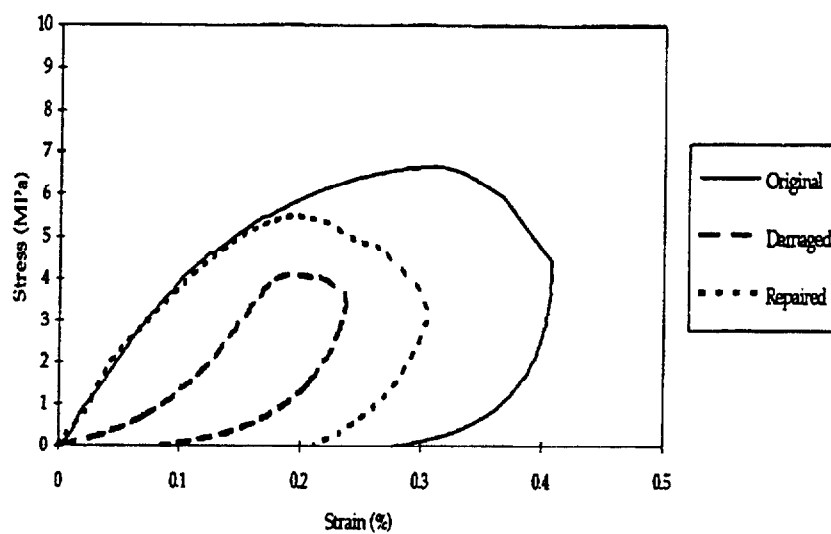
Figure 2: Compressive Stress-Strain Relation for Plain and Grouted Piers

Each pier was loaded to failure in compression to determine its compressive characteristics. After load removal, test piers were reloaded to determine the

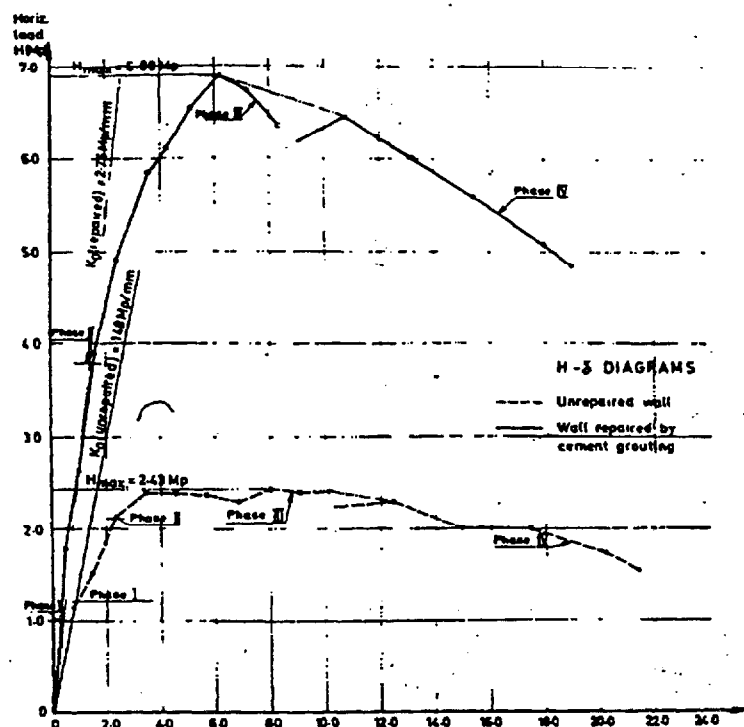
Figure 1: Typical Force-Deflection Curves for Plain and Grouted Stone Walls

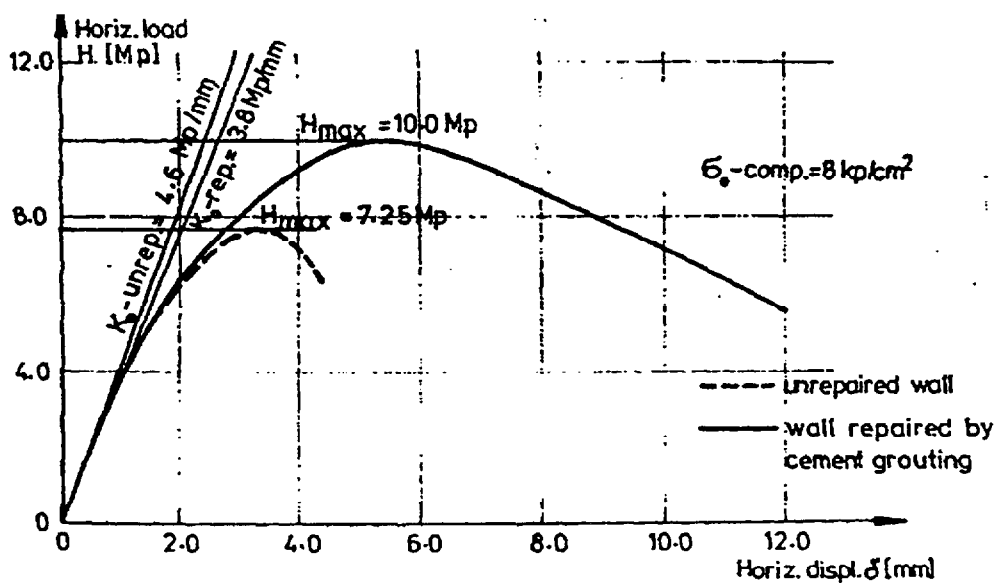
Figure 2: Typical Force-Deflection Curve for Plain and Grouted Brick Walls

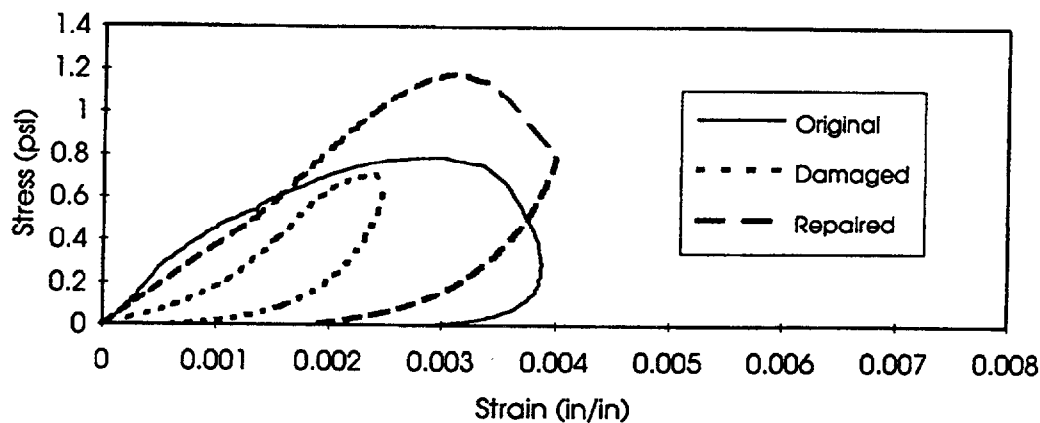
Figure 1: Compressive Stress-Strain Behavior of a Pier

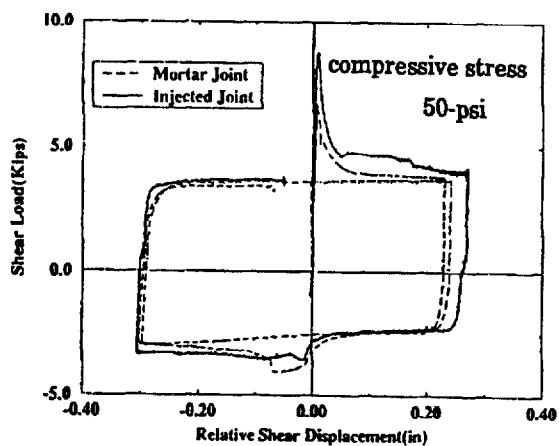
Figure 2: Measured Shear Force-Deflection Relations

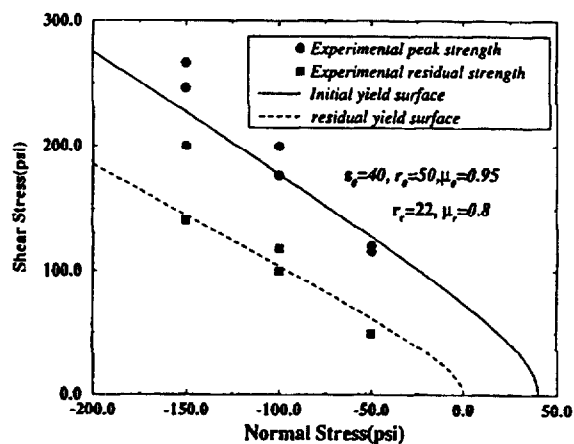
Figure 3: Shear Stress vs. Normal Stress

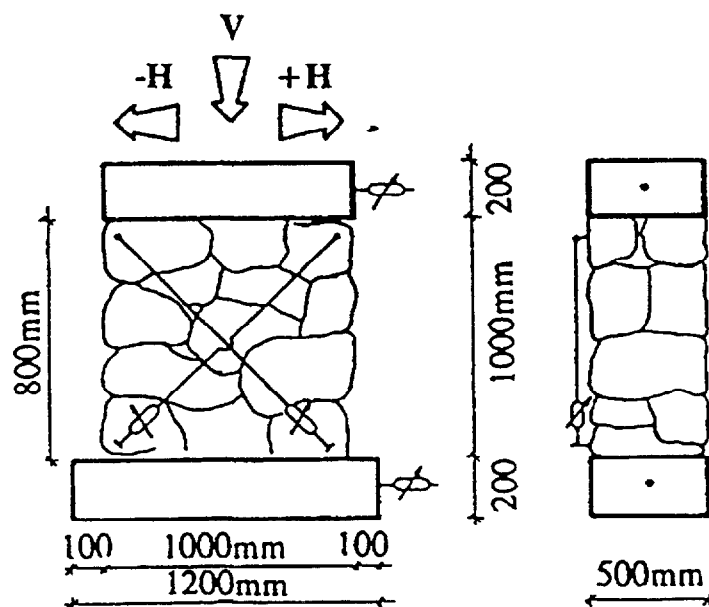
Figure 1: Description of Stone Masonry Pier Specimen

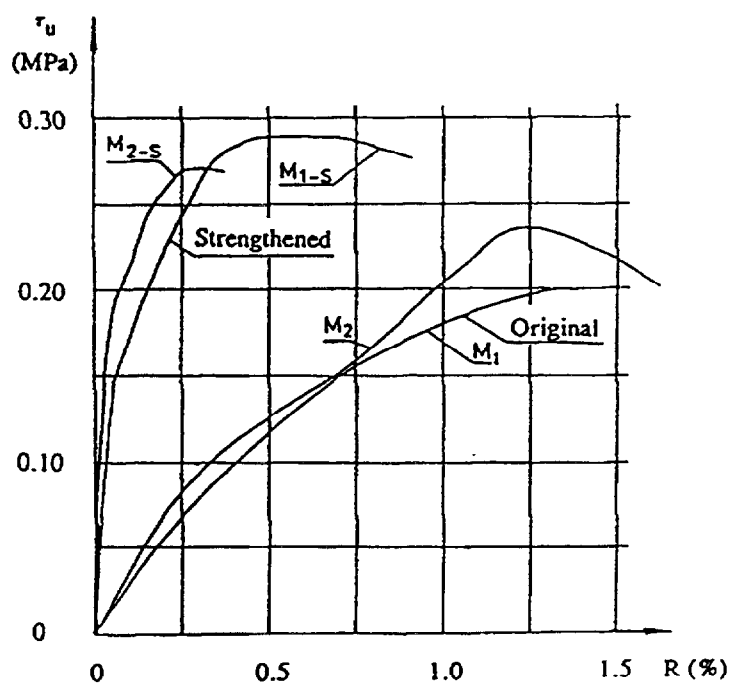
Figure 2: Measured Shear-Deflection Curves for Grouted and Plain Walls

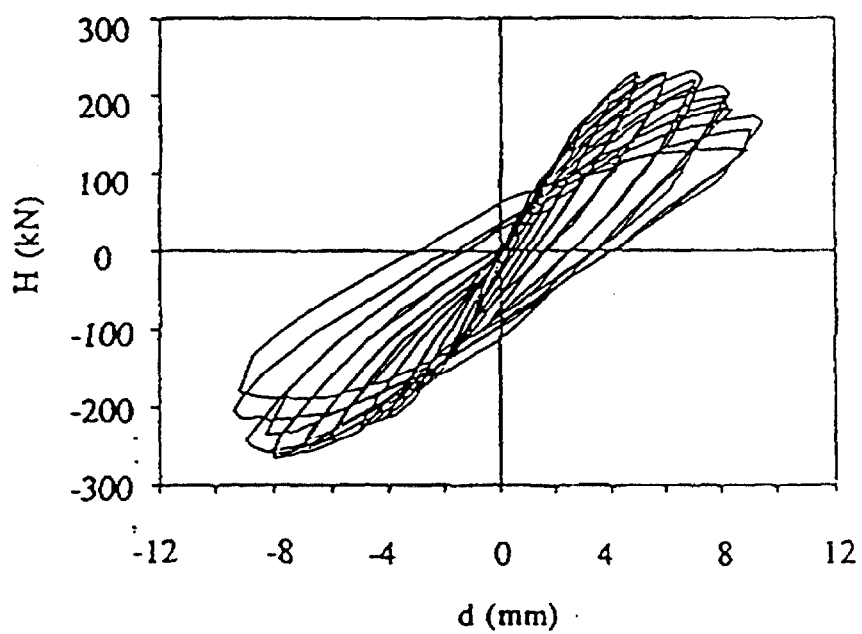
Figure 3: Typical Shear-Deflection Curve for Grouted Pier

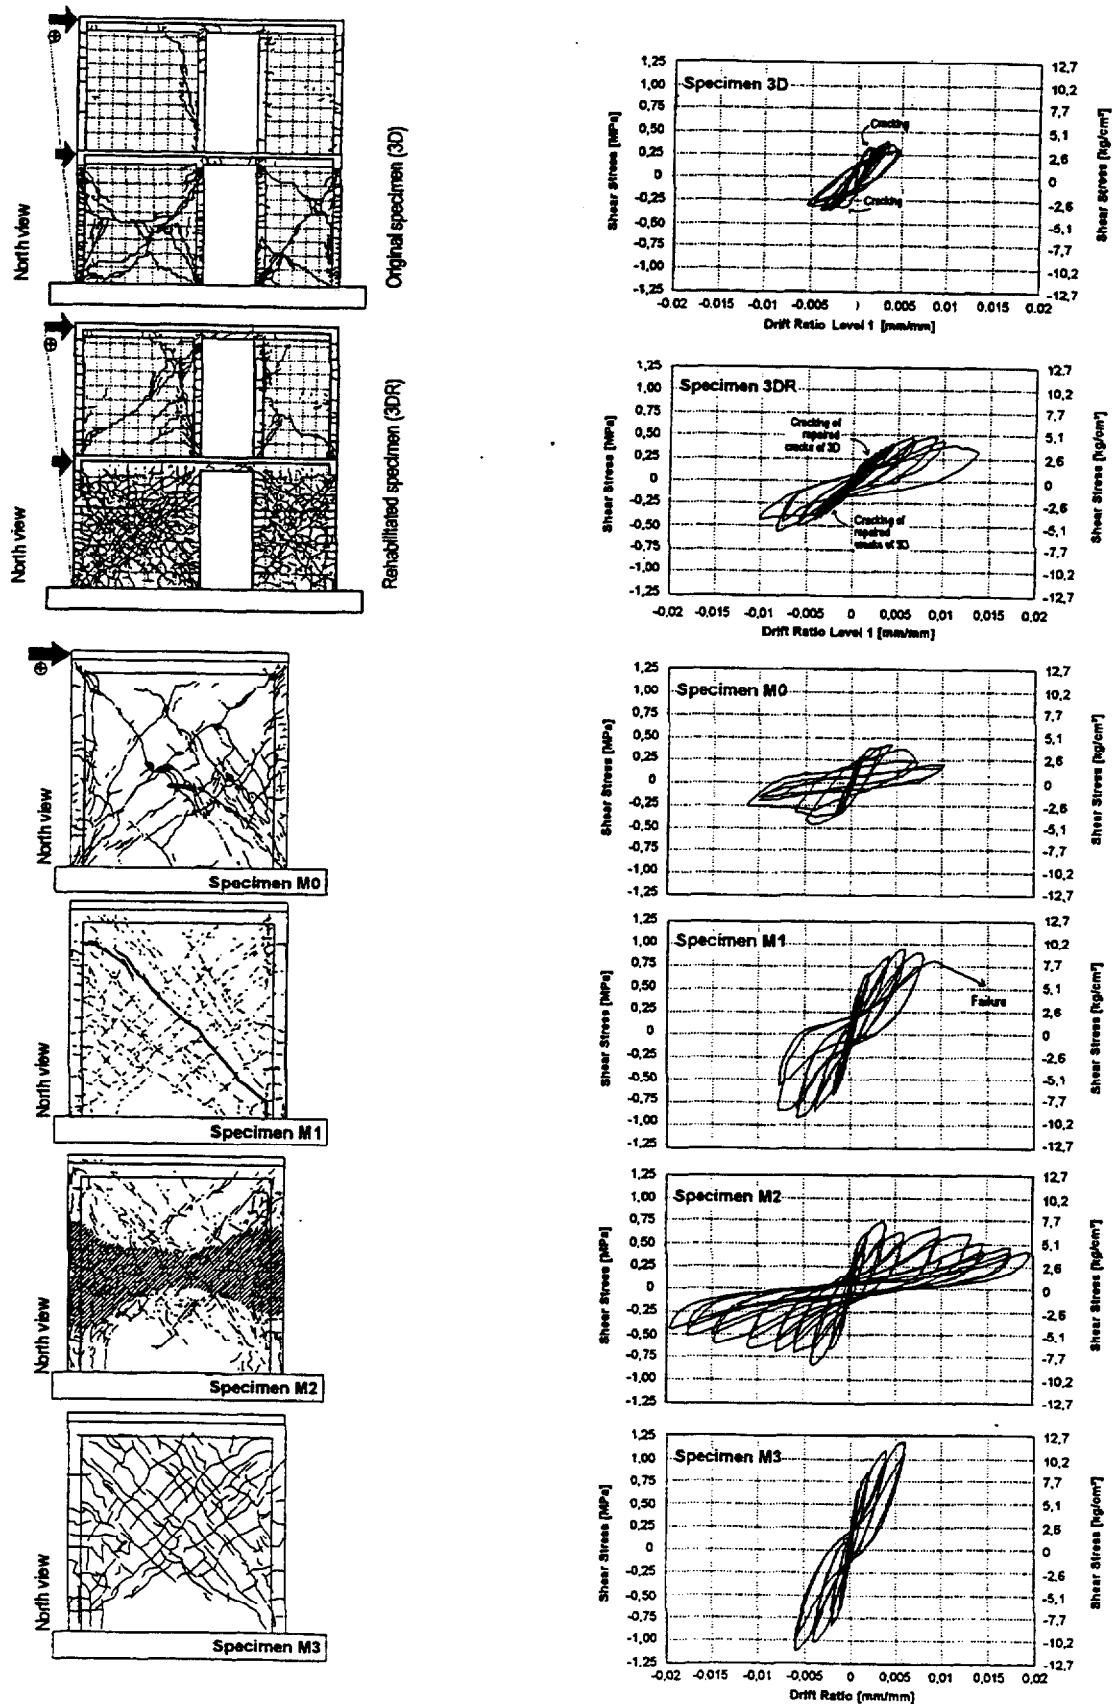
Figure 1: Final Crack Patterns and Force-Deflection Curves for Test Walls

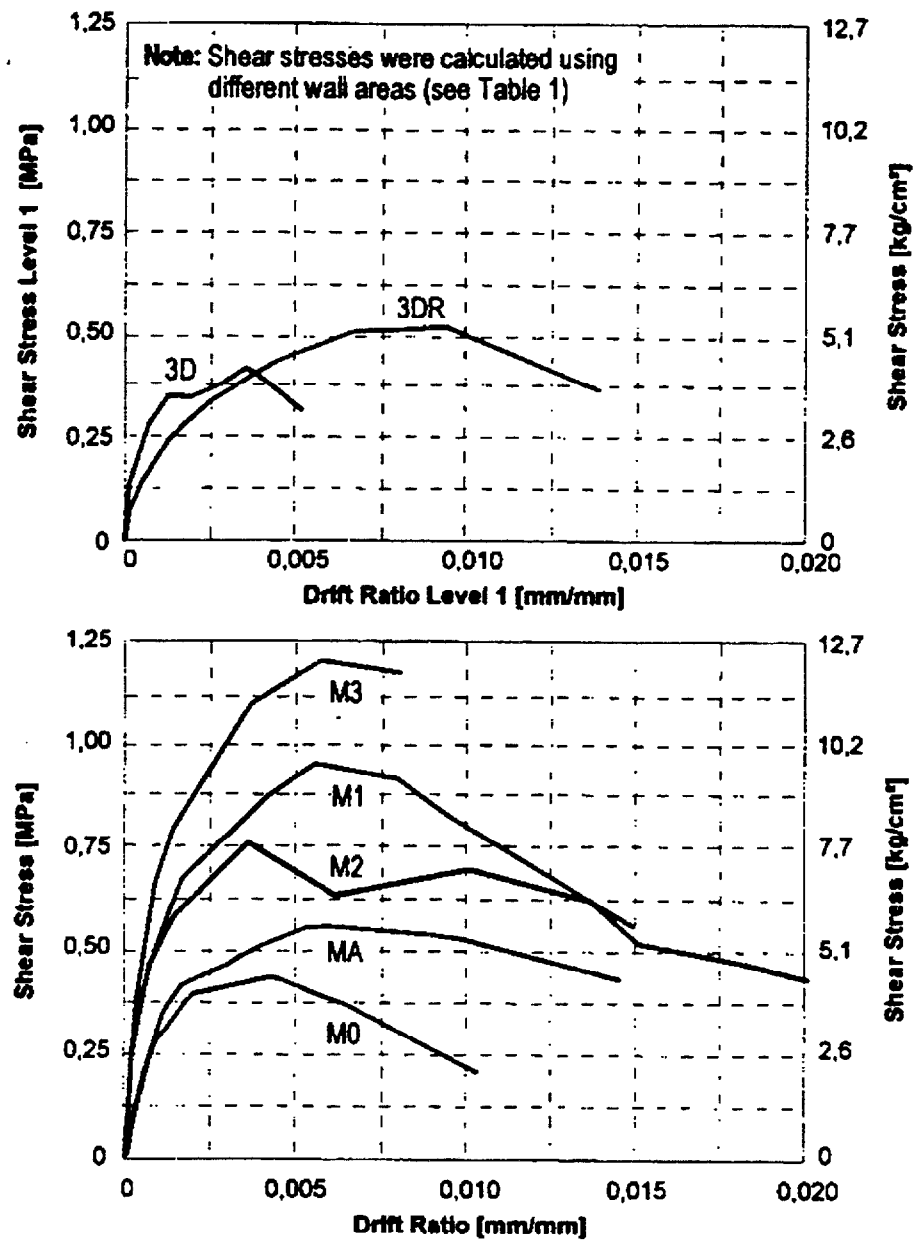
Figure 2: Measured Force-Deflection Envelope Curves

The influence of the rehabilitation procedure on stiffness, strength and deformation capacity is illustrated in Figure 2 where envelopes of measured shear stress vs. drift ratio are presented. The lowest maximum drift for the rehabilitated walls was 0.7%.

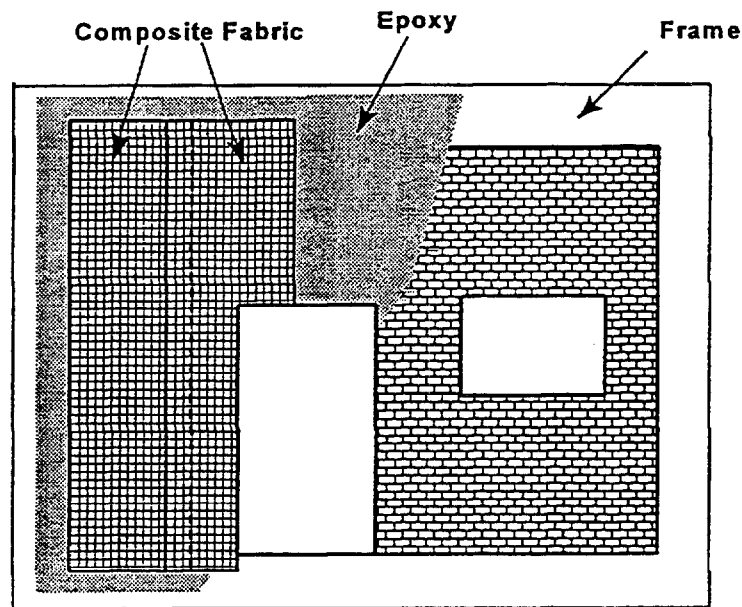
Figure 1: Application of Composite Fabric System

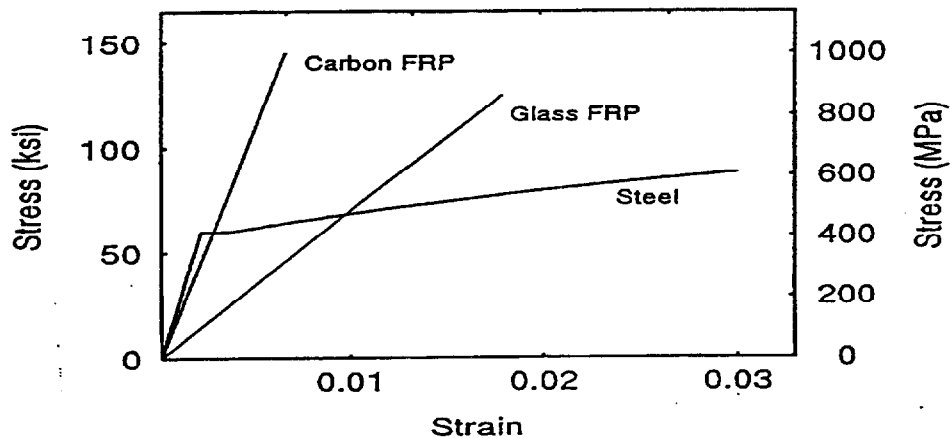
Figure 2: Typical Stress-Strain Curves for Fiber Composites

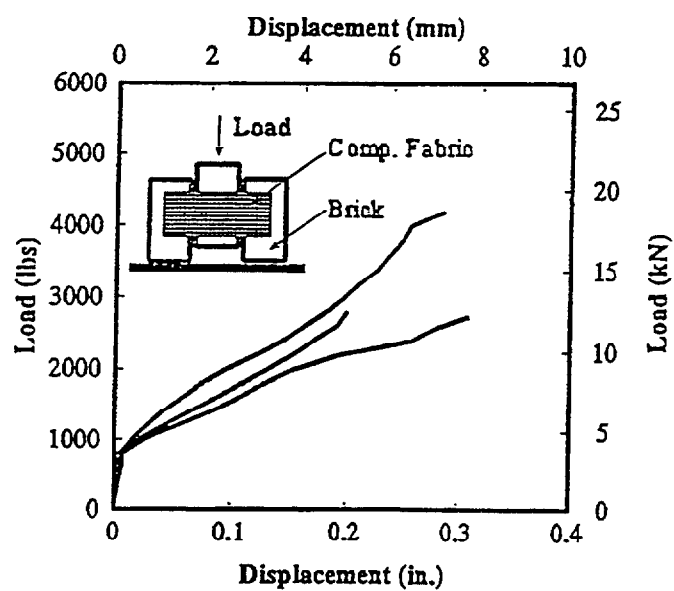
Figure 3: Load-Deflection Curves for Shear Tests

and failed in a ductile manner. Force-deflection curves for specimens tested in shear are shown in Figure 3.

The mode of failure was governed by the strength of the fabric. Lighter fabrics failed in tension while heavier fabrics were able to maintain the integrity of the specimen until the masonry units reached their capacities.

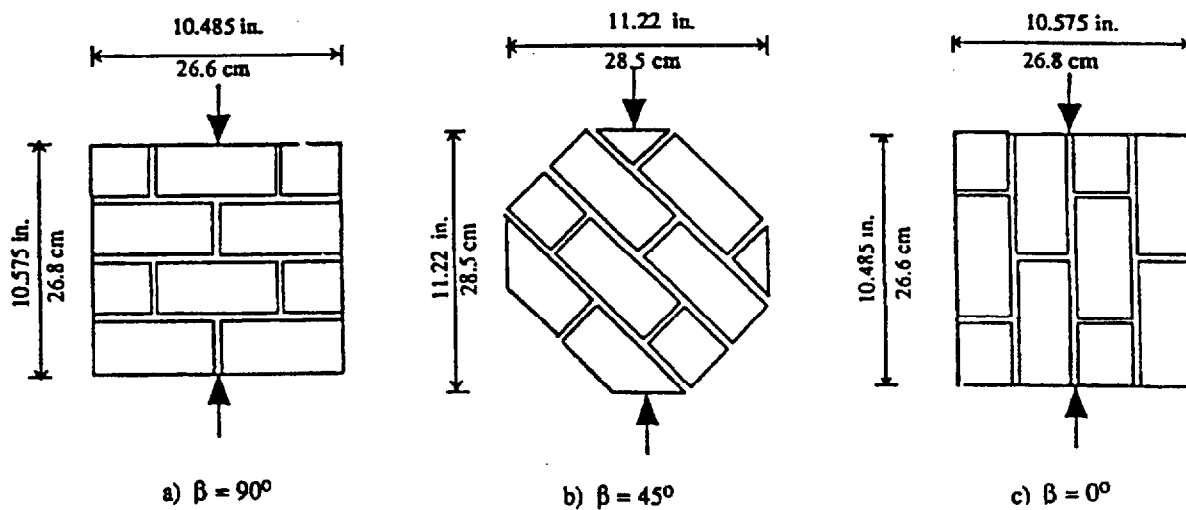
Figure 1: Description of Test Panels

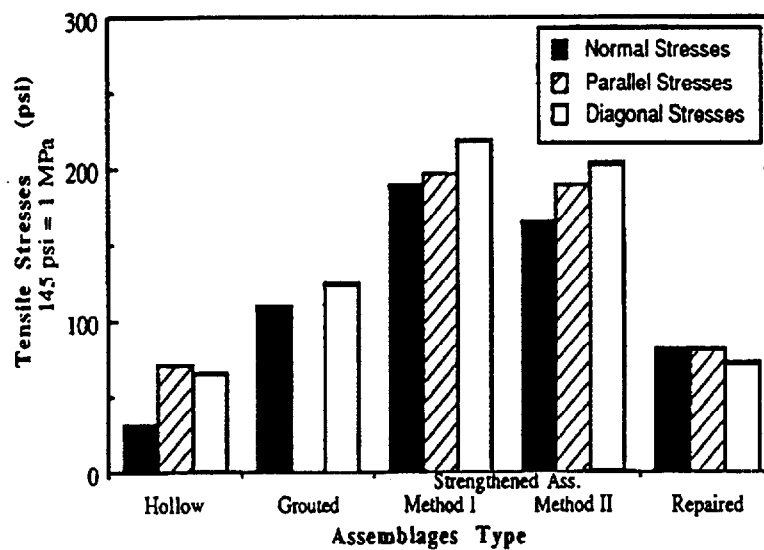
Figure 2: Tensile Strengths for Test Panels

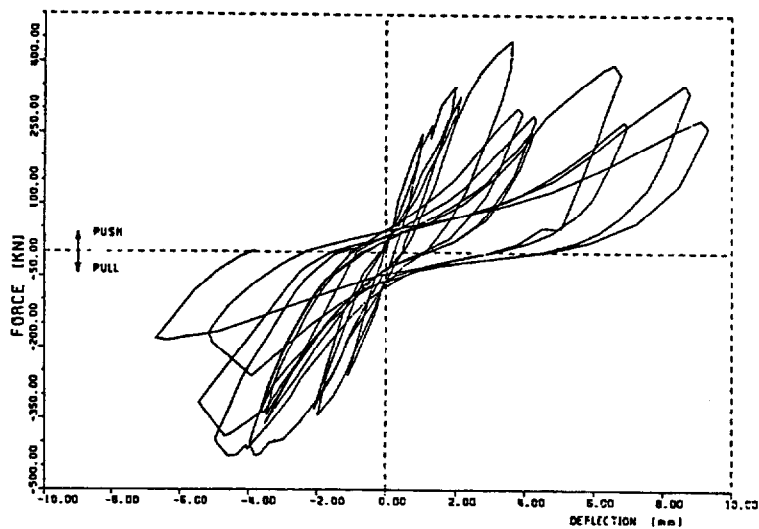
Figure 2: Measured Force-Deflection Behavior of GRC Coated Wall

A sample force-deflection hysteresis curve is shown in Figure 2 for the GRC coated wall. The initial stiffness of the wall reduced with cracking. Disjointed diagonal cracks were observed in the coating material. A significant loss of strength was observed at an 8-mm deflection as a result of the sudden development of a major diagonal crack.

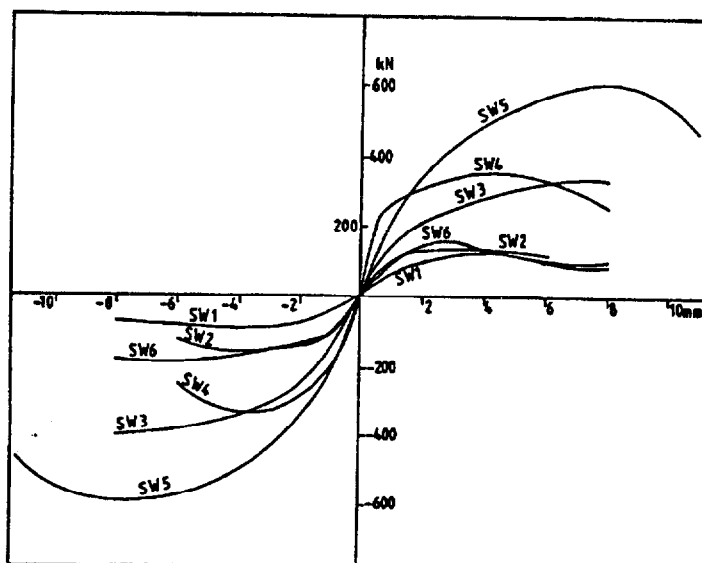
Figure 3 : Envelope Force-Deflection Curves for Test Walls

Lateral force-deflection behavior for the series of six test walls is presented in Figure 3. The prestressed walls (SW1 and SW2) did not perform as expected because sliding was not restrained. From these tests

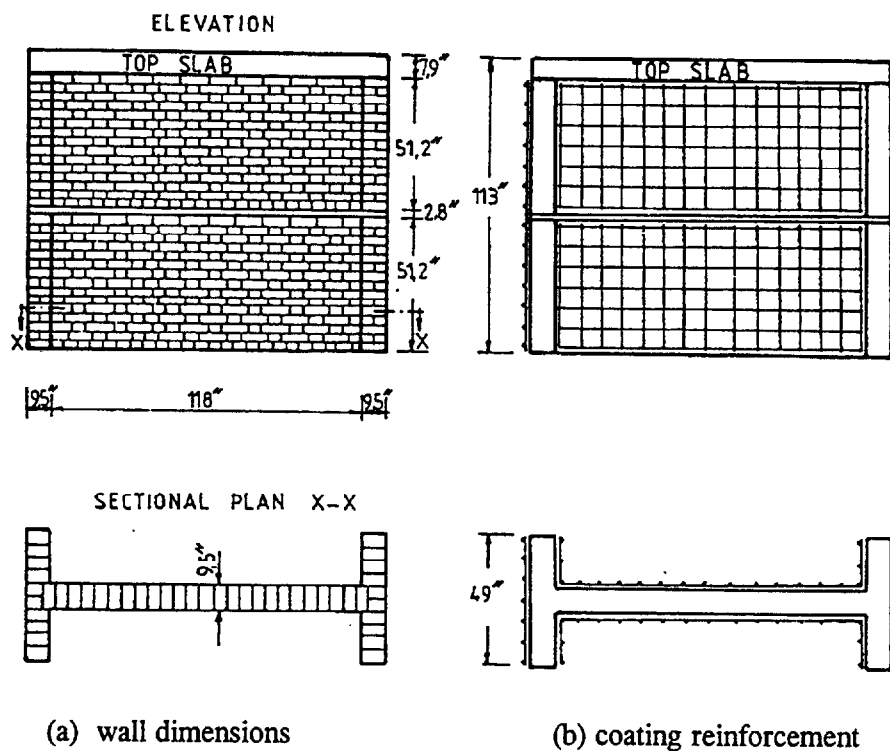
Figure 1: Description of Test Walls

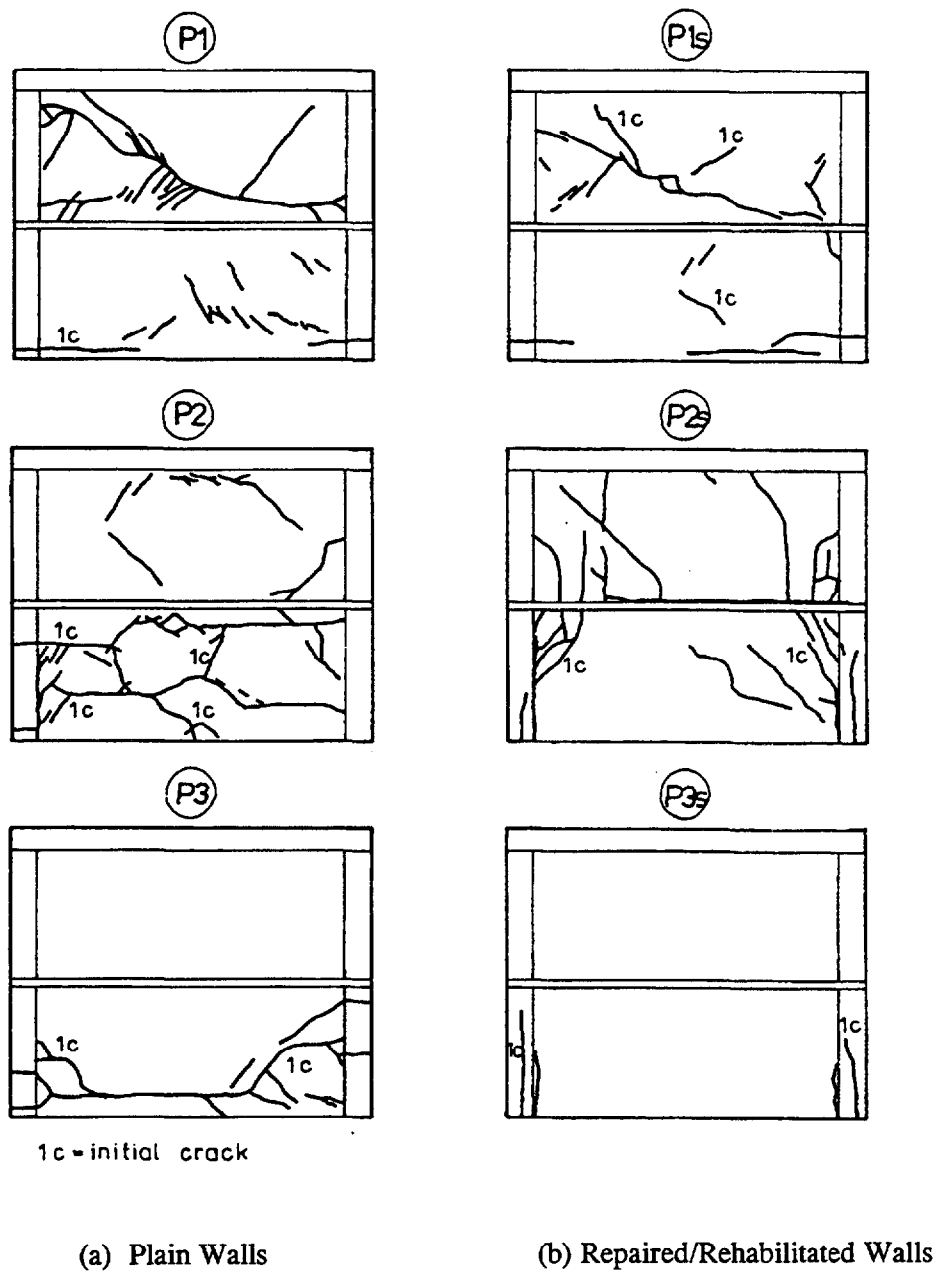
Figure 2: Cracking Patterns for Test Walls

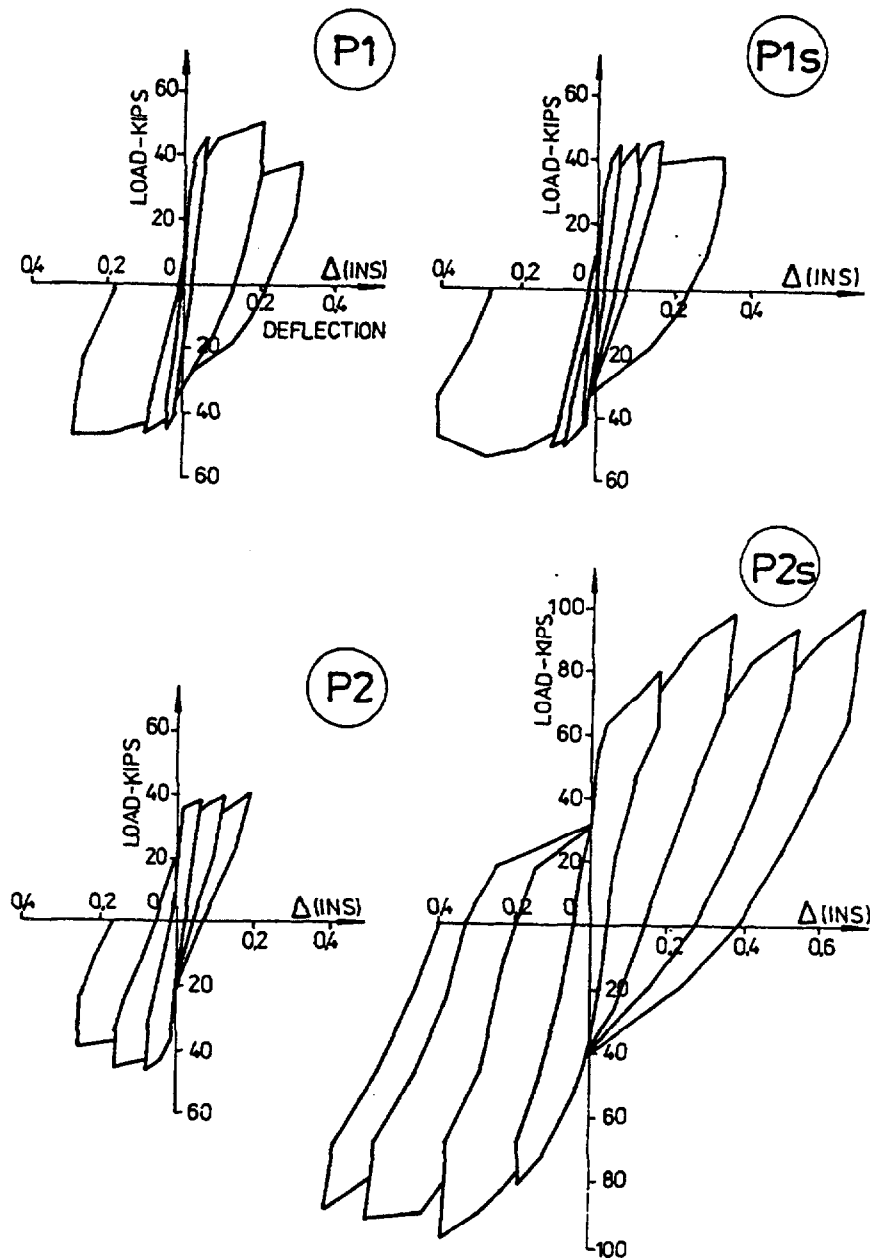
Figure 3: Measured Force-Deflection Curves for Test Walls

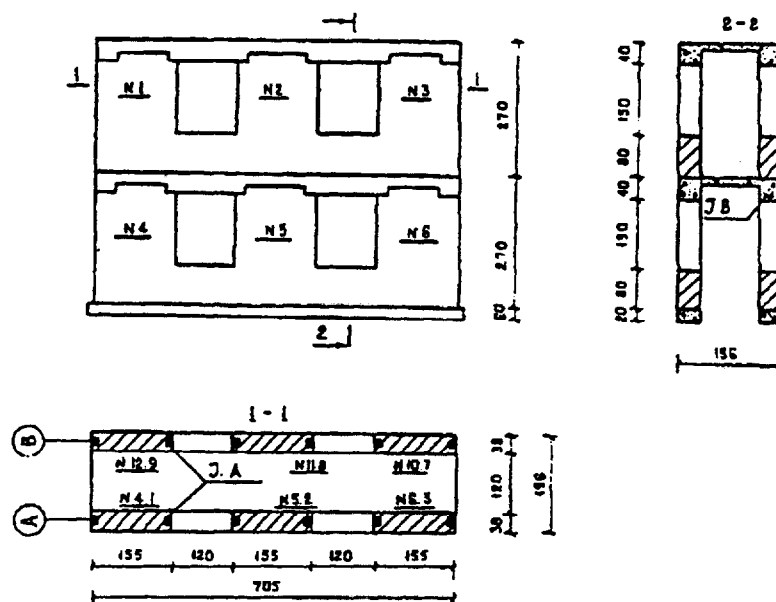
Figure 1: Description of Test Structure

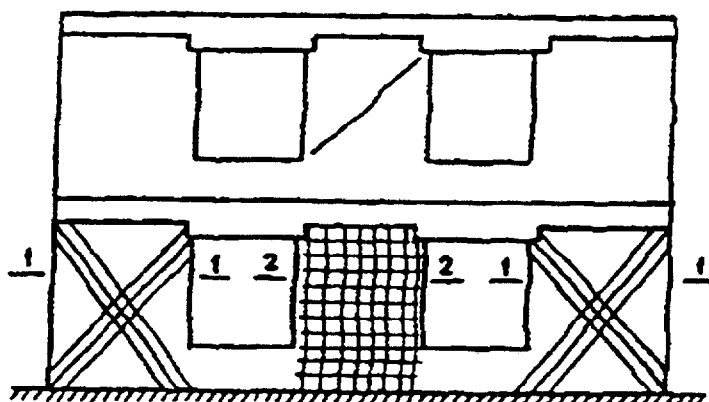
Figure 2: Reinforcing of Repaired Piers

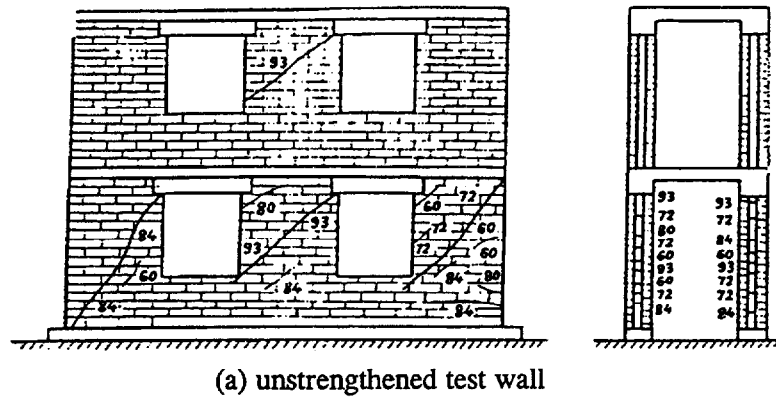
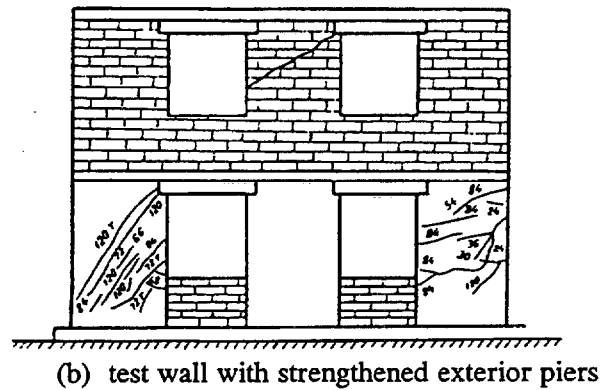
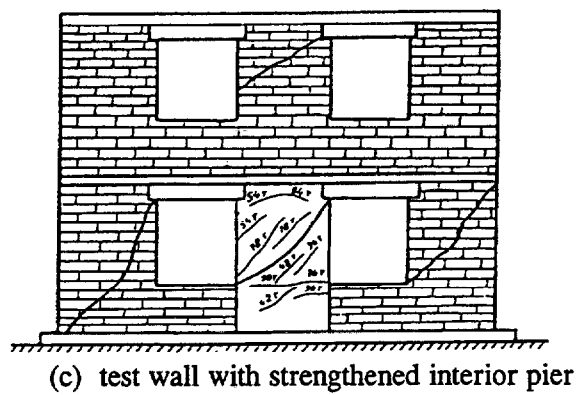
Figure 3: Observed Crack Patterns

Observed cracking patterns for the test walls are depicted in Figure 3. For the unstrengthened wall, cracking was initiated at approximately two-thirds of the peak lateral force. Cracks continued to propagate along the diagonals of the piers until a peak force of 910 kN was reached.

After strengthening the exterior piers, the lateral force capacity was increased to 1175 kN. Small cracks in the exterior piers were detected at approximately a third of this value. The force capacity of the test walls with the interior piers strengthened were 2.9 times the capacity of the unstrengthened wall.

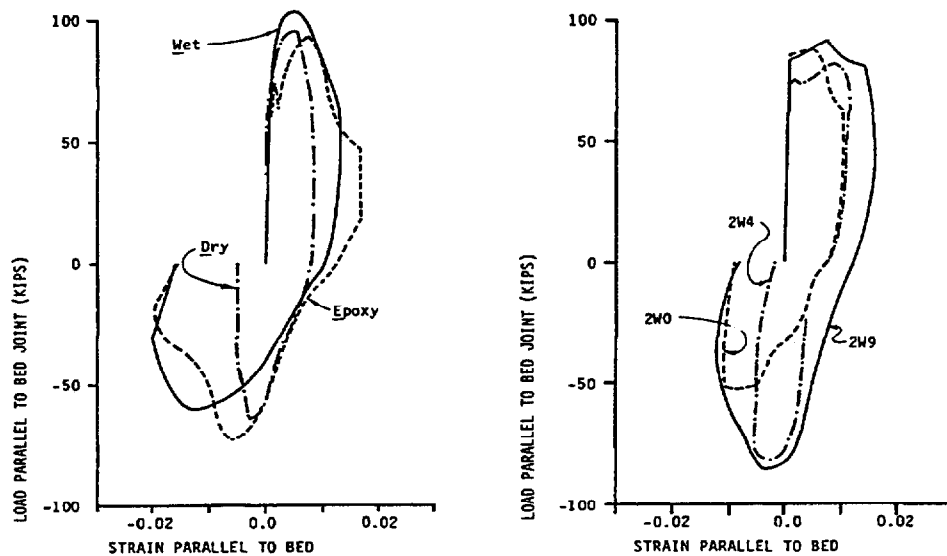
Figure 1: Measured Force-Strain Behavior of Shotcrete Panels

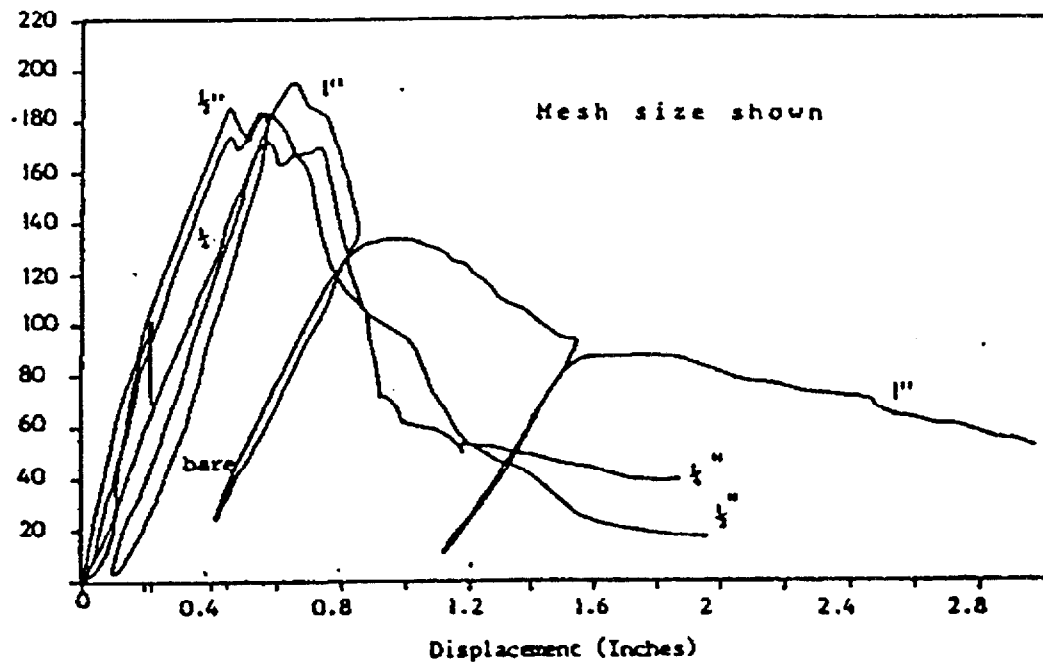
Figure 1: Load vs. Vertical Deformation from Diagonal Split Test

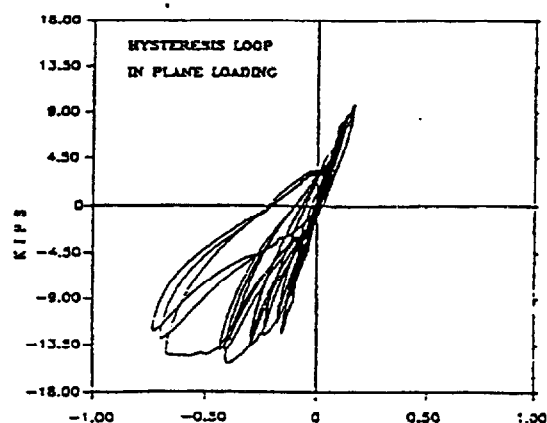
(a) Plain Wall

(b) Coated Wall

Figure 3: Measured In-Plane Behavior

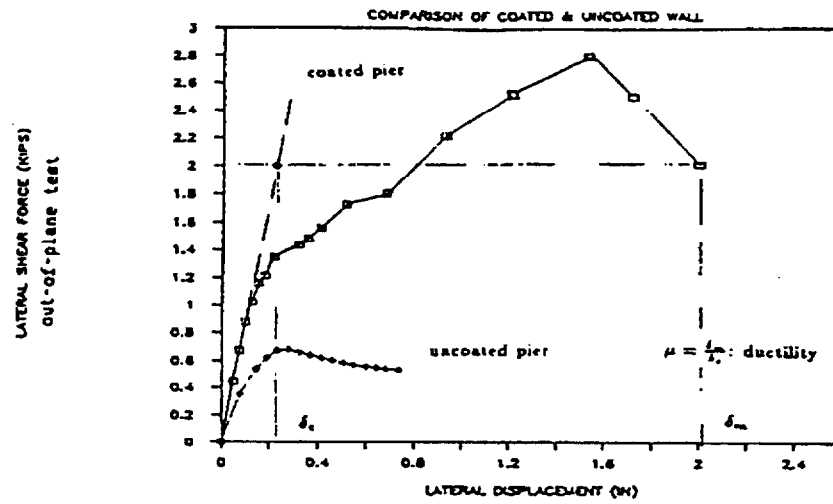
Figure 4: Out-of-Plane Behavior for Coated and Plain Walls

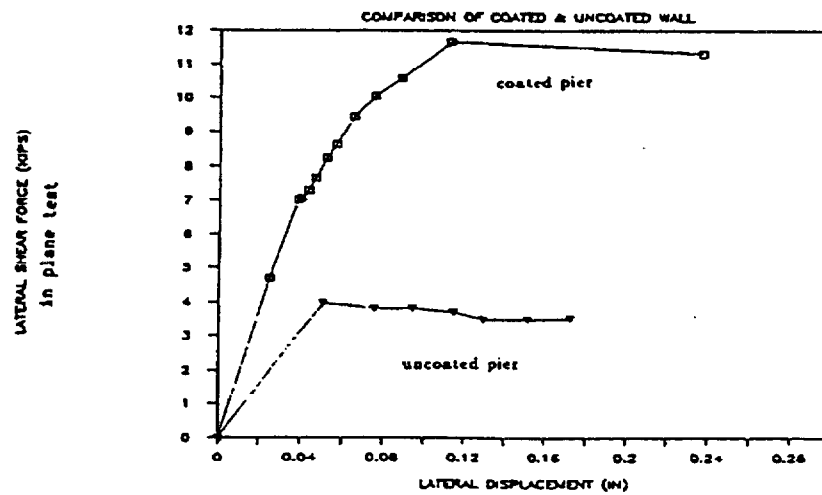
Figure 5: In-Plane Behavior for Coated and Plain Walls
