NIST GCR 97-724-2

APPENDICES: Development of Procedures to Enhance the Performance of Rehabilitated URM Buildings

Bret Lizundia, William T. Holmes, Margaret Longstreth, and Alan Kren
Rutherford & Chekene
303 Second Street, Suite 800 North
San Francisco, California 94107

APPENDIX A

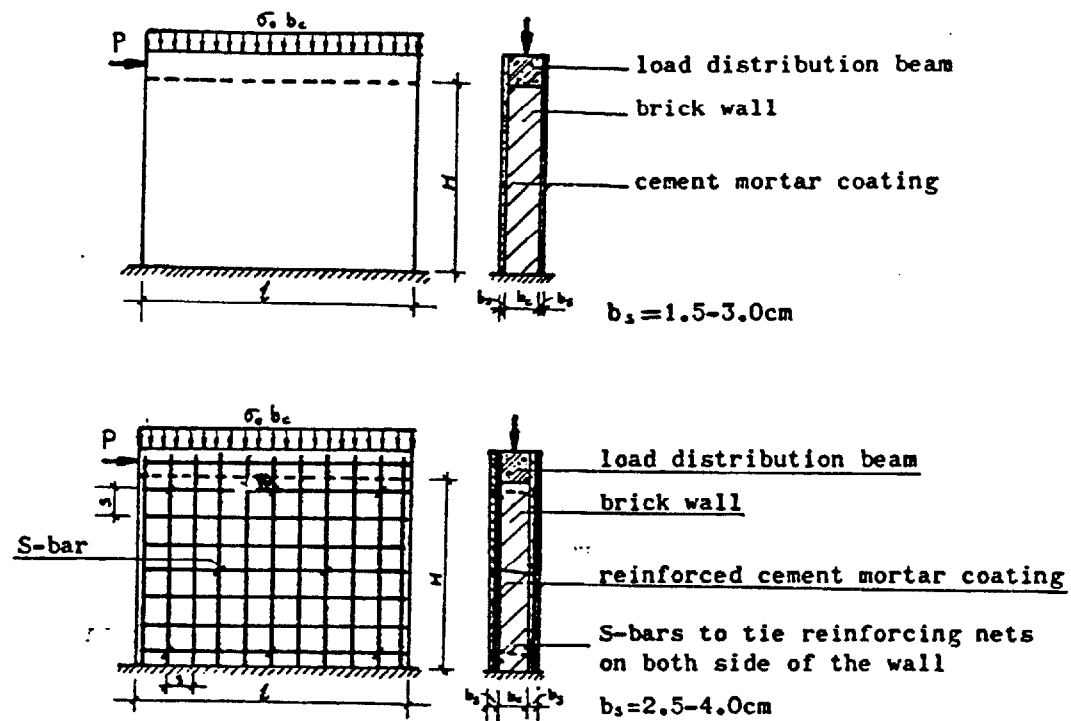
Figure 1: Unreinforced and Reinforced Coating Methods

For walls strengthened with unreinforced or reinforced coatings, the contribution of the masonry shear strength is added with that of the coating. For uncracked walls, the participation of the masonry is limited by the tensile strength of the masonry. Expressions for α_c in Table 1 are based on the coating reaching its cracking strength for unreinforced coatings, or yielding of reinforcement for reinforced coatings. For cracked walls, the masonry shear strength is taken as simply a frictional coefficient times the vertical compressive force, and its participation is taken at 84% when used with an unreinforced coating and at 100% when used with a reinforced coating.

The shear strength of the mortar coating is taken as an index value of mortar shear stress times the area of the coating. The participation of the coating for uncracked walls is taken as 100% for unreinforced coatings and 84% for reinforced coatings. Participation of the coating for cracked walls is again taken as 100% for unreinforced coatings but is neglected entirely for cracked, reinforced coatings.

Wall shear strength attributable to the coating reinforcement is considered in full for either uncracked or cracked walls.

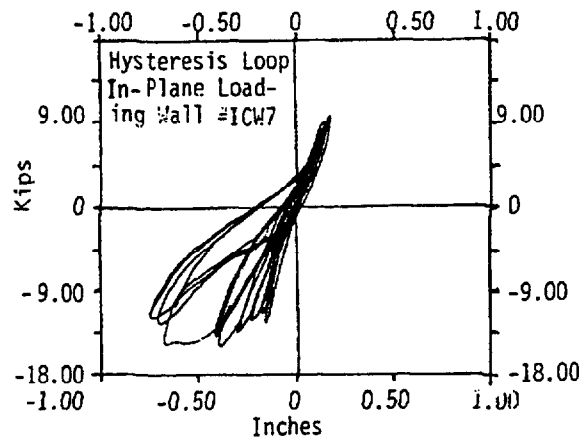
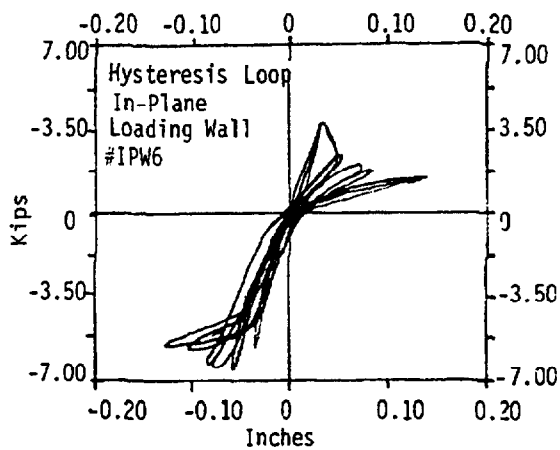
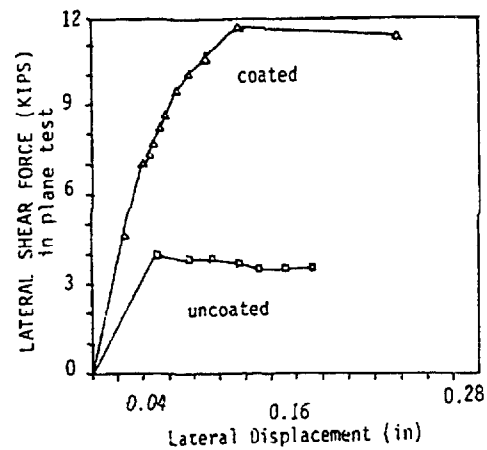
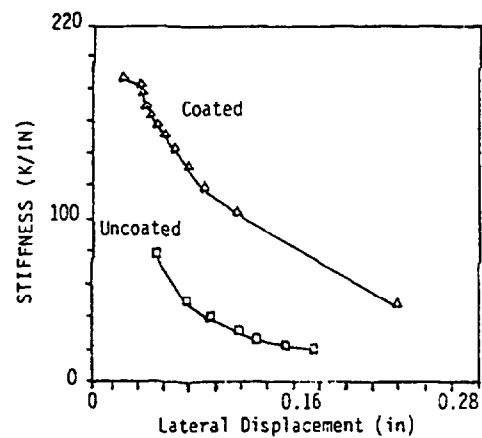
(a) Coated Wall

(c) Envelope Curves for Plain and Coated Walls

(b) Plain Wall

(d) Stiffness of Plain and Coated Walls

Figure 1: Measured In-Plane Behavior of Plain and Coated Walls

Inelastic action of the uncoated piers when tested statically was a result of flexural cracking in addition to sliding and rocking movements. First cracking was observed during the second cycle of loading (Figure 1b). For the coated piers, one specimen failed in flexure while the other failed due to a collapse of the loading device. For the coated specimen limited by flexure (Figure 1a) a horizontal crack developed along the wall base, but no rigid body motion about the base was observed.

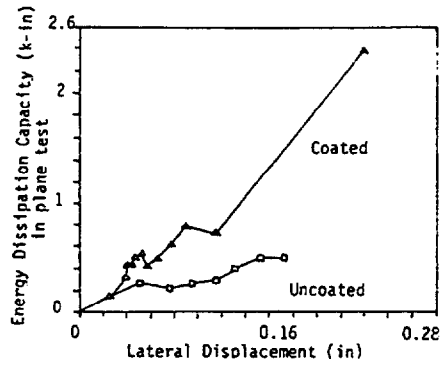
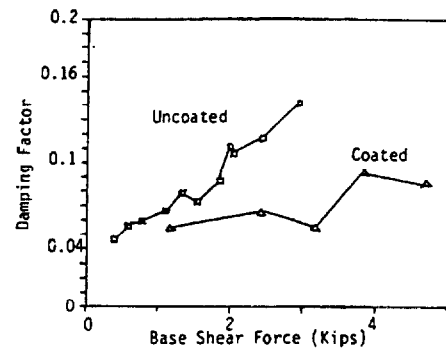
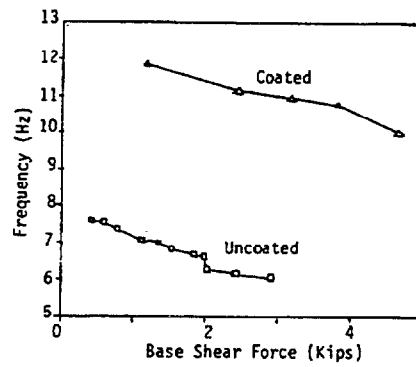
(a) Energy Dissipation

(b) Damping Factors

(c) Frequencies

Figure 2: Energy Dissipation, Damping and Frequencies for Plan and Coated Walls

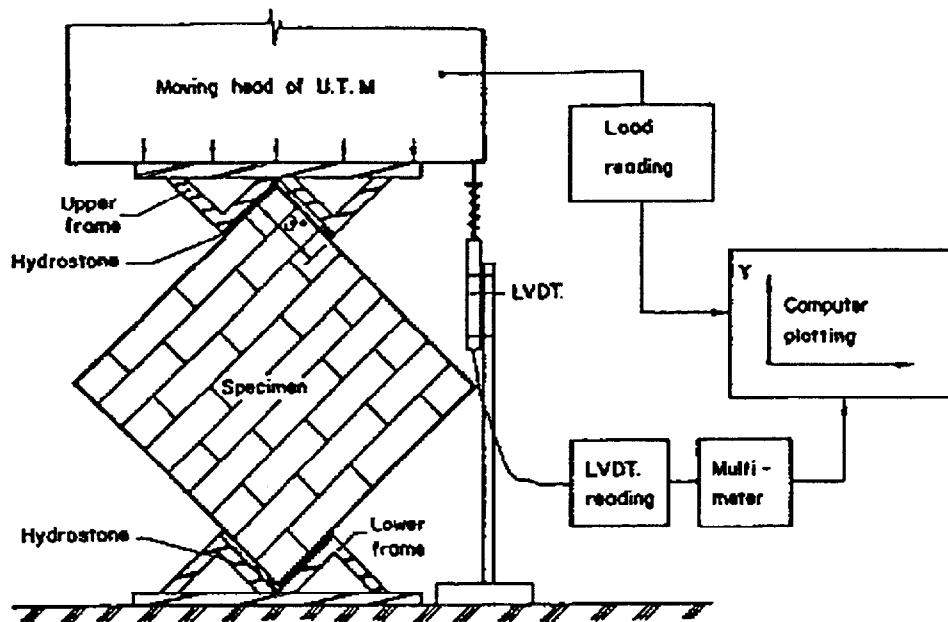
Figure 1: Test Set-up

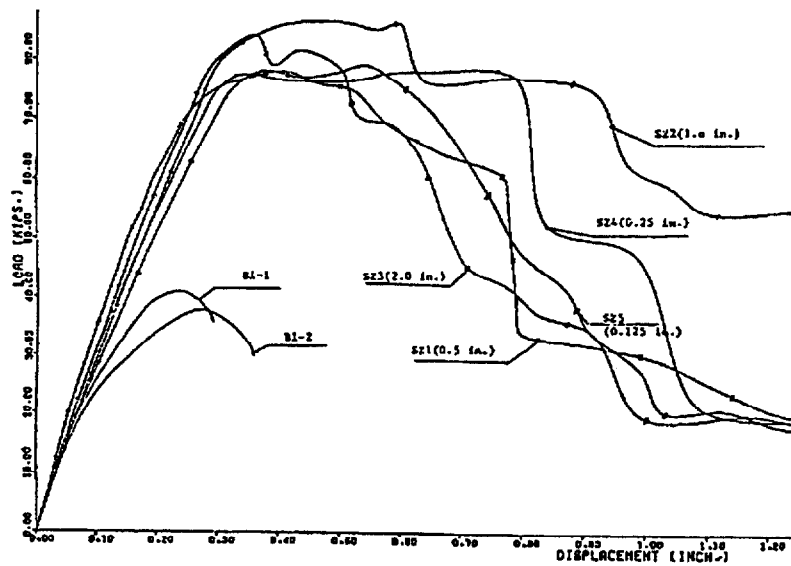
Figure 2: Measured Load Deflection Curves

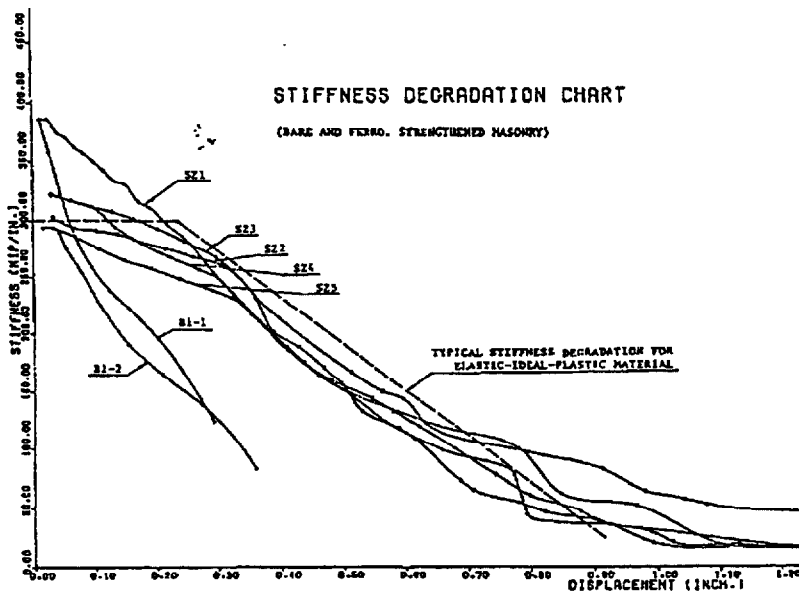
Figure 3: Lateral Stiffness vs. Deflection of Test Panels

Stiffness degradation was reduced with the coating (Figure 3). The coated specimens behaved in nearly an ideal plastic manner whereas the stiffness of the non-retrofitted test panels reduced rapidly.

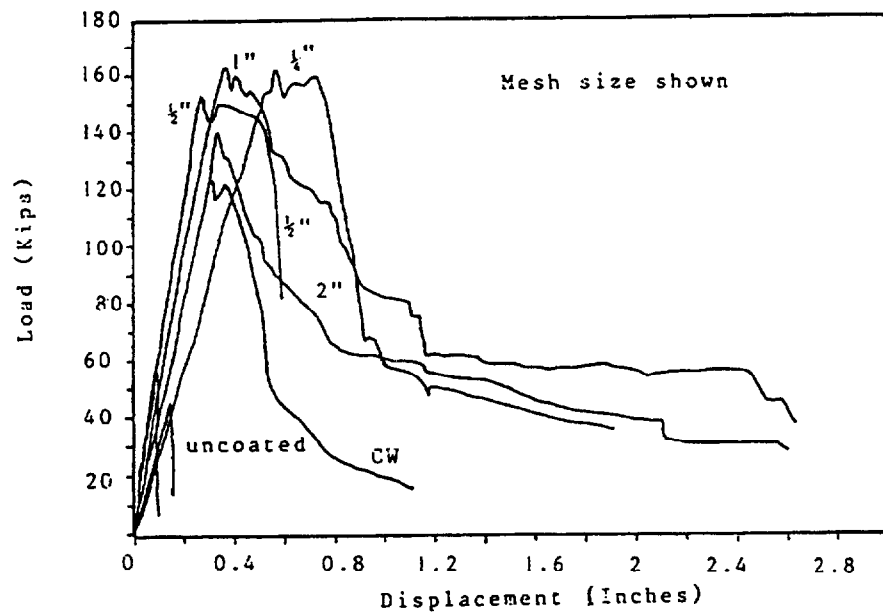
Figure 1: Force-Deflection Relations for New Brick Panels (B type)

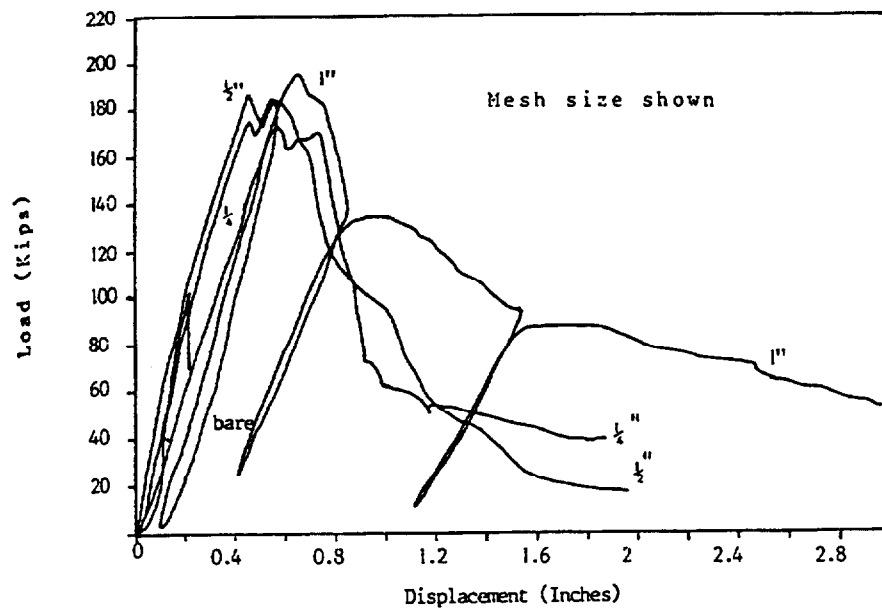
Figure 2: Force-Deflection Relations for Old Brick Panels (L type)

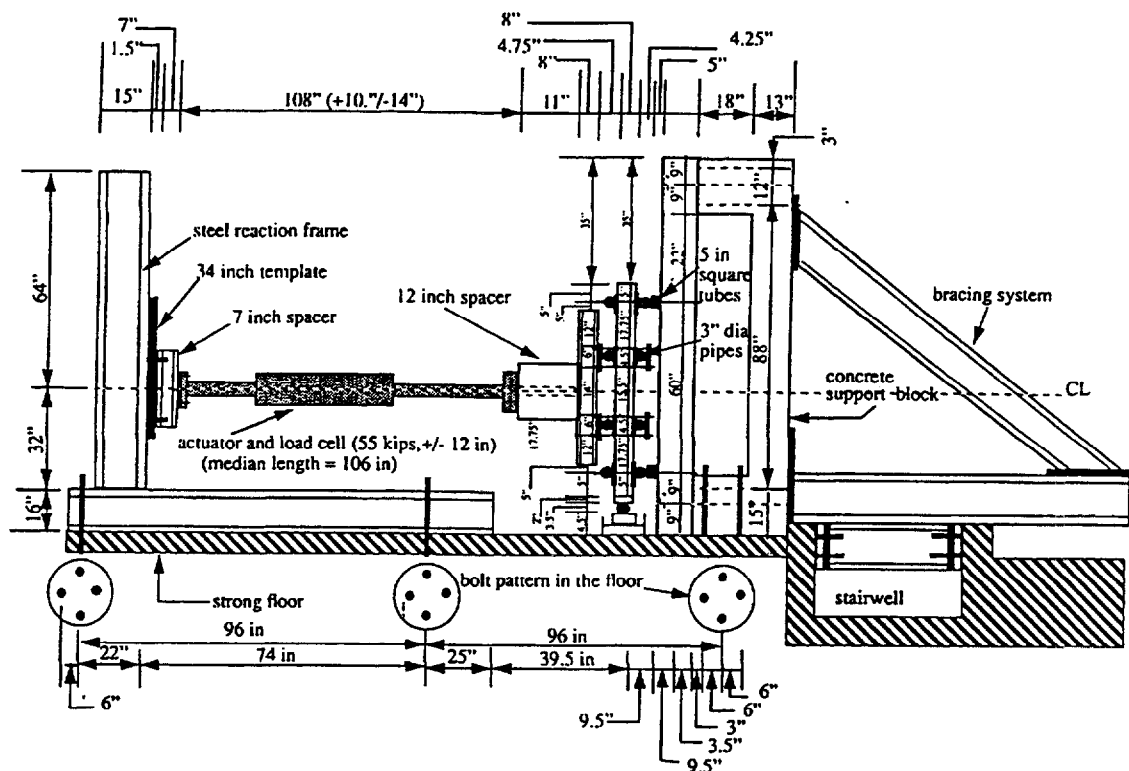
Figure 1: Test Set-up

Each test wall was 72 inches wide by 70 inches high, and was laid in double wythe running bond. Wall specimens were subjected to a two-point loading using a servo-hydraulic actuator to simulate face loading on a vertical strip of wall (Figure 1). Loads were reversed and repeated, and continued until fracture of the fabric occurred.

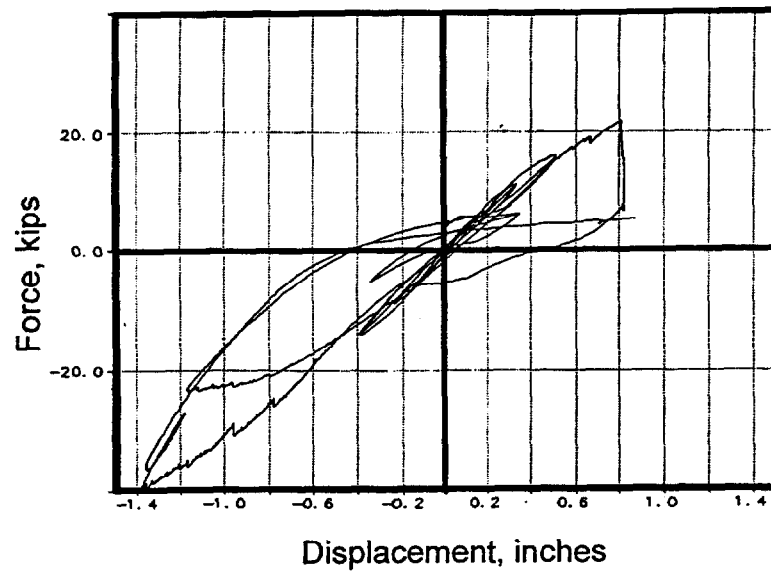
Figure 2: Measured Load Deflection Curves

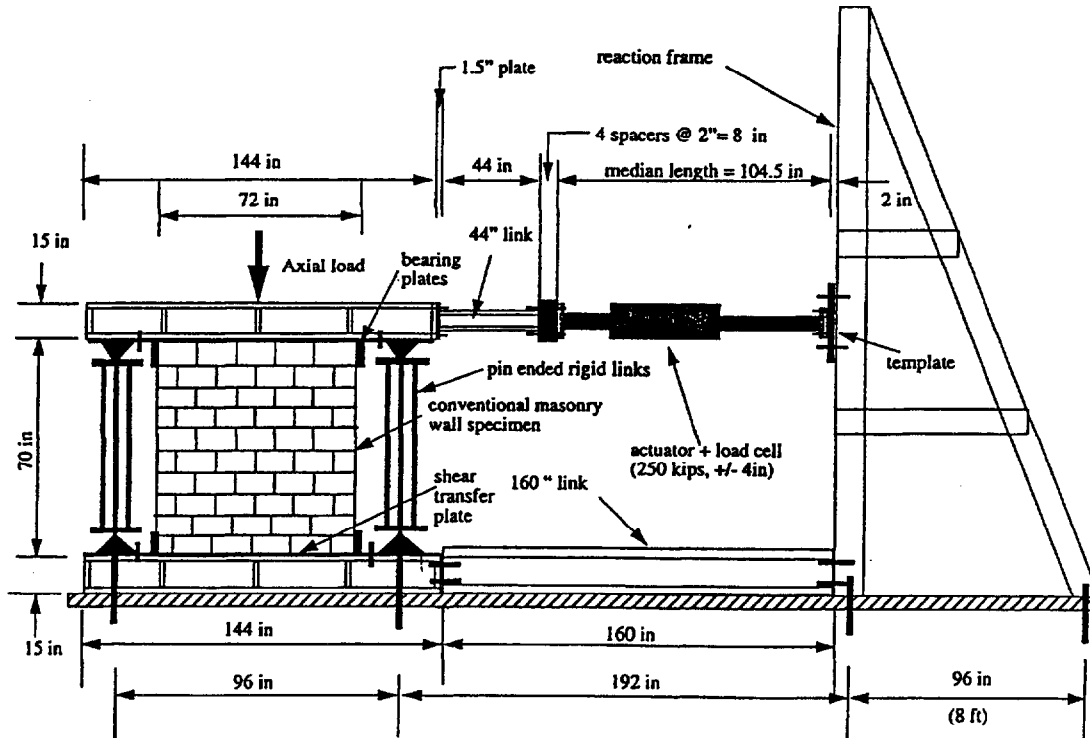
Figure 1: Test Set-up

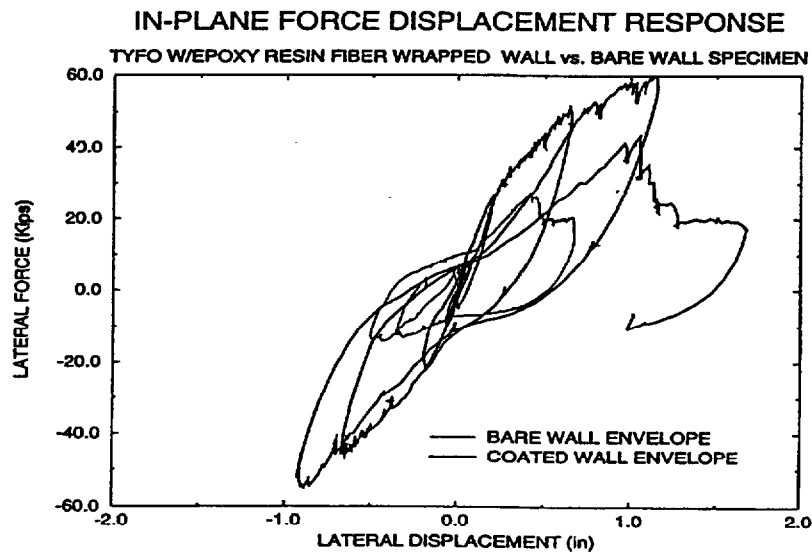
Figure 2: Measured Load Deflection Curves

Damage to the plain wall was a result of diagonal cracking which caused a sudden and sharp reduction in strength. Damage to the rehabilitated test wall was a result of debonding of the fabric on the west face which was followed by debonding of the fiber bands on the east face. Debonding of both fiber reinforcements was concentrated along the diagonals where tensile stresses were high. Lateral strength of the rehabilitated wall dropped when diagonal tension cracks developed.

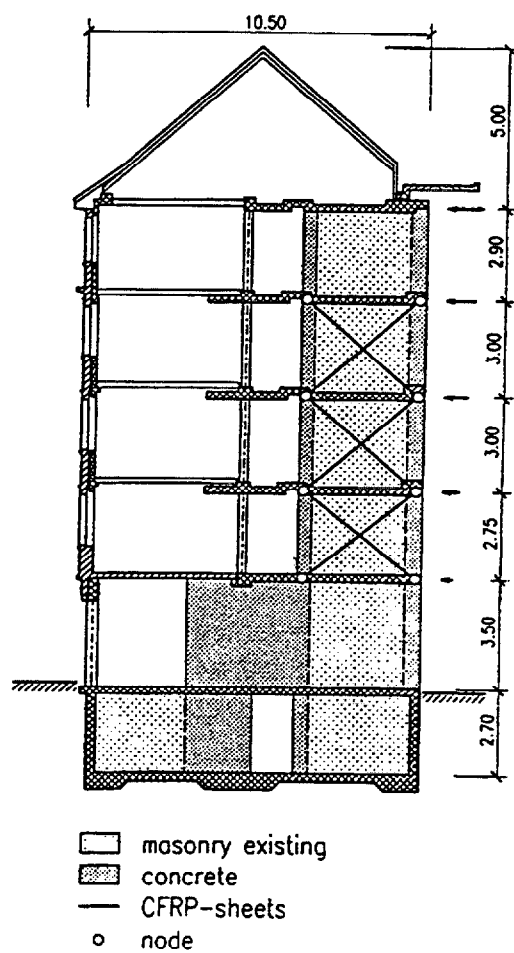
Figure 1: Location of Sheets
(dimensions in meters)

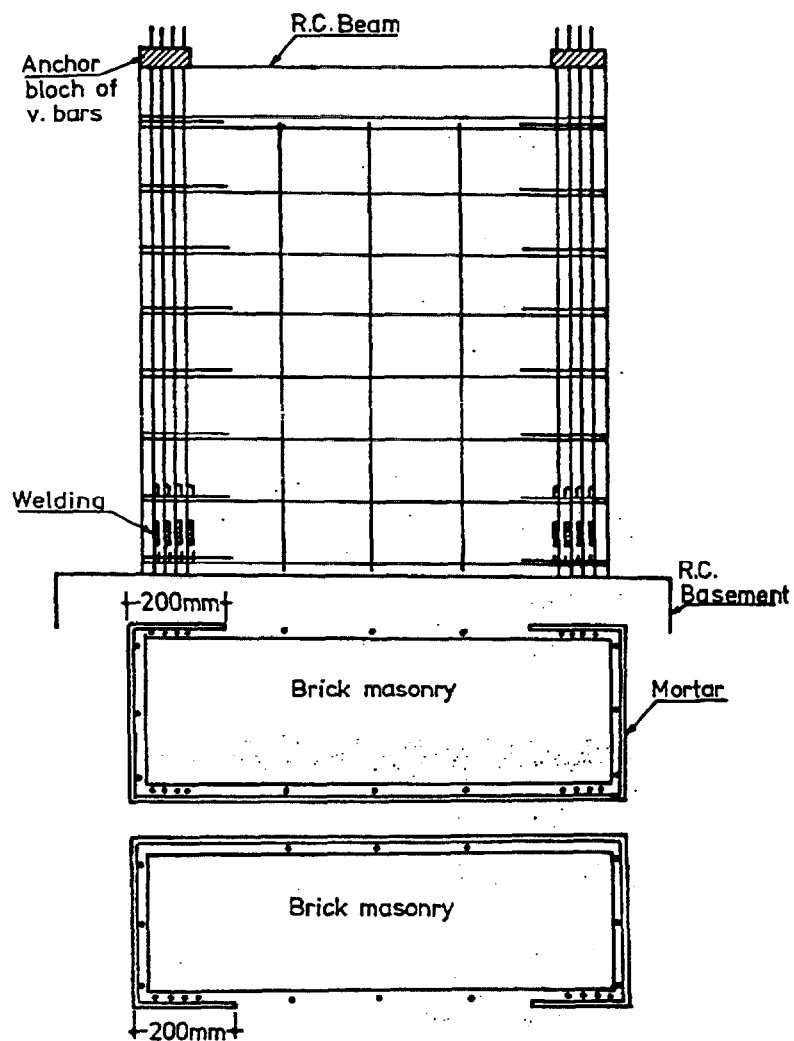
Figure 1 Description of Test Wall Strengthened with External Reinforcement (MC)

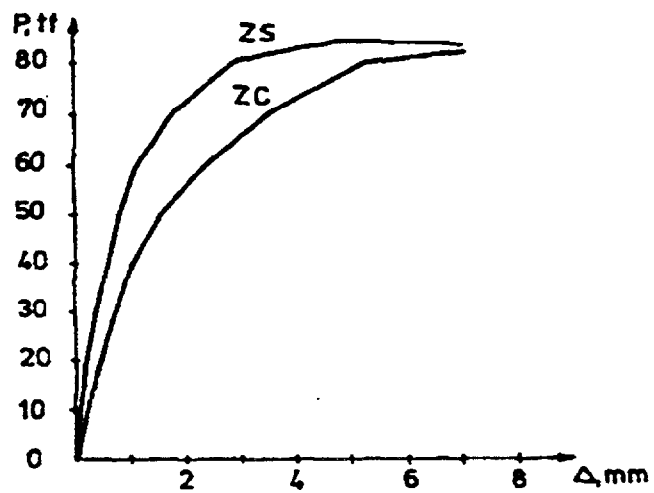
Figure 2 Measured Load-Deflection Relations (ZS and ZC Specimens)

Behavior of the unstrengthened wall specimen (ZS in Figure 2) was generally limited by crushing of masonry at the wall toe, and for certain specimens, by diagonal tension cracking. When the wall was strengthened with welded wire mesh, the mortar coating delaminated because of poor adhesion to the surface of the masonry. As a result, the retrofit scheme did not increase the lateral in-plane strength or stiffness of the wall (ZC in Figure 2).

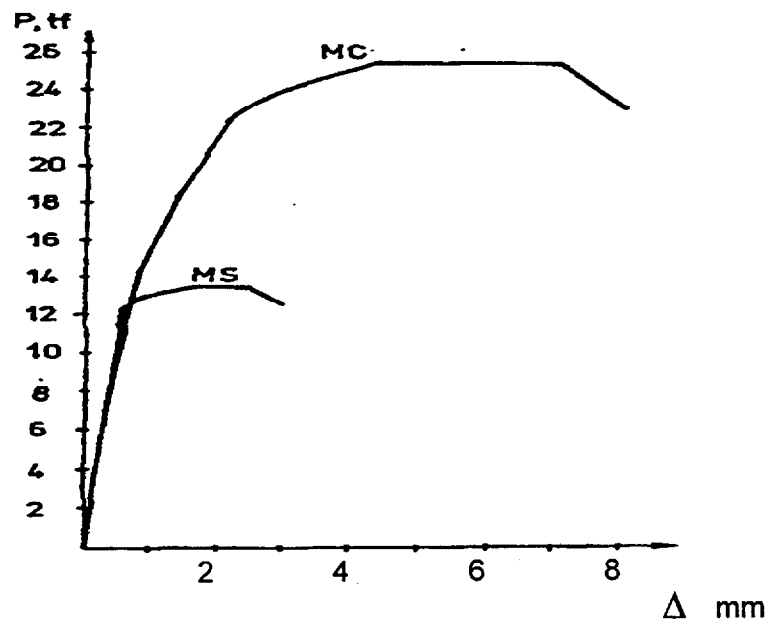
Figure 3 Measured Load-Deflection Relations (MC and MS Specimens)

For the second series of tests, the strength of the unstrengthened wall (MS) was limited by masonry compressive stress at the wall toe. Failure of the strengthened test wall (MC) was a result of yielding of reinforcement. Delaminations of the coating were not observed despite the lack of anchorage. The retrofit method resulted in significant enhancements in both strength and stiffness (Figure 3).

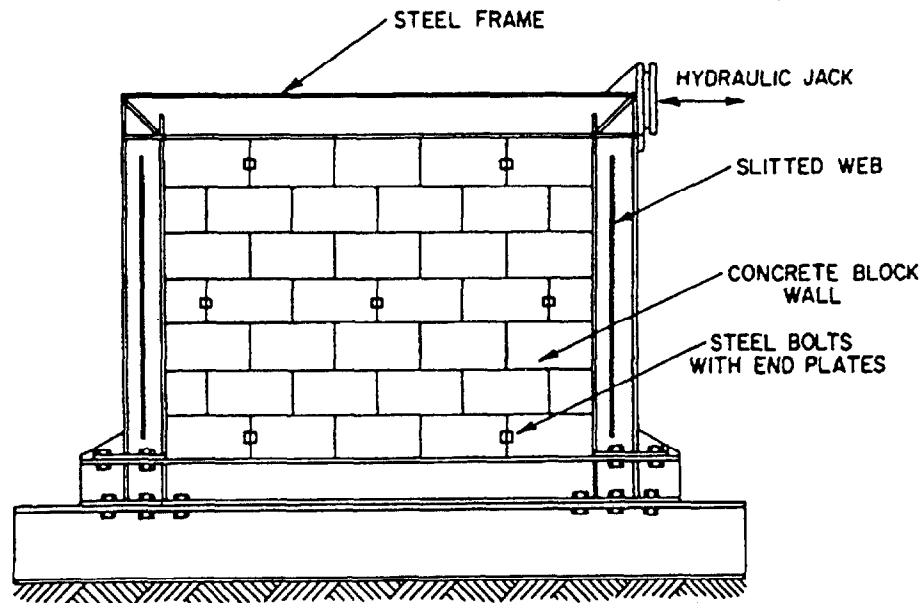
Figure 1: Description of Test Wall

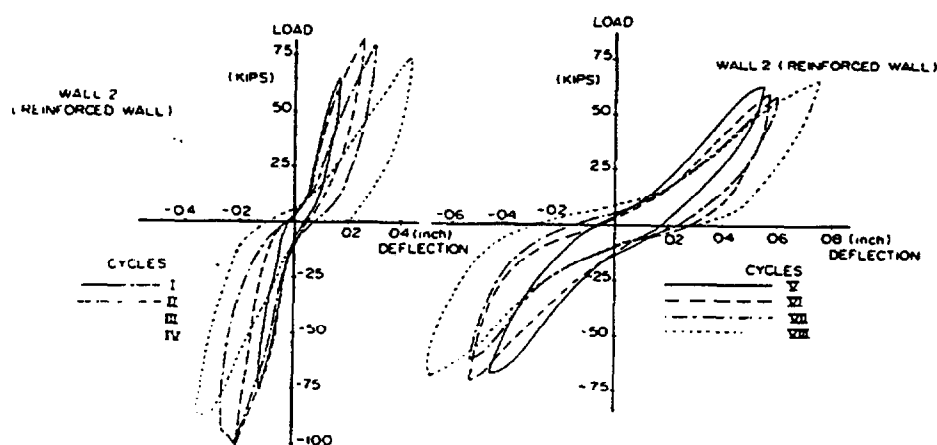
FIG. 2 LOAD DEFLECTION CURVES FOR REINFORCED WALL

Figure 2: Load-Deflection Relations for Wall 2

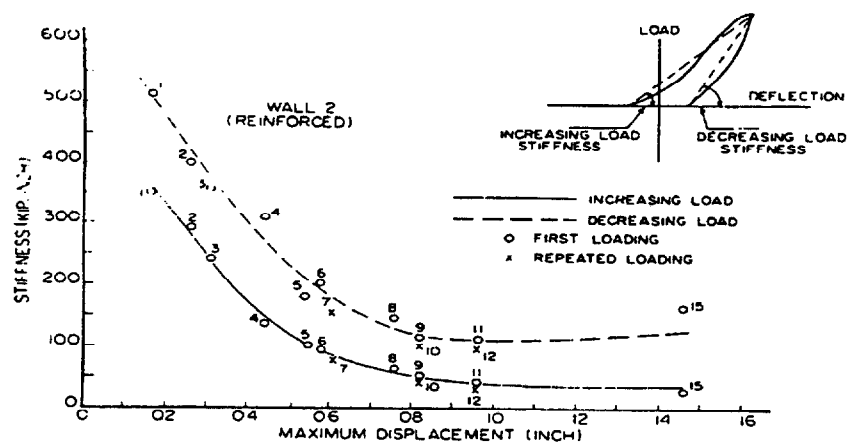
FIG. 3 STIFFNESS DEGRADATION CURVE FOR REINFORCED WALL

Figure 3: Stiffness Reductions for Wall 2

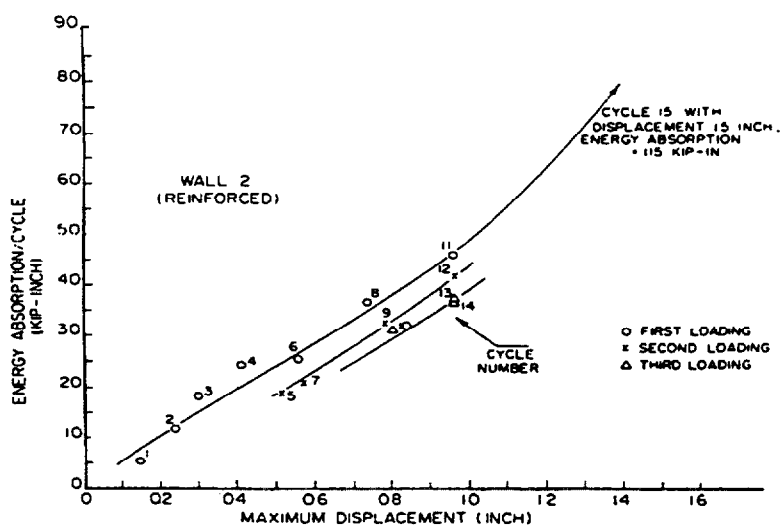
FIG. 4 ENERGY DISSIPATION CURVE FOR REINFORCED WALL

Figure 4: Energy Dissipation for Wall 2

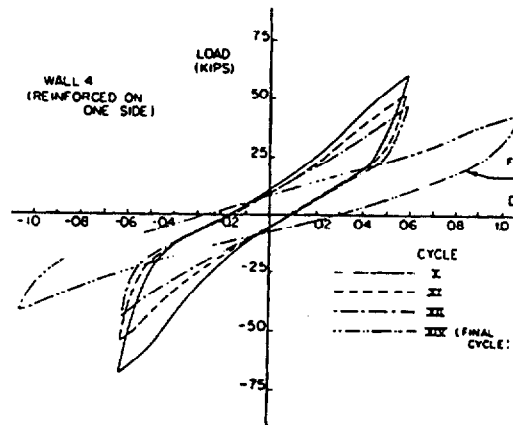
FIG. 10 LOAD DEFLECTION CURVES FOR WALL REINFORCED ON ONE SIDE

Figure 5: Load-Deflection Relations for Wall 4

2. *Wall with Reinforcement on One Side (Wall No. 4):* Seven anchor bolts were used to increase the bonding of the reinforcing layer to the masonry wall. The load-deflection curves (Figure 5) and stiffness degradation curves (Figure 6) were similar to those of the wall reinforced on both sides (Wall No. 2). With reinforcement on only one side of a wall, there was some difference in energy absorption capacity (Figure 7) and damage patterns.

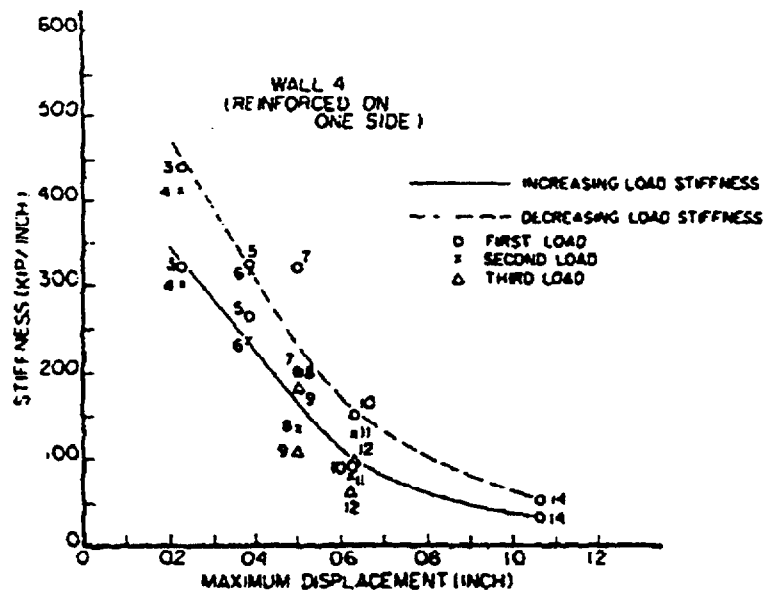
Figure 6: Stiffness Reductions for Wall 4

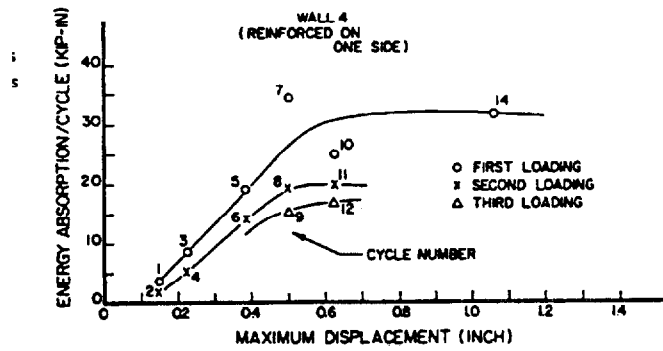
FIG. 9 ENERGY ABSORPTION CURVE FOR WALL REINFORCED

Figure 7: Energy Dissipation for Wall 4

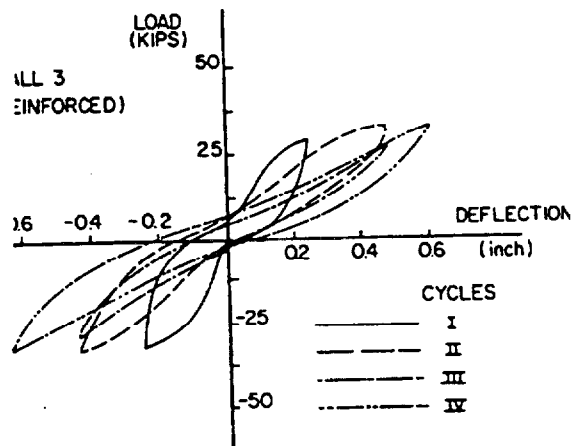
FIG. 11 LOAD DEFLECTION CURVE FOR UNREINFORCED WALL

Figure 8: Force-Deflection Relation for Unstrengthened Wall 3

3. *Damaged Wall with Reinforcement on Both Sides (Wall No. 3):* The test wall was loaded until cracks developed along the joints. Then, two reinforcing layers were applied to the damaged wall and the wall was retested. Load deflection curves for the first four cycles of unreinforced wall are shown in Figure 8. The maximum load in all cycles remained below 33 kips. The load deflection curves for the first four cycles of the repaired wall are shown in Figure 9. The stiffness of the repaired wall was much better than that of the undamaged wall. The stiffness degradation and the energy absorption capacity for the unreinforced and the

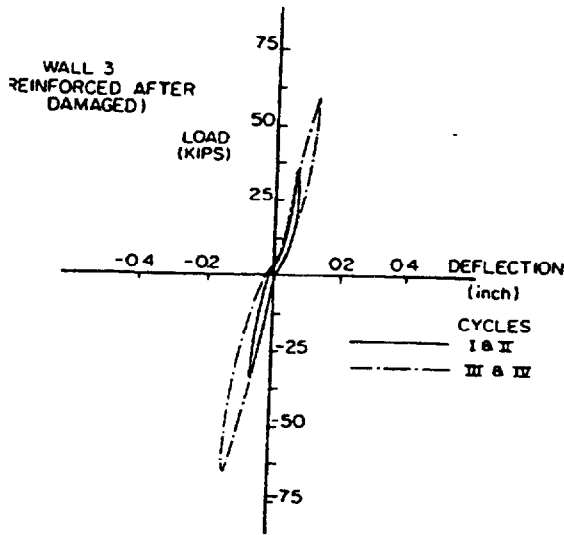
FIG. 12 LOAD DEFLECTION CURVE FOR REPAIRED WALL

Figure 9: Force-Deflection Relation for Repaired Wall 3

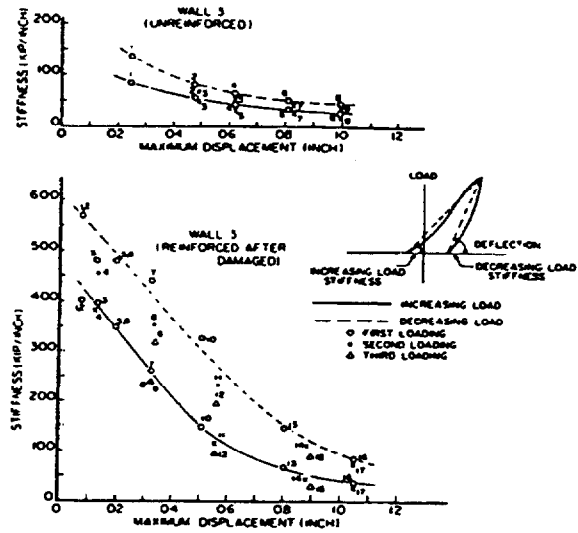
FIG. 13 STIFFNESS DEGRADATION CHARACTERISTICS

Figure 10: Stiffness Reductions for Wall 3

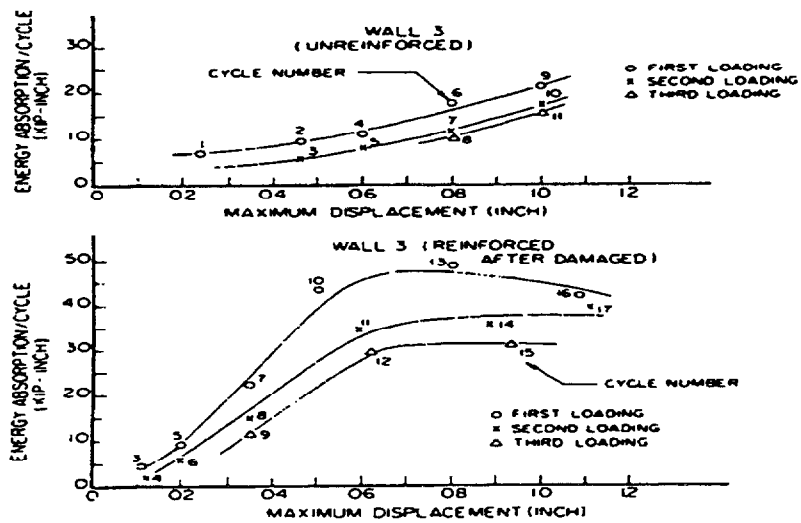
FIG. 14 ENERGY ABSORPTION CURVES

Figure 11: Energy Dissipation for Wall 3

repaired wall are shown in Figures 11 and 12.

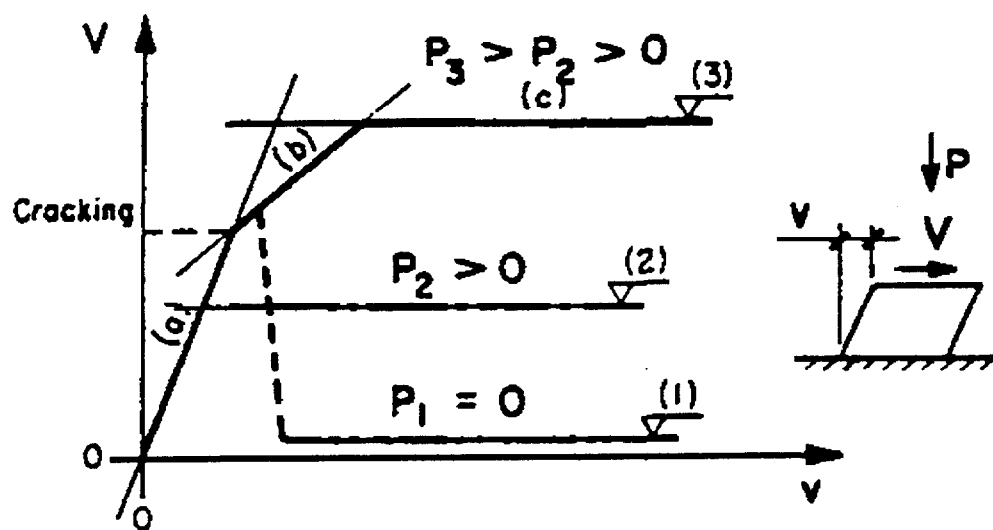
Figure 1: Effect of Vertical Prestress on Lateral Force-Deflection Behavior of a Wall

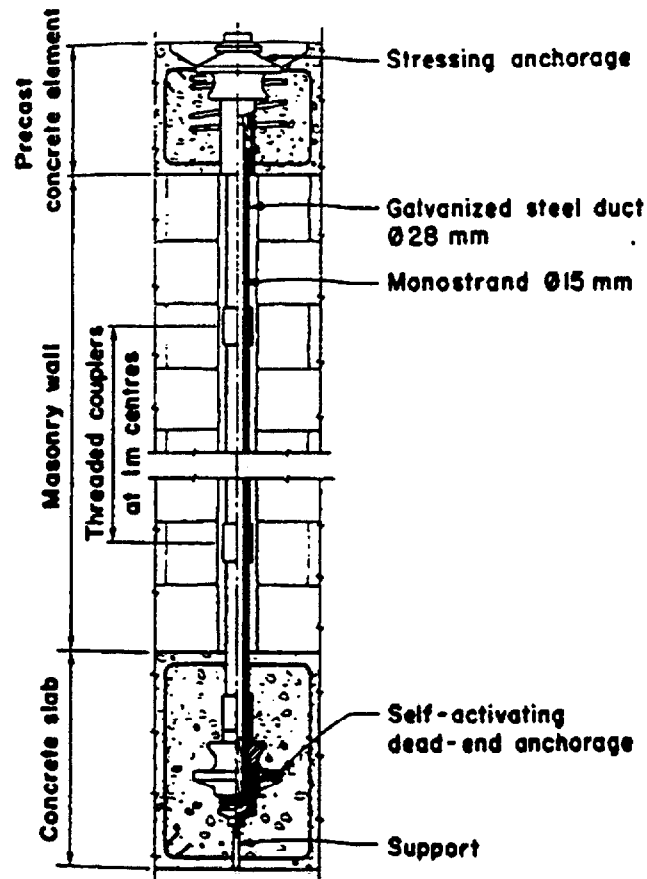
Figure 1: Typical Tendon for Post-Tensioned Masonry

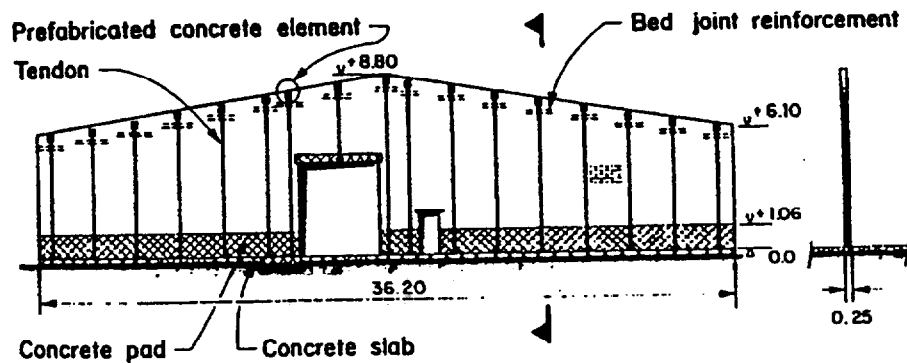
Figure 2: Post-Tensioned Masonry Walls for Factory in Regensdorf

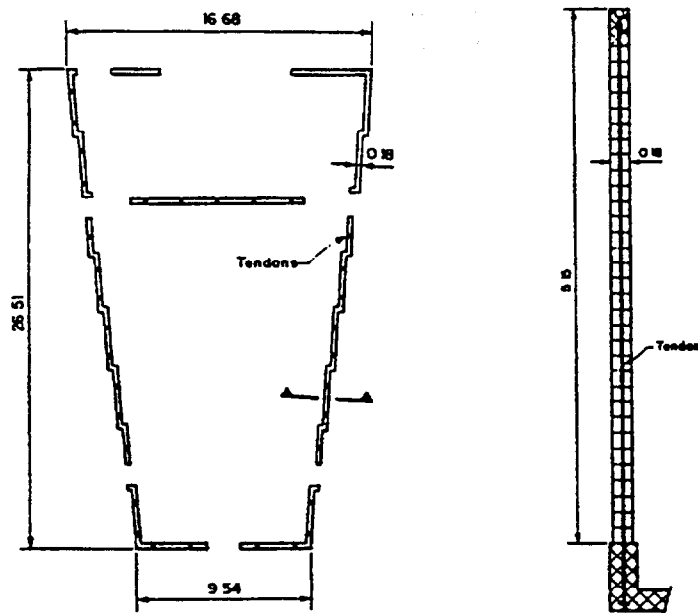
Figure 3: Plan of a Movie Theater and a Cross Section of a Post-Tensioned Wall

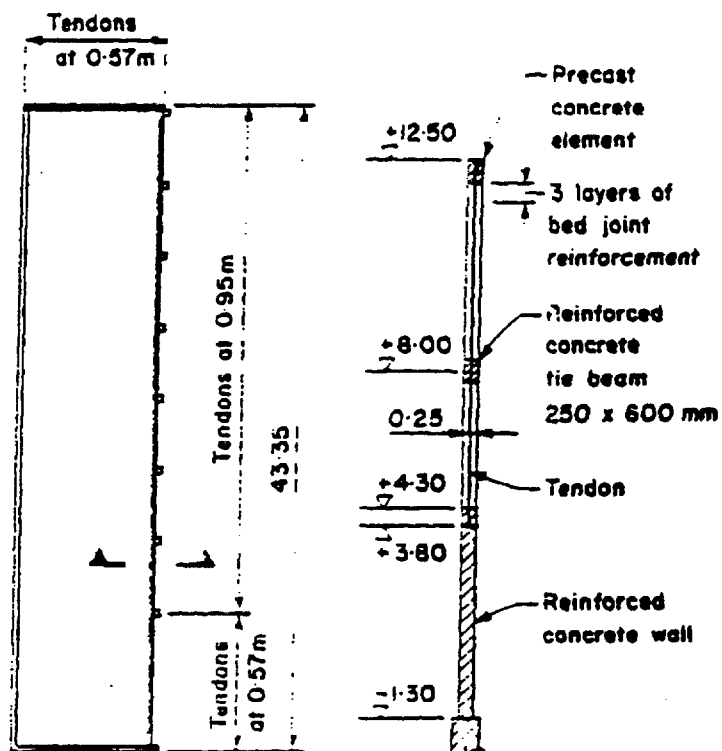
Figure 4: Plan of Warehouse and a Section through the Post-Tensioned Wall

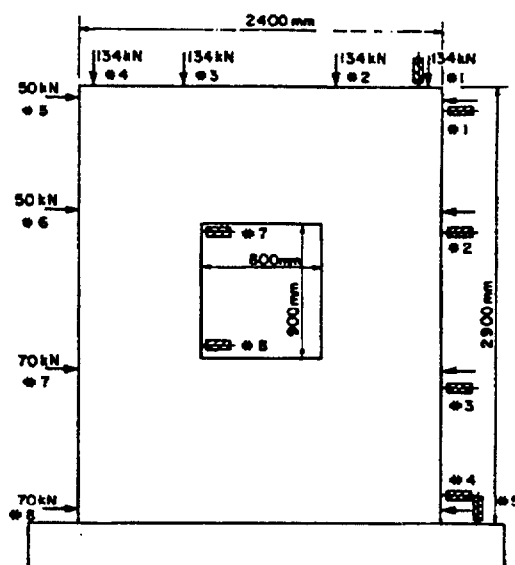
Figure 1: Description of Post-Tensioned Masonry Test Wall

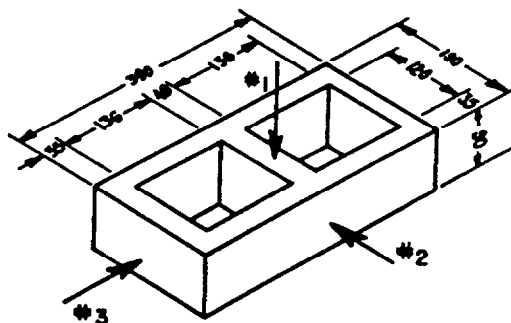
Figure 2: Typical Hollow Clay Unit

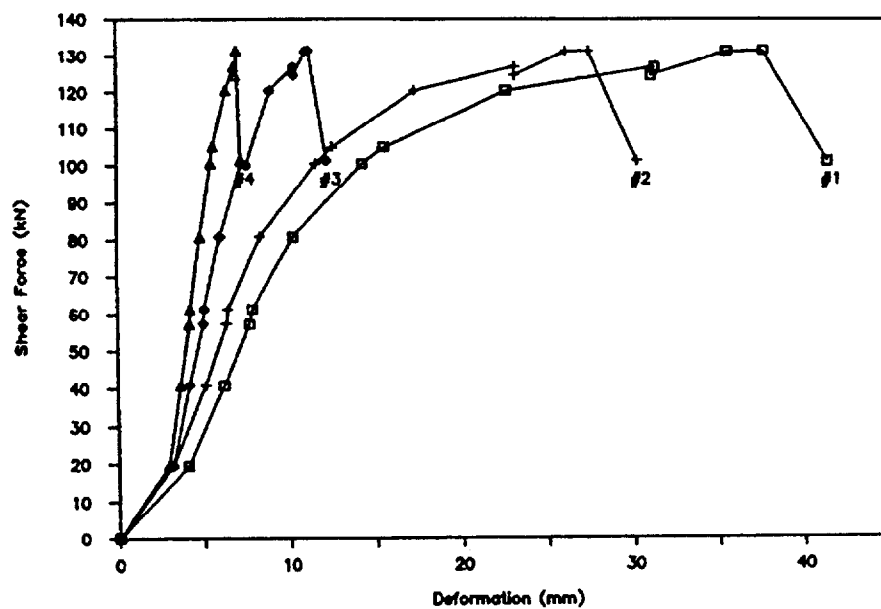
Figure 3: Force-Displacement Relations for Test Wall

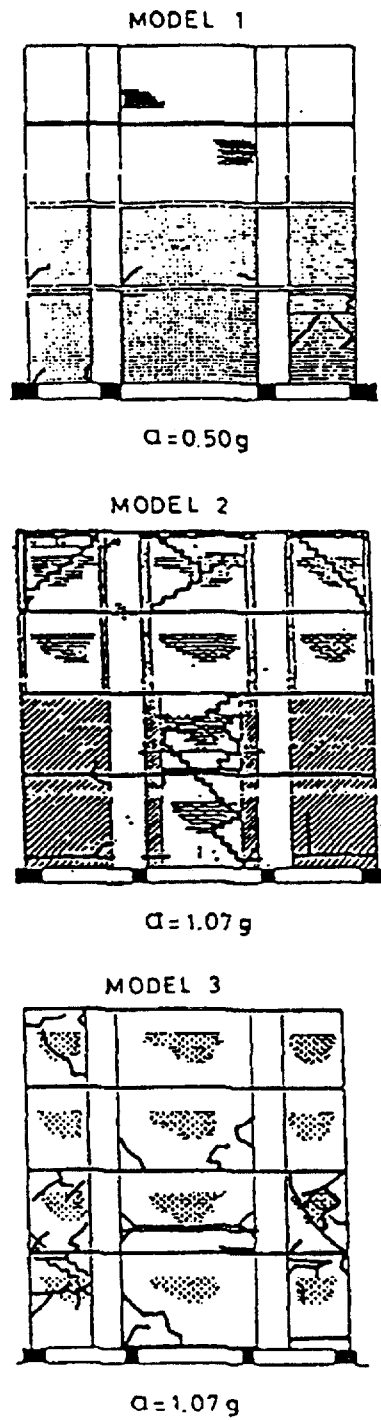
Figure 1 : Observed Cracking Patterns for Test Walls

The two strengthening methods increased the lateral strength of the building systems. Each technique resulted in a failure mechanism (Figure 1) that distributed the energy over the height of the structure, and provided a high energy absorption capacity.

Behavior of the first structure was characterized by intensive damage to the first story with slight damage to the second story. Masonry damage was observed across all stories for the second and third structures.

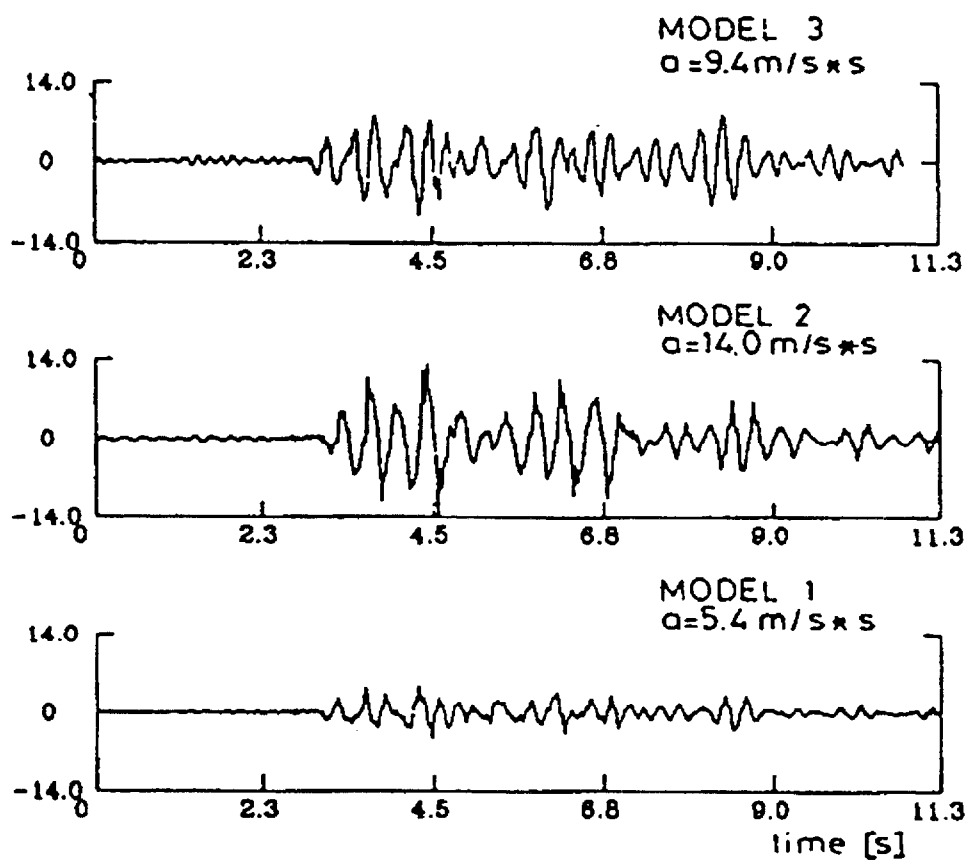
Figure 2: Measured Acceleration Histories for Three Test Structures

Measured acceleration histories recorded at the fourth floor (Figure 2) indicated that the first test structure had little or no amplification of base accelerations while the amplification factors for the second and third structures were approximately 3 and 2 respectively. These tendencies were related to the different damage mechanisms for the three structures.

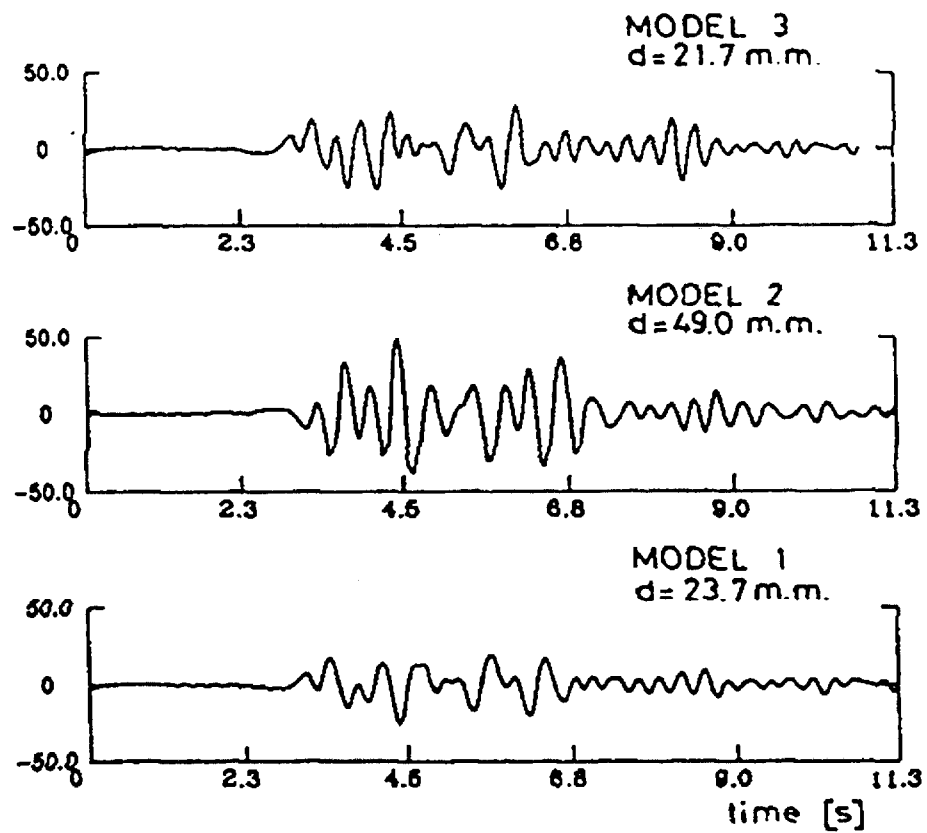
Figure 3: Measured Displacement Histories for Three Test Structures

Measured deflection histories at the fourth floor (Figure 3) indicated that the first structure deflected almost twice as much as the second structure. This was a result of the greater extents of damage for the first test structure.

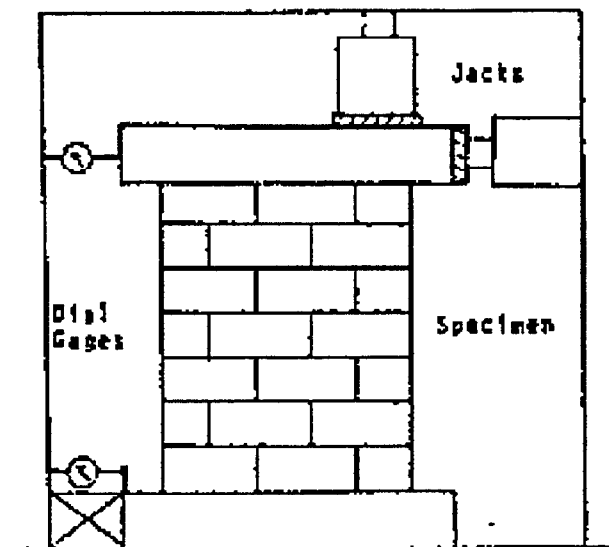
Figure 1: In-Plane Test Setup

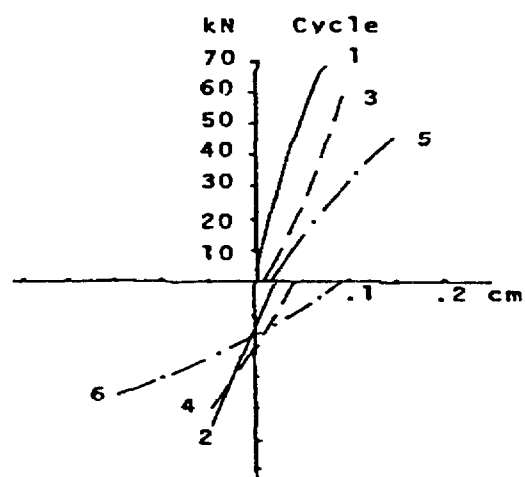
Figure 2: Measured Force-Deflection Relation for In-Plane Loading

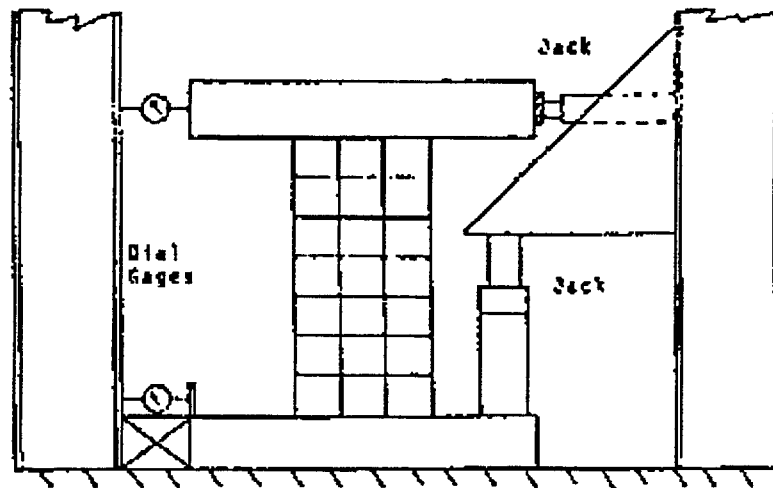
Figure 3: Out-of-Plane Test Setup

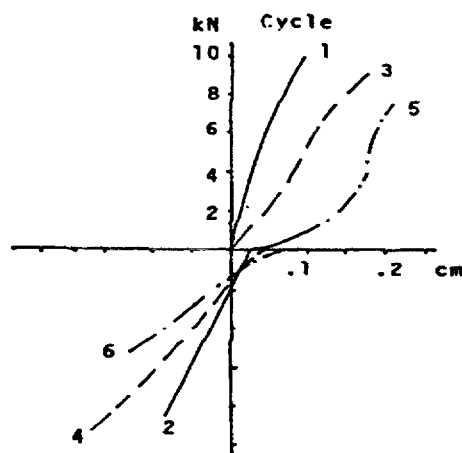
Figure 4: Measured Force-Deflection Relation for Out-of-Plane Loading
