NIST GCR 97-724-2

APPENDICES: Development of Procedures to Enhance the Performance of Rehabilitated URM Buildings

Bret Lizundia, William T. Holmes, Margaret Longstreth, and Alan Kren
Rutherford & Chekene
303 Second Street, Suite 800 North
San Francisco, California 94107

APPENDIX A

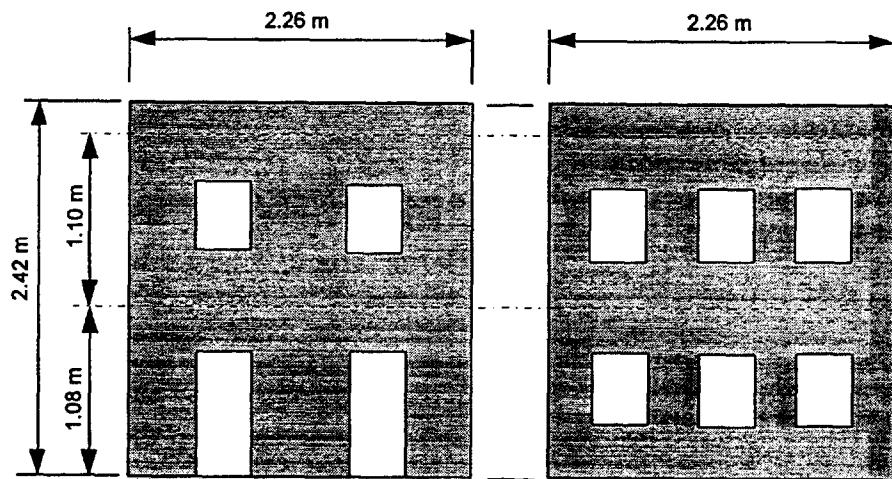
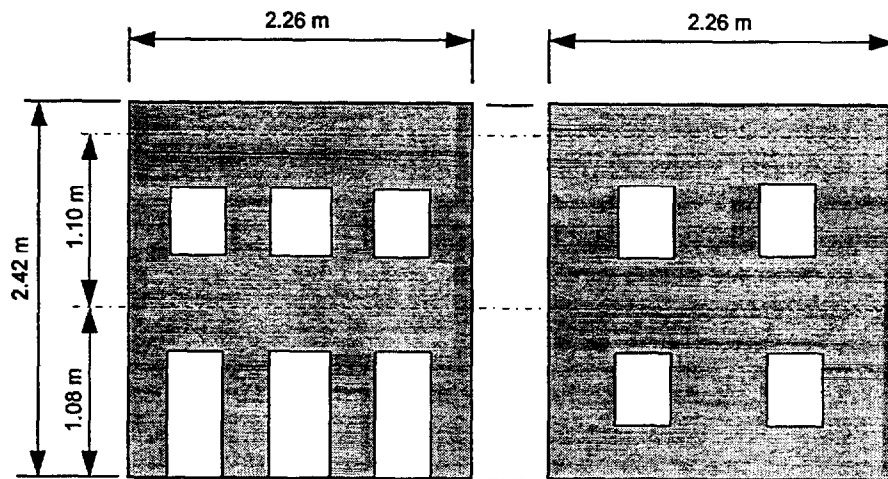
(a) Test Structure S1

(b) Test Structure S2

Figure 1: Description of Test Structures

Test Structure S2 was weaker than S1 as a result of enlarging the window openings; however, its performance was better because less damage occurred to the base-story piers. Cracks were observed at the top and bottom bed joints of the slender piers of the "door wall" of S2. Little or no damage was observed on the opposite "window wall" because lateral forces were limited by the shear force that could be resisted by the weaker of the two walls. Horizontal cracks in the piers closed following the earthquake simulations as a result of gravity stress. Structure S1 was also controlled by rocking, but had more extensive cracking because shear forces were higher.

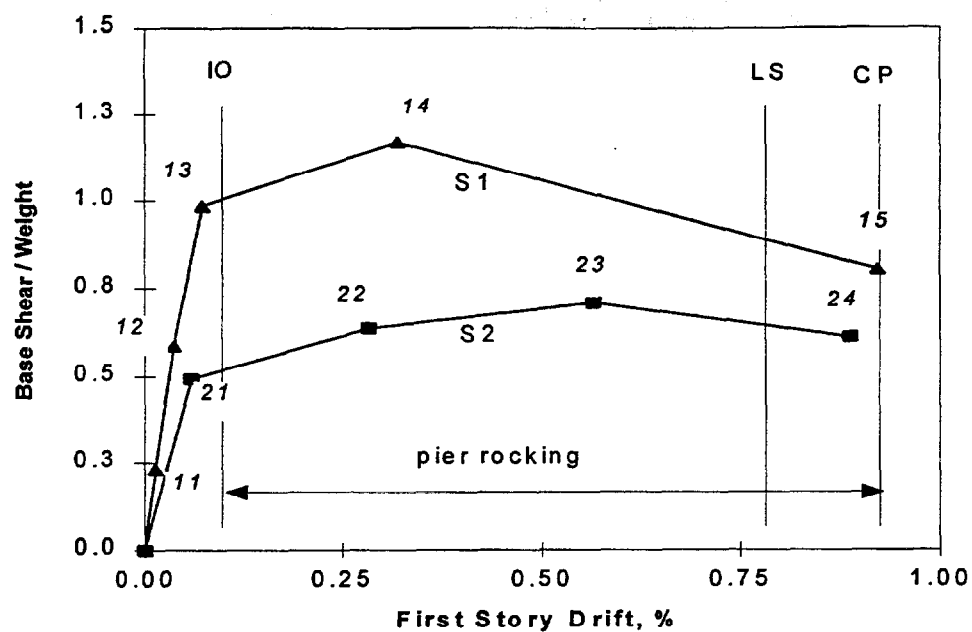
Figure 2: Overall Behavior of Each Test Structure

Initial cracking was observed for both structures at less than 0.1% drift. Maximum in-plane drifts were in the range of 1%.

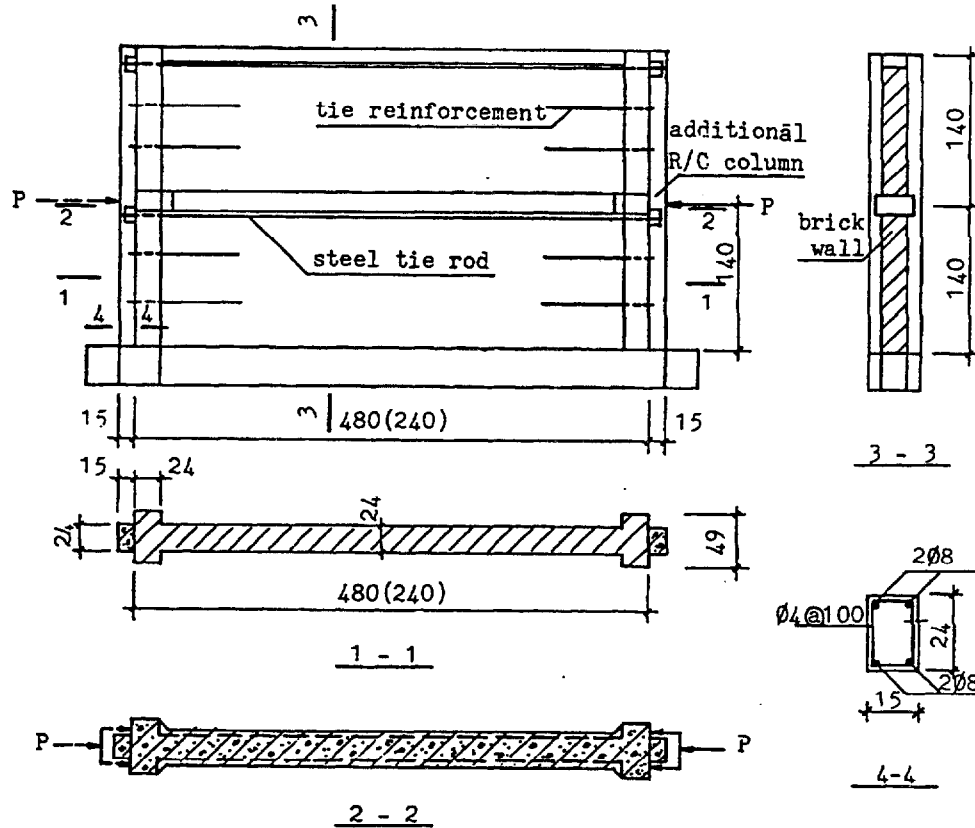
Figure 1: Description of Test Wall

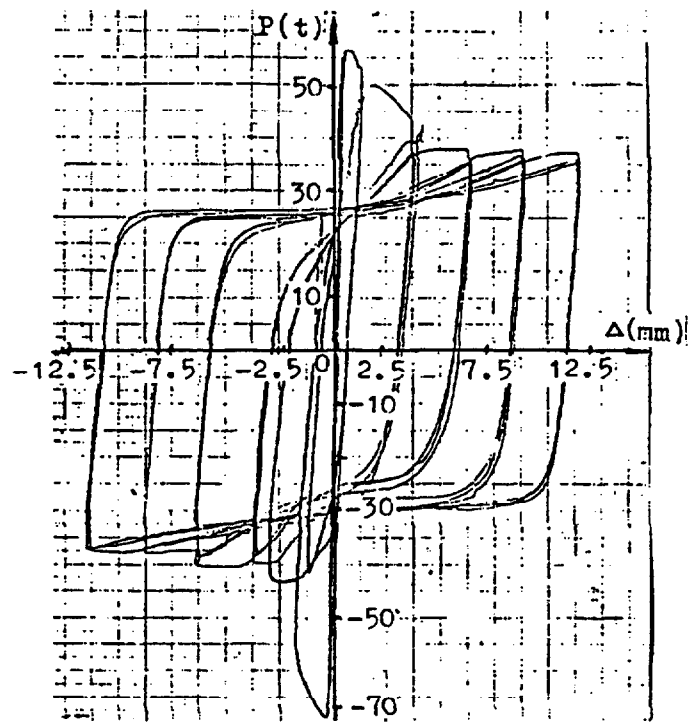
Figure 2. Measured Force-Deflection Curve for Unstrengthened Wall

The force-deflection behavior for the plain, unstrengthened and unreinforced masonry walls (Figure 2) revealed a stable hysteresis loop. Frictional forces resisted shear along bed joints after the formation of initial stair-stepped diagonal cracks.

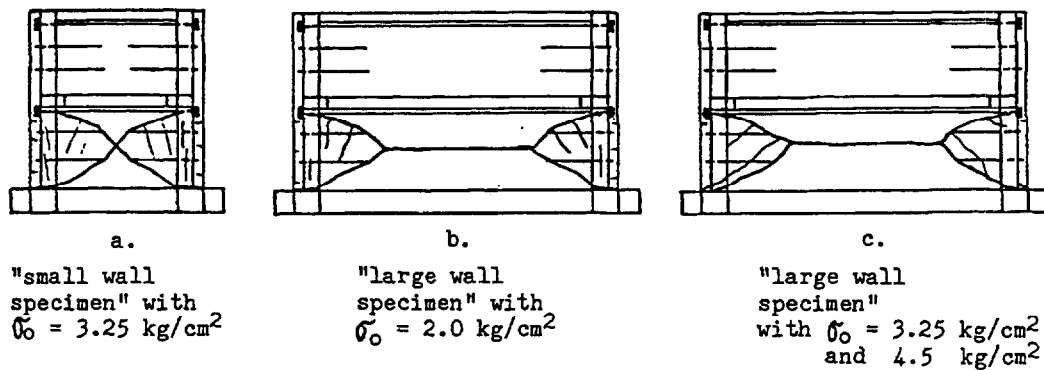
Figure 3. Observed Failure Modes for Strengthened Walls

The experimental investigation revealed three failure modes (Figure 3) for masonry walls strengthened with the rehabilitation procedure: (a) flexural cracking in the columns followed by diagonal tension cracking, (b) diagonal tension cracking with some flexural cracking in the columns and (c) diagonal tension cracking with no flexural cracking in the columns. The first mode occurred for the walls with the shorter length. The third mode occurred with the walls with the higher vertical compressive stress.

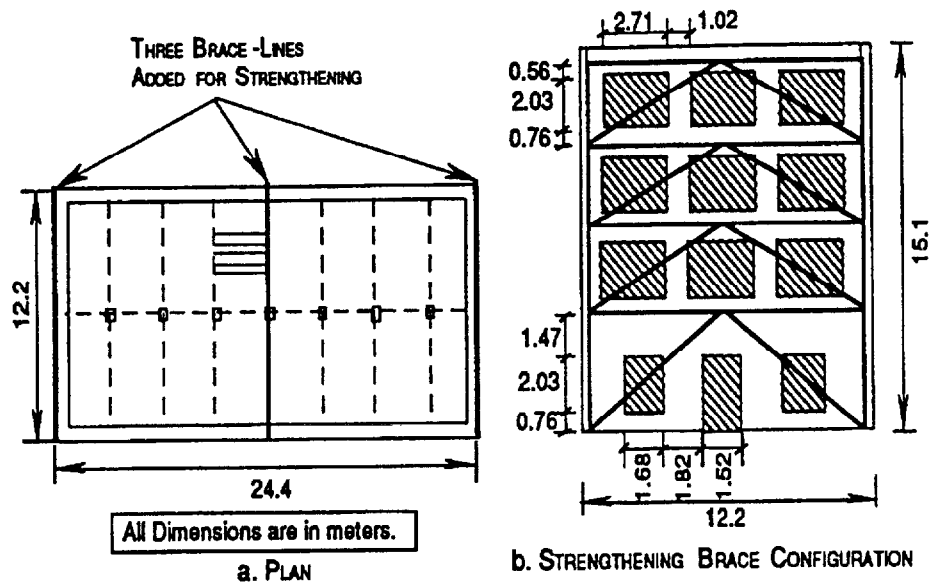
Figure 1: Prototype Building Used in Investigation

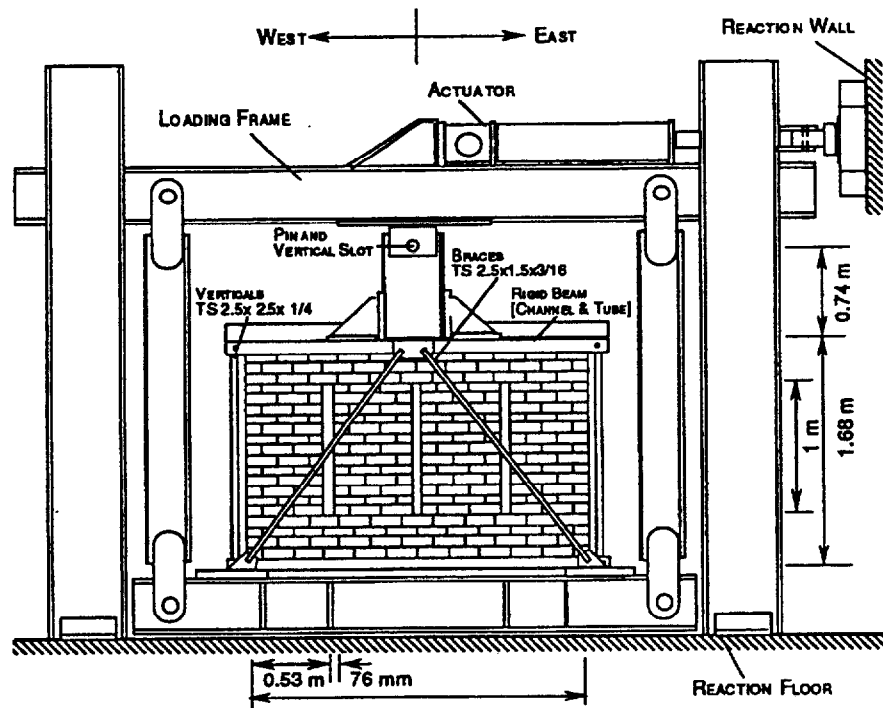
Figure 2: Test Specimen and Loading Frame

The steel braces were 2.5"x 1.5"x 3/16", ASTM A500 Grade B tubes. To prevent out-of-plane buckling of the braces and damage to the wall, the braces were oriented with the weak axis perpendicular to the plane of the wall. Additionally, pin-ended vertical steel members were provided at both ends of the wall to resist overturning moments. Horizontal forces were applied at

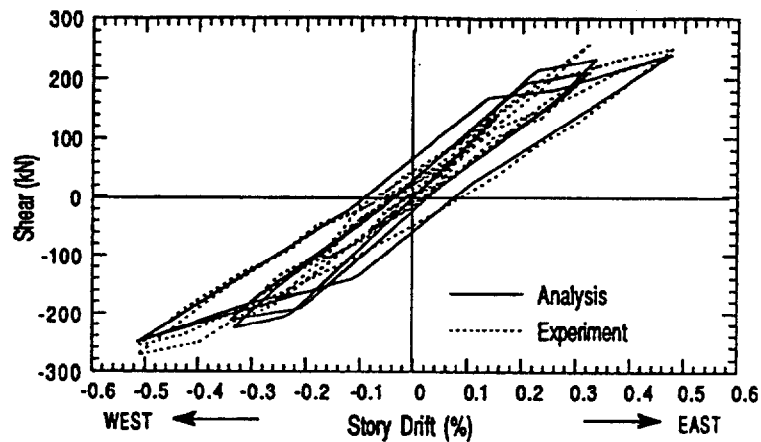
Figure 3: Measured and Calculated Force-Deflection Behavior of Bracing Members

Strength of the retrofitted system was limited by strength of a weld connecting a bracing member to a steel gusset plate at a story drift equal to 0.75%. This was due to inadequate penetration of the weld on one side of the gusset plate resulting in differential stress concentrations in the unbalanced fillet welds.

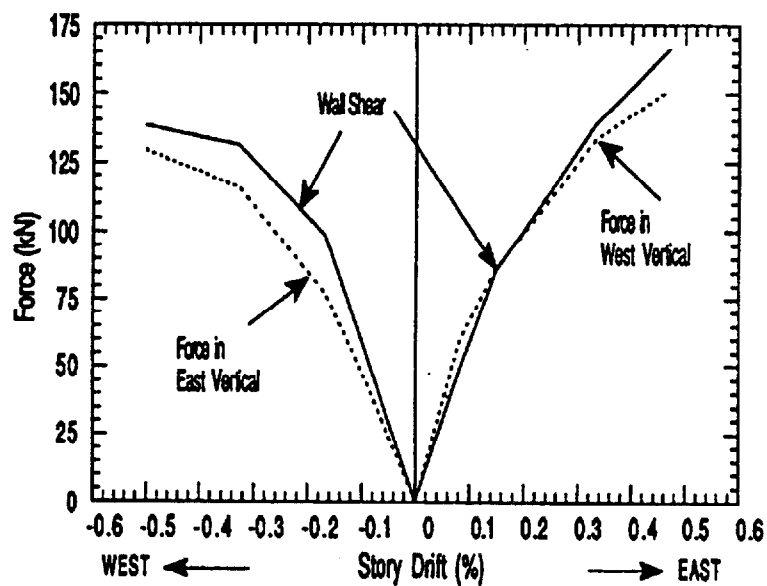
Figure 4: Shear Resisted by Wall and Forces in Vertical Members

Due to the increased hold-down forces in vertical steel members of the bracing system, the rocking capacity of the masonry piers was significantly increased. The observed maximum shear was 147 kN which was much larger than the estimated 9 kN rocking shear for a non-retrofitted wall.

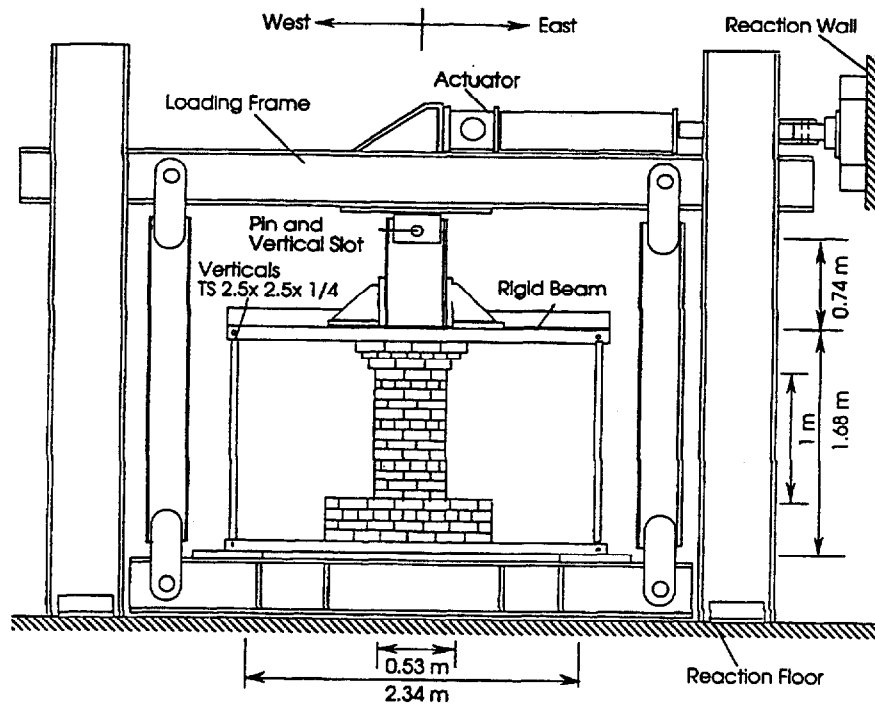
Figure 1: Test Set-up

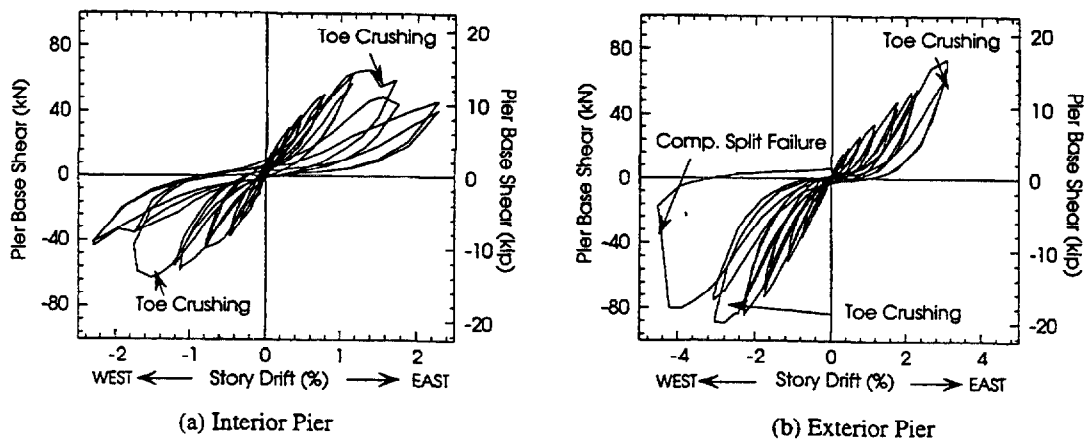
Figure 2: Measured Load Deflection Curves

For the interior pier, the first flexural cracks were observed at approximately 0.2% drift. The piers then continued to rock until severe crushing of the toe occurred at approximately 2.2% drift where shear strength decreased to 60% of maximum strength.

Similar behavior was observed for the exterior pier however the shape of the hysteresis loop was asymmetrical. Cracking was observed in the sill near the toe at 0.75% drift. A significant strength decrease was observed at 3.0% drift when toe crushing occurred. The cracking pattern was asymmetrical as were the peak strengths for each direction of loading. The ultimate limit state was vertical splitting at a drift of 4.5%.

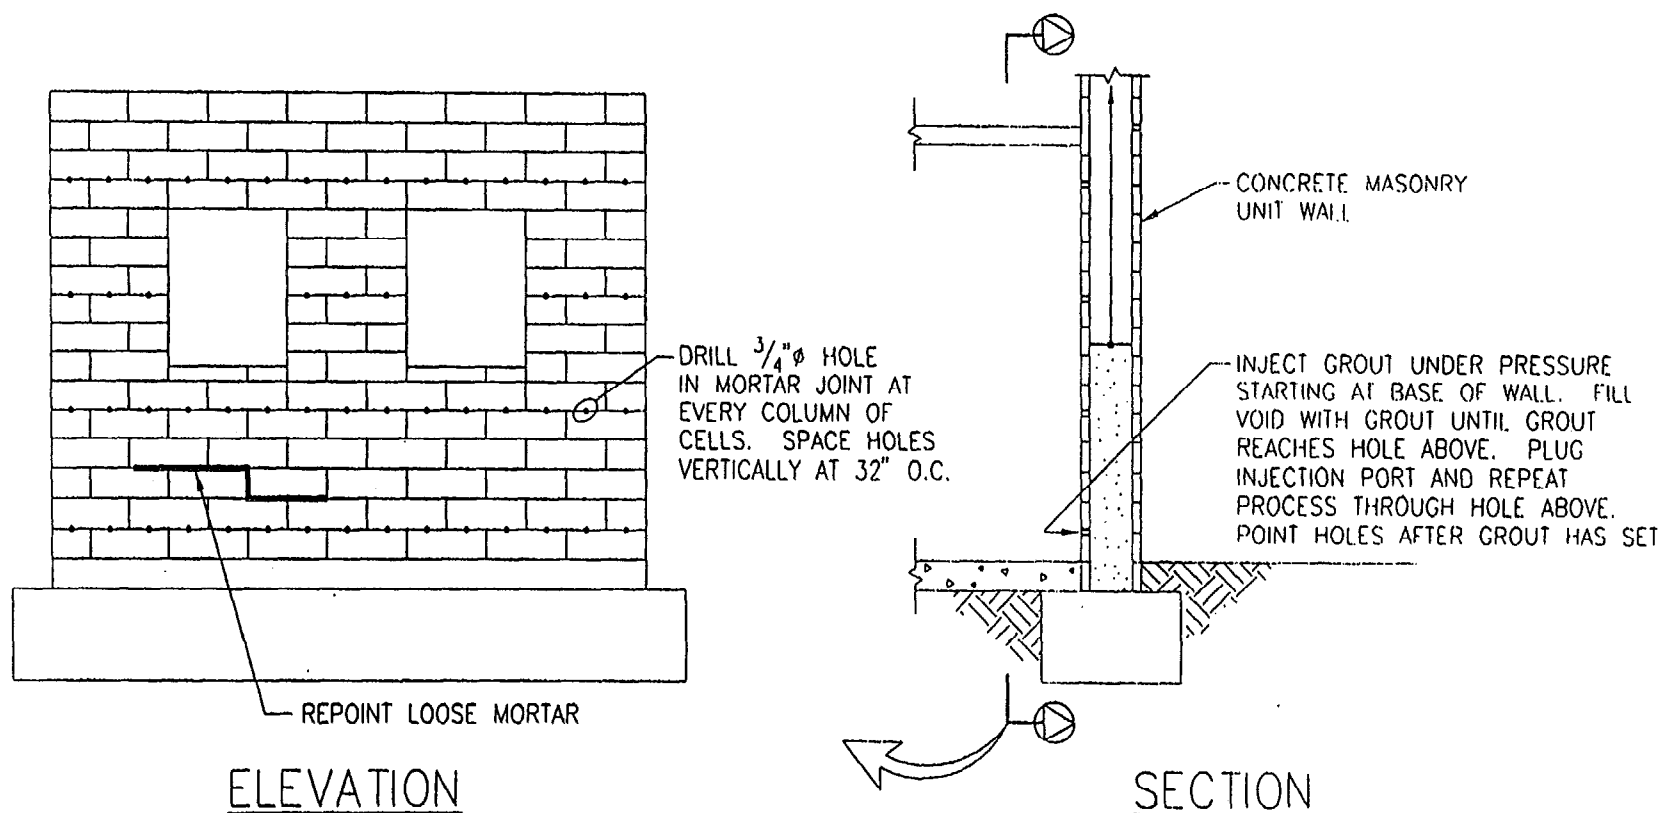
1. INJECTION MAY BE DONE FROM EITHER THE EXTERIOR OR INTERIOR SIDE OF THE WALL.
2. THOROUGHLY FLUSH INSIDE OF WALL WITH WATER 24 HRS. PRIOR TO INJECTION.
3. GROUT COMPOSITION IS 1 PART TYPE I OR II CEMENT, $\frac{1}{2}$ PART FLYASH, $\frac{1}{2}$ PART TYPE S LIME AND 4 PARTS CLEAN SAND. IMMEDIATELY CLEAN GROUT OFF OF WALL SURFACE.
4. ON-SITE INSPECTOR SHALL CONTINUOUSLY INSPECT ENTIRE FLUSHING AND GROUTING PROCEDURE AND TEST GROUT FLOW WITH DRILLED VERIFICATION HOLES AND/OR NONDESTRUCTIVE METHODS.
5. TESTING LABORATORY SHALL TEST GROUT SAMPLES FOR COMPRESSIVE STRENGTH.
6. HORIZONTAL SPACING OF INJECTION PORTS IS BASED ON THE ASSUMPTION THAT CLOSED END MASONRY UNITS ARE USED. WHERE OPEN END UNITS ARE USED, SPACING MAY BE INCREASED.
7. ENHANCEMENT PROCEDURE MAY BE USED TO FILL VOIDS IN CAVITY WALLS, WALLS WITH RUBBLE CORES AND BEHIND VENEERS.

Figure D-1: Grout and Epoxy Injection

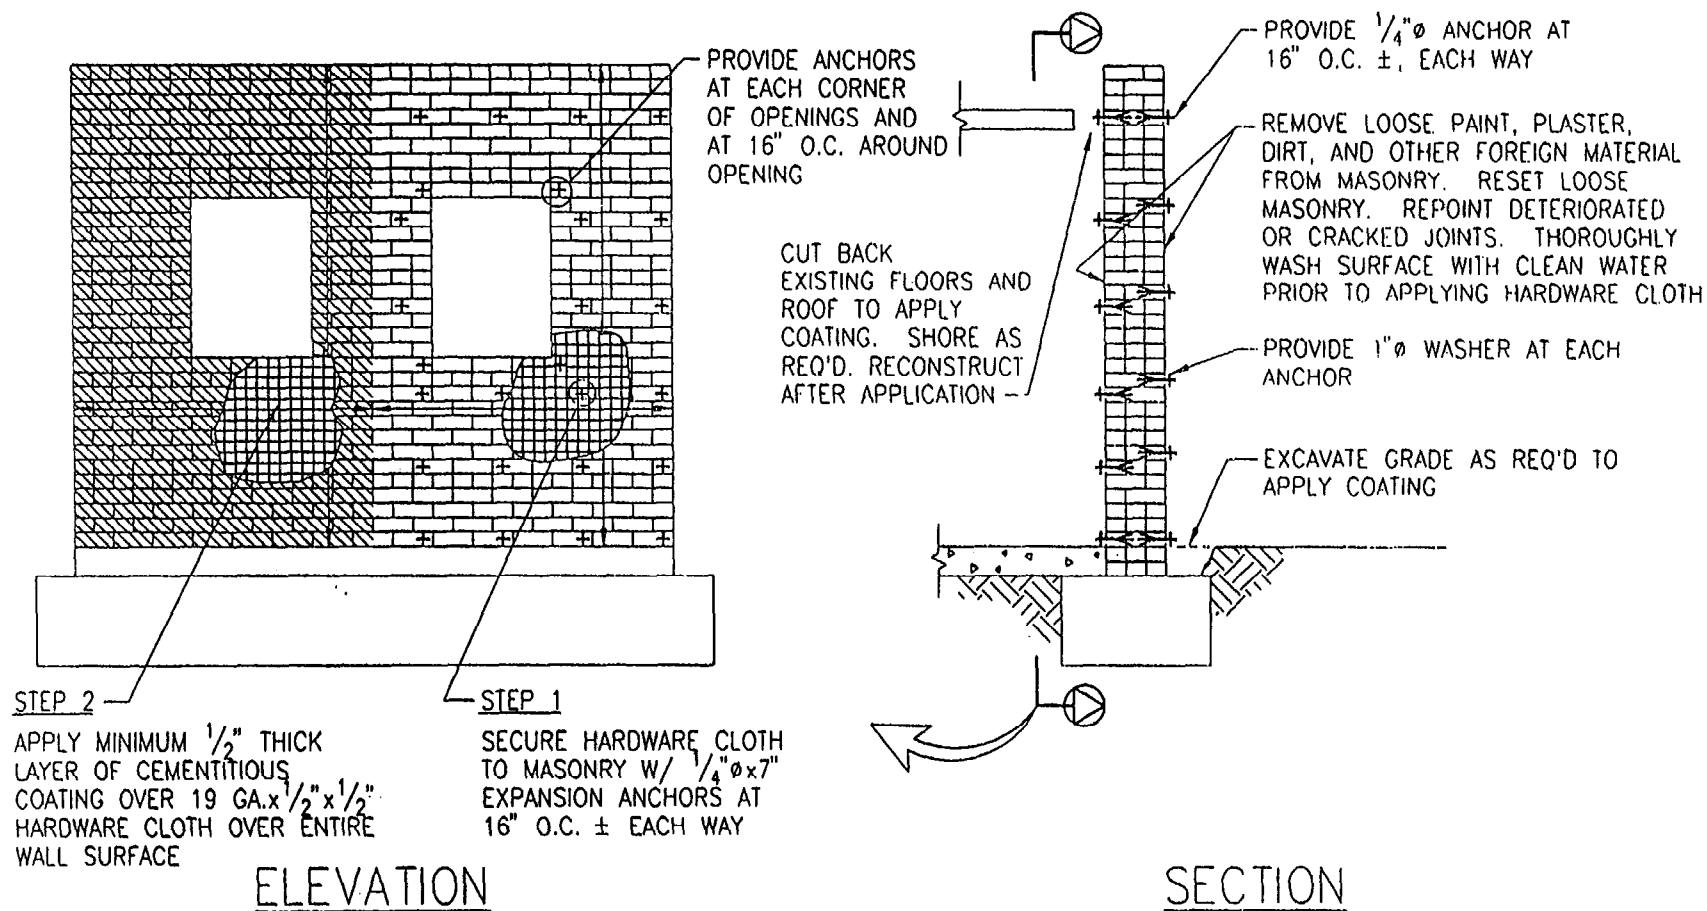
1. COAT BOTH INTERIOR AND EXTERIOR SURFACES.
2. COATING COMPOSITION IS 1 PART TYPE I OR II PORTLAND CEMENT TO 3 PARTS CLEAN SAND. ADD CLEAN WATER TO ACHIEVE THE CONSISTENCY OF PLASTER.
3. ON-SITE SPECIAL INSPECTOR SHALL INSPECT FINAL SURFACE PREPARATION, HARDWARE CLOTH INSTALLATION AND COATING APPLICATION.
4. TESTING LABORATORY SHALL TEST CEMENTITIOUS PLASTIC SAMPLES FOR COMPRESSIVE STRENGTH.

Figure D-2: Surface Coatings

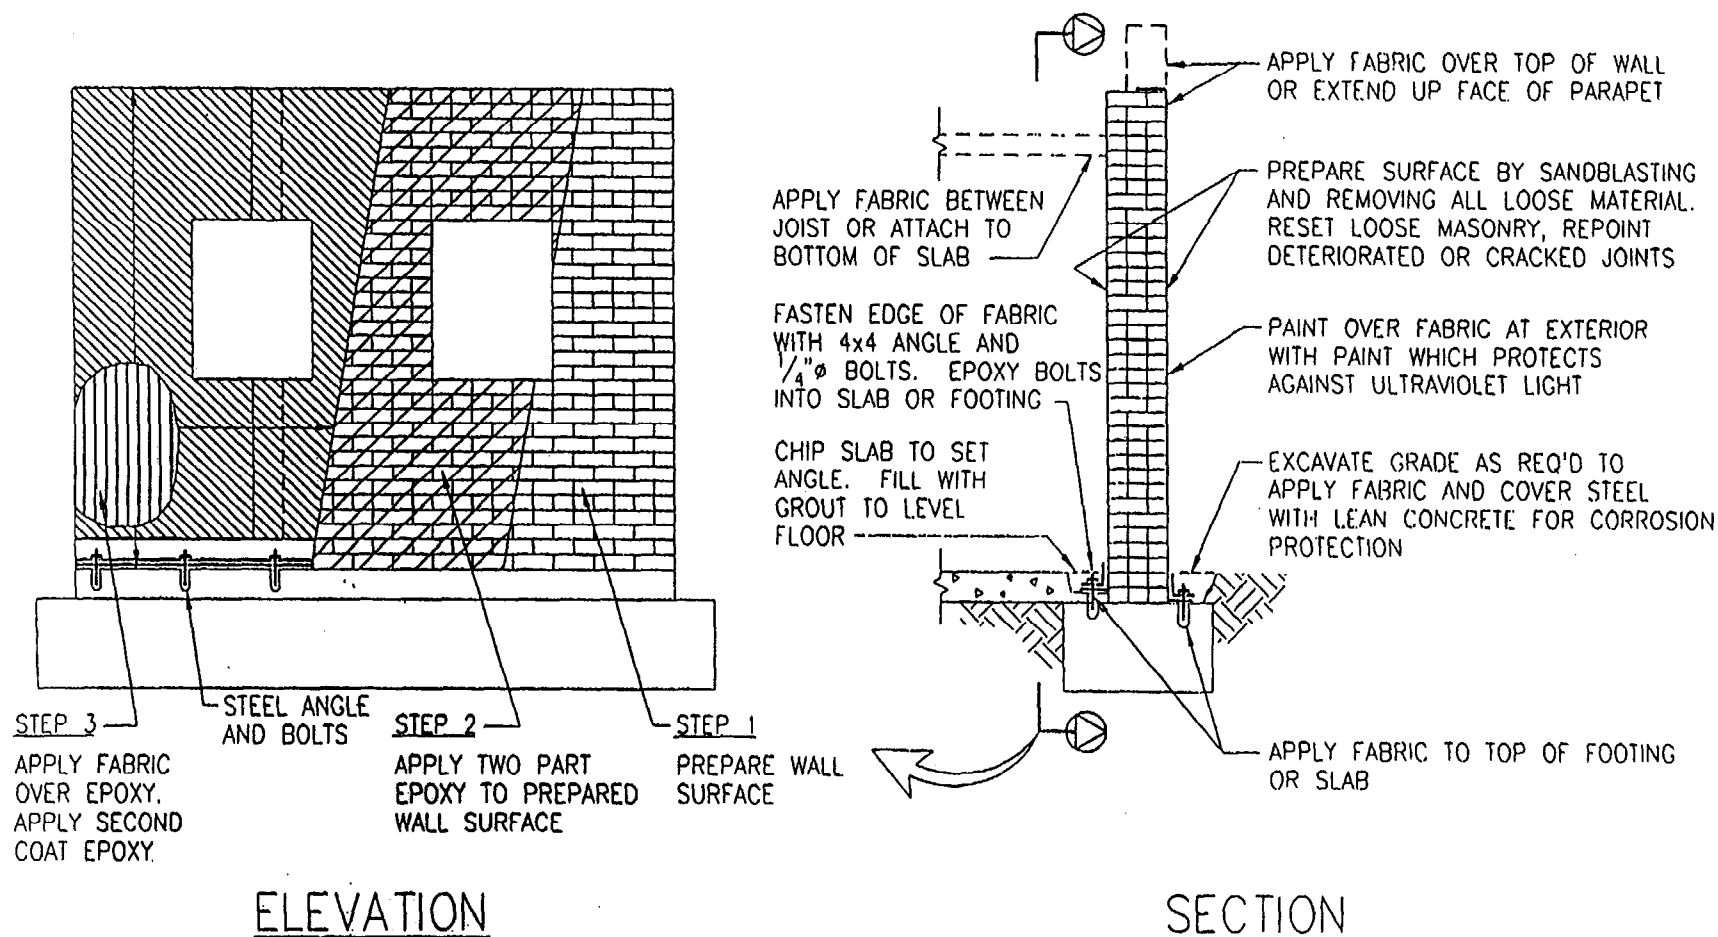
1. COAT INTERIOR AND EXTERIOR SURFACES.
2. ON-SITE SPECIAL INSPECTOR SHALL INSPECT SURFACE PREPARATION, FABRIC APPLICATION AND ANGLE INSTALLATION.
3. FABRIC IS HIGH STRENGTH FIBER MATERIAL, SUCH AS FIBERGLASS OR FIBER COMPOSITE

Figure D-3: Adhered Fabrics

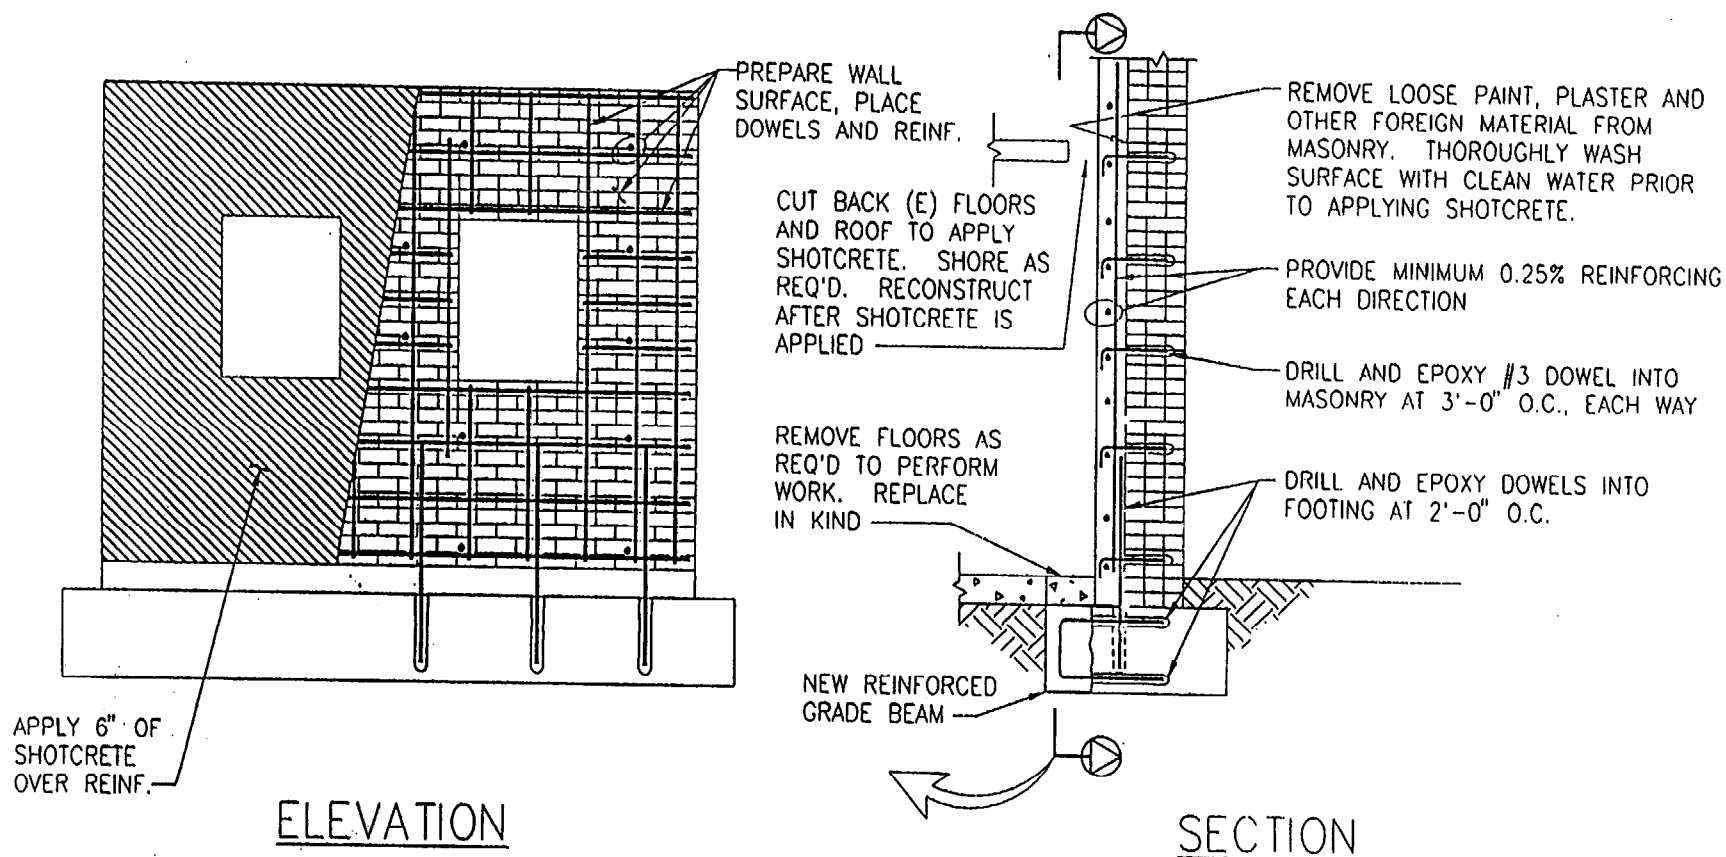
1. A TEST PANEL MOCKUP SHALL BE MADE. SPECIAL INSPECTOR SHALL INSPECT TEST PANEL REBAR AND SHOTCRETE PLACEMENT.
2. ON-SITE SPECIAL INSPECTOR SHALL INSPECT ALL DOWEL AND REINFORCING STEEL INSTALLATION, CONCRETE PLACEMENT AND SHOTCRETE PLACEMENT.
3. TESTING LABORATORY SHALL TORQUE TEST 10% OF DOWELS AND TEST CONCRETE FOR STRENGTH.

Figure D-4: Shotcrete Overlay

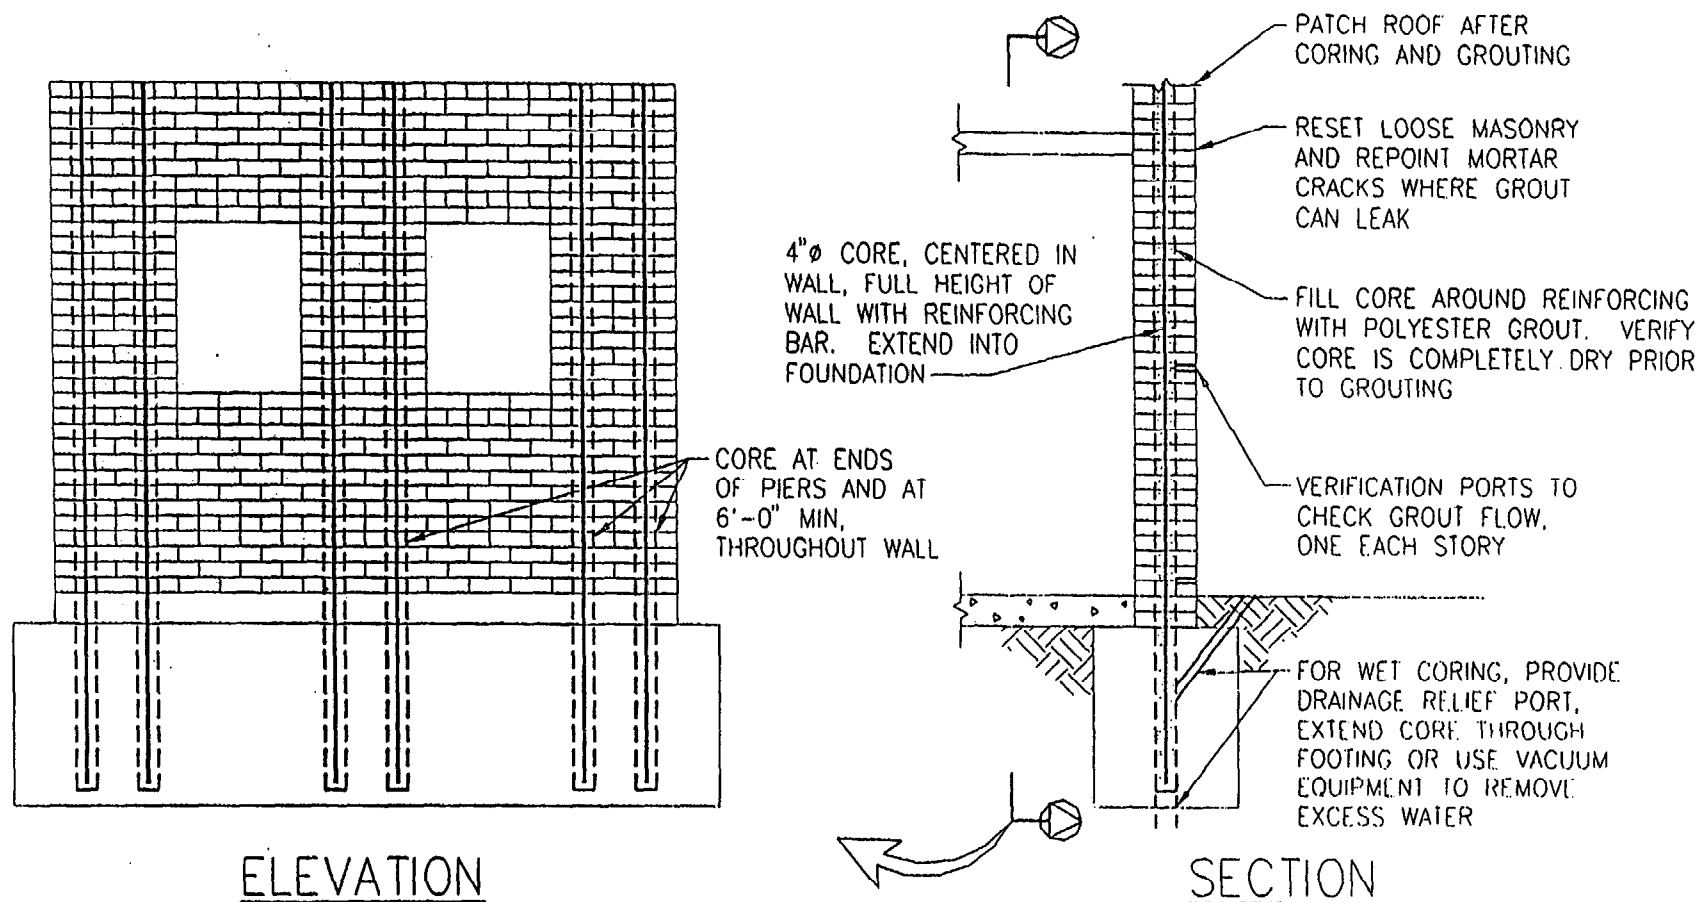
1. ON-SITE SPECIAL INSPECTOR SHALL INSPECT CORES, REINFORCING STEEL, GROUT MIXTURE AND PLACEMENT.
2. TESTING LAB SHALL TEST GROUT SAMPLES FOR COMPRESSIVE STRENGTH.
3. CORES MAY BE DRILLED WITH WET OR DRY DRILLING EQUIPMENT. FOR DRY CORING, PROVIDE DUST PROTECTION. FOR WET CORING, VERIFICATION HOLES ALSO SERVE AS DRAINAGE RELIEF PORTS.
4. NON-SHRINK CEMENTITIOUS GROUT MAY BE USED IN LIEU OF POLYESTER GROUT. FLUSH WITH WATER PRIOR TO GROUTING.

Figure D-5: Reinforced Cores

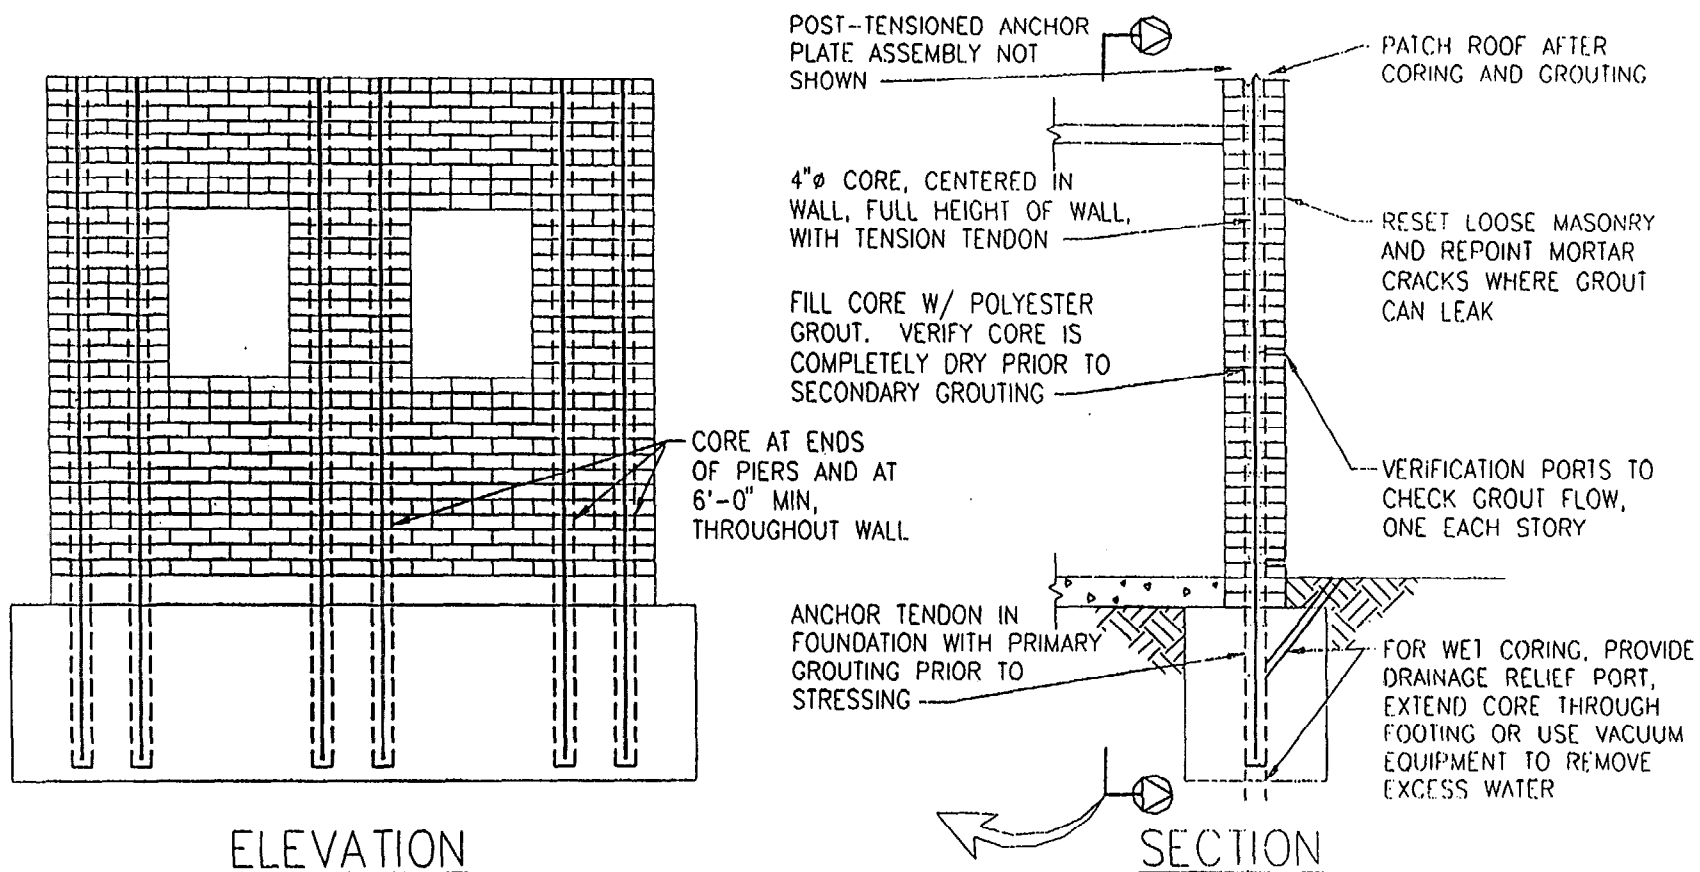
1. ON-SITE SPECIAL INSPECTOR SHALL INSPECT CORES, PLACEMENT AND STRESSING OF TENDONS, GROUT MIXTURE AND PLACEMENT.
2. TESTING LAB SHALL TEST GROUT SAMPLES FOR COMPRESSIVE STRENGTH.
3. CORES MAY BE DRILLED WITH WET OR DRY DRILLING EQUIPMENT. FOR DRY CORING, PROVIDE DUST PROTECTION. FOR WET CORING, VERIFICATION HOLES ALSO SERVE AS DRAINAGE RELIEF PORTS.
4. NON-SHRINK CEMENTITIOUS GROUT MAY BE USED IN LIEU OF POLYESTER GROUT. FLUSH WITH WATER PRIOR TO GROUTING.

Figure D-6: Post-Tensioned Masonry

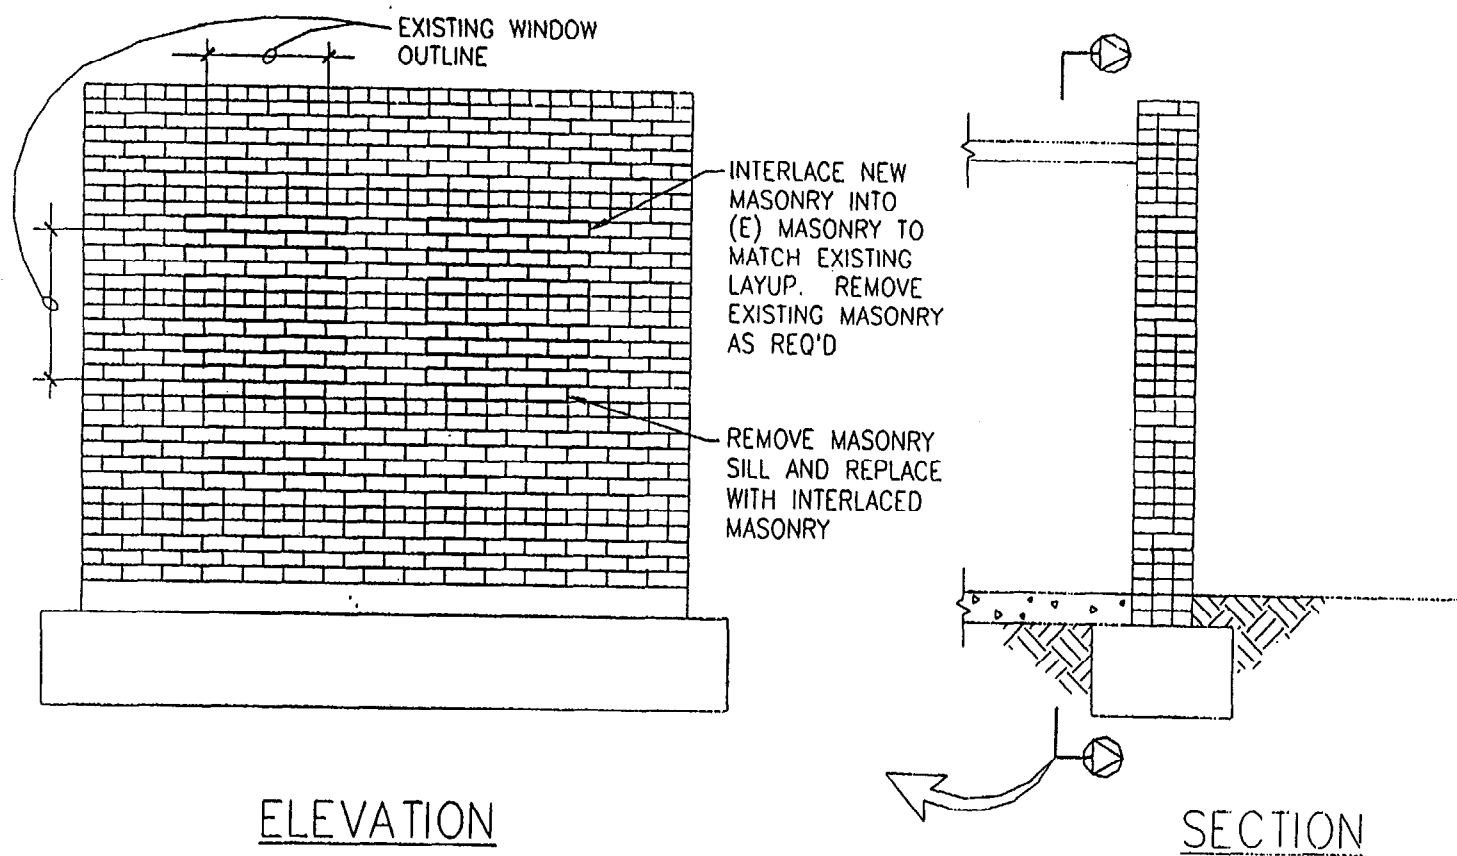
1. NO SPECIAL INSPECTION REQUIRED.
2. SIZE AND STRENGTH OF NEW MORTAR AND MASONRY TO CLOSELY MATCH EXISTING MORTAR AND MASONRY.

Figure D-7: Infilled Openings

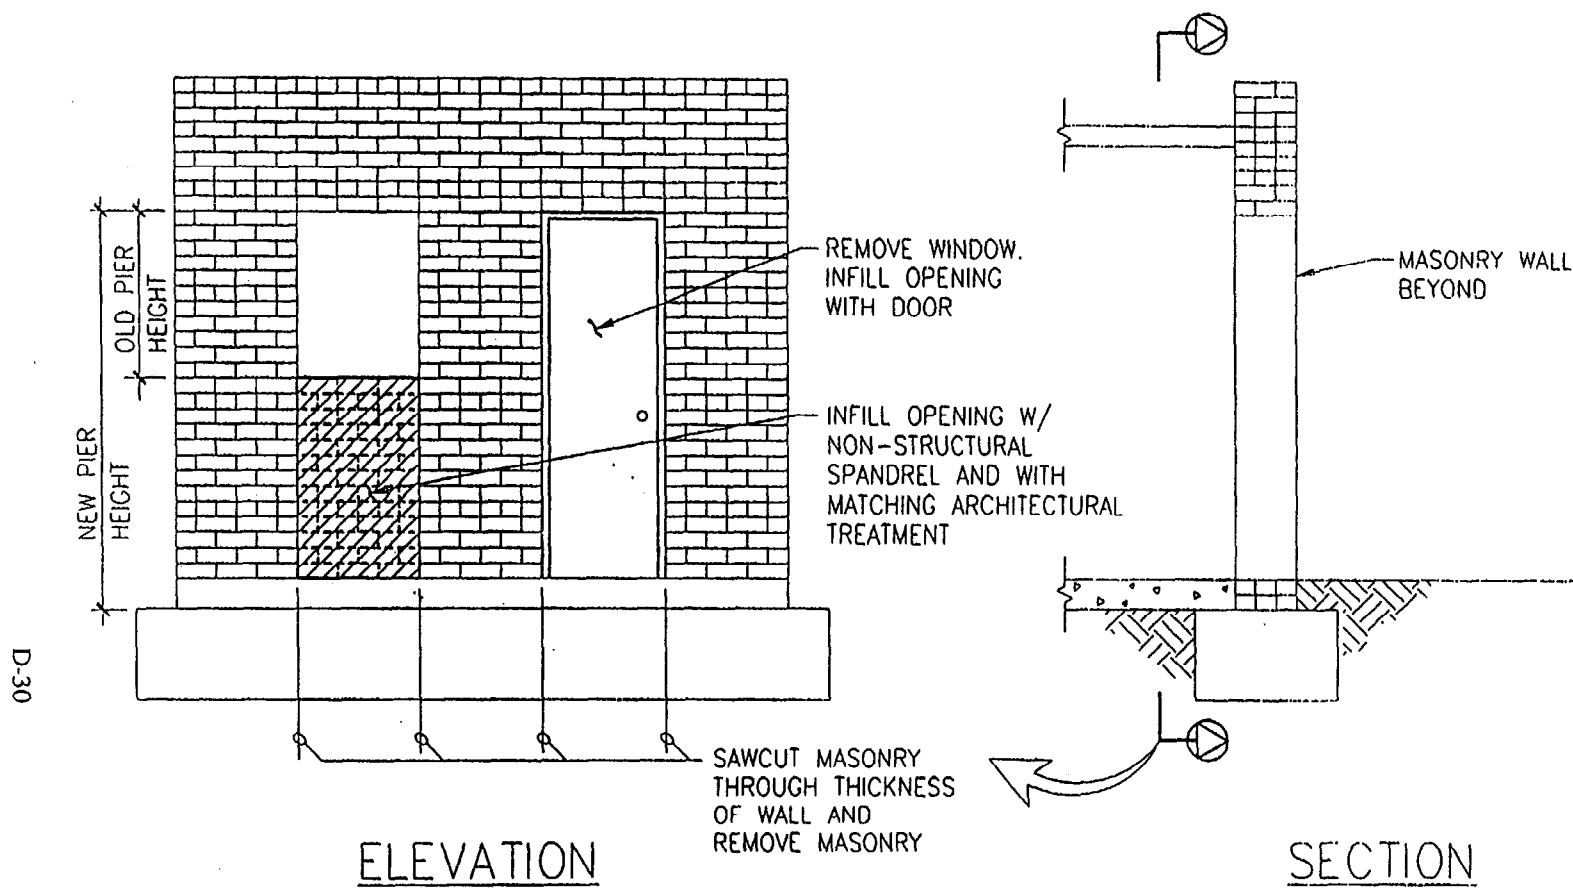
Figure D-8: Enlarged Openings

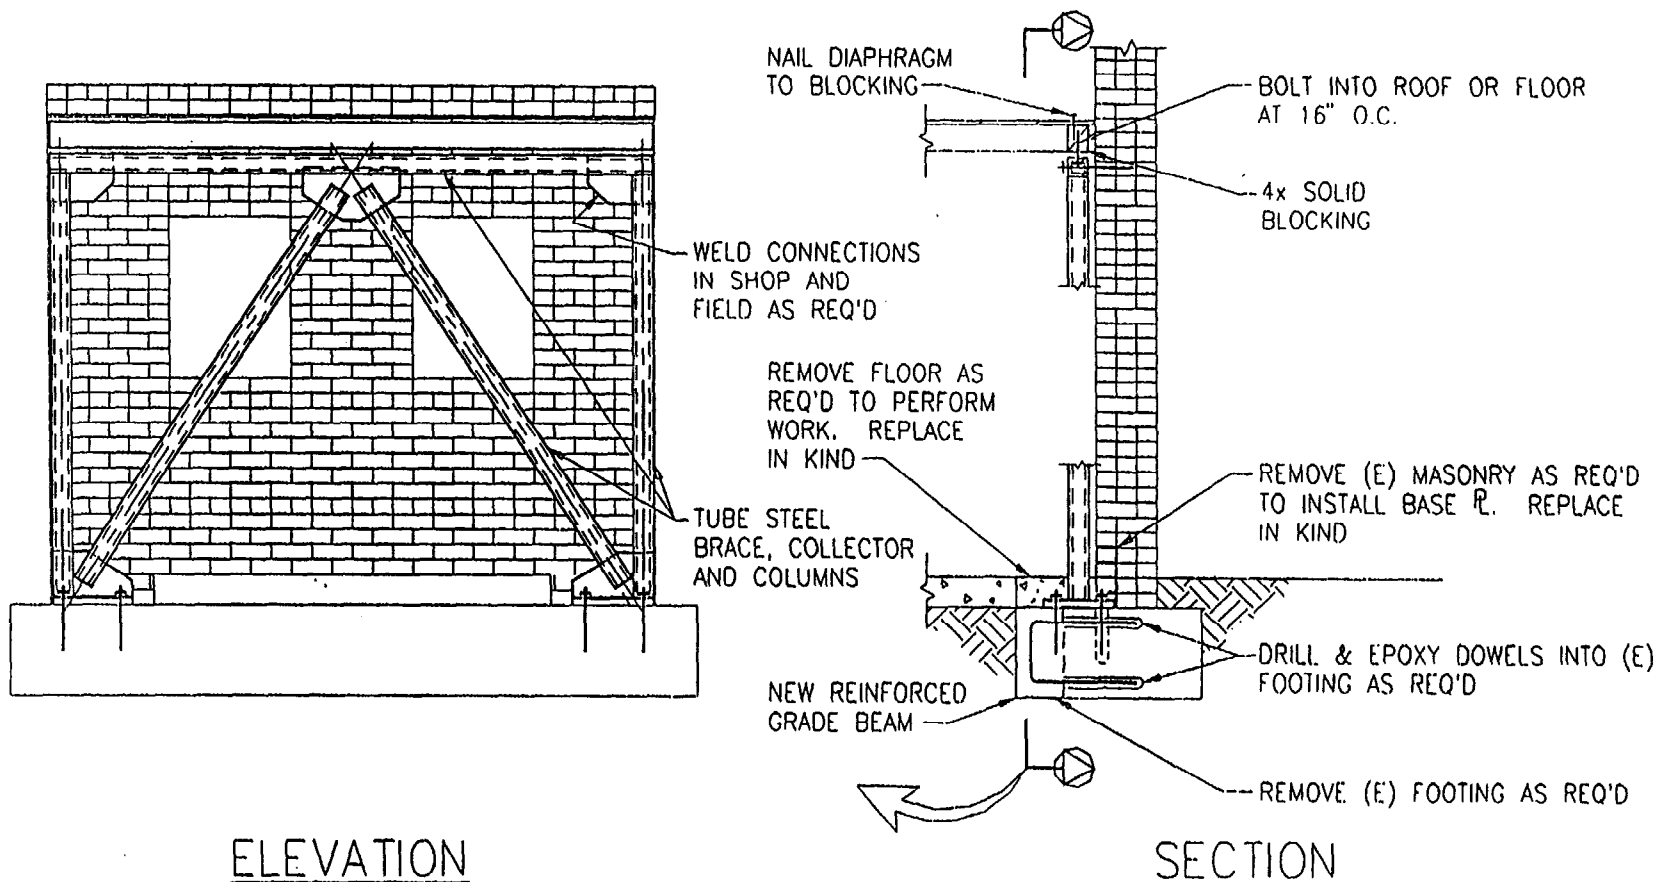
1. SPECIAL INSPECTOR SHALL REVIEW STEEL MILL CERTIFICATES AND WELDING PROCEDURE SPECIFICATIONS AND SHALL INSPECT SHOP WELDING.
2. ON-SITE SPECIAL INSPECTOR SHALL INSPECT CONCRETE REINFORCING, CONCRETE PLACEMENT AND FIELD WELDING.
3. 'X' BRACING AND DIAGONAL BRACING ARE FREQUENTLY USED IN ADDITION TO CHEVRON BRACING.

Figure D-9: Steel Bracing

Cost Estimate and Assumptions: Assuming bracing as shown in Figures D-9 and D-11 constructed on each end of the prototypical building, and limited foundation strengthening, the estimated cost of the enhancement technique for the prototypical building is \$9.29 to \$17.03 per square foot. The estimated cost of special inspection and testing is \$0.35 per square foot.
