NIST GCR 97-724-2

APPENDICES: Development of Procedures to Enhance the Performance of Rehabilitated URM Buildings

Bret Lizundia, William T. Holmes, Margaret Longstreth, and Alan Kren
Rutherford & Chekene
303 Second Street, Suite 800 North
San Francisco, California 94107

APPENDIX A

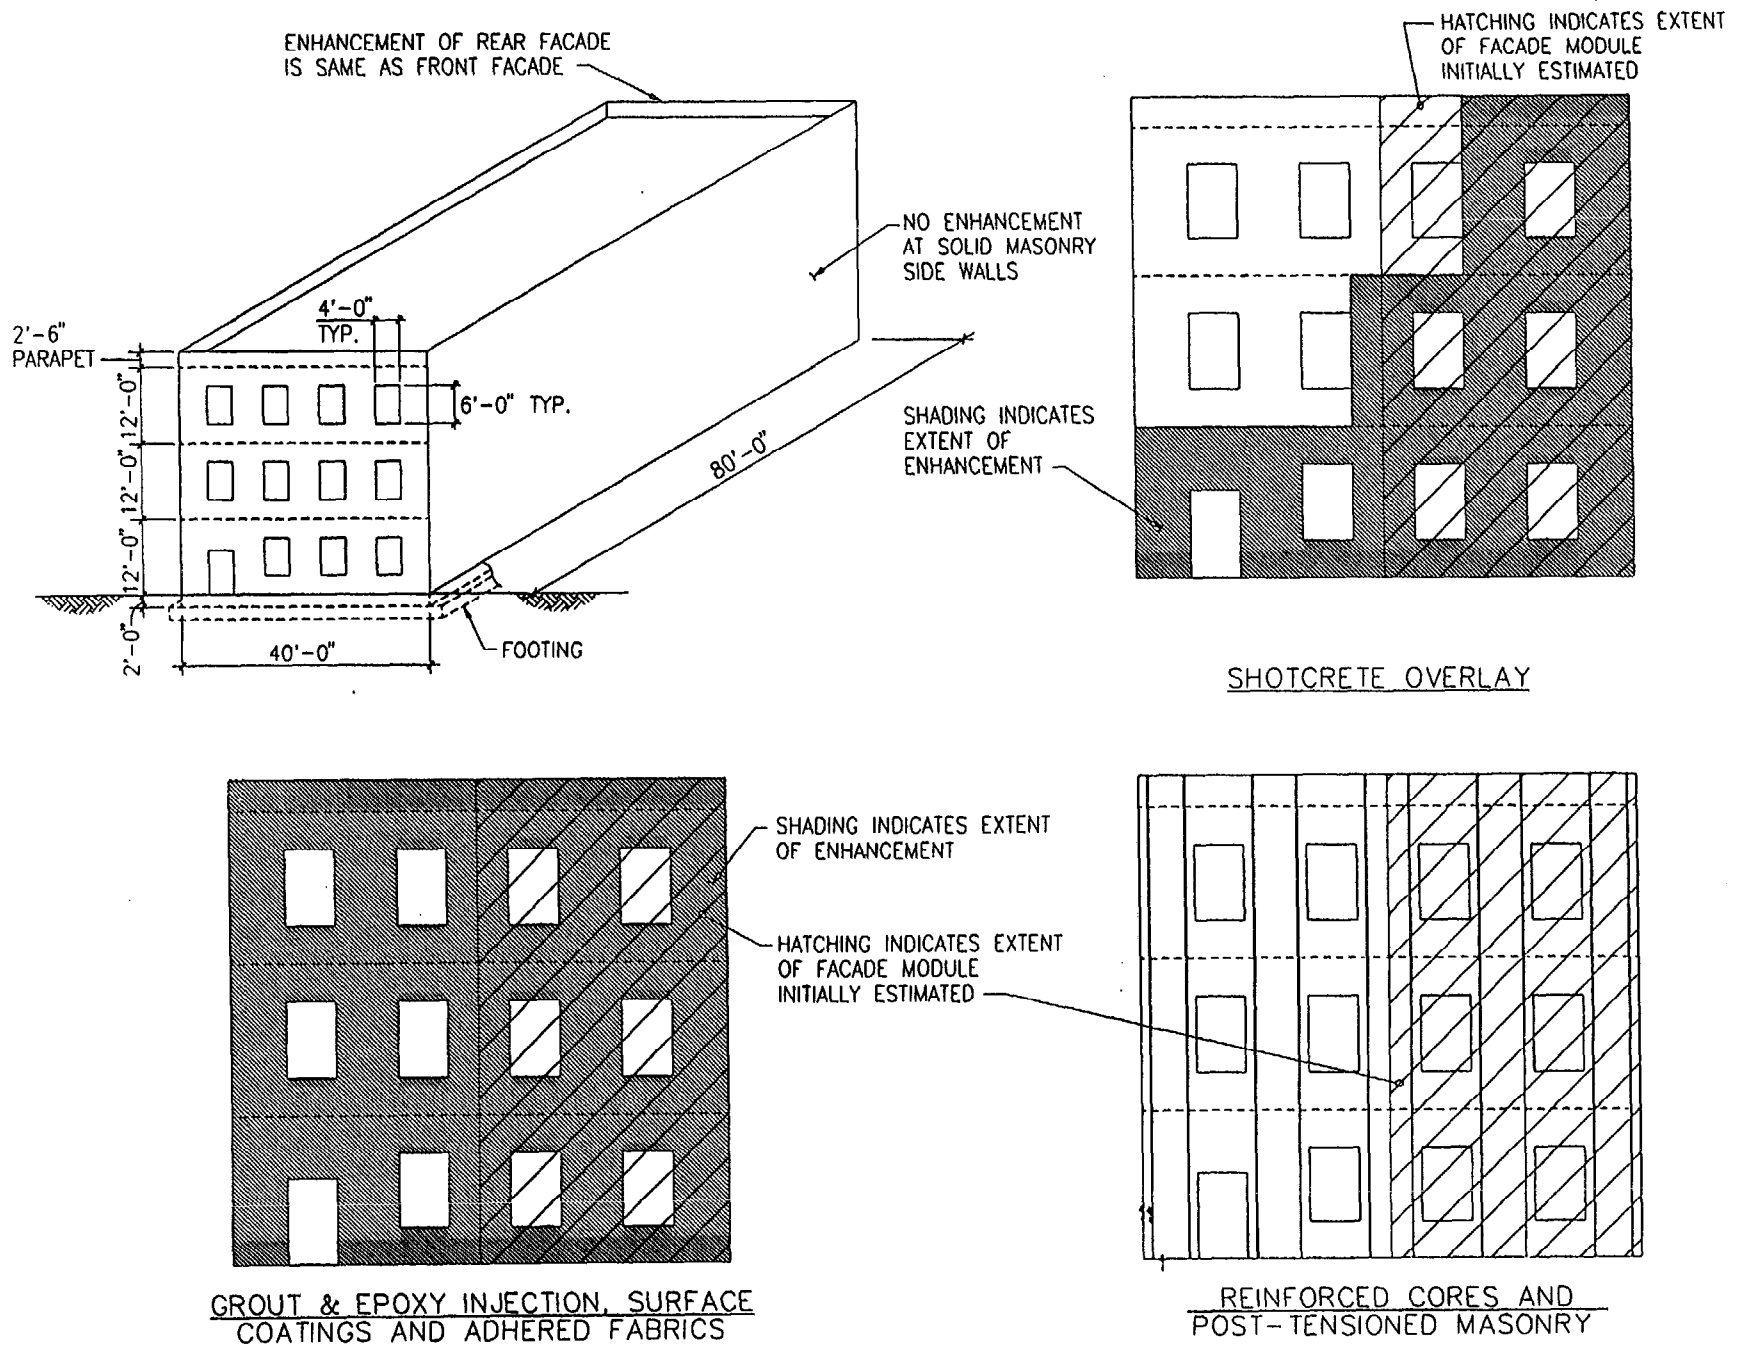
Figure D-10 : Model Building and Facades

Cost Estimate and Assumptions: Assuming bracing as shown in Figures D-9 and D-11 constructed on each end of the prototypical building, and limited foundation strengthening, the estimated cost of the enhancement technique for the prototypical building is \$9.29 to \$17.03 per square foot. The estimated cost of special inspection and testing is \$0.35 per square foot.

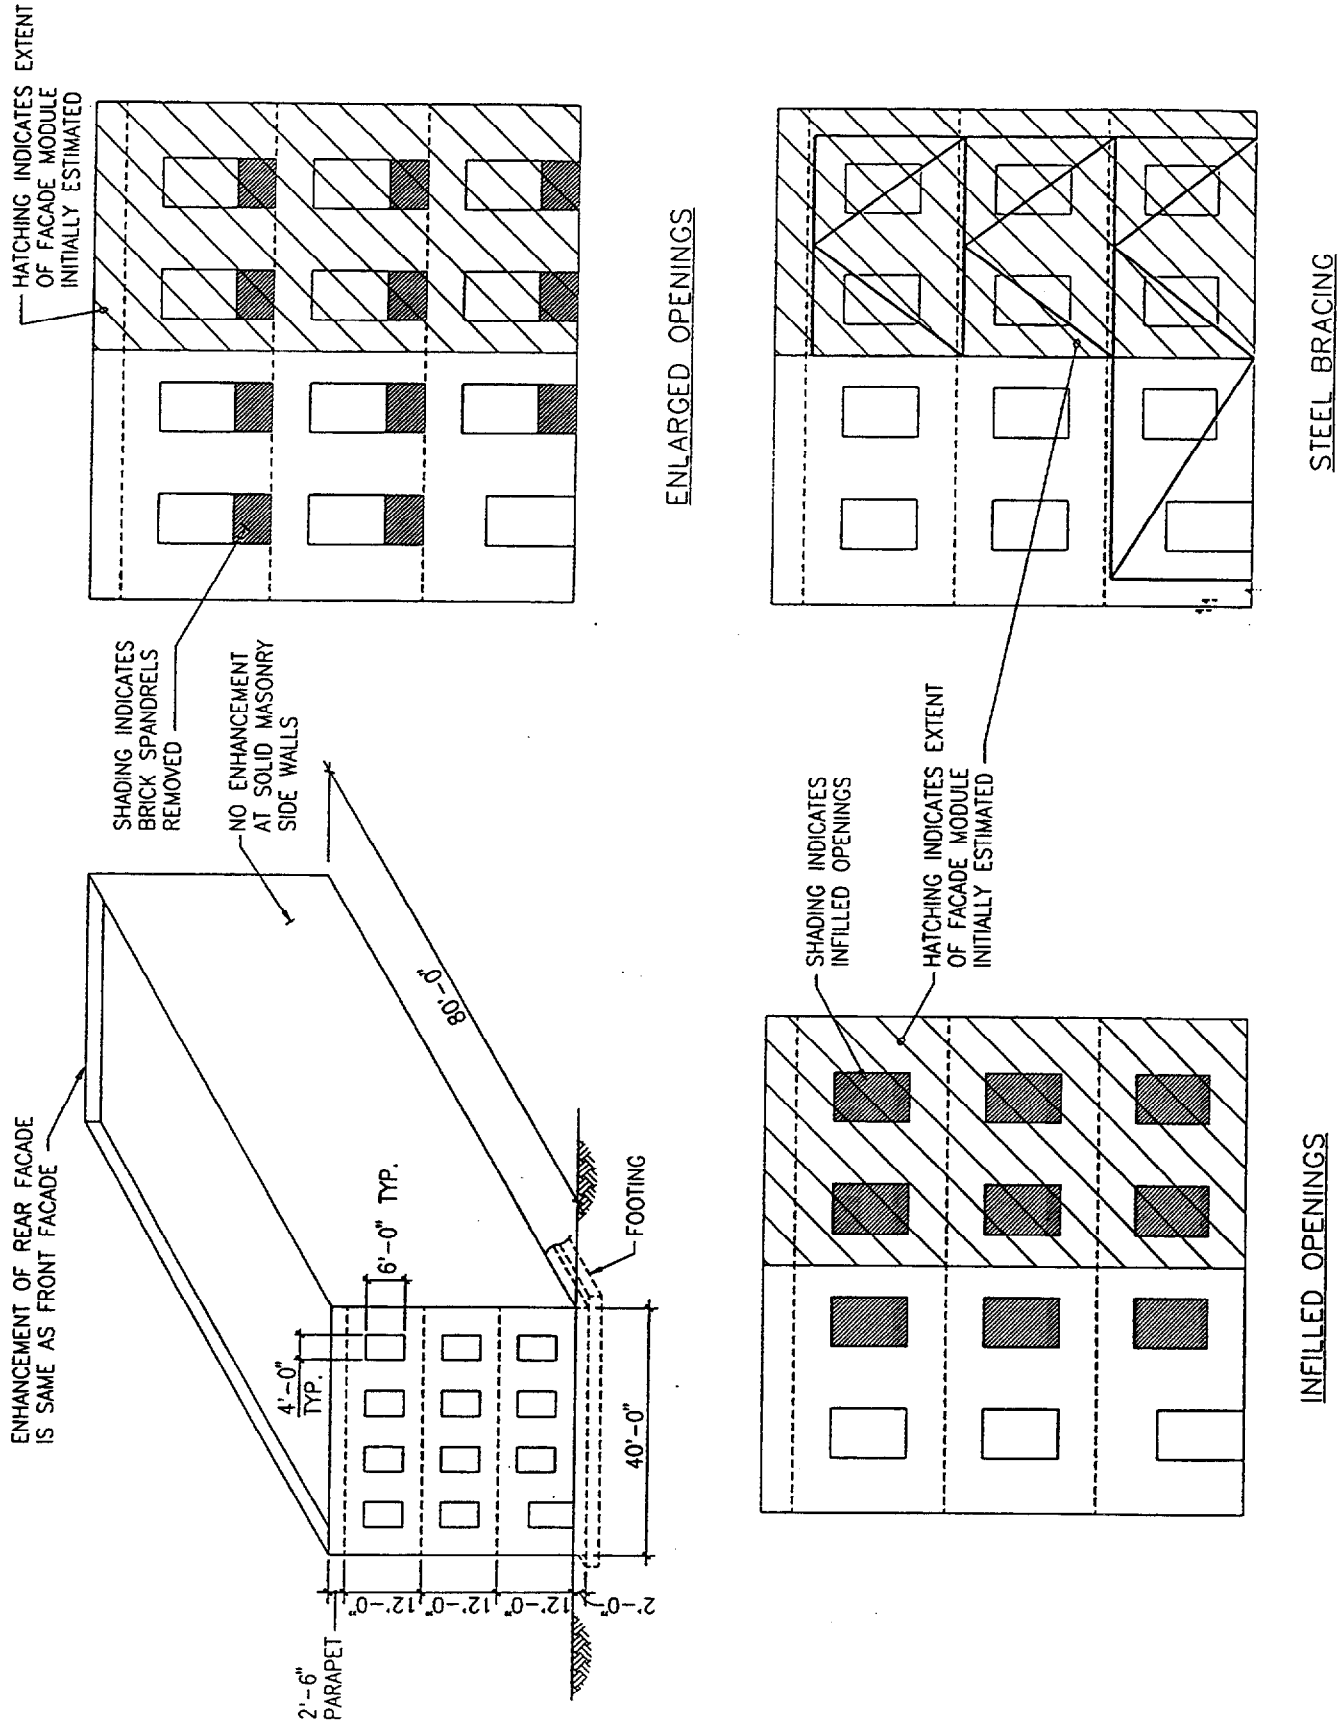
Figure D-11 : Model Building and Facades
