Daniel Brandon, *Research Institutes of Sweden*;

Experimental study of fire-induced-delamination of cross laminated timber

Introduction

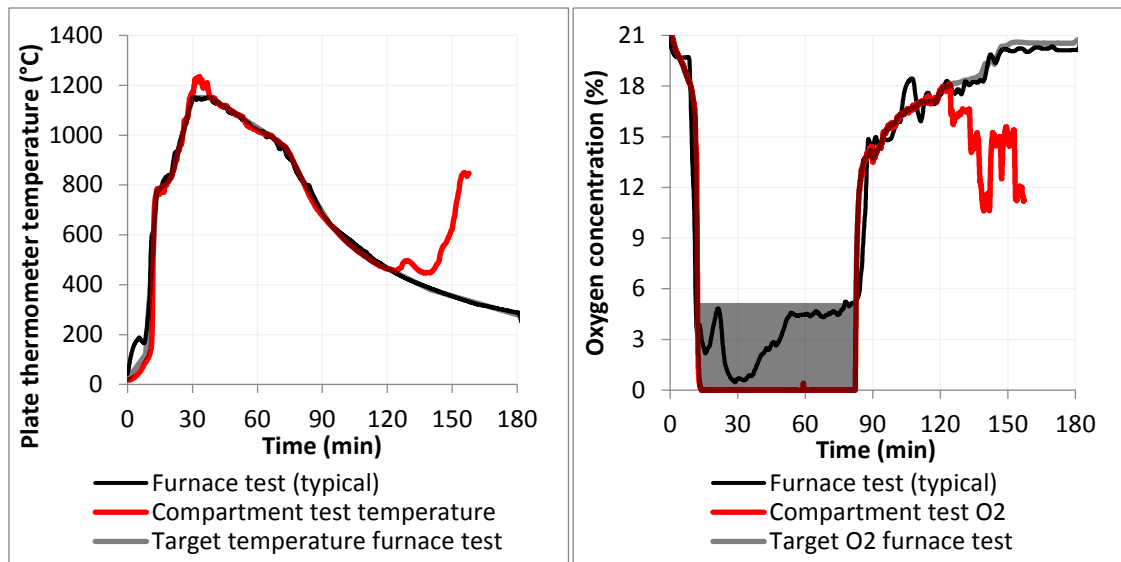
Figure 2: Temperatures and oxygen concentrations of the furnace and compartment tests.

The intermediate scale tests were performed in a furnace with internal dimensions of 1.0 m × 1.0 m and the CLT specimen was placed above the furnace, as shown in Figure 1. Plate thermometers were facing away from the specimen positioned at 100 mm (which corresponded to the full-scale compartment test) and at 150 mm from the CLT surface. The oxygen concentration was measured in the exhaust of the furnace. The implemented plate thermometer temperatures and oxygen content were replicated from the full scale compartment fire tests during the first 120 minutes of the test. To achieve this, the oxygen content was adjusted by adding nitrogen or regular air into the furnace through an inlet, when needed. In the full scale compartment fire tests, delamination has led to fire regrowth after approximately 150 minutes. In order to identify delamination in the furnace test, the sudden temperature rise resulting from delamination observed at 150 minutes of the full-scale compartment fire test, was disregarded and the target temperature of the intermediate scale test was extrapolated for the last part of the test. The target oxygen concentration was also extrapolated after 120 minutes, using oxygen measurements of a similar fire test without delamination (see Figure 2).

The oxygen concentration and the plate thermometer temperature at 100 mm from the CLT surface were controlled to be similar to that of the full scale compartment fire test with an exposed CLT ceiling. In Figure 2 indicates the accuracy of this replication in a typical furnace test in which no CLT delamination took place.

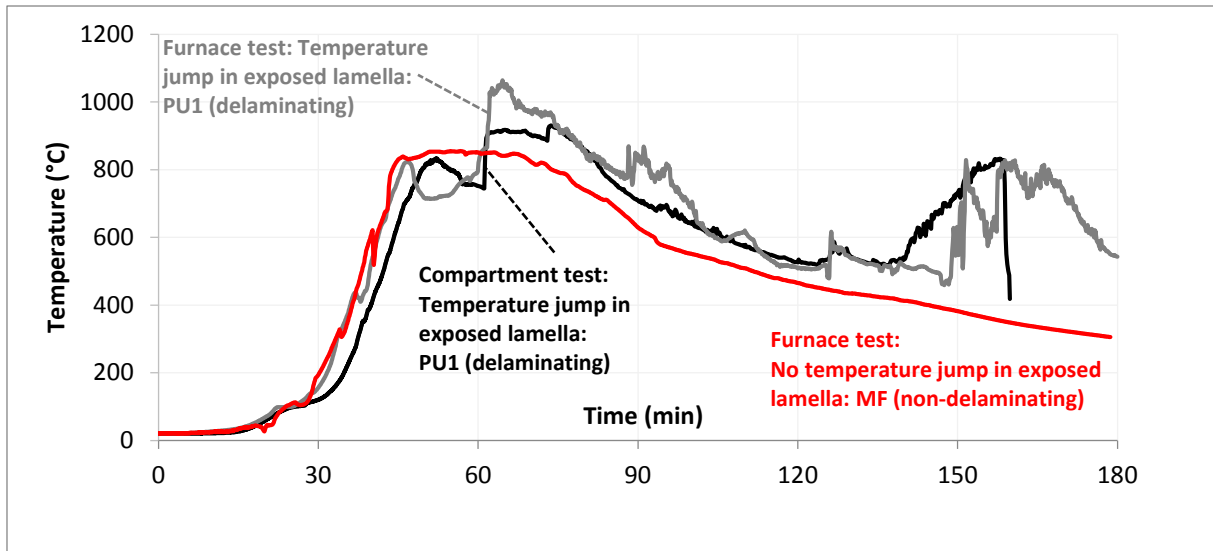
Figure 3: Typical temperatures of thermocouples inside CLT at 20 mm from the exposed surface (in the exposed lamella) of furnace tests and the compartment fire test.

The aim of the replication was to impose structural damage to the CLT in a relatively cheap intermediate scale furnace test that is comparable to the damage observed in the full scale compartment fire test. A comparative study of damages imposed on the CLT in both (compartment and furnace) was performed to evaluate whether this aim was achieved. In the full report [4] it was shown that the measured char depth in the CLT after the furnace test was within the range of the char depths measured in the CLT ceiling of the compartment. It was also shown that the temperatures measured in the CLT at different depths generally corresponded well between both tests if the same CLT was tested. Figure 3 shows temperatures inside CLT at a depth of 20 mm (measured from the exposed surface) for three different tests. The temperatures of the compartment test and the furnace test with PU1 adhesive followed a similar trend and values. Both tests involved a significant temperature jump of temperatures measured in the exposed lamella at around 60 minutes, indicating that delamination took place in both tests. It should be noted that the temperatures were measured in 12 locations in the exposed layer of lamellae and that there was a variation of times at which this significant temperature jump took place. Figure 4 shows box plots indicating this variability. The times at which temperature jumps occurred in the CLT of the furnace tests were approximately similar to those in the CLT of the compartment test, indicating that the fire exposure is comparable.

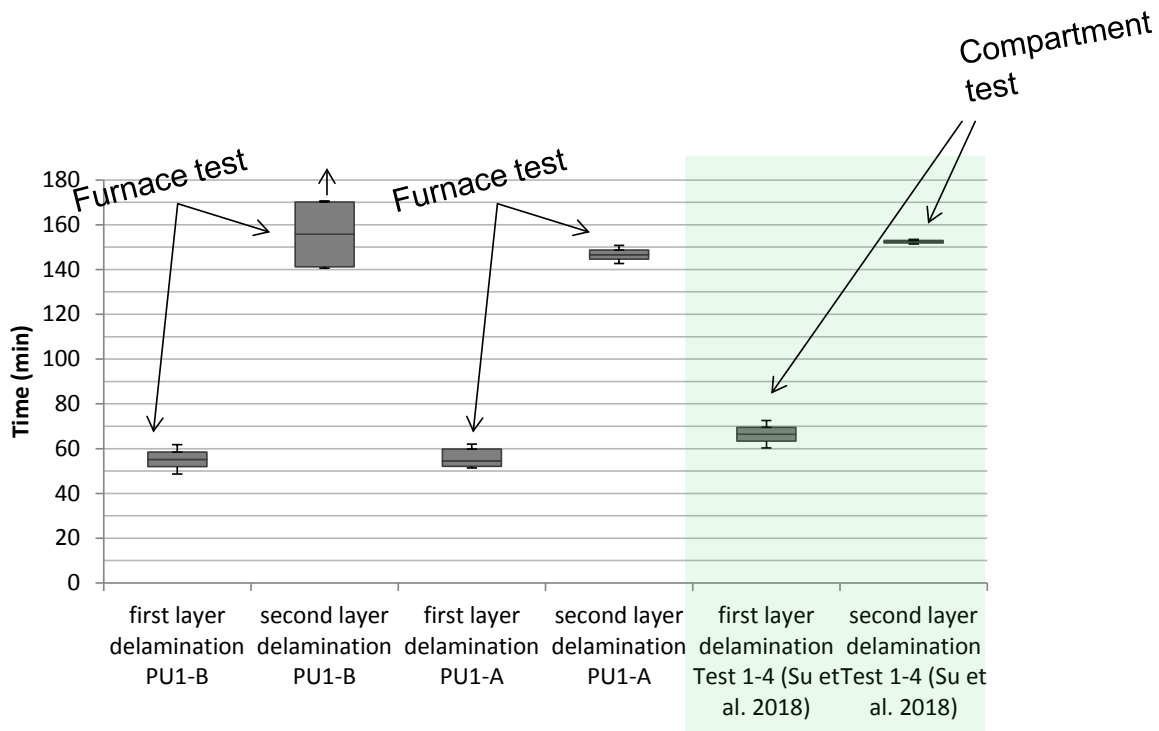
Figure 4: Times of temperature jumps measured in the bond line
