NIST Technical Note 2215

Characteristics of Nuclear Power Plant Fires Involving Electrical Enclosures

This report provides an overview of the characteristics (e.g., ignition sources, severity, and damage type) of electrical enclosure fires that occurred in US nuclear power plants between 1990 and 2011, as reported in the Fire Events Database (FEDB). Key findings are summarized below. Note: to provide a broader perspective on the causes and results of these events, this report provides an overview of *all* reported fire events in NPPs, including “non-challenging” events. Certain steps in probabilistic risk analyses may only consider the outcomes or results (e.g., ignition frequencies or fire size distributions) of a subset of these fires (e.g., “challenging” or “potentially challenging” events). For further information regarding fire ignition frequencies and non-suppression probability, the reader is referred to NUREG 2169. Additionally, the reader is referred to NUREG 2230 for further guidance regarding the analysis of fire risk posed by growing vs. interruptible fires.

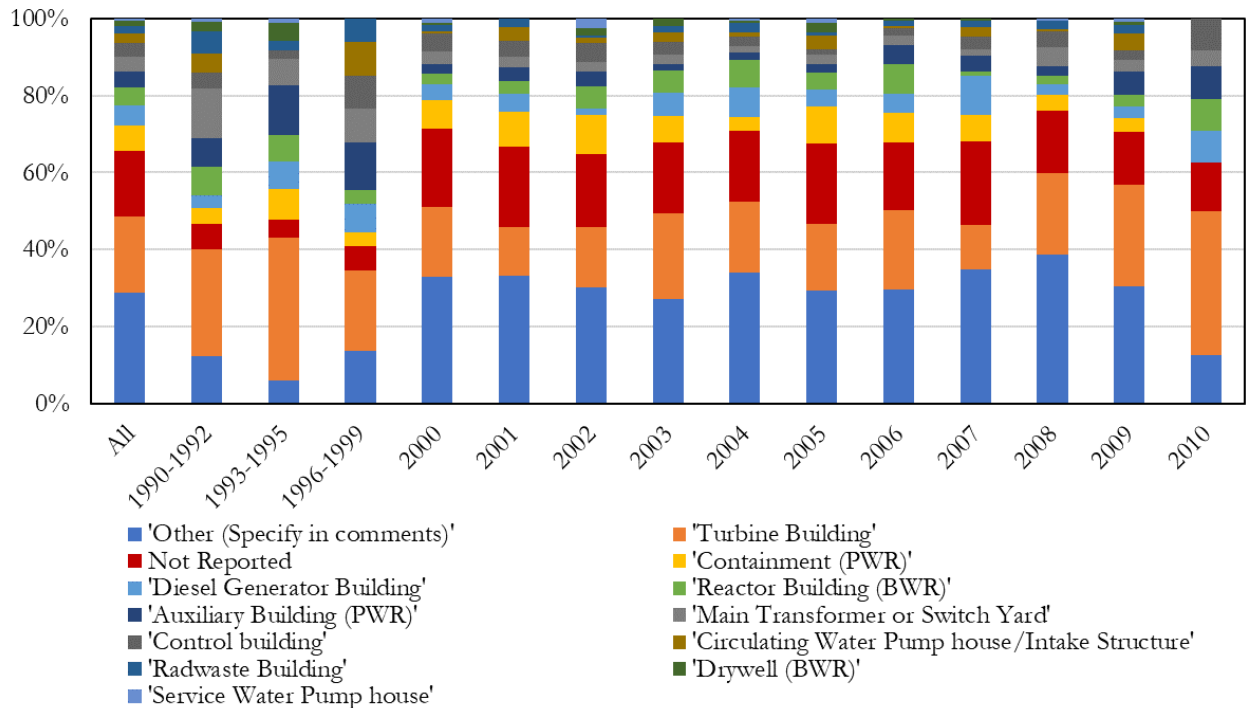
Figure 2. Starting location (“Building Start”) frequency of reported fire events in the FEDB by year

Figure 2 plots time-resolved frequencies for fire locations of reported events in the FEDB (i.e., fractions of events with a specific “Building Start” option out of all fire events recorded during that time period). Here, fire event frequencies are generally reported in one-year intervals except between 1990-1999; a longer time interval is used during these years to ensure that each interval contains at least 80 unique fire events (see Fig. 1), which allows for calculation of more meaningful distributions of event frequencies. Presented in this form, these results indicate no significant trend in fire location with time. That is, between 1990 and 2011, no single “Building Start” location shows a consistent increase or decrease in reported fire event frequency. Beginning in the year 2000, fire event location was three times more likely to be reported as ‘Other’ or ‘Not Reported’ as compared to from events in the FEDB reported prior to the year 2000. Tabulated values for the information plotted in Fig. 2 are available in Table A1 of Appendix A.

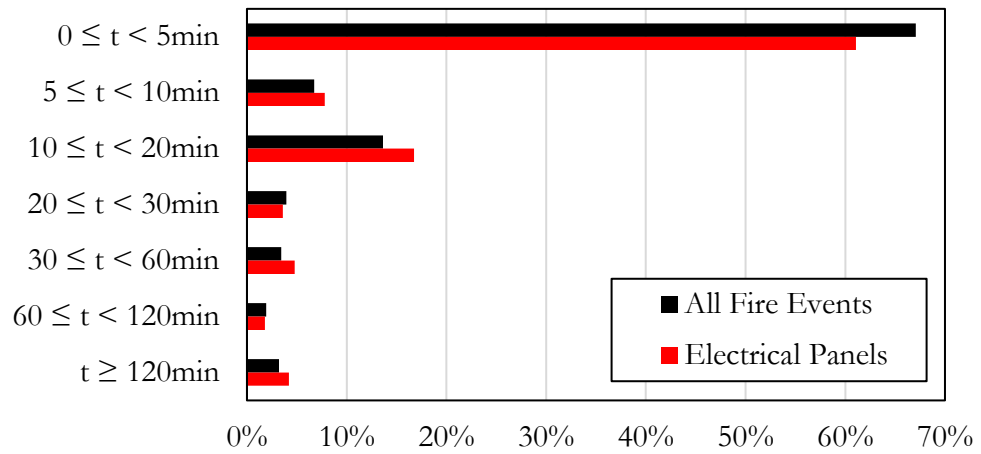
Figure 14. Duration of fire events reported in the FEDB: Comparison between all reported events and those starting in electrical panels.
