The ASTM Copper Strip Corrosion Test: Application to **Propane with Carbonyl Sulfide and Hydrogen Sulfide**

Wendy C. Andersen, Aziz I. Abdulagatov, and Thomas J. Bruno*

Physical and Chemical Properties Division, National Institute of Standards and Technology, 325 Broadway, Boulder, Colorado 80305-3328

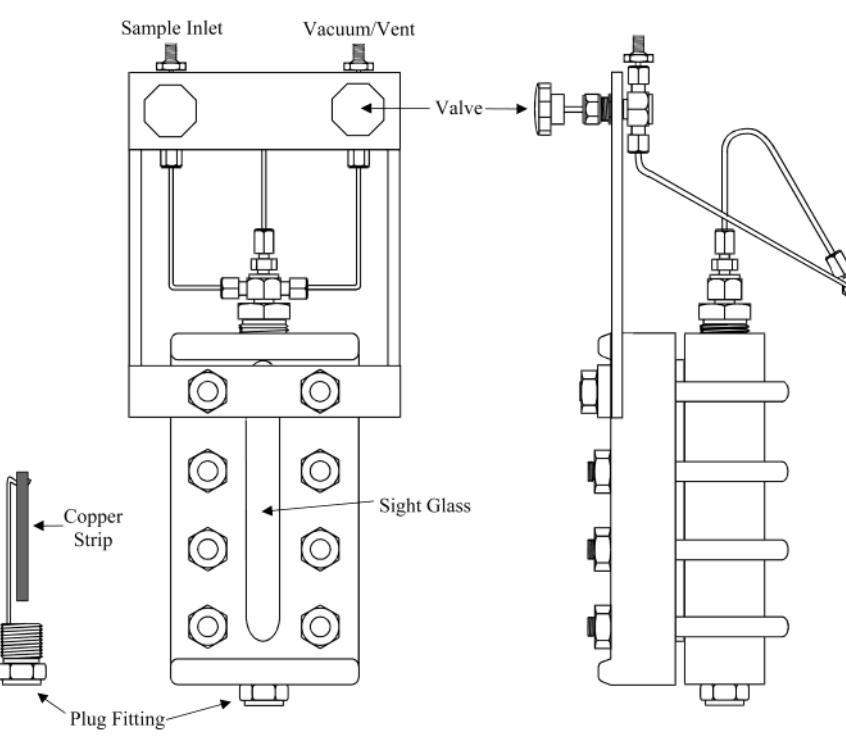
Figure 1. Apparatus used for copper strip corrosion testing.

gauge equipped with a type 316 stainless steel body, and capable of operation to 8.3 MPa (1200 psig) at 38 °C (100 °F) (Figure 1). The sight glass gauge was used instead of the commercial vessel proposed by ASTM guidelines in order to allow observation of the liquid level in the filled container. A type 316 stainless steel pipe plug at the bottom of the sight glass gauge was fitted with a length of type 316 stainless steel rod terminated in a hook, upon which the prepared copper strip was suspended. The apparatus was furnished with a manifold to allow filling, evacuation, and venting. A well-stirred water bath (sized with a favorable filling factor to accommodate the sight glass gauge was thoroughly cleaned and the final rinse was done with distilled, deionized water.

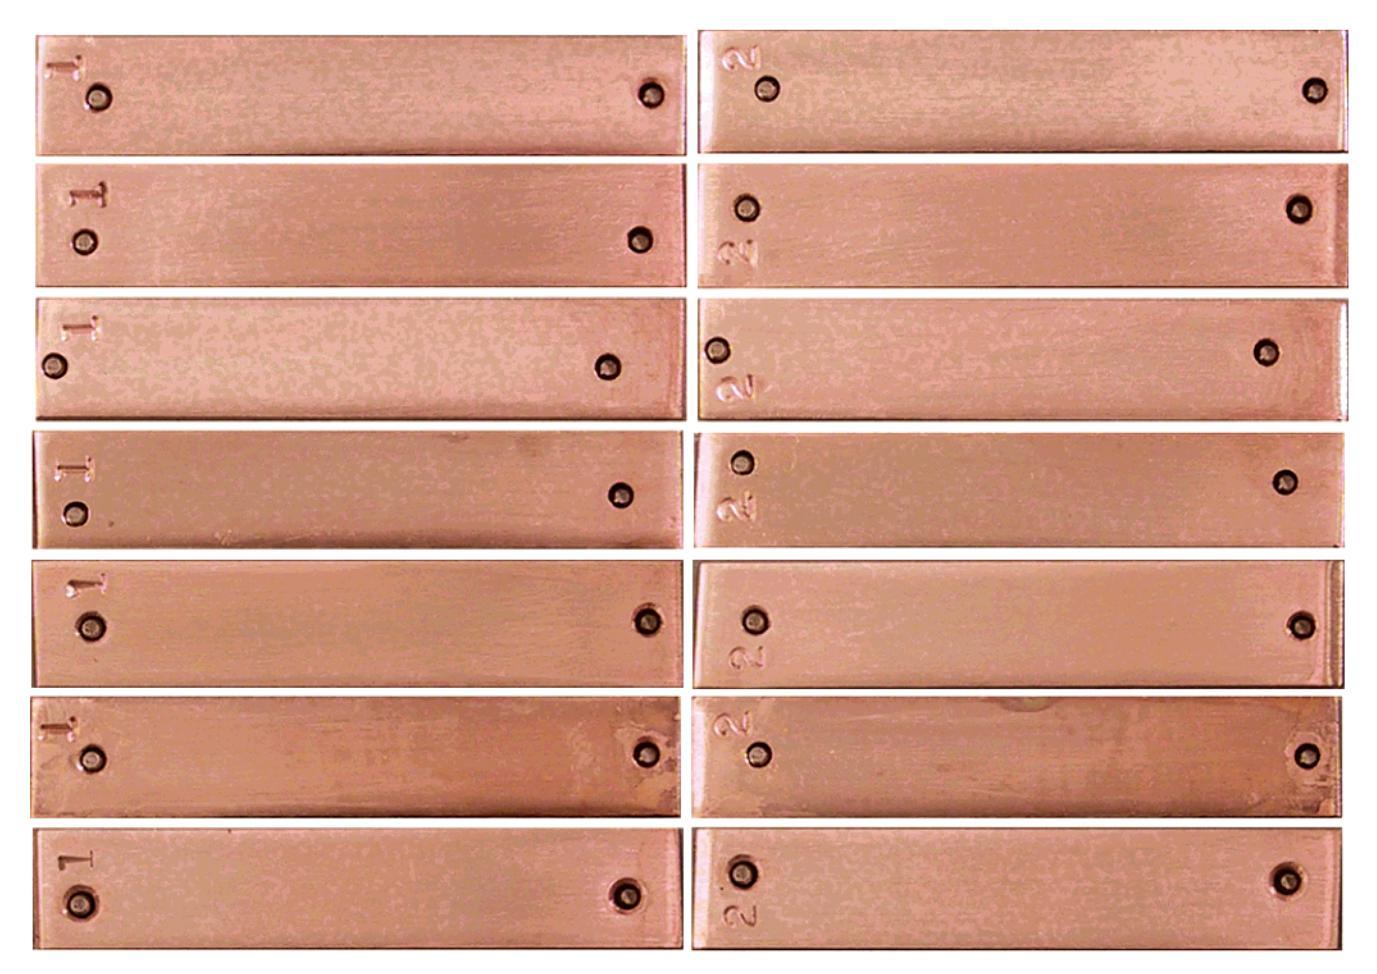
Figure 2. Post-corrosion test images of copper strips (side 1 and 2) are shown after exposure to mixtures with COS concentrations (ppm, mass/mass) from top: 0, 500, 750, 1000, 500 (2 h test), 1000 (2 h test), 1000 (commercial grade propane).

purity propane. Samples of the ultra high purity propane (with no added COS) were also subjected to the corrosion test. Figure 2 represents the before and after images of the COS + propane mixtures, and Table 2 summarizes our interpretation of corrosion levels. The pure propane produced a copper strip indistinguishable from the freshly polished strip. The copper strip exposed to the 500 ppm (mass/mass) mixture was also recovered unchanged from the pristine strip, and therefore was rated "0" (actually not ratable on the ASTM scale). For the 750 and 1000 ppm (mass/mass) mixtures, the copper strips were recovered from the test in a condition barely

discernible from the pristine strip, and were given an ASTM 1a classification. Duplicate mixtures of 500 and 1000 ppm (mass/mass) COS were prepared and corrosion tested. There was no difference in test results for duplicate measurements. Additional mixtures of 500 and 1000 ppm (mass/mass) COS were tested for 2 h rather than the ASTM-specified 1 h. In both cases, the resulting copper strips were somewhat more tarnished than the strips from the 1 h test, with an ASTM classification of 1a for the 500 ppm (mass/mass) mixture and 1b for the 1000 ppm (mass/mass) mixture. In no case was a "failed" result obtained for a COS + propane mixture.

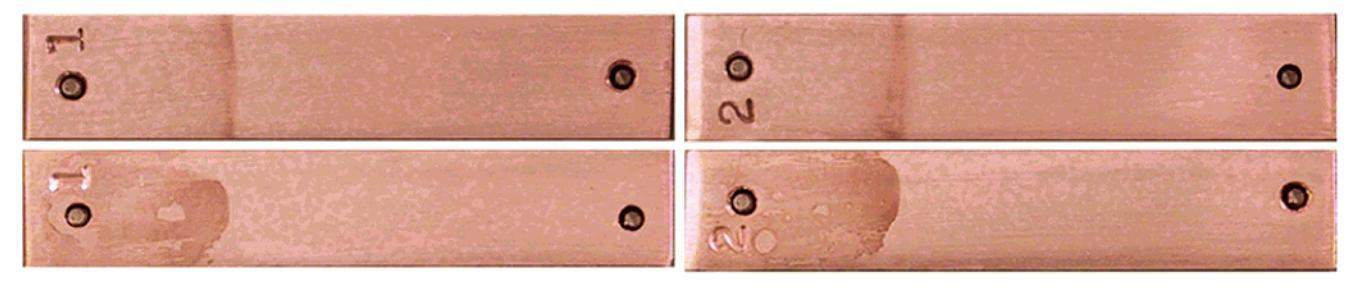
Figure 3. Post-corrosion test images of copper strips (sides 1 and 2) are shown after exposure to mixtures with COS concentrations of 500 (top) and 1000 (bottom) ppm (mass/mass). Lower (right) 2/3 of the strip was submerged in water.

Tests were also performed on 500 and 1000 ppm (mass/mass) mixtures where 20 mL of water was added to the test vessel. For these experiments, there was more corrosion present on the copper strip; however, neither of the concentrations produced more than an ASTM 1b rating (Figure 3). Our study of the COS hydrolysis reaction rate supports this observation, in which we found that the rate of COS hydrolysis is proportional to the quantity of water present.⁹ It is therefore not surprising that more corrosion is observed under test conditions in which more water is present. In these experiments, the water covered the lower 2/3of the copper strip. It is interesting that the majority of the corrosion occurred above the water phase, in the propane phase. This observation was unexpected, ¹⁹ since any appreciable H₂S that formed from the hydrolysis

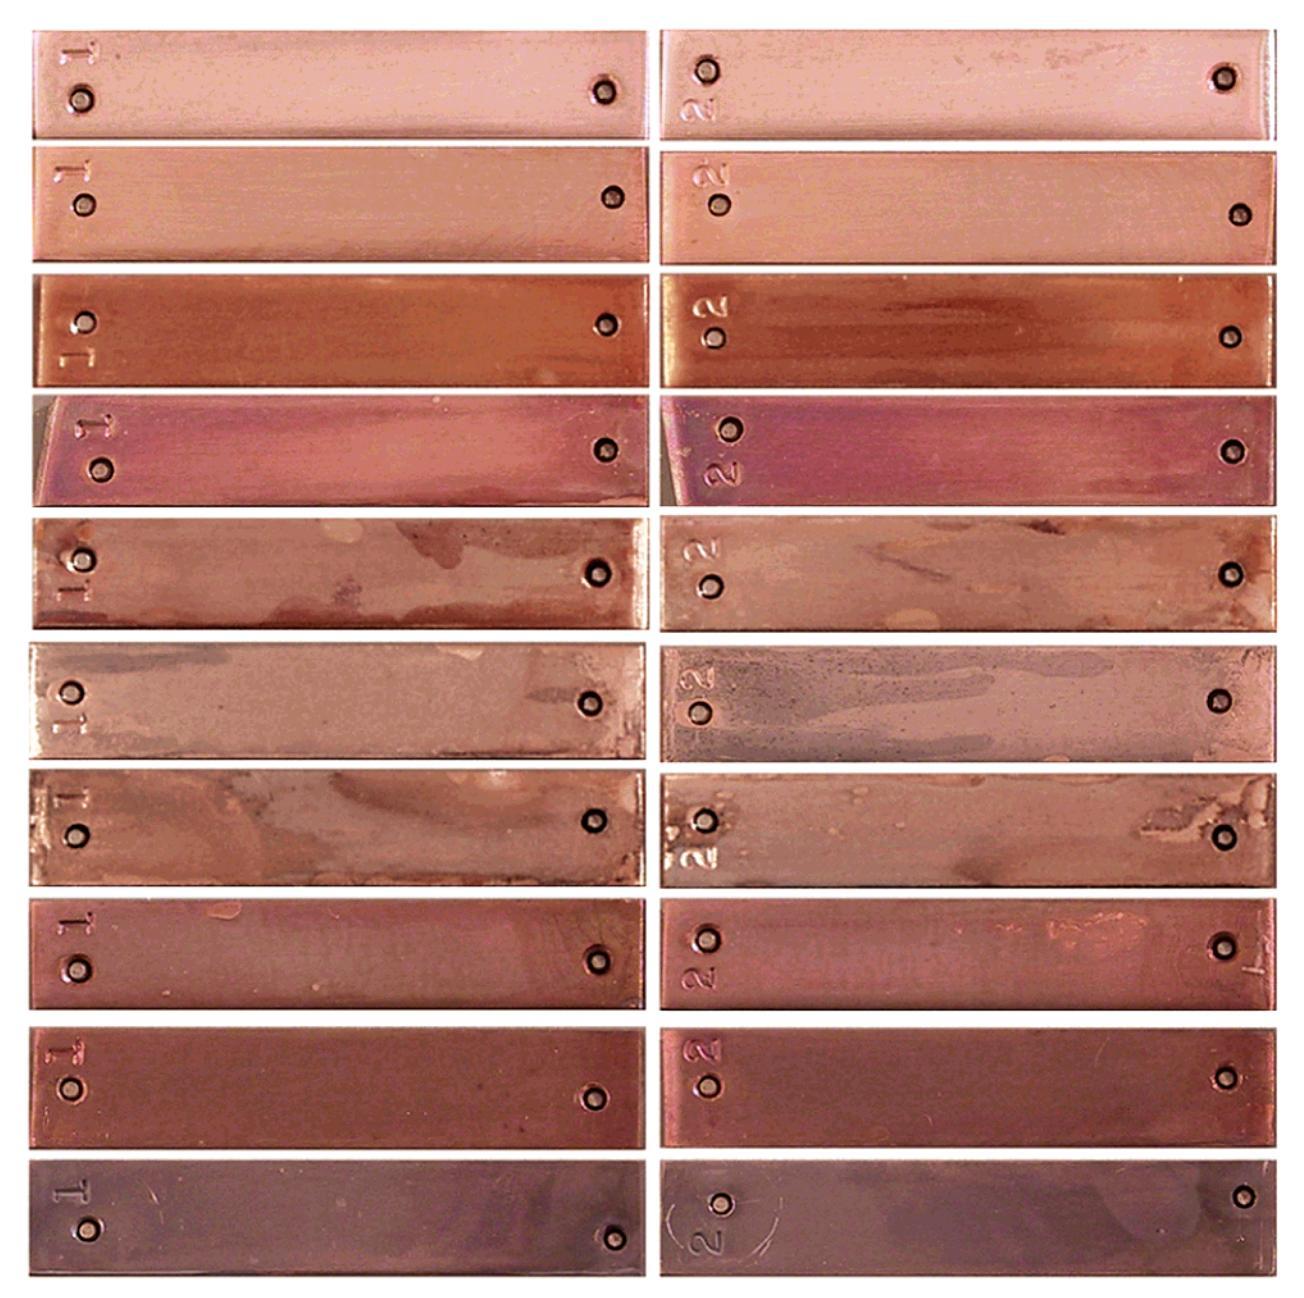
Figure 4. Post-corrosion test images of copper strips (sides 1 and 2) are shown after exposure to mixtures with H_2S concentrations (ppm, mass/mass) from top: 0, 3.5, 6, 8, 13, 25, 50, 100, 500, pure H_2S .

Copper Strip Corrosion Tests on H₂S + Propane. On the basis of the reports in the literature, one would have expected moderate concentrations (50 to 100 ppm, mass/mass) of COS in propane to cause copper strip corrosion test failure. When we could not produce a copper strip test failure under any conditions with COS mixtures, we tested standard mixtures of H₂S in ultra high purity propane to confirm the validity of the corrosion test. By measuring H₂S propane mixtures over a wide concentration range, we attempted to reproduce the various levels of tarnish shown on the ASTM copper strip corrosion standards to quantify how much H₂S is necessary to cause the various classifications of corrosion. Before and after images are shown in Figure 4. Duplicate 3.5 ppm (mass/mass) H₂S mixtures were prepared and tested. Test results were identical for the two mixtures and the result for one of the 3.5 ppm (mass/mass) mixtures is shown in Figure 4. While the severity of corrosion does indeed increase with increasing H₂S concentration, it was impossible to interpret the majority of our results within the accepted classifications of the corrosion standards. In fact, many of the results we obtained did not resemble any of the lithographs. The 13, 25, and 50 ppm (mass/mass) H_2S mixtures appeared to produce similar results, despite the progressive increase in H_2S concentration. More remarkable was the fact that 100 and 500 ppm (mass/mass) mixtures did not completely corrode the copper. We could not even cause an ASTM 4c level classification by filling the moistened vessel with pure H_2S at 1.55 MPa (225 psig)! While these results clearly demonstrate a limitation of the copper strip corrosion test, the single most disturbing result is that our 3.5 ppm (mass/mass) mixture of H_2S in propane passed the copper strip test with a 1a classification. LPG with this level of H_2S would not generally be considered merchantable.
