REPORT OF TEST FR 4011

December 1, 2001

Passenger Minivan Fire Tests

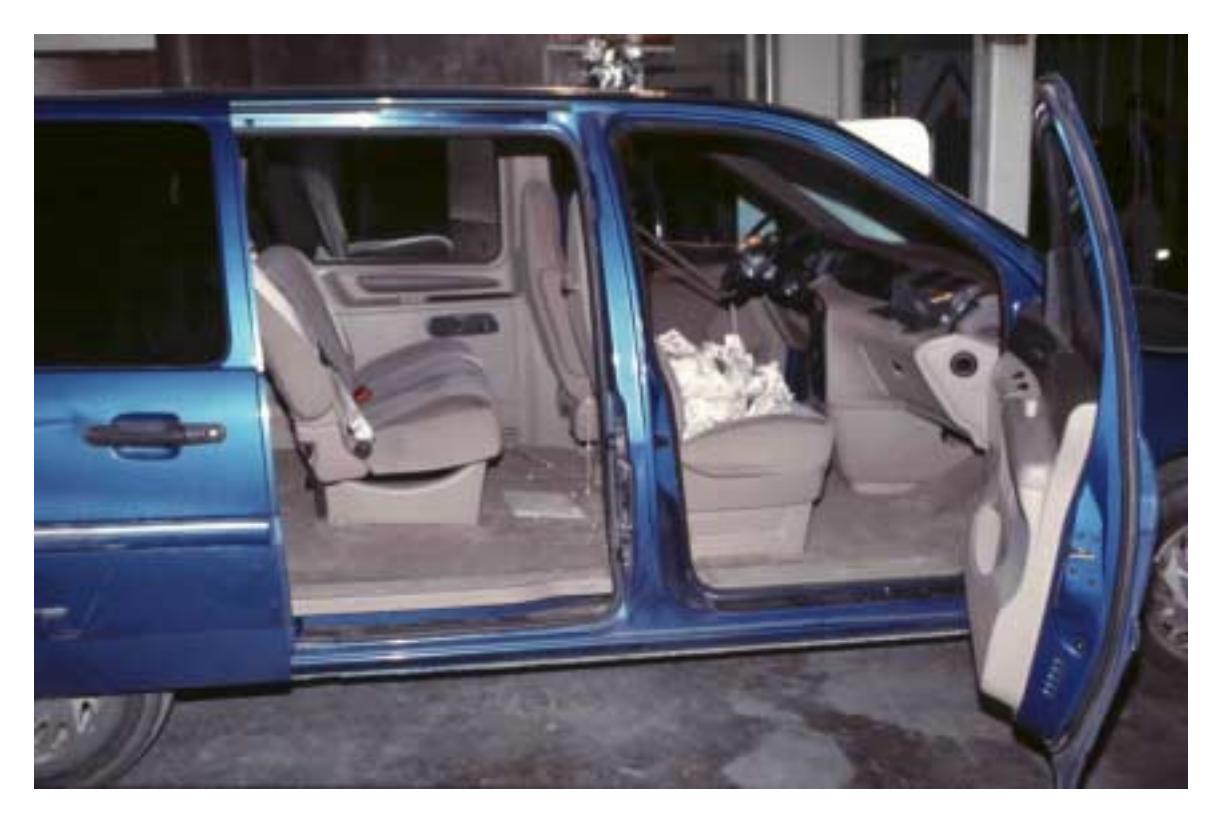
Figure 1. Photograph of van from passenger side with open doors

As part of a fire investigation, the U.S. Department of Treasury's Bureau of Alcohol, Tobacco and Firearms (ATF) was interested in determining the likelihood and hazard associated with a fire in a passenger minivan. Figure 1 presents a photograph of the test arrangement showing the minivan placed under the main calorimetry hood in the Large Fire Research Facility at the National Institute of Standards and Technology. Figure 2 presents the test arrangement in plan and elevation views with dimensions.

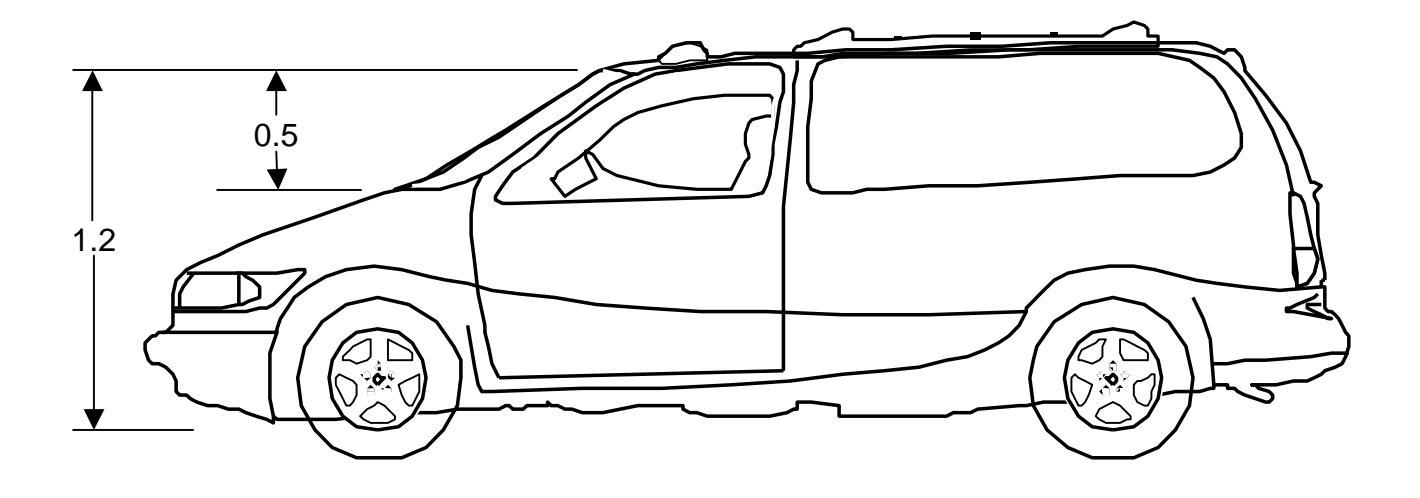
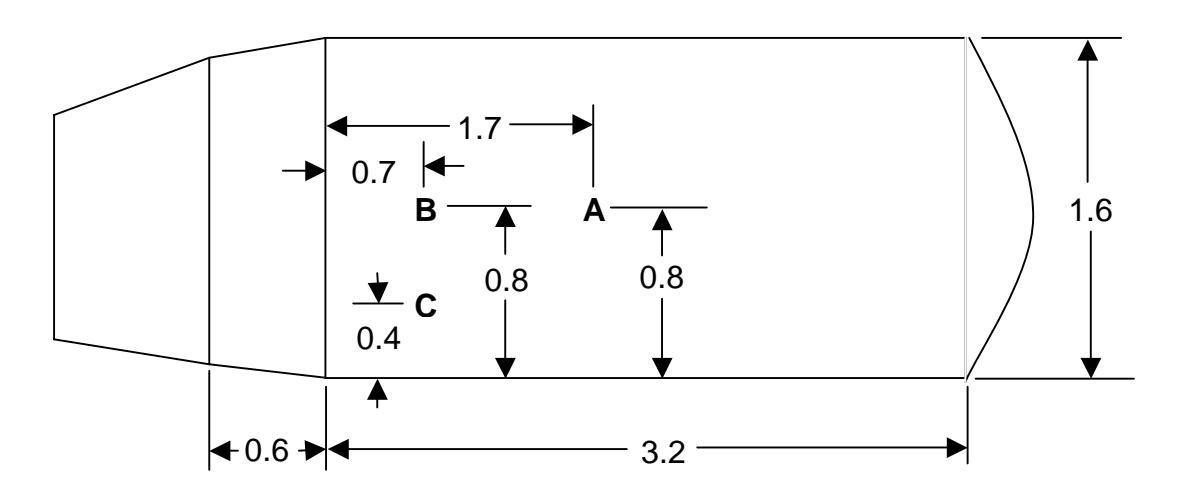
Figure 2. Plan and elevation views of the van showing general dimensions. (A, B, and C represent the three instrumentation locations. All dimensions in meters)

Both experiments were conducted with the vehicle centered under the main exhaust hood. A diagram of the test arrangement with dimensions is shown in Figure 2. The vehicle used for these tests was a typical model year 1995 passenger minivan. The minivan had exterior damage sufficient for an insurance company to consider the van totally destroyed. The insurance company donated the van for this research effort. Since the tests involved only the passenger compartment, the exterior damage did not impact this research effort.

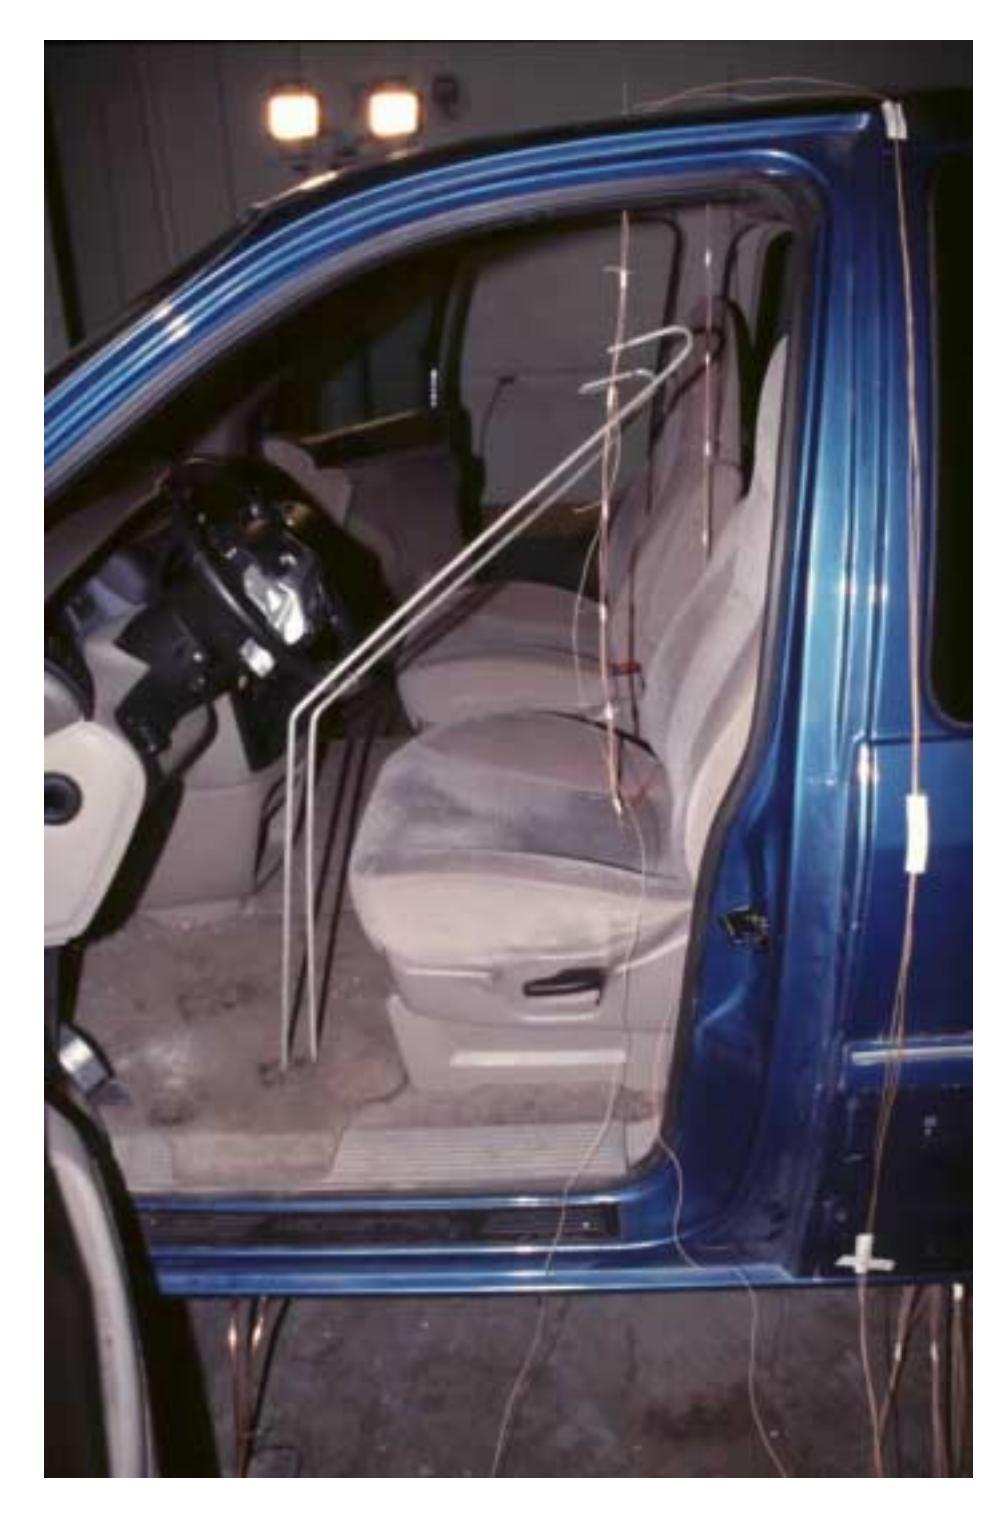
Figure 3. Photograph of van from driver side showing gas sampling probes and thermocouple arrays

In addition to heat release rate, temperatures were measured at several locations within the van. Thermocouple arrays were placed above the drivers seat, in between the driver and front passenger seat, and between the two passenger bench seats (see Figure 3). The two thermocouple arrays had thermocouple beads located at the ceiling and at the following distances below the ceiling: 0.15 m, 0.3 m, 0.46 m, 0.61 m, 0.76 m, 0.91 m, 1.07 m, and 1.22m (6 in, 12 in, 18 in, 24 in, 30 in, 36 in, 42 in, and 48 in). The thermocouple beads for the third thermocouple array, above the driver's seat, stop at the top of the seat cushion 0.91 m (36 in) below the ceiling. Thermocouples were placed at the same three locations on the roof of the van. All of the thermocouples were constructed using 0.25 mm (0.01 in) diameter, Type K thermocouple wire. Based on work presented in references [6] and [7], the temperature measurements are estimated to be within ± 5 % of the actual values.

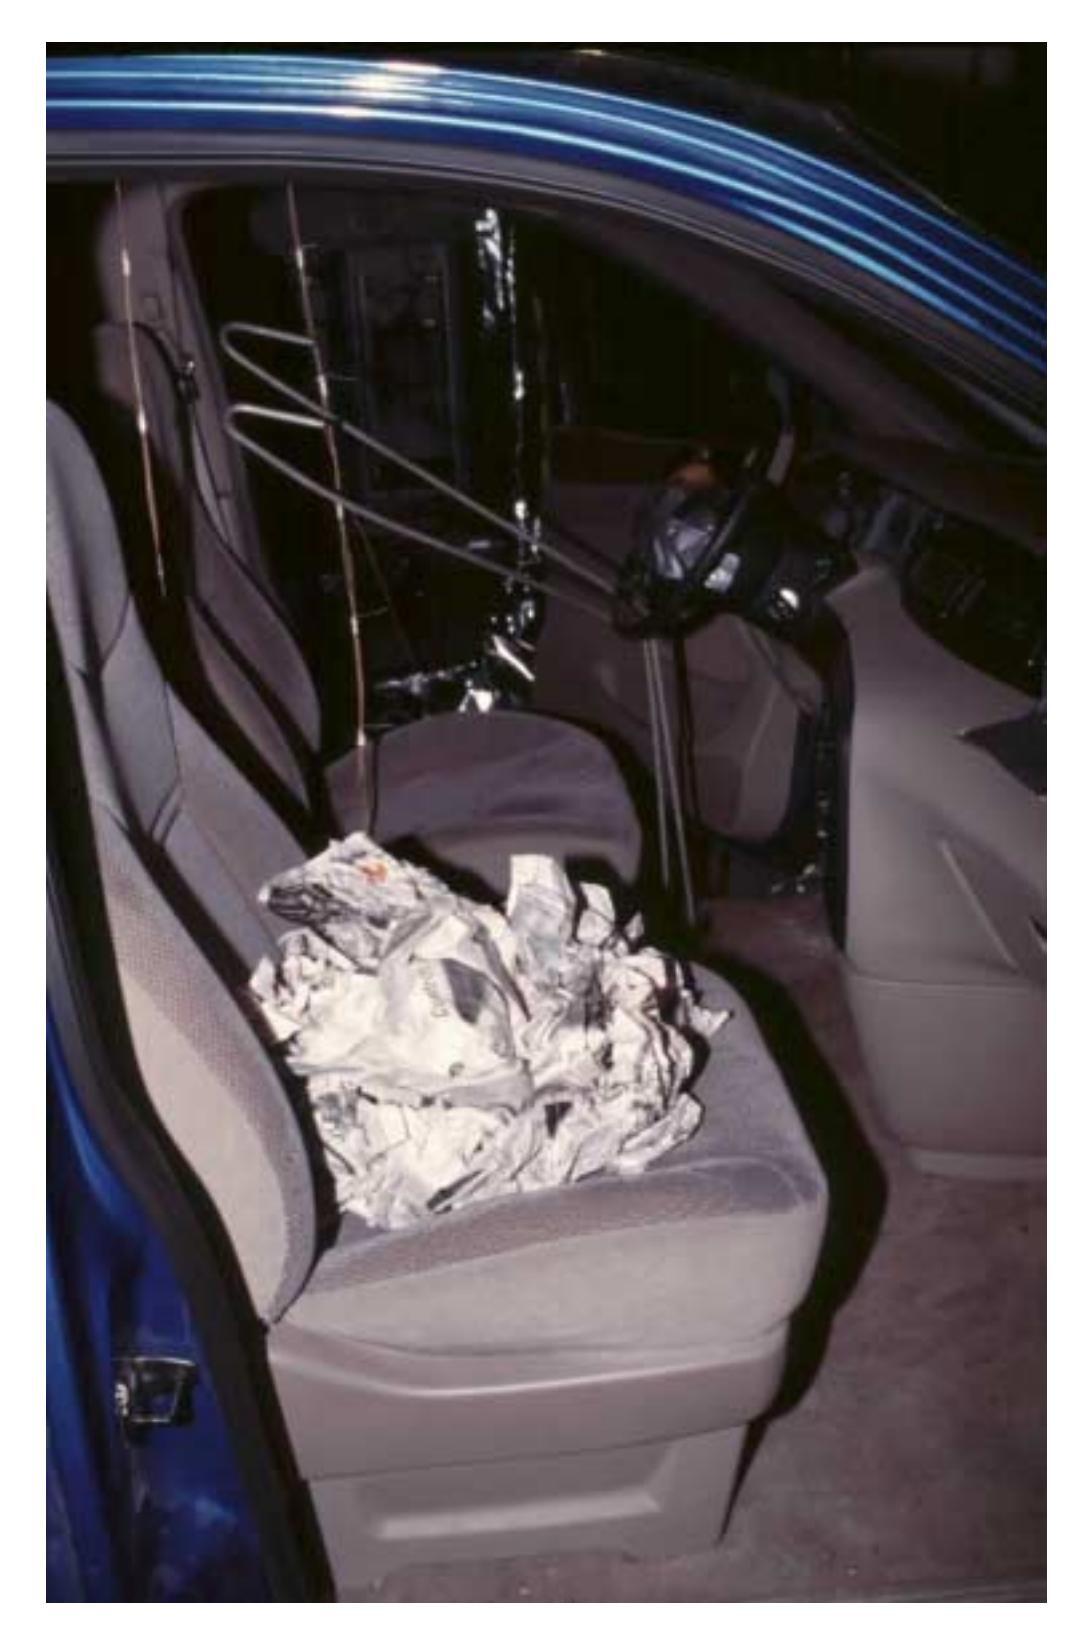
Figure 4. Photograph of van from passenger side showing placement of paper in passenger seat for use as ignition source for first test

Two passenger minivan fire experiments were conducted in the Large Fire Research Facility at the National Institute of Standards and Technology. The two tests were conducted inside the same minivan. For the first test, approximately 0.317 kg (0.697 lb) of paper was placed on the front passenger seat (Figure 4). All of the doors and windows in the minivan were closed, and the paper was ignited using a butane lighter similar to those used to for charcoal grills. Flames reached the headliner within 3 min after ignition (Figure 5). At 5 min after ignition, the van was completed filled with smoke and no fire could be seen through the windows (Figure 6). The van doors were left closed for an additional 25 min (Total Test Time – 30 min). At the end of 30 min, the passenger side door was opened (Figure 7). The damage resulting from the first fire is shown in Figures 8 and 9.

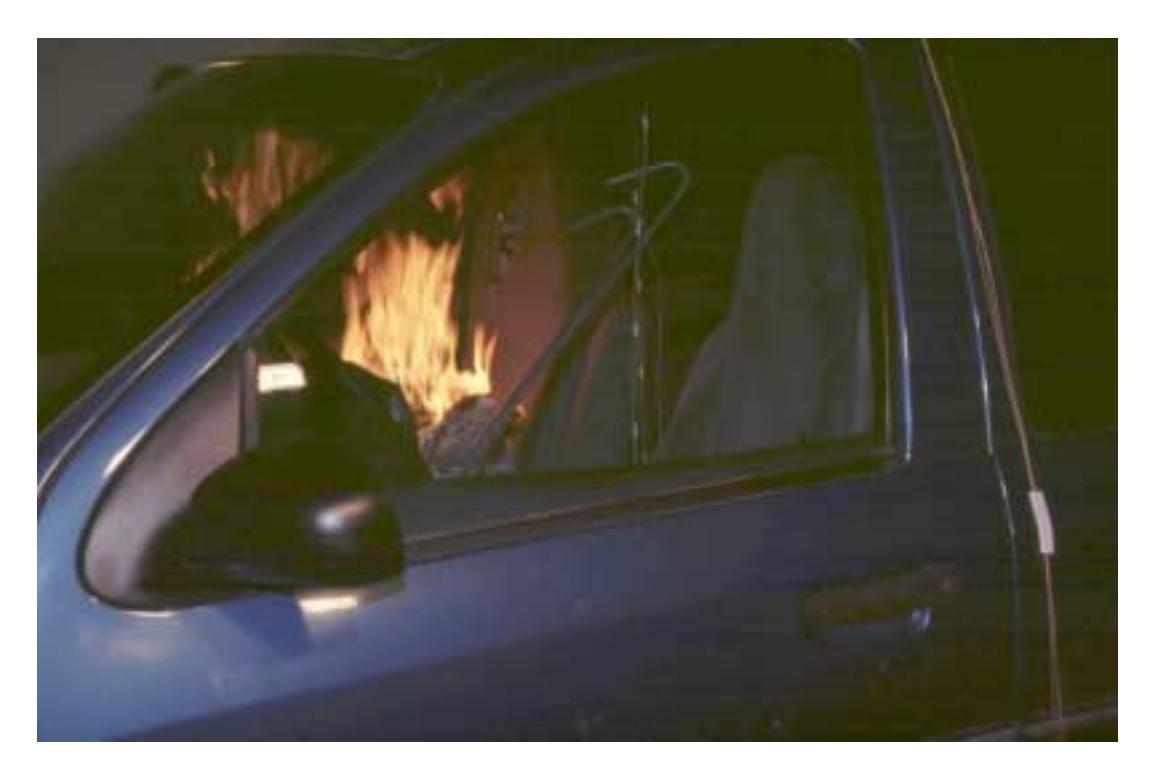
Figure 5. Photograph of van approximately 1 min after ignition with flames reaching headliner

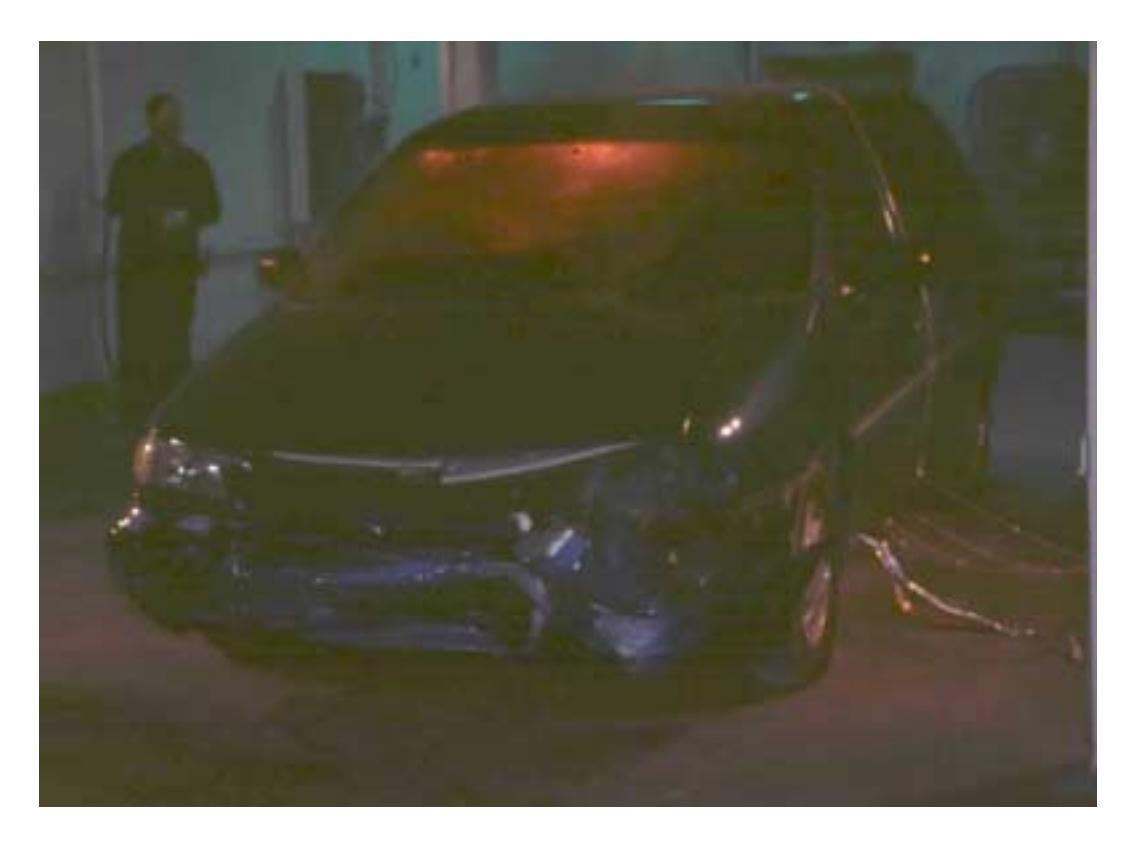
Figure 6. Photograph of van at 5 min after ignition

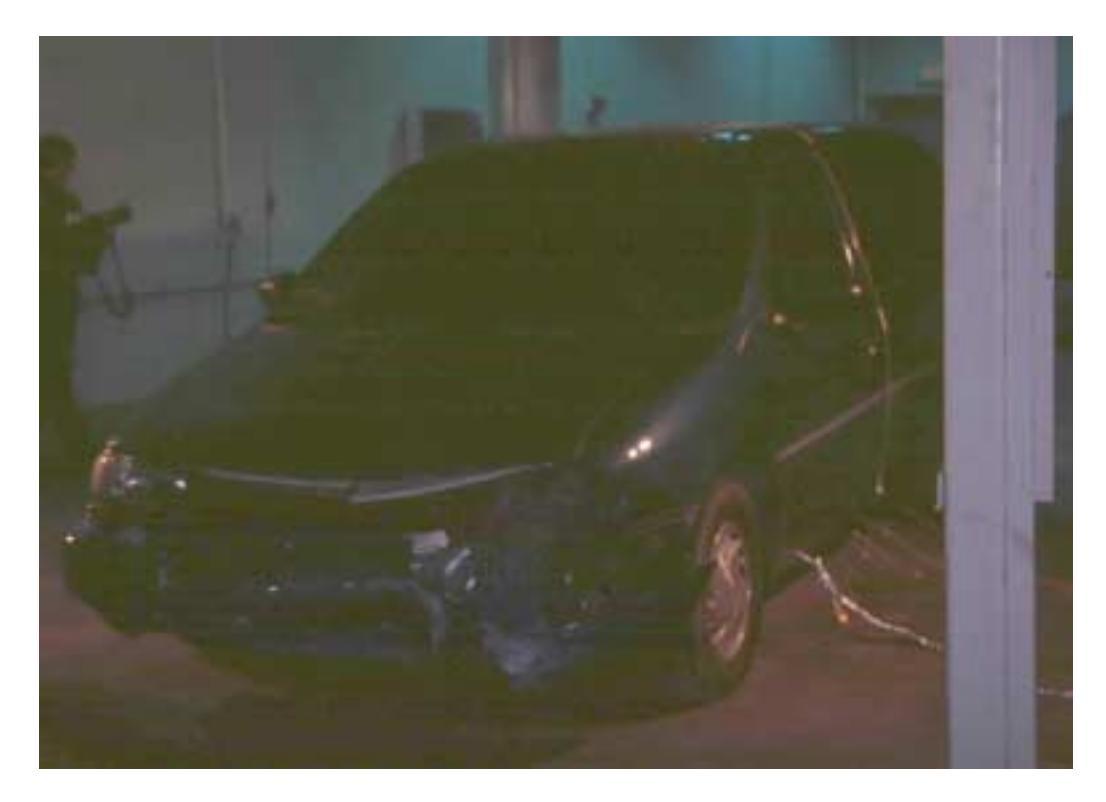
Figure 7. Photograph of van at 30 min after ignition just prior to opening of the passenger side door

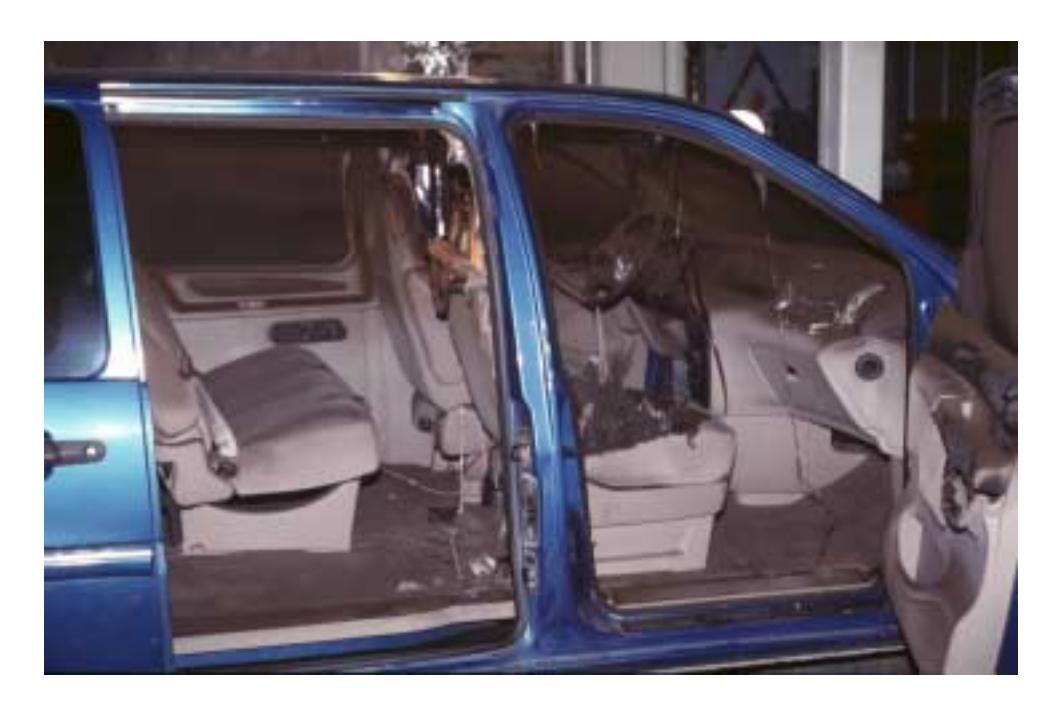
Figure 8. Photograph of van after passenger side doors were opened

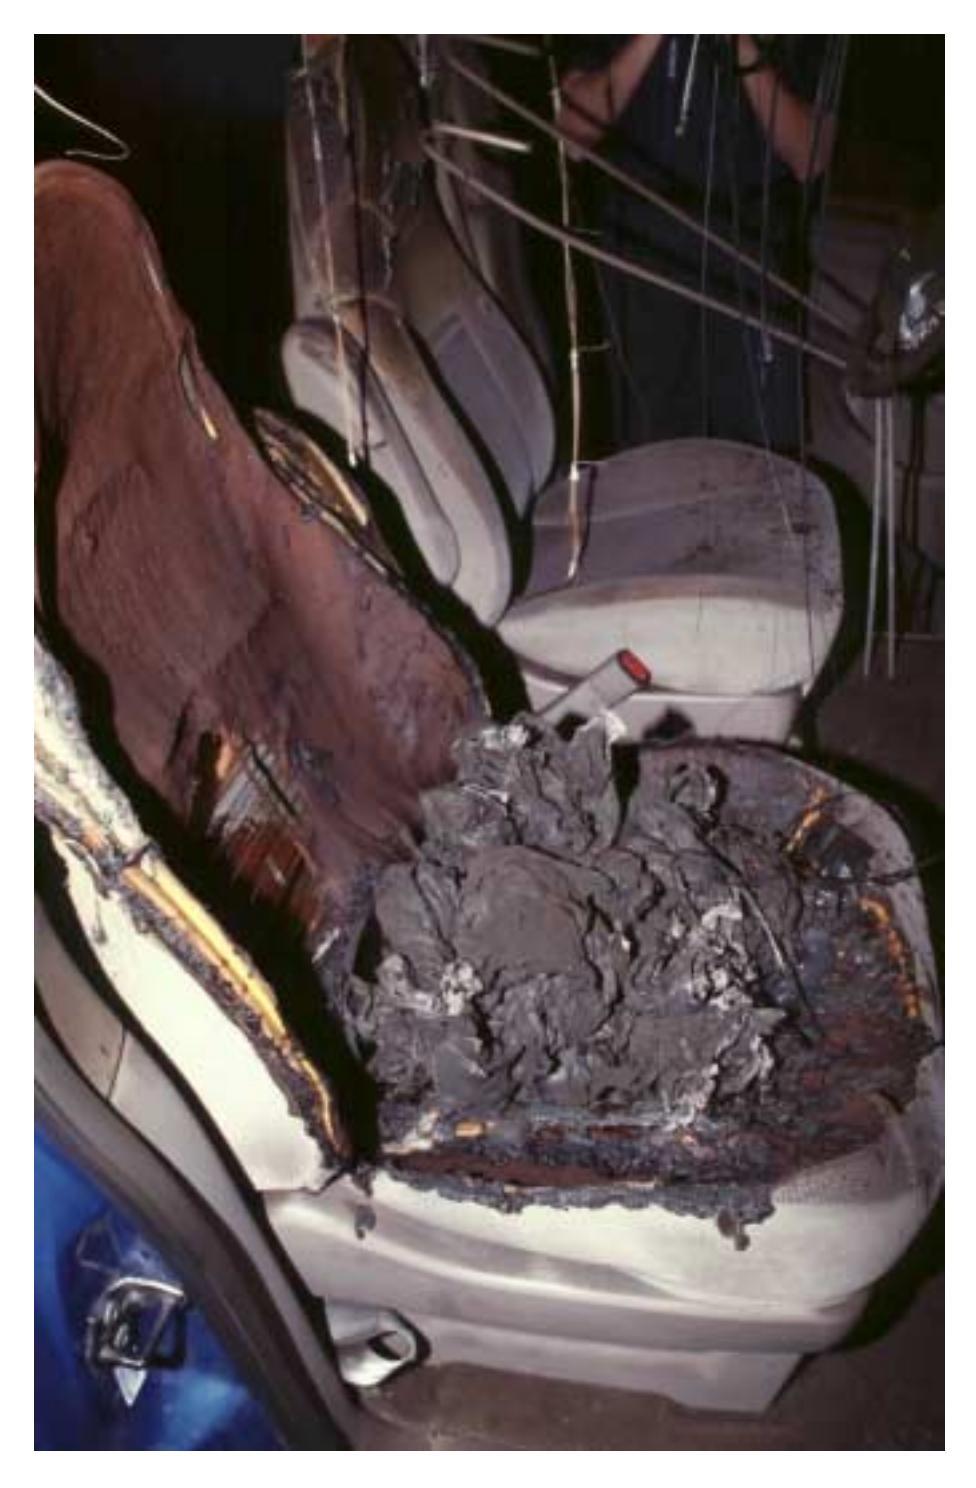
Figure 9. Photograph showing damage to front passenger side seat of van

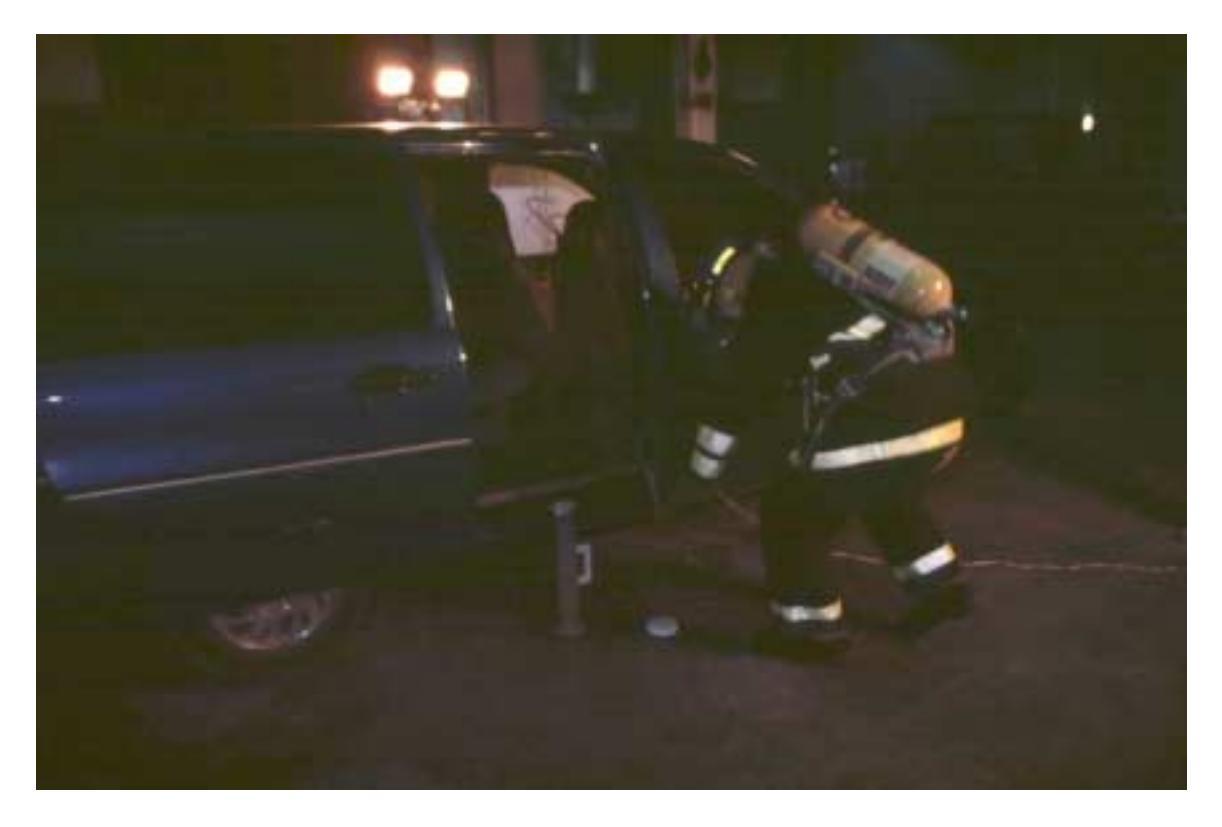
Figure 10. Photograph showing fire fighter preparing gasoline for ignition of second test

The second experiment utilized 2 L (0.53 gal) of gasoline distributed throughout the minivan. Gasoline was poured on the driver's seat, front passenger seat, and on the floor and passenger seat behind the front seats (Figure 10). The front driver's side and passenger windows were left fully open; all other doors and windows were closed. For the second fire, the gasoline was ignited with an electric match. Immediately after ignition, the passenger compartment was filled with flames that projected from the open windows (Figure 11). As the fire progressed, closed van windows cracked and fell from their holders (Figure 12). Approximately 4 min after ignition, the fire was extinguished. The damage resulting from the second fire is shown in Figures 13, 14, and 15.

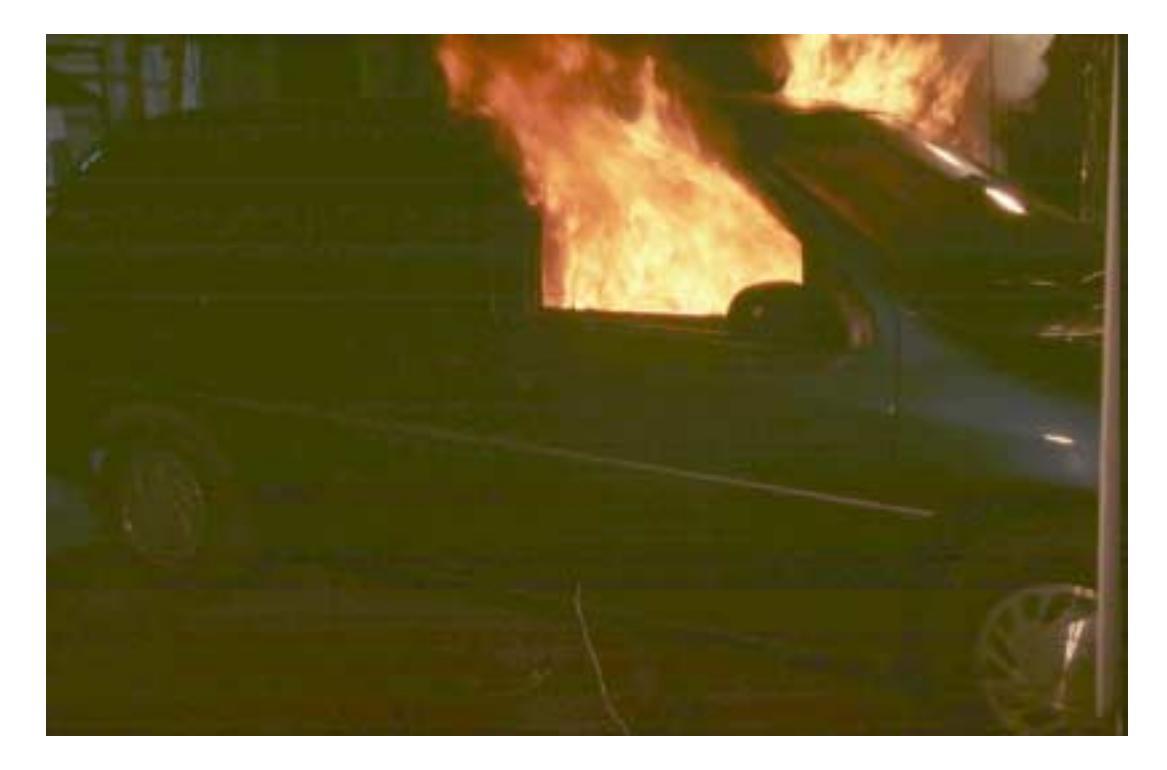
Figure 11. Photograph showing the van immediately after ignition of the gasoline in the van with flames visible extending from both the driver side and passenger side open windows

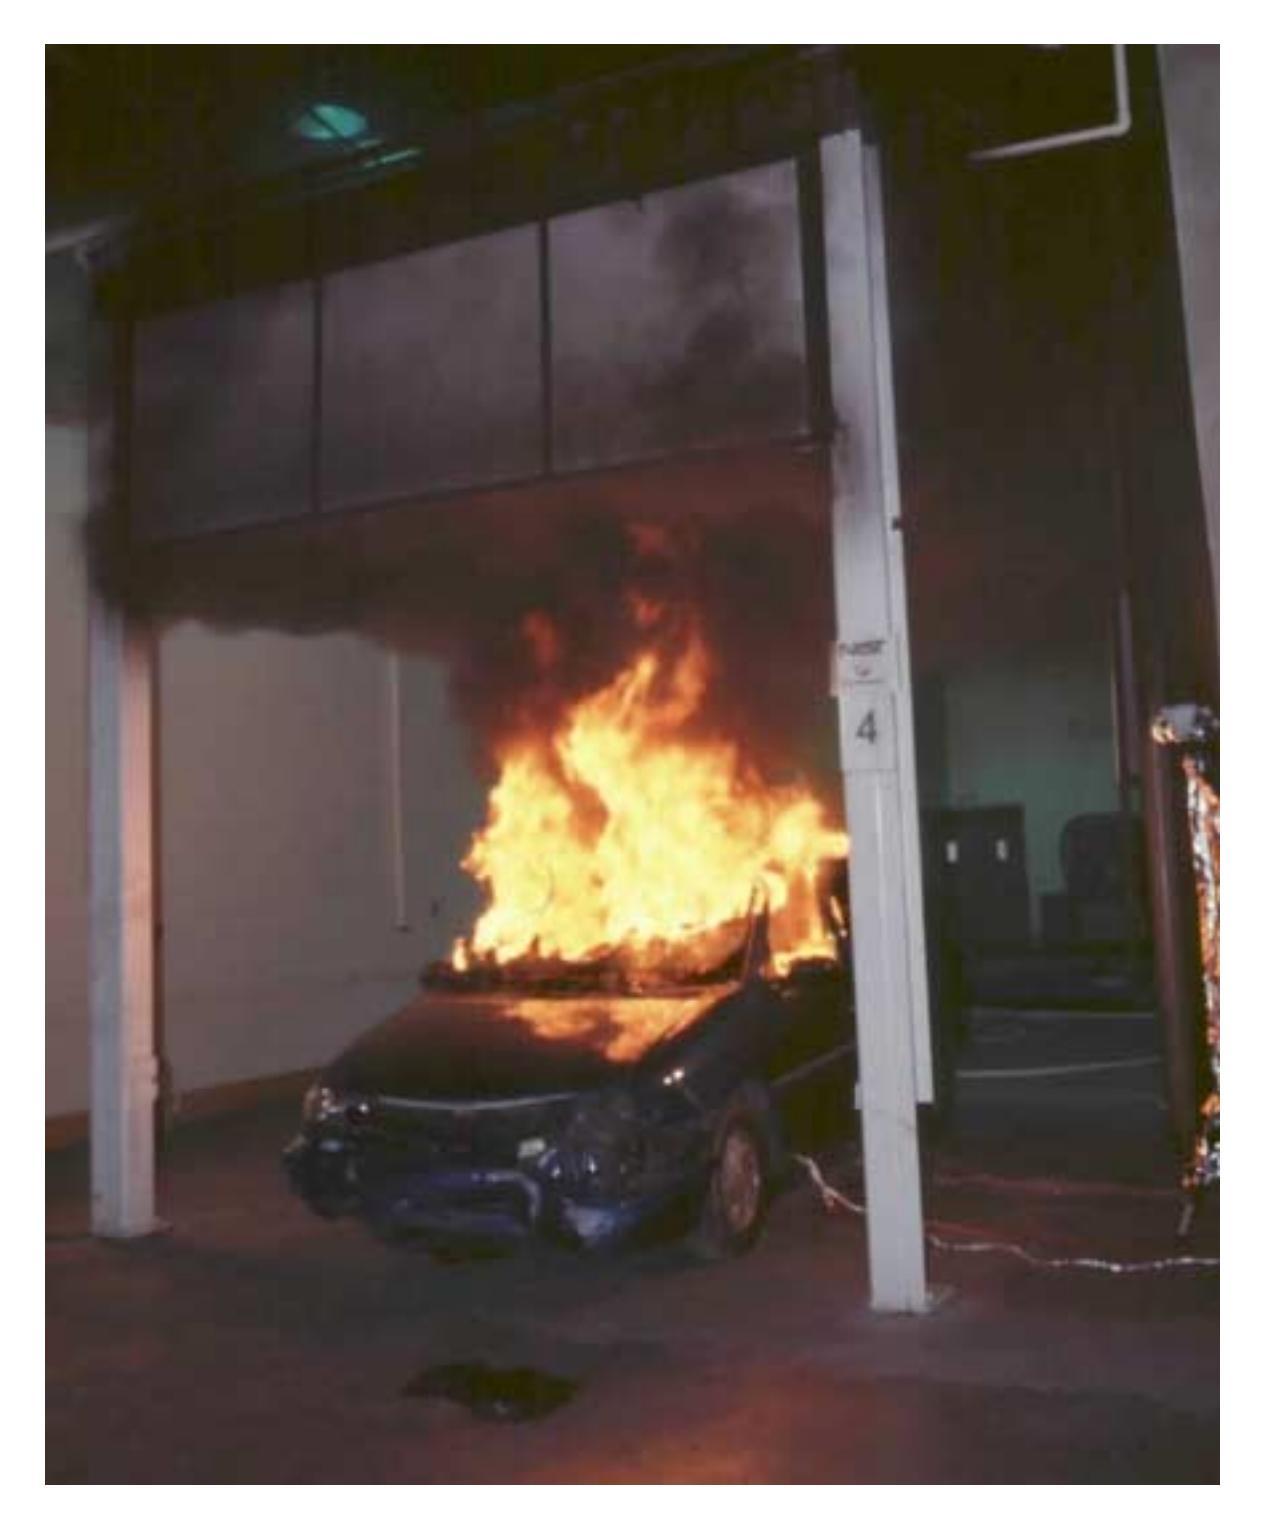
Figure 12. Photograph showing van after failure of the front window

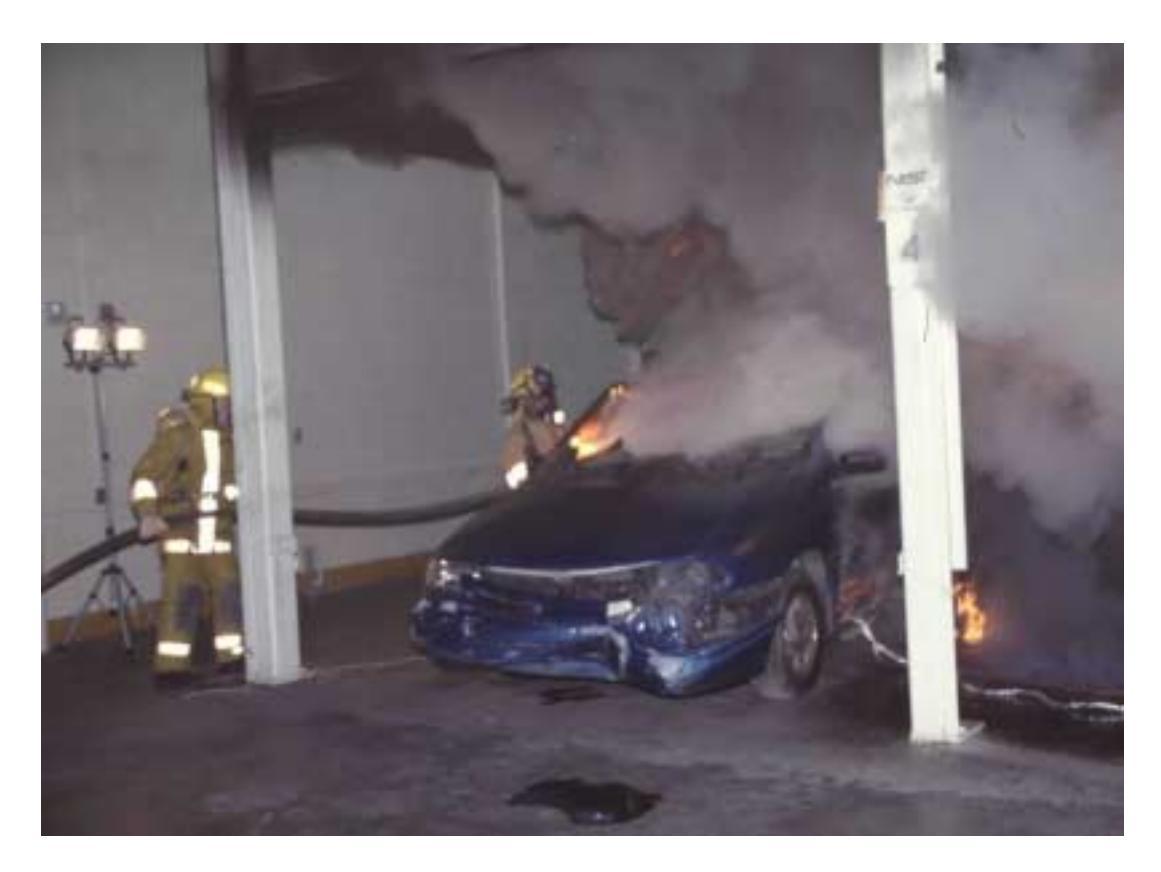
Figure 13. Photograph showing extinguishment of the second fire

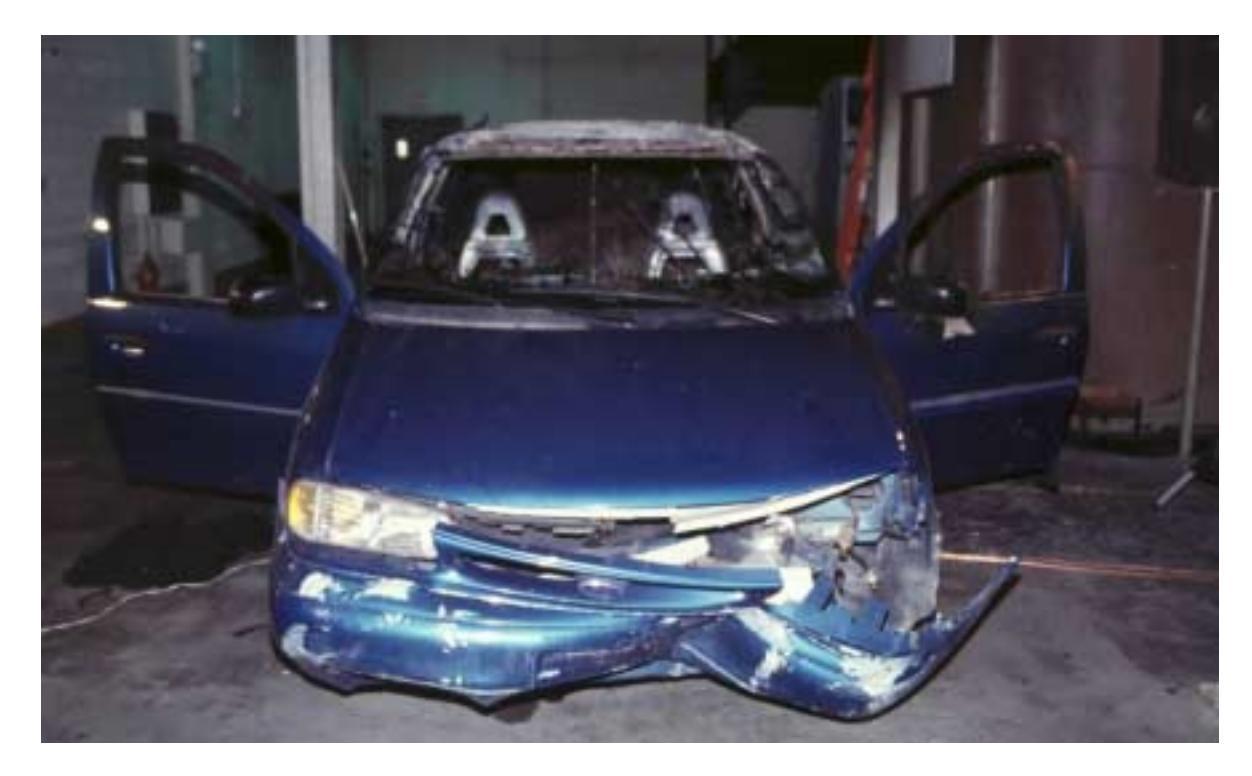
Figure 14. Photograph of the front of the van showing damage resulting from second fire test

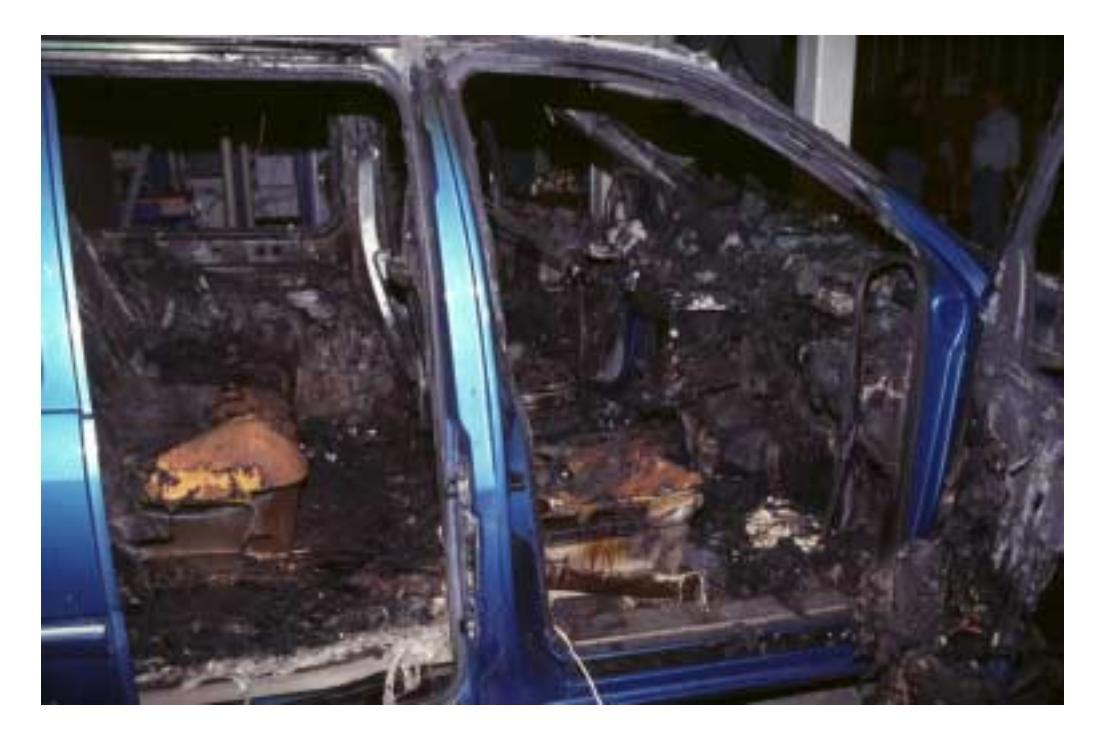
Figure 15. Photograph of the passenger side of the van showing damage in the interior resulting from the second fire test

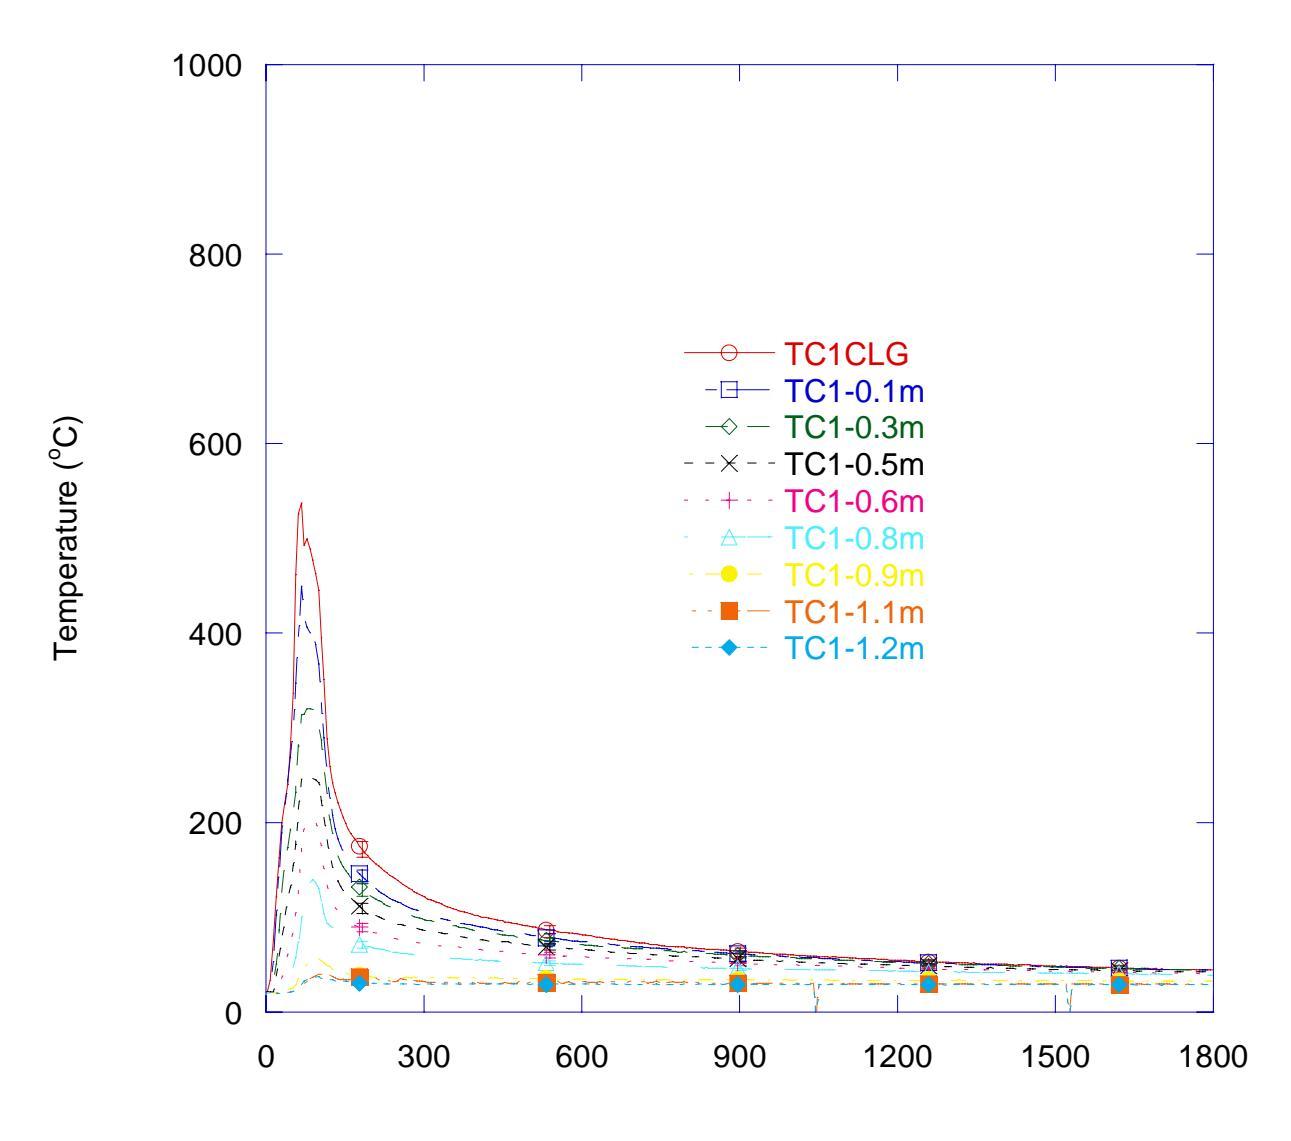
Figure 16. Graph of the temperatures in the center of the van behind the front seat during the first test

The temperature profiles obtained within the passenger compartment of the minivan during the first test are shown in Figures 16 – 18. Peak temperatures of between 500 °C (932 °F) and 750 °C (1382 °F) are reached at the ceiling within 2 min after ignition. The temperatures peak and decrease rapidly within the first 4 min of the test. After about 5 min, the temperatures within the passenger compartment have decreased to less than 150 °C (302 °F). Roof temperatures at the three thermocouple locations are shown in Figure 19. The temperatures range from 50 °C (122 °F) to 95 °C (203 °F) depending on location. The gas concentrations measured in the passenger compartment during the first test are shown in Figure 20. The oxygen concentration falls to below 5 % within the first 2 min. Correspondingly, the concentrations of carbon dioxide and carbon monoxide increase to 13 % and 2 %, respectively. An equipment failure resulted in no oxygen measurements at the 0.25 m (10 in) location. All of the products of combustion remained inside the minivan until the door was opened. Therefore, no heat release rate information could be obtained during the first test.

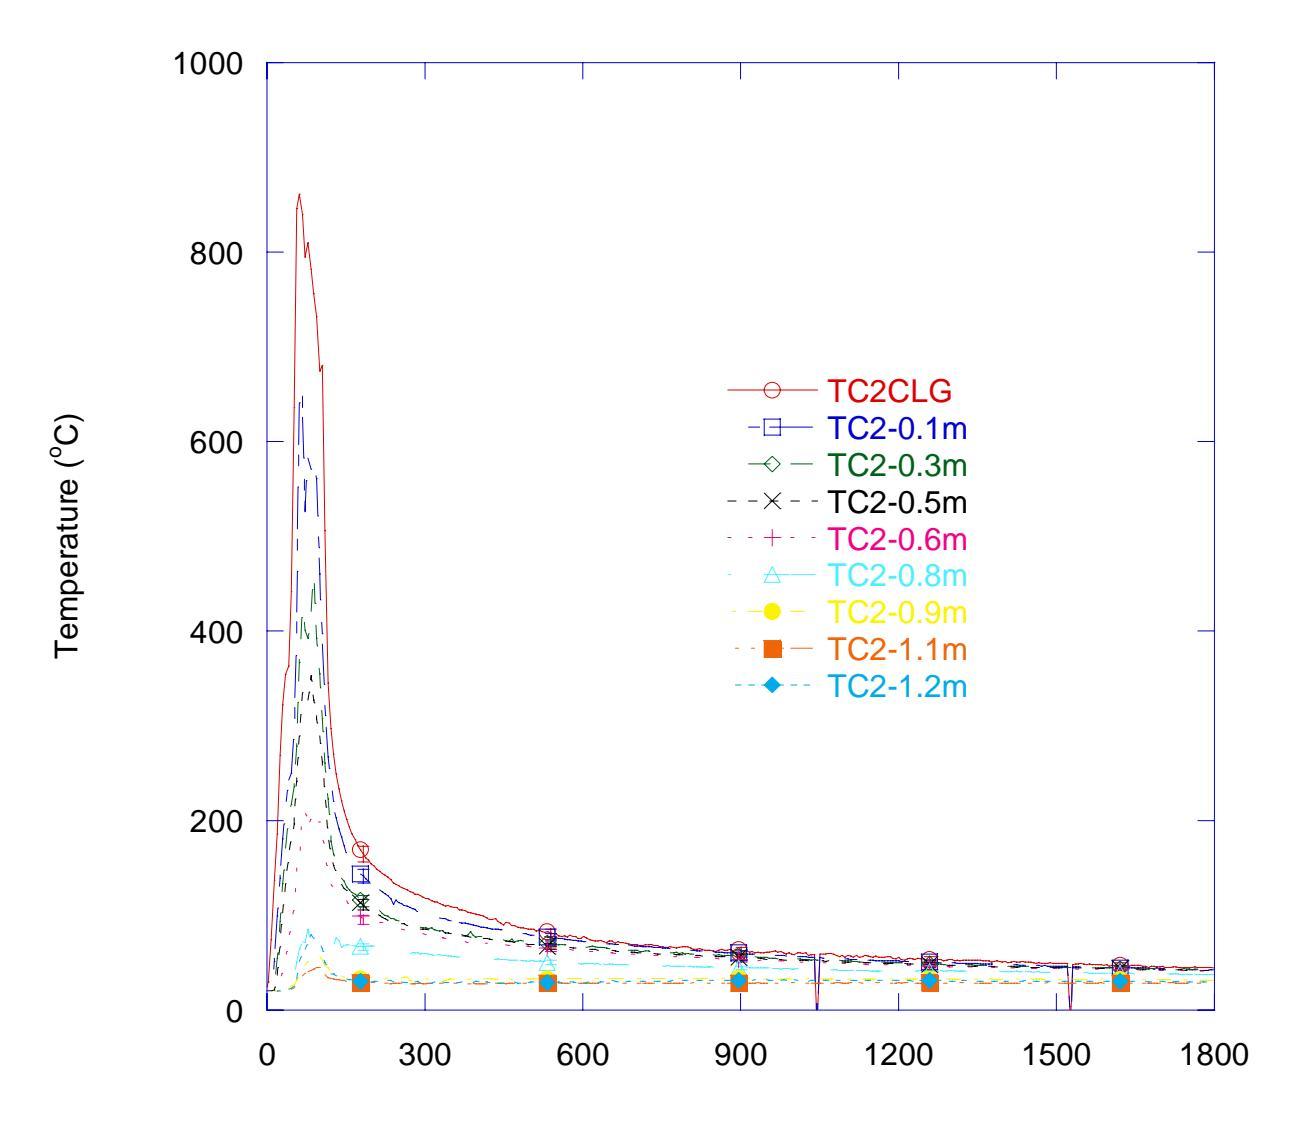
Figure 17. Graph of the temperatures in the center of the van between the two front seats during the first test
