REPORT OF TEST FR 4011

December 1, 2001

Passenger Minivan Fire Tests

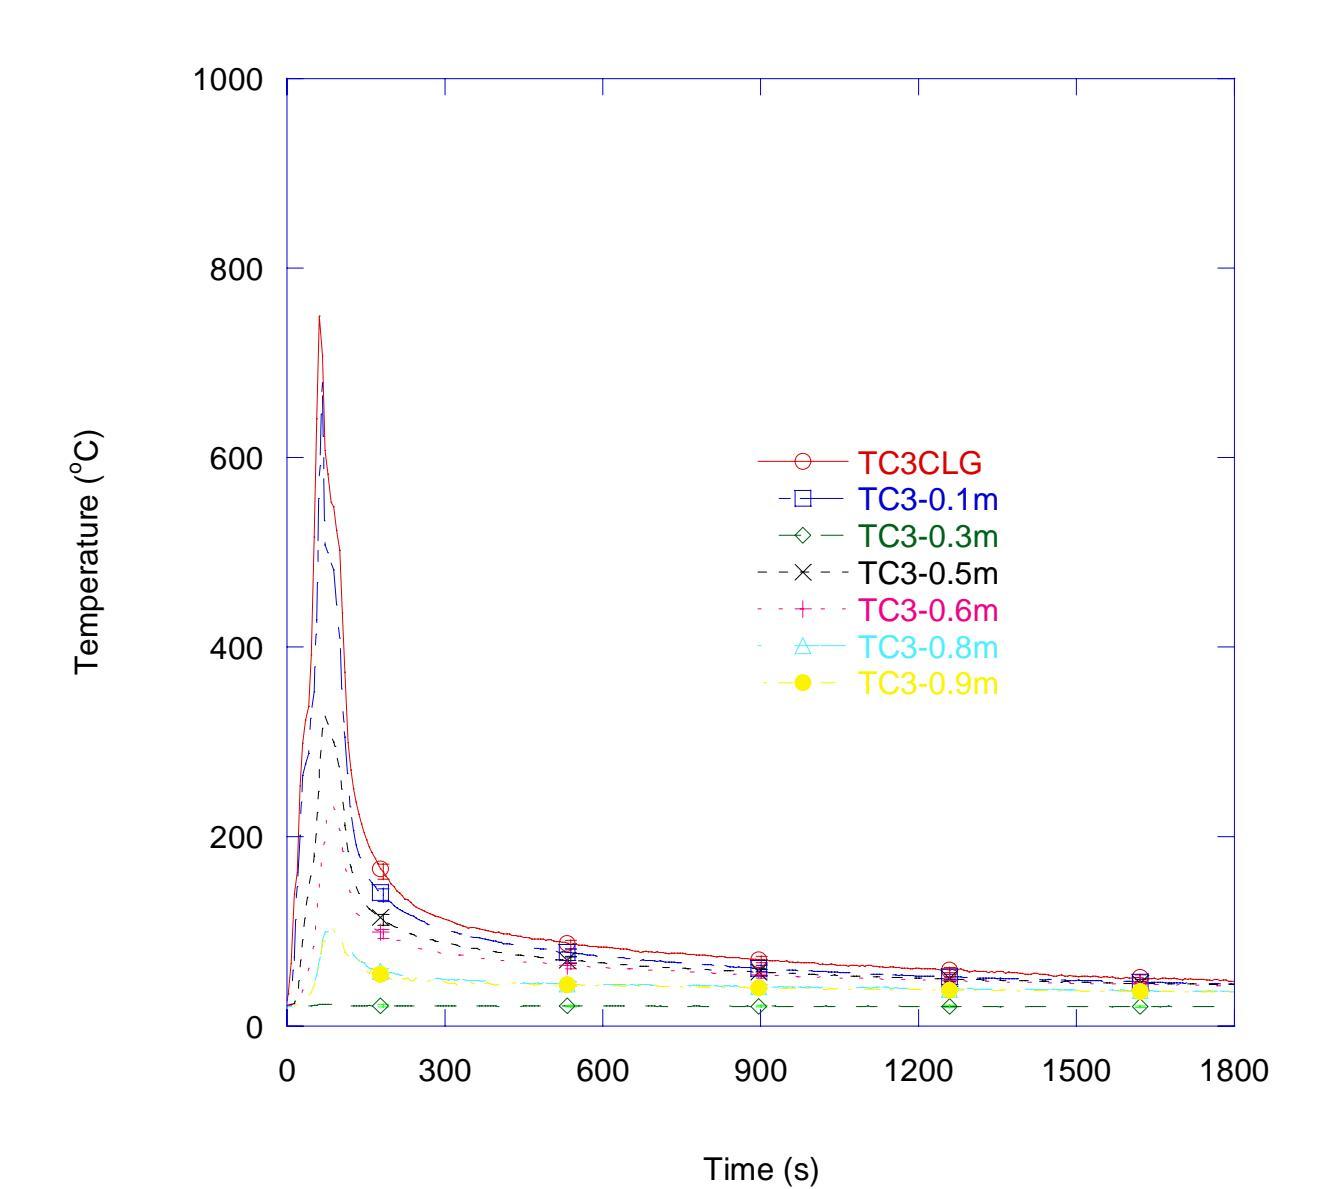
Figure 18. Graph of the temperatures above the drivers seat during the first test

The temperature profiles obtained within the passenger compartment of the minivan during the first test are shown in Figures 16 – 18. Peak temperatures of between 500 °C (932 °F) and 750 °C (1382 °F) are reached at the ceiling within 2 min after ignition. The temperatures peak and decrease rapidly within the first 4 min of the test. After about 5 min, the temperatures within the passenger compartment have decreased to less than 150 °C (302 °F). Roof temperatures at the three thermocouple locations are shown in Figure 19. The temperatures range from 50 °C (122 °F) to 95 °C (203 °F) depending on location. The gas concentrations measured in the passenger compartment during the first test are shown in Figure 20. The oxygen concentration falls to below 5 % within the first 2 min. Correspondingly, the concentrations of carbon dioxide and carbon monoxide increase to 13 % and 2 %, respectively. An equipment failure resulted in no oxygen measurements at the 0.25 m (10 in) location. All of the products of combustion remained inside the minivan until the door was opened. Therefore, no heat release rate information could be obtained during the first test.

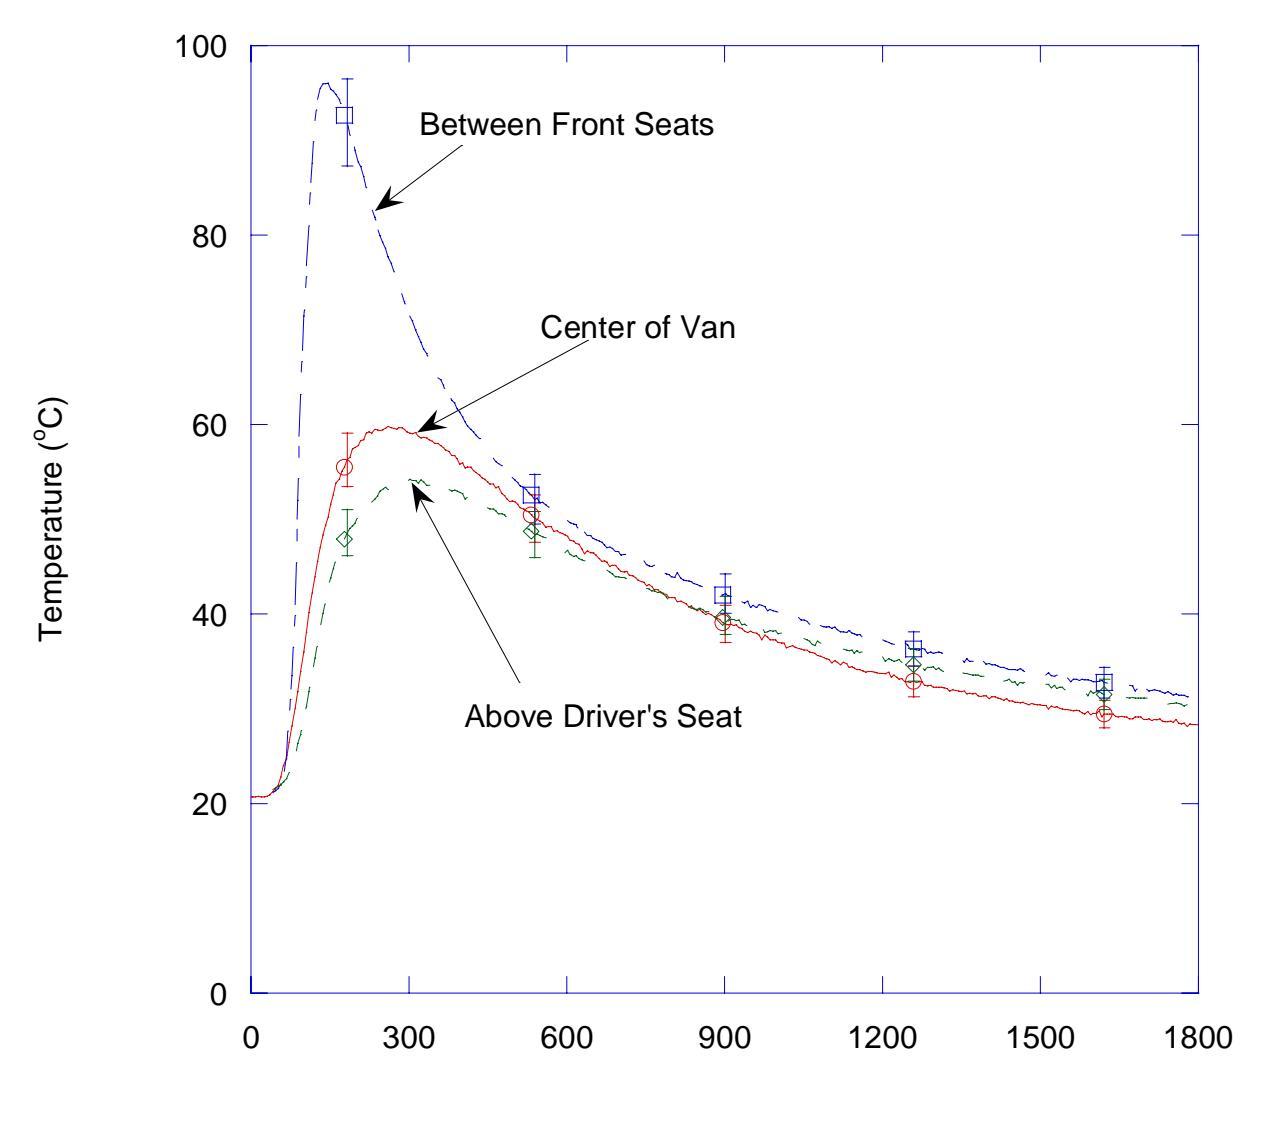
Figure 19. Graph of the temperatures above the roof of the van at the three thermocouple array locations during the first test

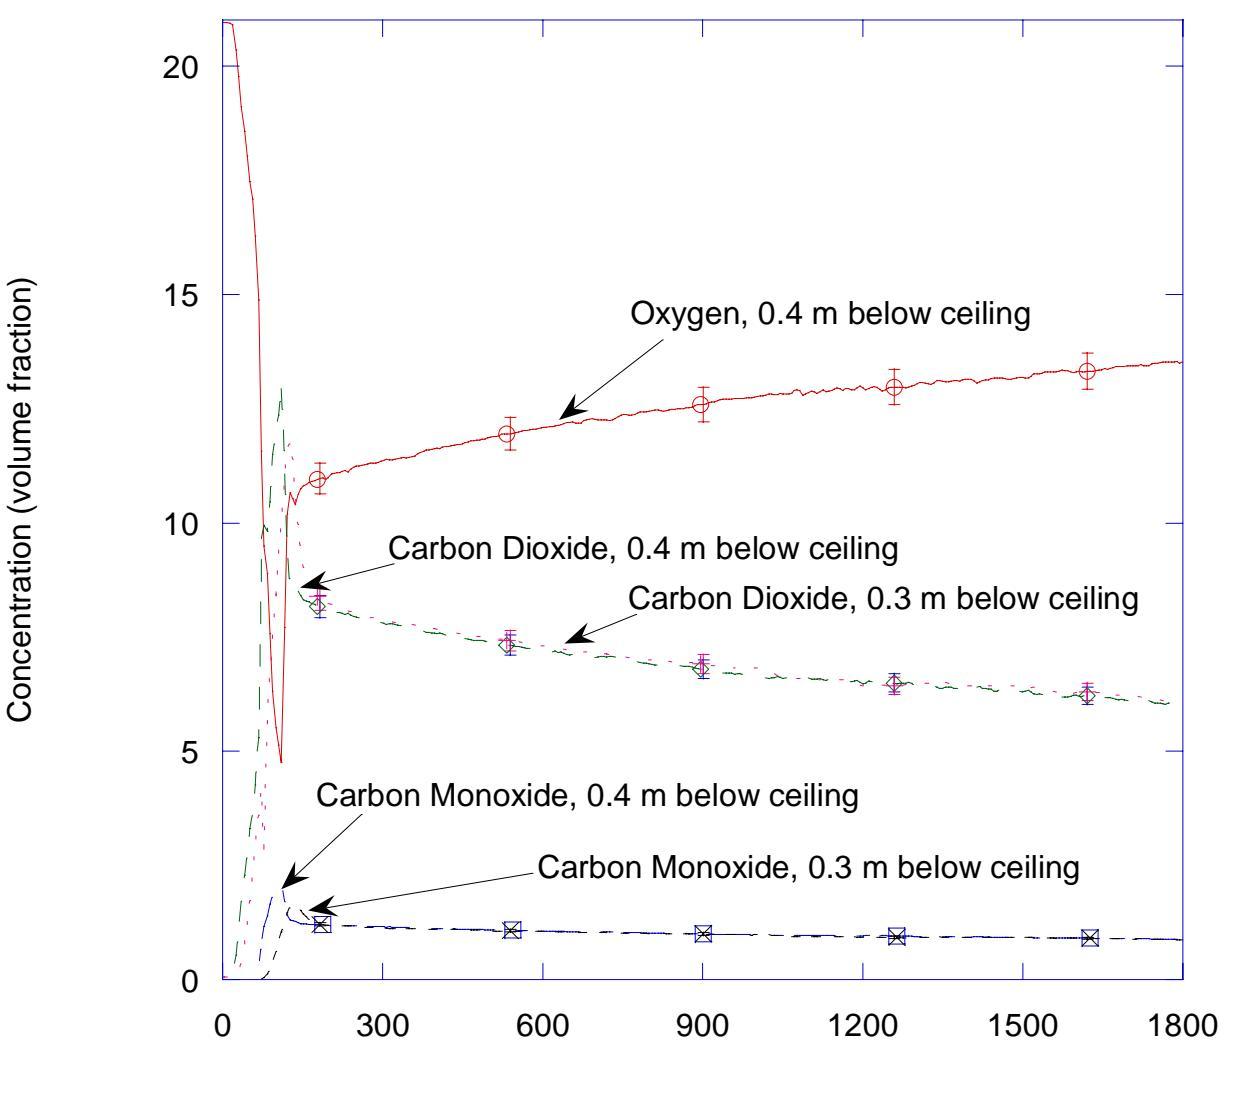
Figure 20. Graph showing concentrations of oxygen, carbon dioxide, and carbon monoxide in van at two locations above center of driver's seat during first test

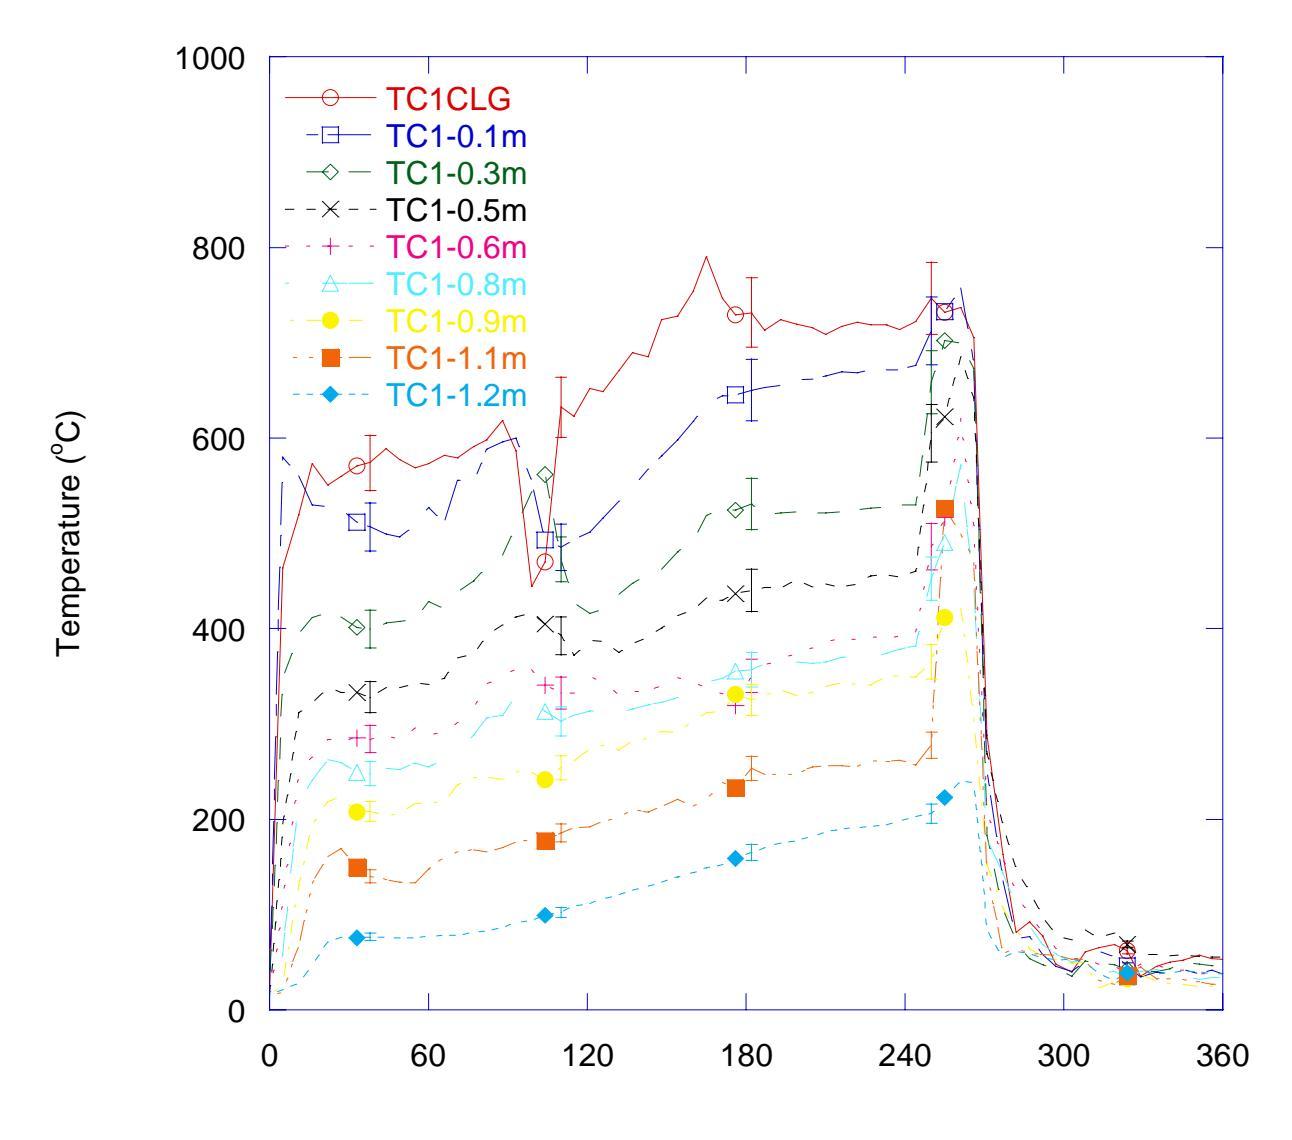
Figure 21. Graph of the temperatures in the center of the van behind the front seat during the second test

The temperature profiles obtained within the passenger compartment of the minivan during the second test are shown in Figures 21 - 23. Peak temperatures of between 600 °C (1112 °F) and 800 °C (1472 °F) are reached at the ceiling within 30 s after ignition. The temperatures peak and remain at high levels for the duration of the test. Roof temperatures at the three thermocouple locations are shown in Figure 24. After about 60 s, the roof temperature has increased to

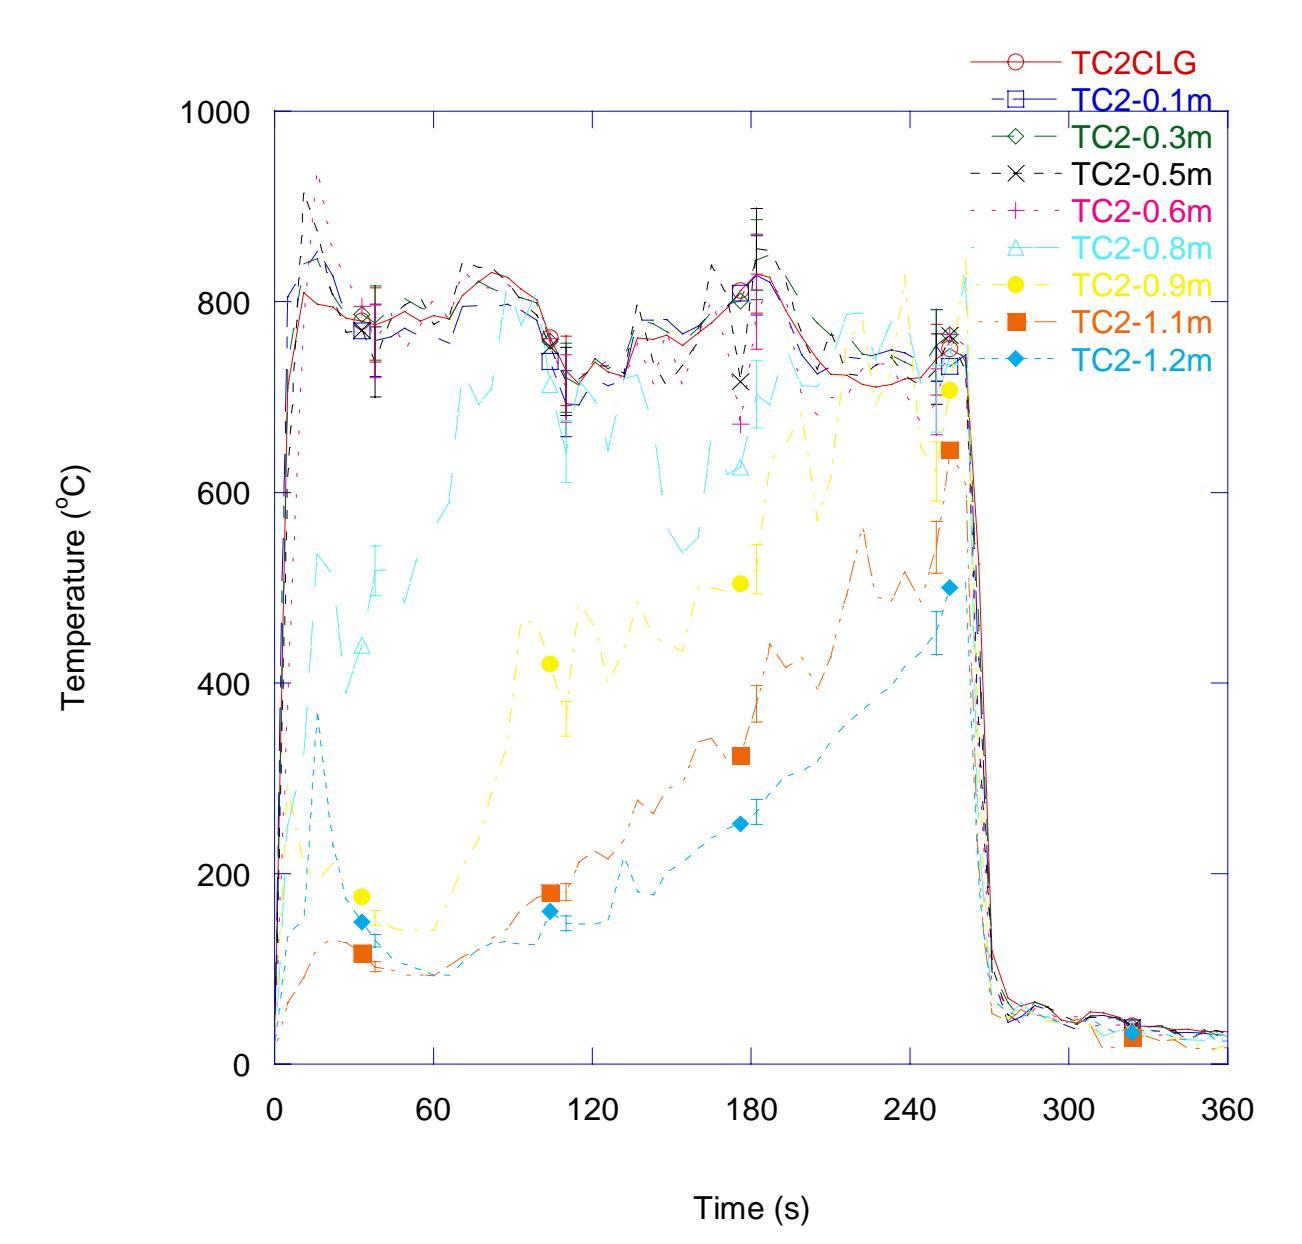
Figure 22. Graph of the temperatures in the center of the van between the two front seats during the second test

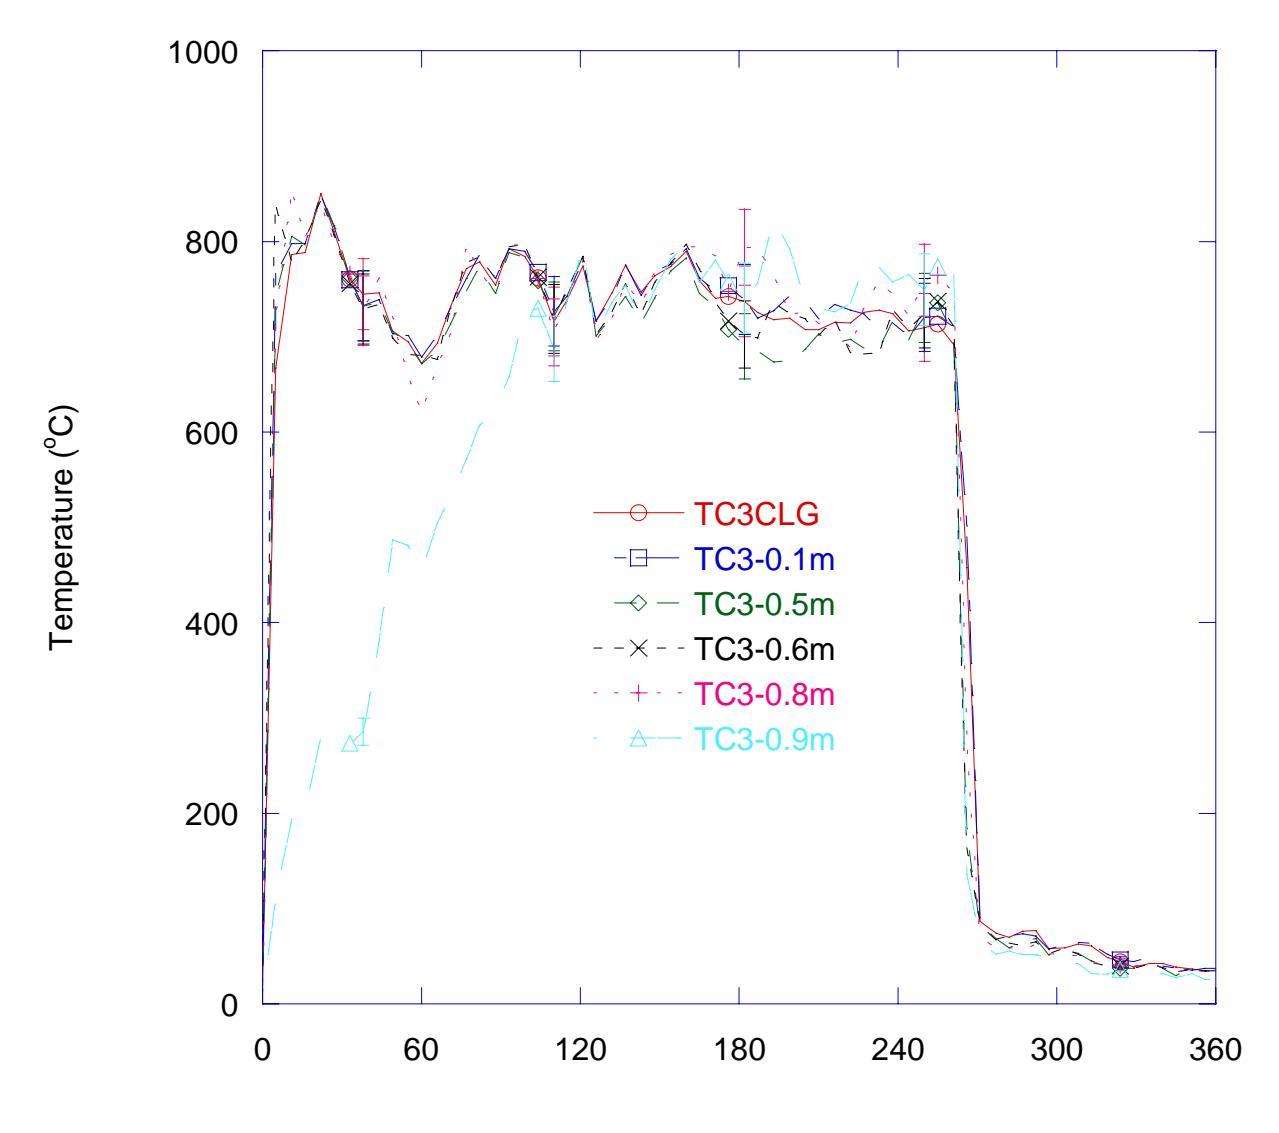
Figure 23. Graph of the temperatures above the drivers seat during the second test

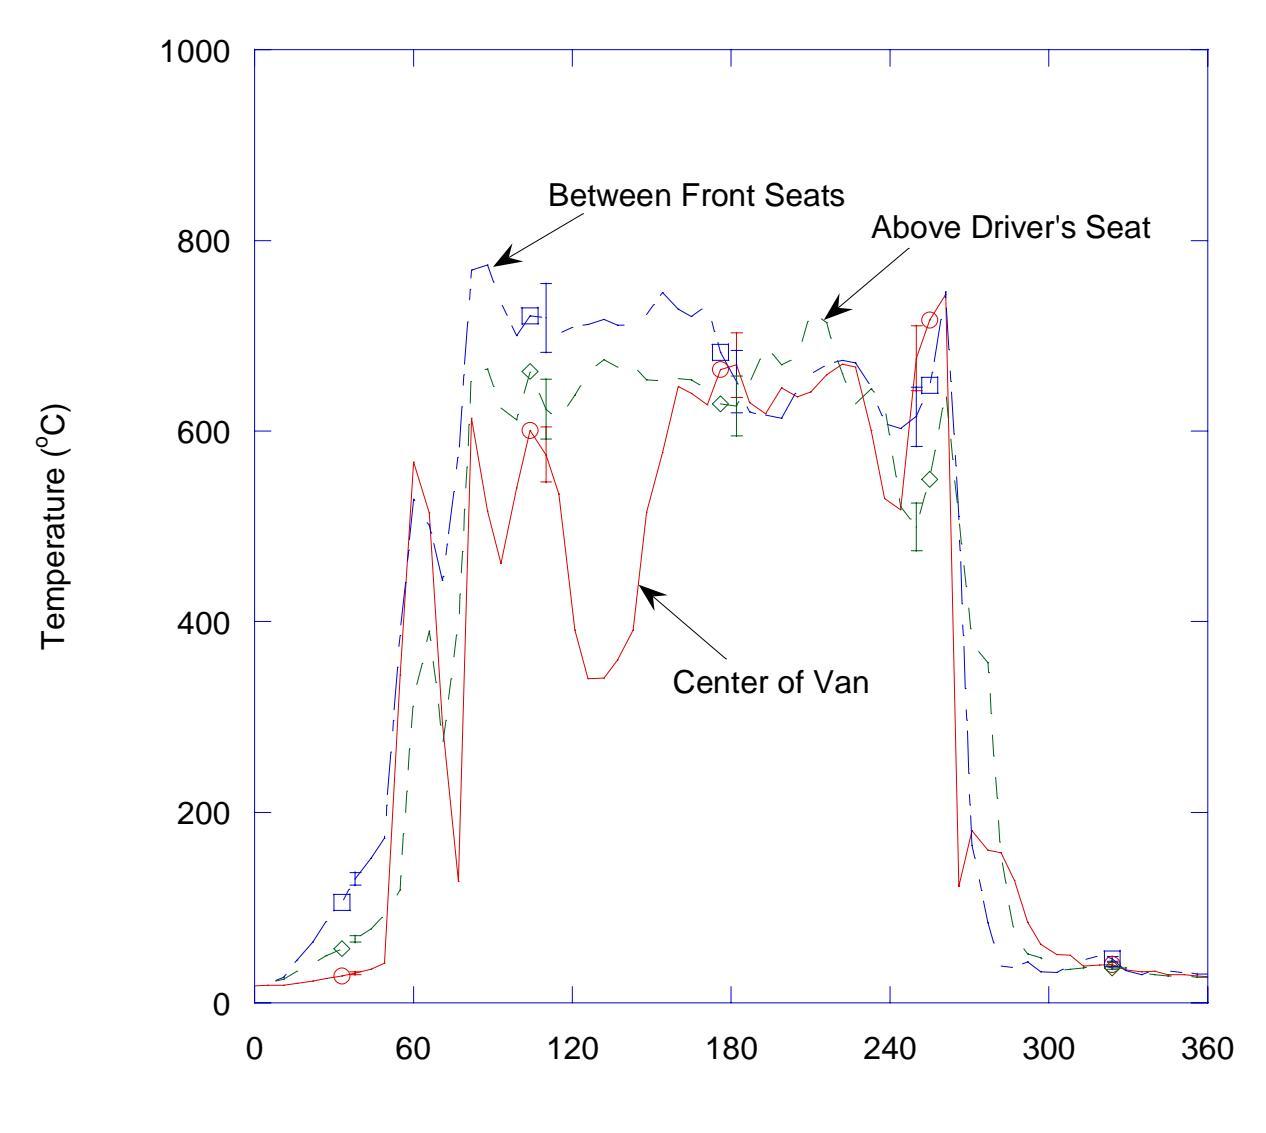
Figure 24. Graph of the temperatures above the roof of the van at the three thermocouple array locations during the second test

approximately 650 °C (1202 °F) and remains at that level. The gas concentrations measured in the passenger compartment during the second test are shown in Figure 25. Within the first min, the oxygen concentration falls to below 5%. Correspondingly, the concentrations of carbon dioxide and carbon monoxide increase to 13% and 2%, respectively. After the first min, the oxygen concentration begins increasing until it reaches a value of about 10%. The concentrations of carbon dioxide and carbon monoxide decrease and ultimately stabilize at values of 7.5% and 0.5%, respectively. An equipment failure resulted in no oxygen measurements at the 0.25 m (10 in) location. The heat release rate obtained during the second test is presented in Figure 26. The peak heat release rate for this test was 2.4 MW.

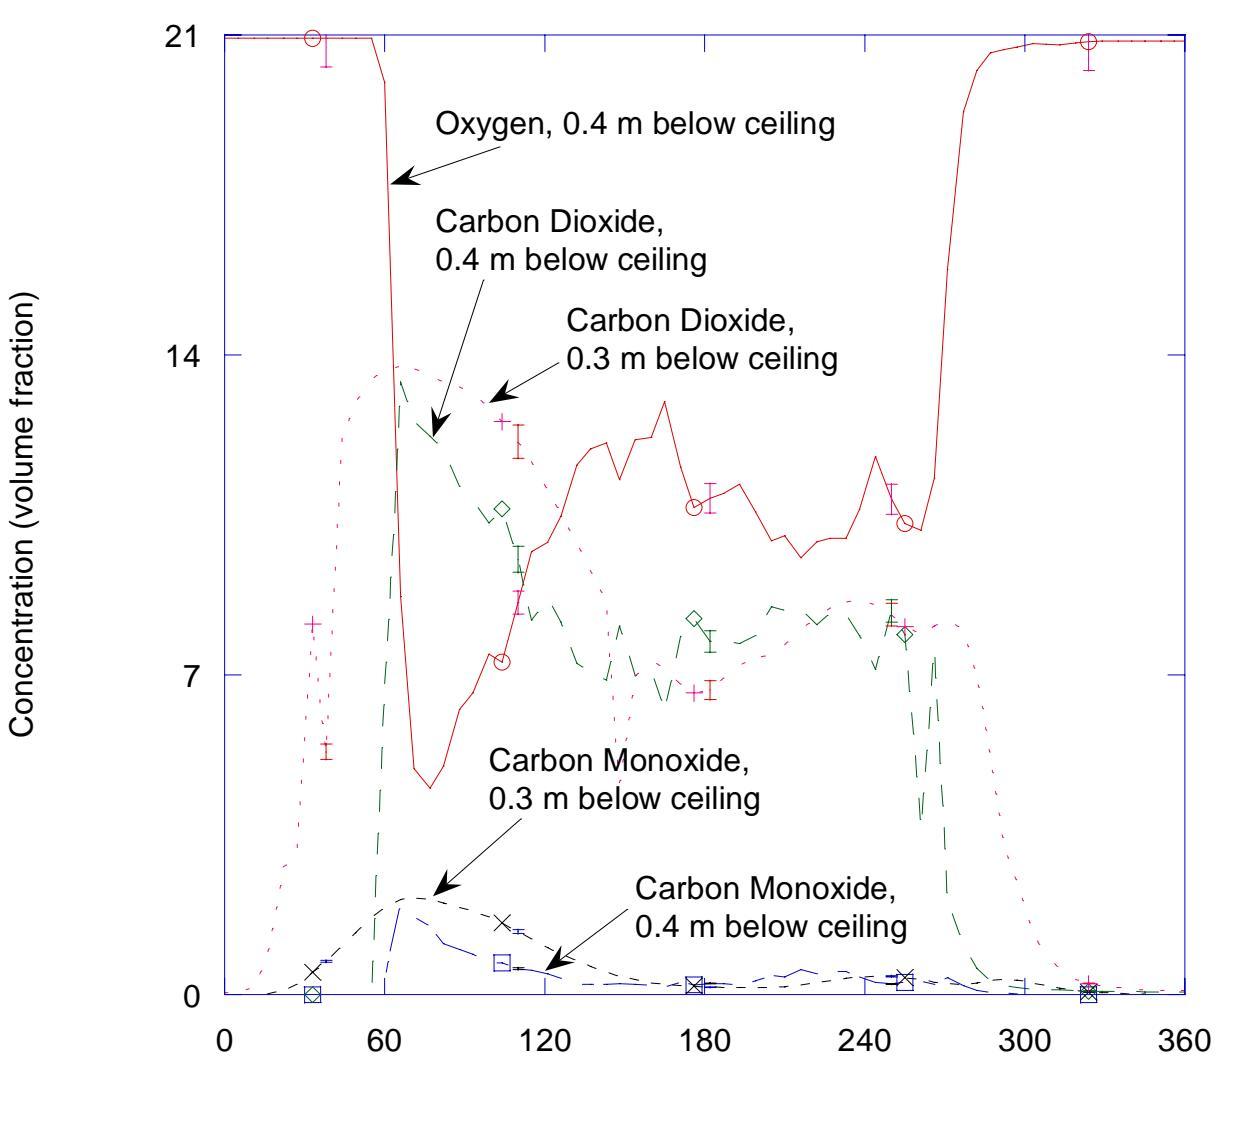
Figure 25. Graph showing concentrations of oxygen, carbon dioxide, and carbon monoxide in van at two locations above center of driver's seat during the second test

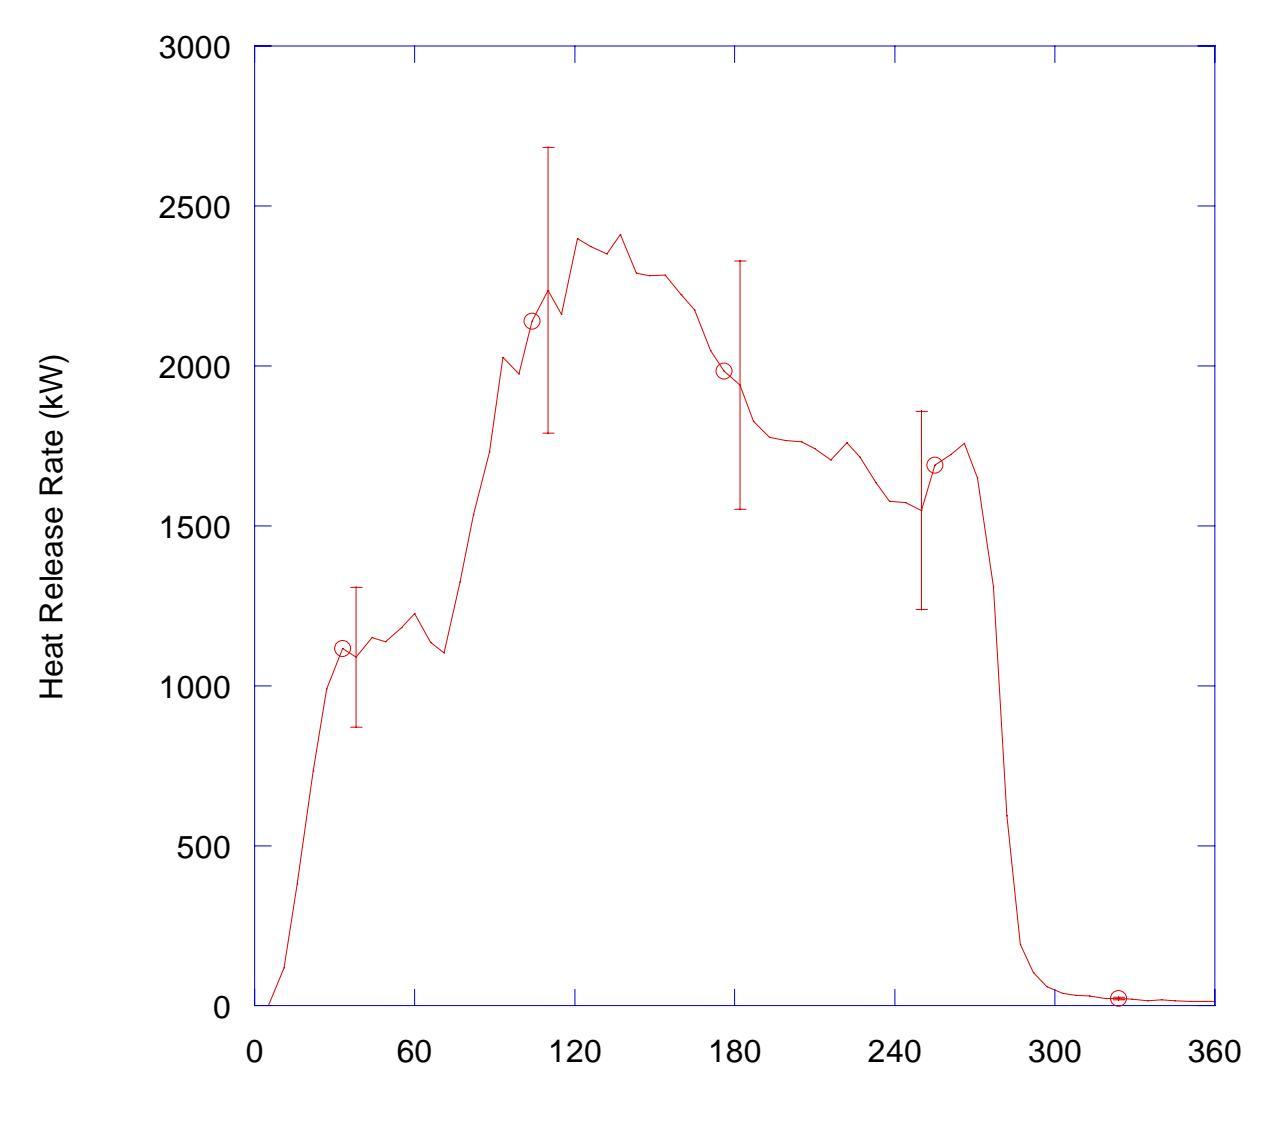
Figure 26. Graph showing heat release rate determined from measurements in the exhaust hood obtained during the second test
