FIREBRAND ATTACK ON CERAMIC TILE ROOFING ASSEMBLIES

ABSTRACT

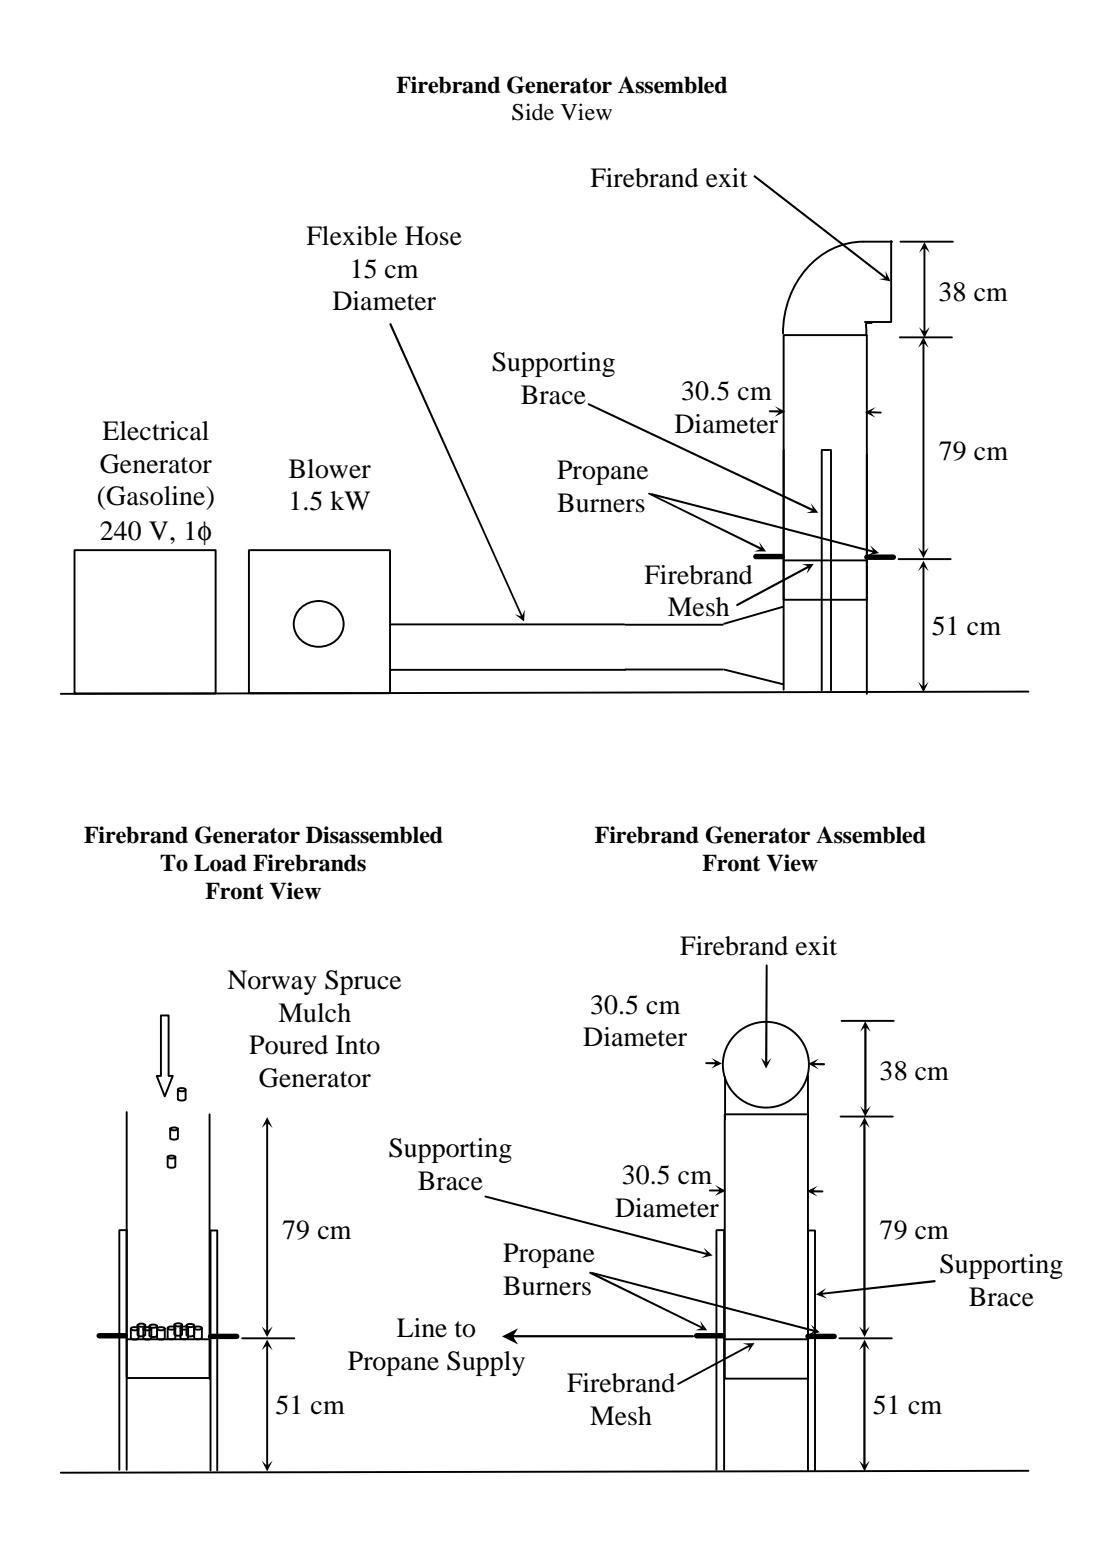
Figure 1 Firebrand Generator - Top Panel shows the device fully constructed while the bottom panel displays the procedure for loading the device.

Figure 1 is a drawing of the NIST Firebrand Generator. A brief description of the device is provided here for completeness and follows prior descriptions very closely^{3,5}. This version of the device was scaled up from a first-generation, proof-of-concept Firebrand Generator⁷. The bottom panel displays the procedure for loading the Norway Spruce (*picea abies Karst*) tree mulch into the apparatus. Norway Spruce (*picea abies Karst*) was chosen since it belongs to the *Pinaceae* family, which includes such species as Ponderosa Pine (*Pinus Ponderosa*) and Douglas-Fir (*Pseudotsuga menziesii*); common conifer species dominant in the USA. In addition, Norwegian Spruce is found in more than 20 states in the USA. These trees were used as a source for mulch for the Firebrand Generator since they were quite easy to locate in Japan.

After the Norway Spruce tree mulch was loaded, the top section of the firebrand generator was coupled to the main body of the apparatus (see figure 1). With the exception of the flexible hose, all components of the apparatus were constructed from either galvanized steel or stainless steel (0.8 mm in thickness). The blower was then switched to provide a low flow for ignition (1.0 m/s flow inside the duct measured upstream of the wood pieces). The two propane burners were then ignited individually and simultaneously inserted into the side of the generator. Each burner was connected to a 0.635 cm diameter copper tube with the propane regulator pressure set to 344 kPa at the burner inlet; this configuration allowed for a 1.3 cm flame length from each burner^{1.3}. The Norway Spruce mulch was ignited for a total time of 45 seconds. After 45 seconds of ignition, the fan speed of the blower was increased (2.0 m/s flow inside the duct measured upstream of the wood pieces). This sequence of events was selected in order to generate a continuous flow of glowing firebrands for approximately six minutes duration.

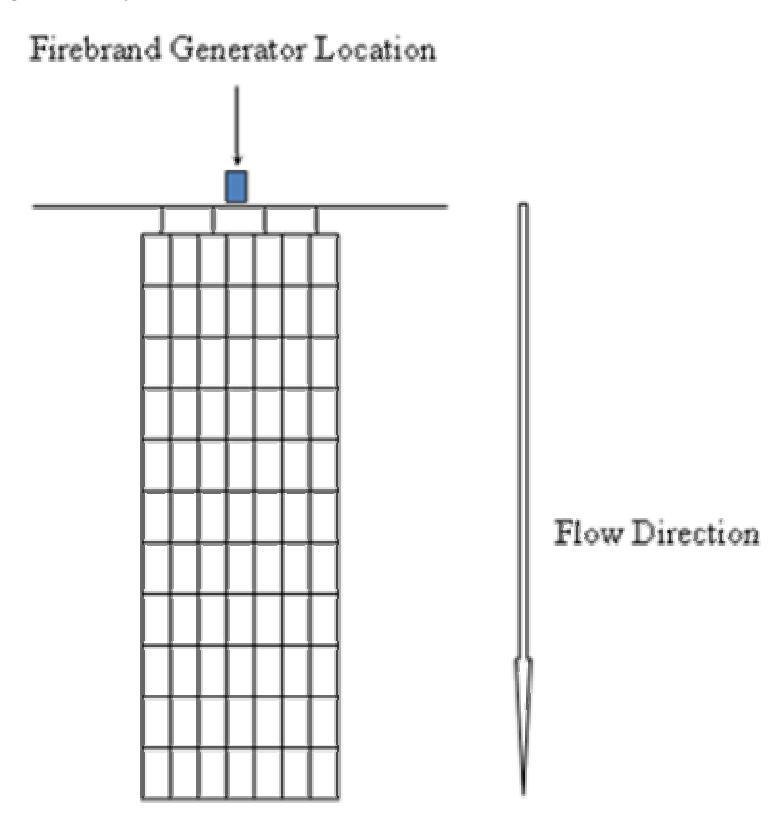
Figure 2 Array of water filled pans used to collect firebrands produced using Firebrand Generator.

The firebrands produced from the Firebrand Generator were captured using an array of water filled pans (see Figure 2). The generated firebrands landed in the water filled pans and the presence of water quenched combustion. The firebrands were subsequently removed from the water pans and dried. Since many of the firebrands produced are cylindrical, the length and diameter of the generated firebrands was measured using calipers. This information was then used to calculate the surface area of the firebrands produced and was plotted as a function of the measured firebrand mass (see Figure 3). Figure 3 also displays the same analysis performed for firebrands collected from Douglas-Fir trees as well as Korean Pine Trees under similar tree moisture content. From the figure, the firebrand generator was capable of approximating the size and mass distribution of firebrands from burning trees up to 0.2 g; similar results have been shown for other mulches used^{3,5}. The uncertainty in determining the surface area is $\pm 10\%$.

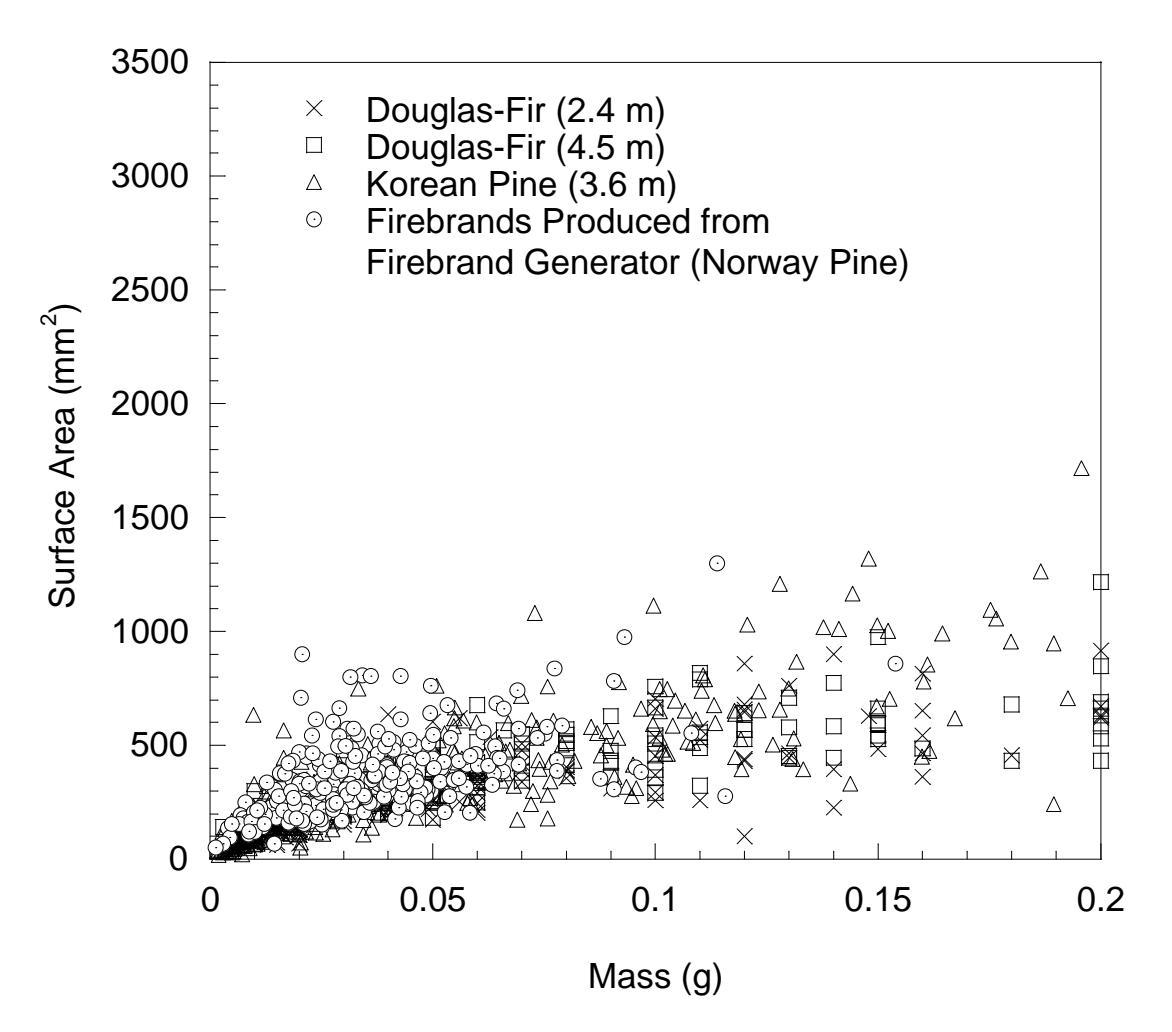
Figure 3 Firebrands measured from burning trees to those produced using Firebrand Generator.

The Firebrand Generator was designed to be able to produce firebrands characteristic to those produced from burning trees. Manzello *et. al.*^{8,9} have done a series of experiments quantifying firebrand production from burning trees. In that work, it was observed that more than 85 % of the firebrands produced from trees were less than 0.4 g. The input conditions for the firebrand generator were intentionally selected to produce firebrands with mass up to 0.2 g. This was accomplished by sorting the

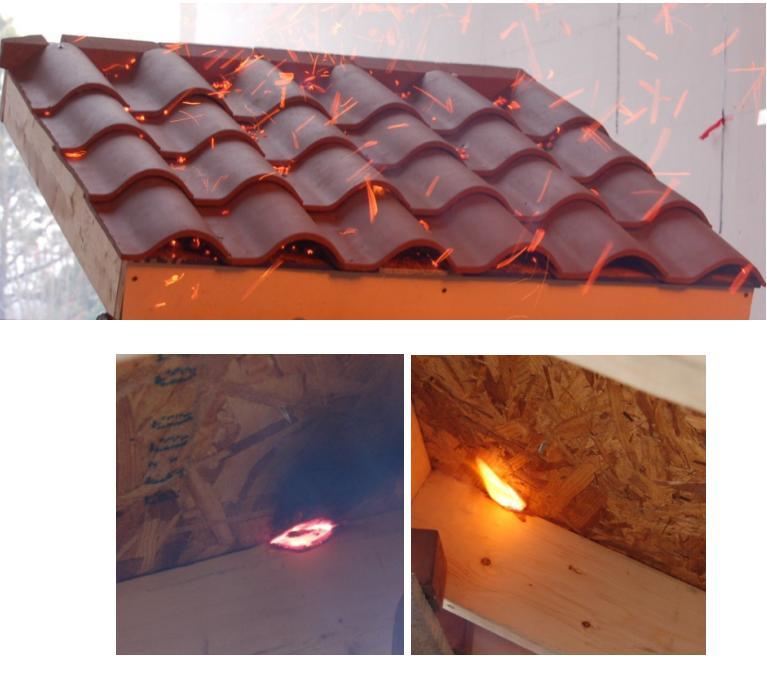
Figure 4 Images of experiments conducted using OSB/CT without bird stops installed. Intense SI was observed within the OSB base layer and eventually FI was observed.

A full scale section (122 cm by 122 cm by 9 mm thick) of a ceramic tile roof assembly was constructed for testing (shown in figure 4). The pitch of the full scale section was fixed at 25°. To be able to control the moisture content of OSB base layer, the experiments were designed in a modular fashion. Specifically, the 122 cm by 122 cm full section was comprised of four separate OSB pieces. This allowed each section to be oven dried and once dried, simply reassembled inside the custom mounting frame.

Figure 4 displays a sequence of images obtained from the case of OSB/CT without the installation of bird stops. Not surprisingly, bird stops are intended to mitigate the construction of nests by birds under the ceramic tiles. Many ceramic tile roofing assemblies found in practice do not have bird stops installed¹. Without the installation of bird stops, the firebrands were observed to be blown under the ceramic tiles. Eventually, several firebrands would collect and would produce smoldering ignition (SI) within the OSB base layer. With continued application of the airflow, holes were formed within the OSB and eventually the SI would transition to flaming ignition (FI). The same result was observed independent of the applied wind tunnel flow.

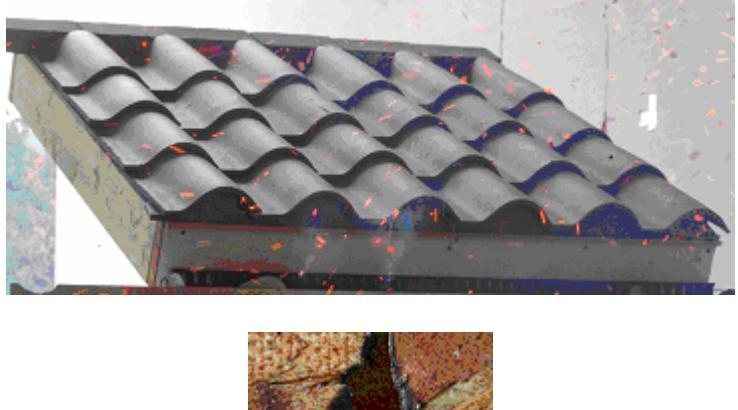
Figure 5 Images of experiments conducted using OSB/CT with bird stops installed. Intense SI was observed within the OSB base layer.

Subsequent to this, a series of experiments were conducted to simulate an aged ceramic tile roof assembly (tar paper not installed) but in this case bird stops were installed. Figure 5 displays images from these tests. Even though bird stops were installed, many firebrands were able to penetrate the gaps that exist between the tile and the bird stops. These firebrands were observed to produce SI within the OSB base layer resulting in holes in the OSB base layer in some cases. The same result was observed independent of the applied FRWTF flow. The SI ignition never transitioned to FI when bird stops were applied.

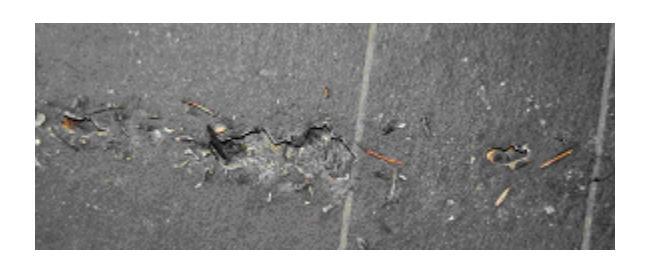
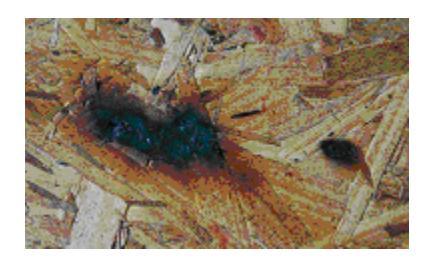
Figure 6 Images of experiments conducted using OSB/TP/CT without bird stops installed. SI was observed within the OSB base layer.

The use of tar paper was then used to simulate a newly constructed ceramic tile roof assembly. With the application of tar paper, experiments were conducted first without bird stops installed. Once again, firebrands were blown under the ceramic tiles. The firebrands were able to burn several holes within the tar paper and produce SI within the OSB base layer (see Figure 6). The SI was not intense enough to result in the production of holes within the OSB base layer.
