Block shear failure of steel gusset plates

C. Crosti

D. Duthinh

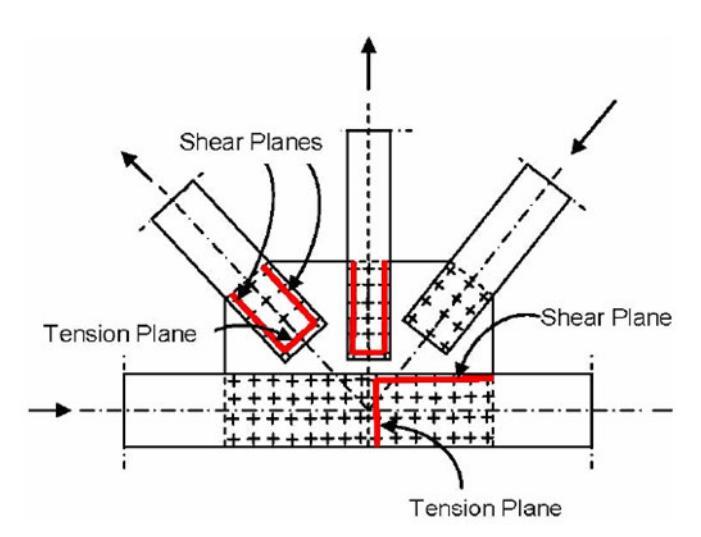
Figure 1. Example of potential block shear rupture planes for gusset plates in tension (FHWA, 2009).

Block shear failure is a limit state that combines tension failure on one plane and shear failure on a perpendicular plane (Fig. 1). The guidelines assume that, when one plane reaches ultimate strength, the other plane develops full yield. Therefore, two possible failure modes can develop: in the first, rupture occurs along the net tension plane and full yield develops along the gross shear plane. The second failure mechanism assumes that rupture occurs along the net shear plane while full yield develops along the gross tension plane.

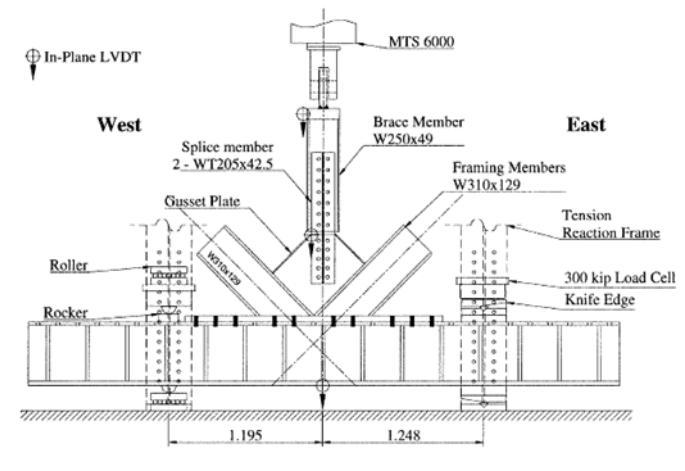
Figure 2. University of Alberta gusset plate test (Nast, Grondin and Cheng, 1999).

This study used shell elements with four-nodes, available in commercial software STRAND, to perform nonlinear finite-element analyses of gusset plates under tension. For validation, we first simulated a test (Fig. 2) performed at the University of Alberta (Nast, Grondin and Cheng, 1999).

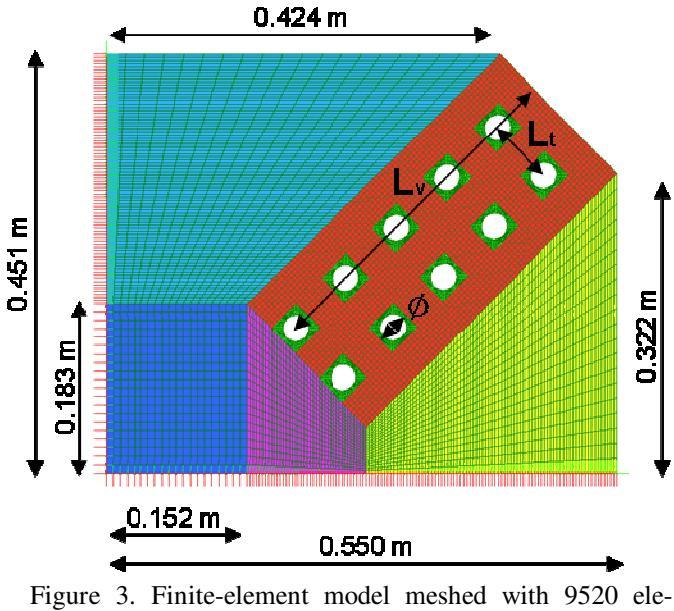
Figure 3. Finite-element model meshed with 9520 elements.

Plate 1 has the dimensions shown in Fig. 3, a thickness of 9.61 mm and ten bolt holes of diameter 24.3 mm (bolt failure is not part of this study). The model is fixed along the two perpendicular edges at the bottom and left. The analysis accounts for the nonlinearity of the material and large displacements. The material is bilinear elasto-plastic, with Young's modulus of 215 GPa, yield strength of 410 MPa and tangent modulus of 2.15 GPa. The analysis uses true stress and true strain.

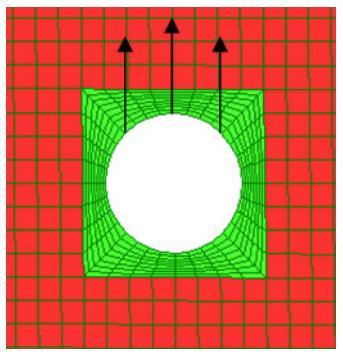
Figure 4. Application of bolt loads.

The tension load is applied by three point loads on the upper half of each bolt hole (Fig. 4).

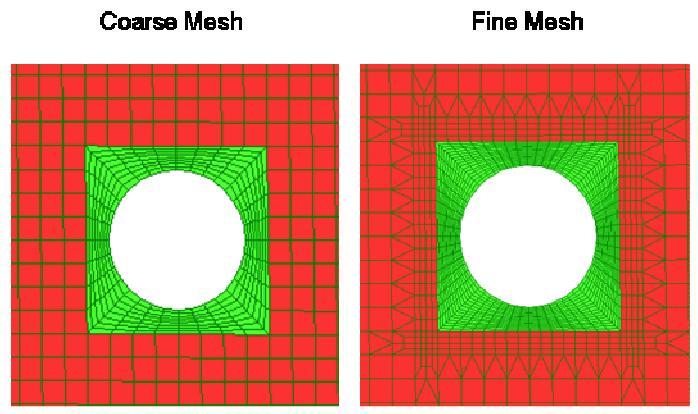
Figure 5. Mesh refinement around holes.

Two levels of mesh refinement were used to model the regions of stress concentration around the bolt holes (Fig. 5) where failure would likely initiate.

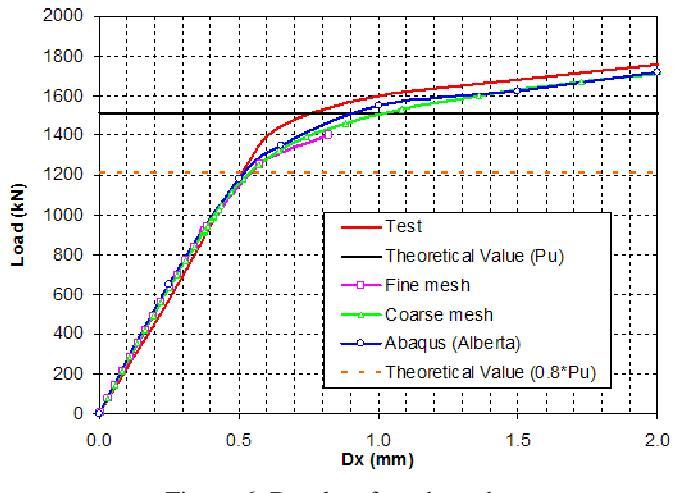
In Fig. 6 the load-displacement response of the node in the middle of the oblique edge is used to

compare the test and numerical results from the University of Alberta with the unfactored FHWA value P_u , the LRFR value 0.80 P_u , and the finite-element results for the coarse and the fine mesh.

Figure 6. Results of mesh study.

Results from the present two STRAND meshes agree well with the ABAQUS model used by the University of Alberta. All three finite-element results slightly underestimate the test results, especially at the onset of yielding. The LRFR value falls on the limit of the elastic range, whereas the unfactored FHWA value produces a small amount of yielding. The coarse mesh is used in the rest of this study.

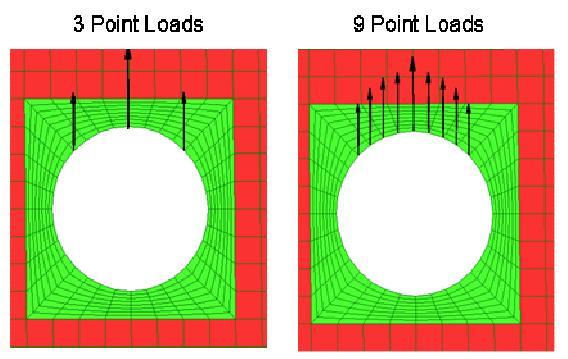
Figure 7. Coarse and fine bolt load application.

The previous finite-element results predicted premature yielding compared to test results. One possible reason is the bolt load, which is applied in too concentrated a fashion at three nodal points for each bolt hole. In the next step, we distributed the bolt load to nine points over a 90° arc (Fig. 7), following a sinusoidal distribution, $P = P_0 \cos \alpha$, where $-45^\circ \le \alpha \le 45^\circ$.

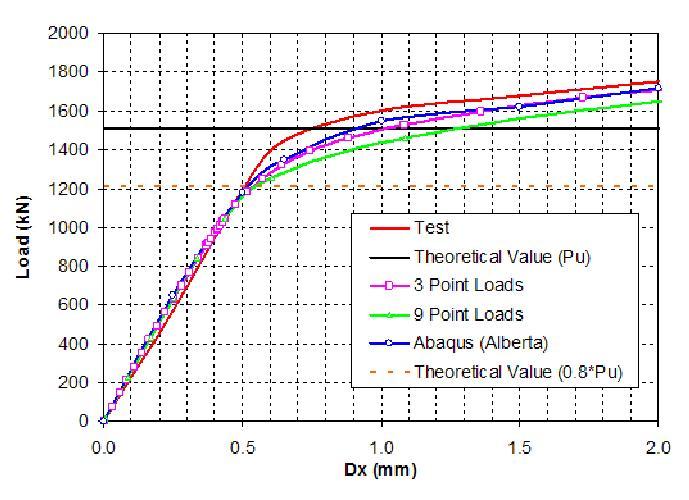
Figure 8. Results for coarse and fine bolt load application.

Figure 8 compares the FHWA values, the test results and the results for the coarse and fine bolt load applications. There is not much difference between the results for the two bolt load applications, even though the trend is opposite to what is expected.

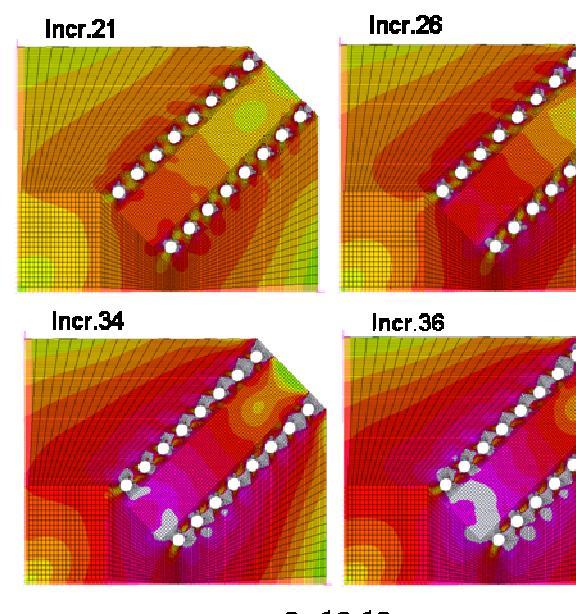
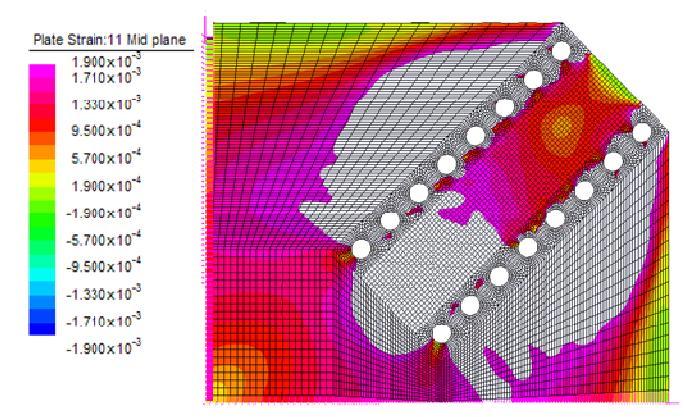
Figure 9. Strain profiles of Plate 2 ($A_{tn} < 0.58A_{vn}$).

Plate 2 has a tension length L_t of 0.139 m, a shear length L_v of 0.358 m and bolt holes arranged as shown in Fig. 9. Since $A_{tn} < 0.58 A_{vn}$, failure is by block shear. Figs. 9 and 10 show the maximum principal strain profile and the load-displacement curve of this gusset plate at various load steps.

In Fig. 9, elastic regions are in color whereas plastic regions and the holes are in white. As expected, straining is most intense between the holes, yielding initiates near the holes, then spreads to the connecting regions. The strain profile is compatible with eventual rupture along the shear plane while full yield develops across the tension plane between the two end holes.

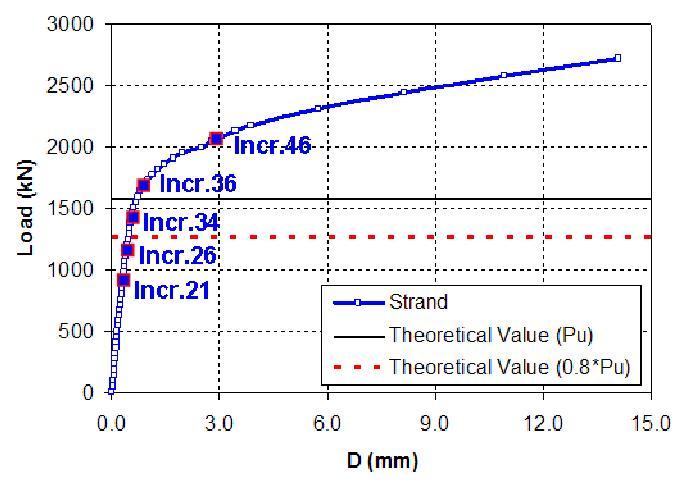
Figure 10. Load displacement for Plate 2.

Figure 10 shows an ultimate load of 2720 kN at a displacement of 14 mm, and thus the LRFR value provides a factor of safety of ultimate load/LRFR value = 2720/1267 = 2.15.

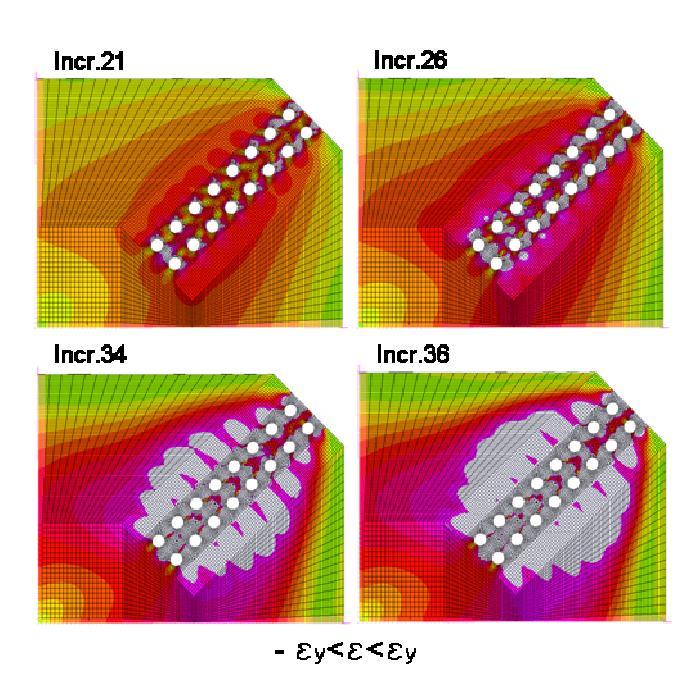
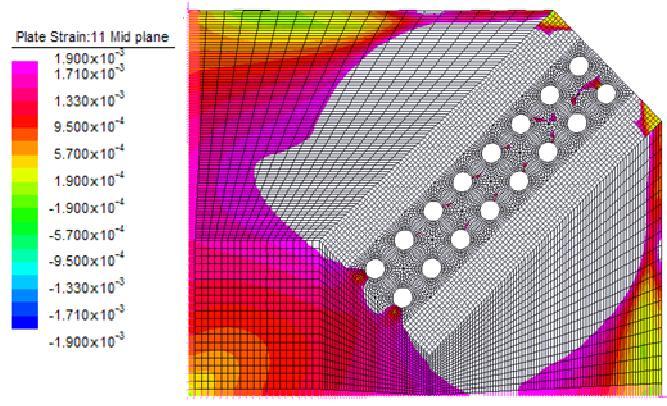
Figure 11. Strain profiles of Plate 3 ($A_{tn} < 0.58A_{vn}$).

The bolts in Plate 3, shown in Fig. 11, are distributed over a narrower width. This gusset plate has a tension length L_t of 0.0462 m and a shear length L_v of 0.358 m. Again, since $A_{tn} < 0.58 A_{vn}$, failure is by block shear.

Similar observations about the maximum principal strain profile and the load-displacement curve can be made for plate 3 as for plate 2.

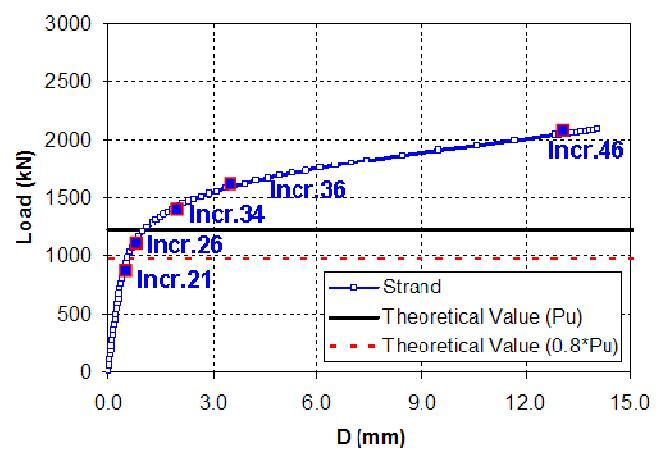
Figure 12. Load-displacement curve for Plate 3.

Fig. 12 shows an ultimate load of 2088 kN at a displacement of 14 mm, and thus the LRFR value provides a factor of safety of ultimate load/LRFR value = 2088/974.4 = 2.14.

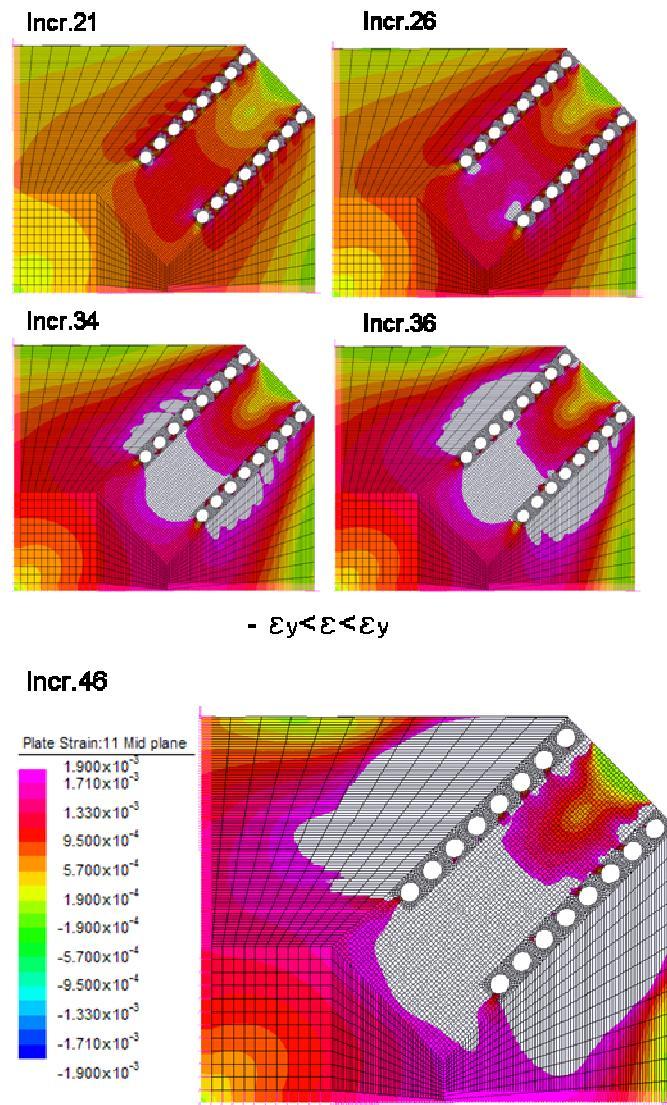
Figure 13 shows the results for Plate 4 with tension length L_t of 0.150 m and shear length L_v of 0.273 m. In this case, $A_m > 0.58 A_{vn}$ and failure is by tension. Fig.14 shows an ultimate load of 2190 kN at a displacement of 7.8 mm, and thus the LRFR value provides a factor of safety of ultimate load/LRFR value = 2190/918.2 = 2.38.

Thus, Plates 2 and 3, which failed by block shear, even though they had rather different hole arrangement, behaved very similarly. Plate 4, which failed by tension, had a slightly higher factor of safety but less ductility than Plates 2 and 3. In all cases, the FHWA values are safe and adequate.

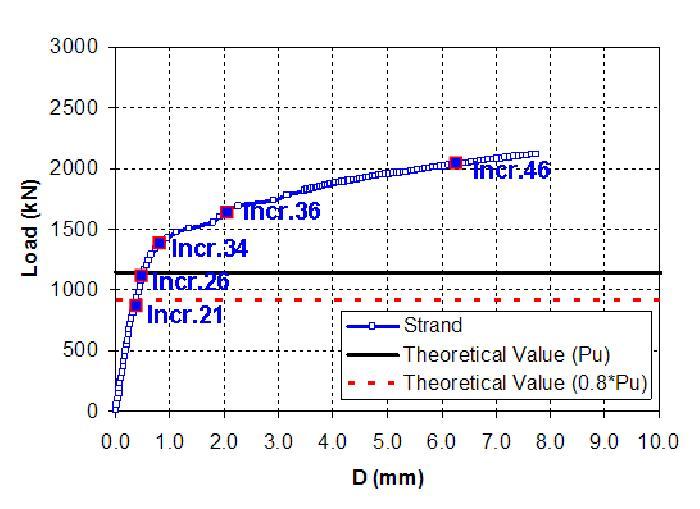
Figure 14. Load-displacement curve for Plate 4.

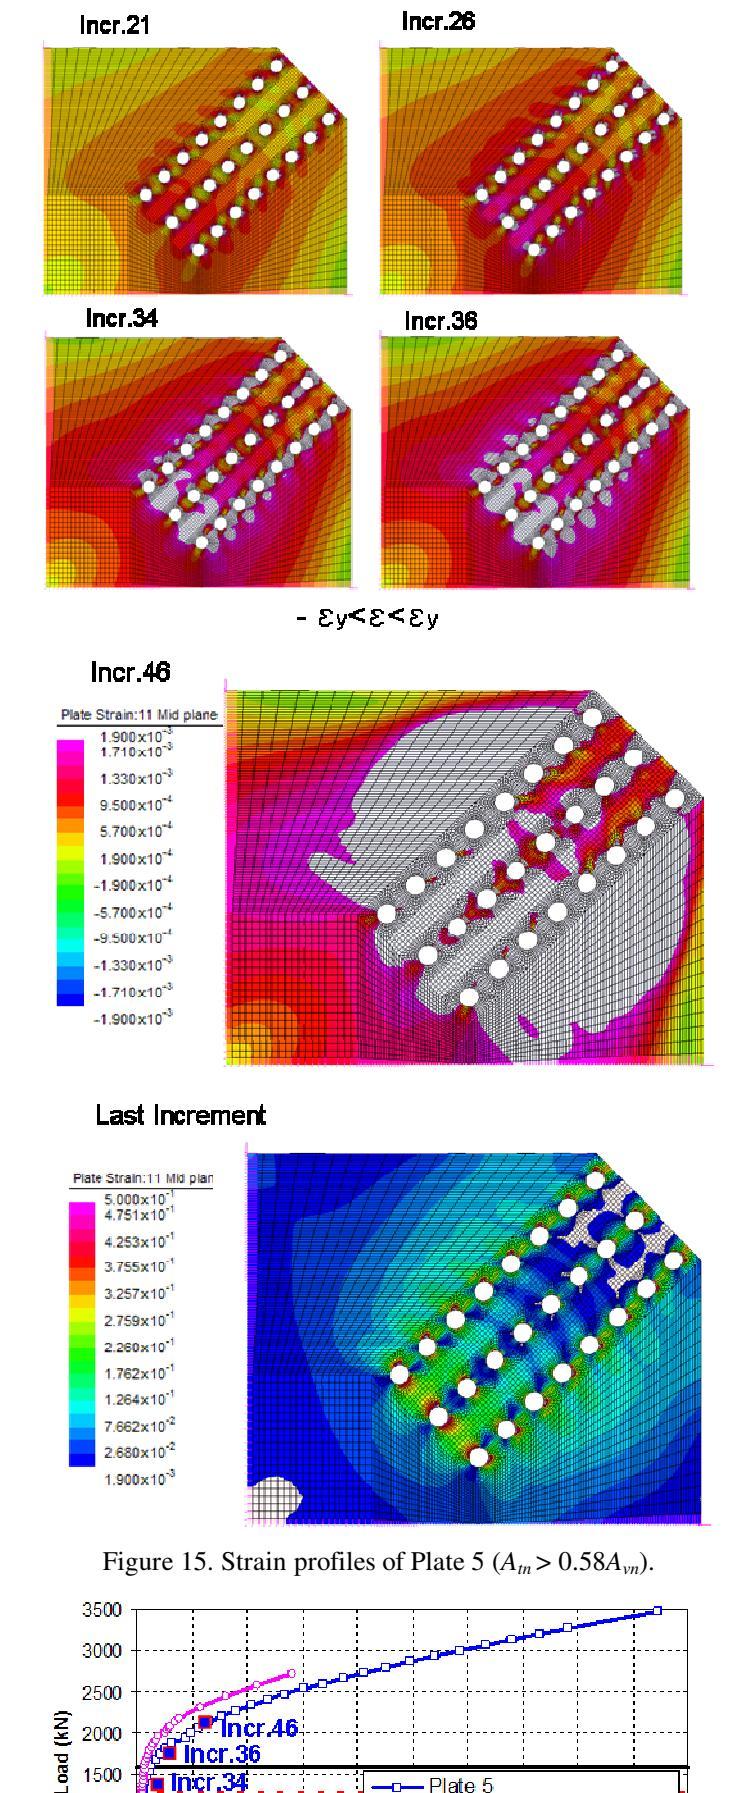
$5.0 \quad 10.0 \quad 15.0 \quad 20.0 \quad 25.0 \quad 30.0 \quad 35.0 \quad 40.0 \quad 45.0 \quad 50.0$ D (mm) Figure 16. Load-displacement curve for Plate 5.

Compared to Plate 2, Plate 5 has a third row of bolts. The strain profiles shown in Fig. 15 include the strains that exceed yield at the last load step, when the highest strains reach 100 % (at a few localized points). The profile has better resolution and is more instructive when the plot is limited to strains of 50 %. In the last plot of Fig. 15, the elastic regions and the holes are in white. Fig.16 shows an ultimate load of 3468 kN at a displacement of 47.3 mm, and thus the LRFR value provides a factor of safety of ultimate load/LRFR value = 3468/1267 = 2.73. Fig. 16 also shows the beneficial effect of adding internal bolts, which increase the strength and ductility of the gusset plate. A simplified analysis that only accounts for the perimeter bolts would underestimate the strength and ductility of the gusset plate.

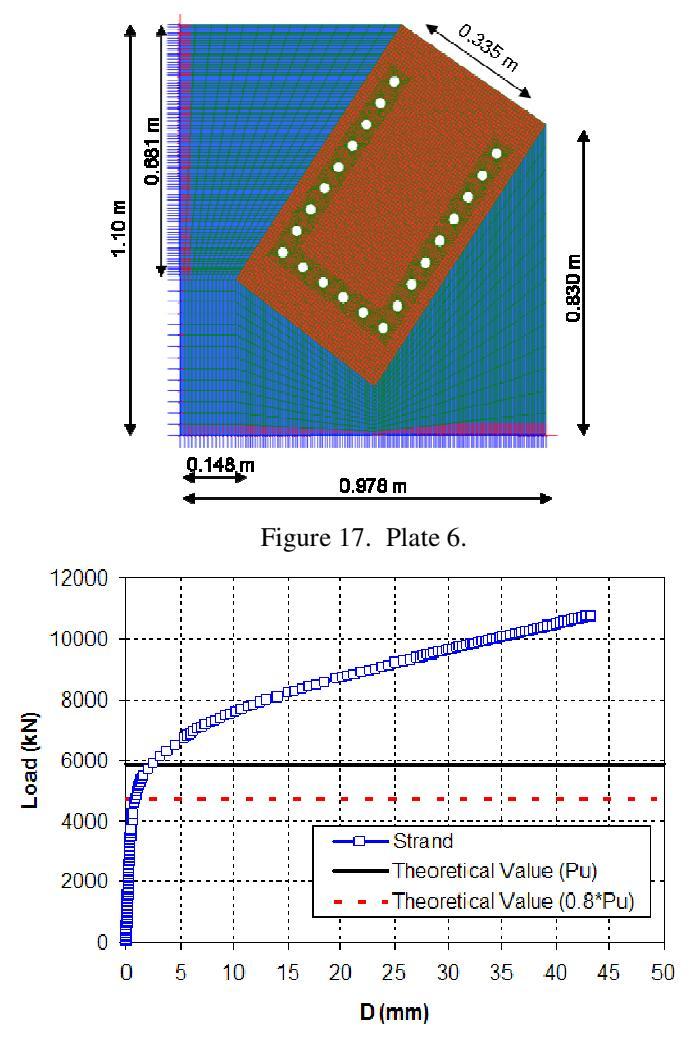
Figure 18. Load-displacement curve for Plate 6.

We now analyze one of the example plates from the guidance document (FHWA, 2009). The gusset plate considered is shown in Fig. 17 and its steel is elasto-plastic, with Young's modulus of 200 GPa, a yield strength of 248 MPa, and a tangent modulus equal to 1% of the elastic modulus. Failure is by block shear. Fig. 18 shows an ultimate load of 10750 kN at a displacement of 43.2 mm, and thus the LRFR value provides a factor of safety of ultimate load/LRFR value = 10750/4704 = 2.28.
