SPECIAL ISSUE PAPER

Fire resistance of cold-formed steel framed shear walls under various fire scenarios

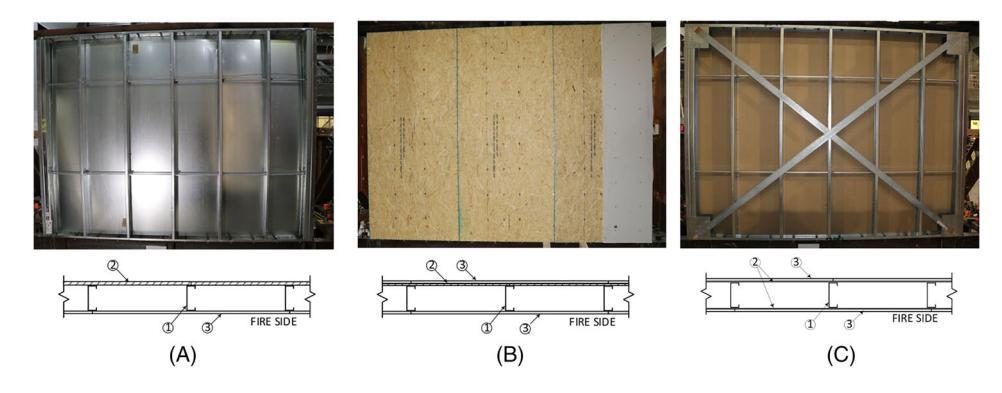
FIGURE 1 Photographs of partially constructed test specimens and cross-sections: A, gypsum-steel sheet composite panel sheathed walls; B, OSB sheathed walls; C, steel strap-braced walls. (1, steel stud; 2, structural sheathing or diagonal bracing; 3, gypsum board) [Colour figure can be viewed at wileyonlinelibrary.com]

Figure 1 shows cross-sections and photographs of the test specimens. They are Type I shear walls* designed using allowable stress design (ASD) nominally following American Iron and Steel Institute (AISI) standards S100-16¹⁸ and S400-15/S1-16.¹⁹ All wall specimens were 2.7 m tall by 3.7 m long. The CFS studs and track were 152 mm wide and had material thickness of 1.37 mm or greater. The gypsum-sheet steel composite panels were a proprietary product that consisted of 0.686-mm thick sheet metal adhered to 16-mm thick Type X gypsum board. The OSB sheathing elements were 11 mm thick wood structural panels. All other gypsum boards were 16 mm thick Type X. The walls were designed to achieve a 1-hour fire-resistance rating per ASTM E119. On the fire-exposed side of the walls, the gypsum board joints were sealed using a base coat of drywall joint compound and paper tape, and the seams and fastener heads then covered with a skim coat of drywall joint compound. No joint compound or paper tape was used on the unexposed side of the wall. The measured moisture content of

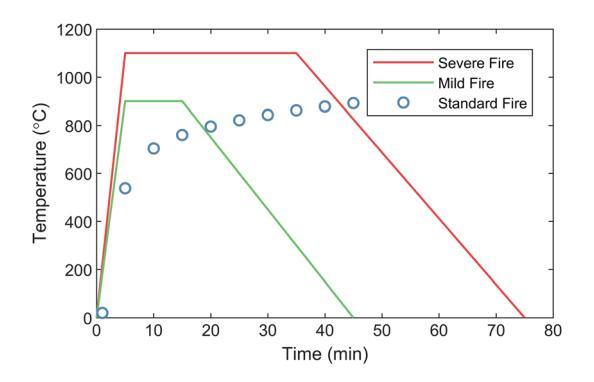
FIGURE 2 Target temperature-time curves for the natural gasfuelled design fires [Colour figure can be viewed at wileyonlinelibrary.com]

- Severe Fire is a postflashover fire of relatively long duration (35 minutes) and a peak upper layer gas temperature of 1100°C.
- *Mild Fire* is a postflashover fire of relatively short duration (15 minutes) and a peak upper layer gas temperature of 900°C.

• *Standard Fire* is a 1-hour temperature-time exposure similar to ASTM E119.

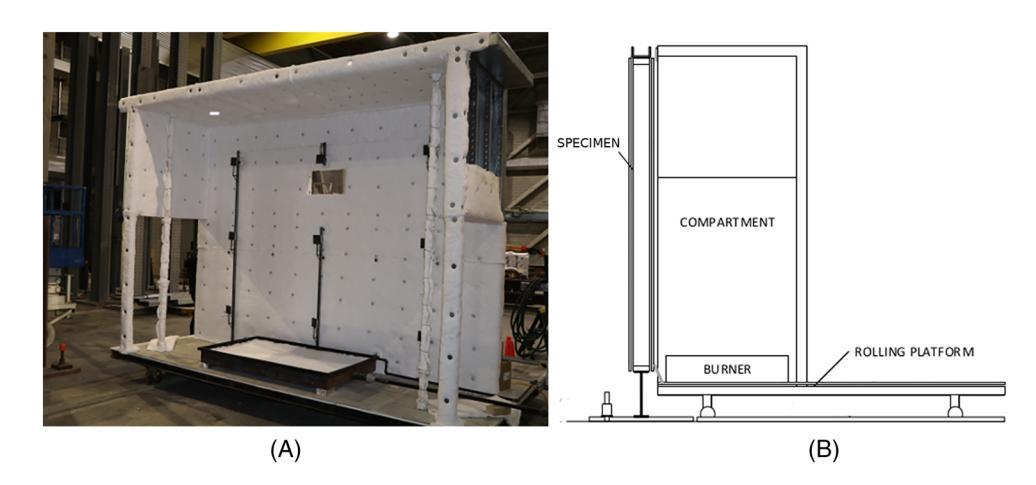
FIGURE 3 Compartment for natural gas-fuelled fires: A, photograph; B, cross-section [Colour figure can be viewed at wileyonlinelibrary.com]

During the Mild, Severe, and Standard fires, the thermal load was applied using a natural gas burner in a three-sided movable compartment adjacent to the test specimen (Figure 3). The interior dimensions were $3.2 \text{ m} \log \times 1.2 \text{ m} \deg \times 2.9 \text{ m}$ high. The compartment had vents located at each side $1.7 \text{ m} \tan 1.2 \text{ m}$ wide. The compartment was lined with two layers of thermal ceramic blanket each 25 mm thick. A window made of fused silica glass was place in the back wall of the compartment to allow observation of the test specimen and video recording.

The burner was 1.4 m long × 0.8 m wide. The gas entered near the bottom of the burner and percolated up through a 25-mm thick layer of thermal ceramic fiber blanket. A positive displacement rotatory flowmeter, pressure gauge, and thermistor were used to measure the mass flow rate of the gas to the burner. The composition of the gas was determined using in-line gas chromatography. The calculated HRR of the burner was rapidly increased to 1.7 MW for 15 minutes for the Mild Fire, 2.3 MW for 35 minutes for the Severe Fire, and increased more slowly up to 1.4 MW for the Standard Fire. The HRR levels for the burner were based on modeling of the test

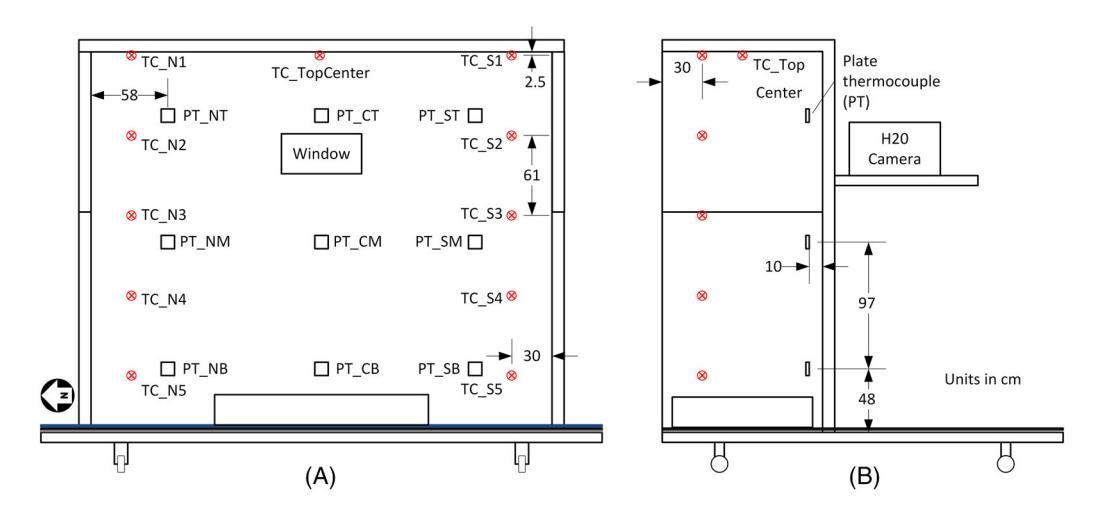
FIGURE 4 Compartment sensors for gas fueled fires: A, looking east; B, looking north [Colour figure can be viewed at wileyonlinelibrary.com]

As shown in Figure 4, the natural gas fuelled compartment was instrumented as follows:

two thermocouple (TC) arrays each with five Inconel-sheathed Type K grounded junction TCs of 3.175 mm outside diameter. The measurement range was -200°C to 1250°C with an expanded uncertainty of $\pm 2.8\%$ of the reading. The top TC was placed 2.5 cm away from the ceiling, and the four remaining TCs were spaced 61 cm from each other. These TCs were not corrected for radiative heating and have a manufacturer-specified response time of about 12 seconds;

- one additional Inconel-sheathed Type K grounded junction TC was placed 2.5 cm from the ceiling at the center of the compartment; and
- nine plate TCs were placed 10 cm from the back wall of the compartment facing the test specimen. Each plate TC probe plate was 100 mm × 100 mm and was specified to operate up to 1200°C. A manufacturer-reported standard uncertainty was not available.

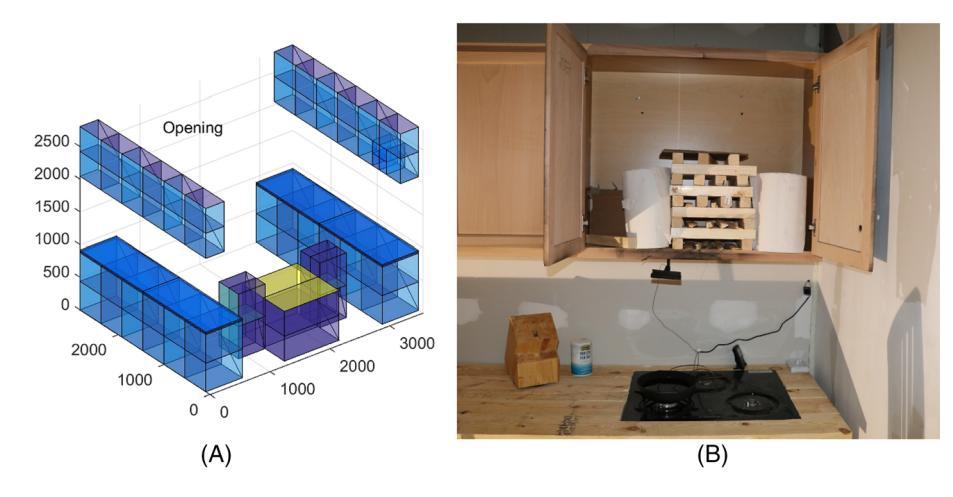
FIGURE 6 (A) Model of the installed fuel (axes units in centimeters) and (B) ignition source and objects of first ignition [Colour figure can be viewed at wileyonlinelibrary.com]

The thermal load in the compartment was provided by typical kitchen furnishings, mostly untreated spruce, pine or fir and particle board. The design fire load was 807 MJ/m_{floor}^2 based on values reported by Bwalya et al.²⁰ The opening factor was selected to be 0.08 m^{1/2} to achieve the desired burn duration of 15 minutes. The fire load and opening factor correspond those used to develop the Mild Fire (Table 1). Figure 6A shows the distribution of the fuel within the compartment. The measured total mass of combustible material was (411 ± 0.1) kg. The estimated energy for each item was determined using calorific values from literature.²⁴ The total estimated energy was 8100 MJ, thus the achieved FLD was 804 MJ/m². The fire started by auto-ignition of 500 mL of corn oil in a 203-mm diameter cast iron pan left unattended on a stove. To ensure the spread of the fire to the cabinets, the doors on the cabinet above the stove were left ajar and a small wood crib and paper towels were placed in the cabinet (Figure 6B).

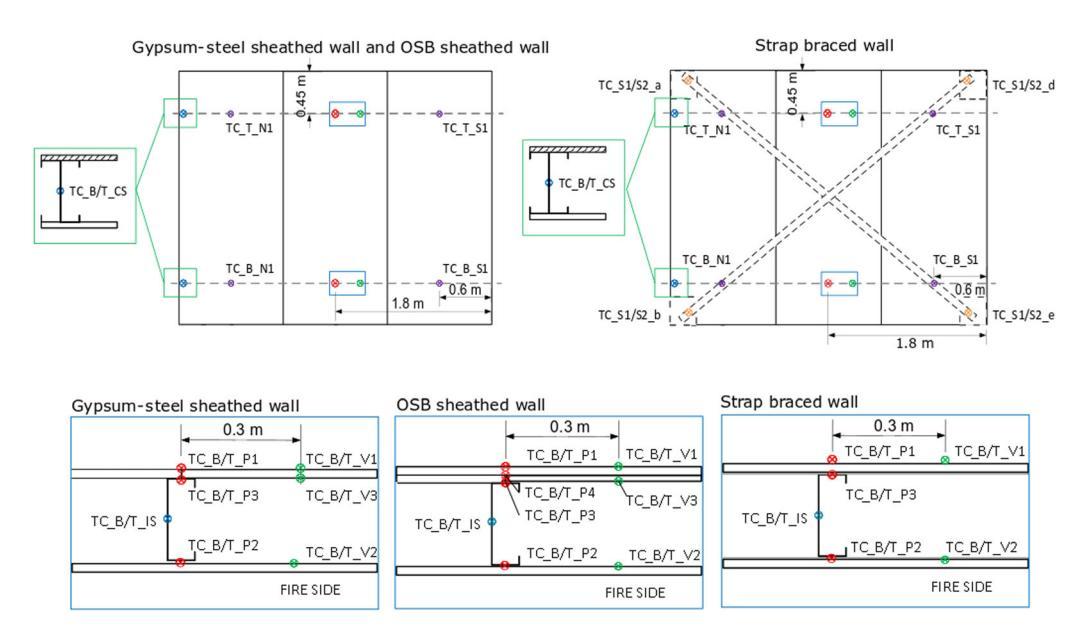
FIGURE 7 Instrumentation in the wall specimens [Colour figure can be viewed at wileyonlinelibrary.com]

Figure 7 shows the locations of the instrumentation in the wall specimens. All walls were instrumented with TCs through the cross-section at four locations, eight TCs on the unexposed side, and two TCs in the chord studs (an axial load-bearing stud located at the ends of shear wall segments or strap-braced walls). Most TCs were 24-gauge Type K bare bead. The TCs were attached to the surfaces by clamping them between materials or compressing against the material using a screw. Self-adhering TCs were used for unexposed side measurements. Velocity probes were placed at the knockout holes 91 cm from the bottom and 61 cm from the top of the chord studs, measuring the

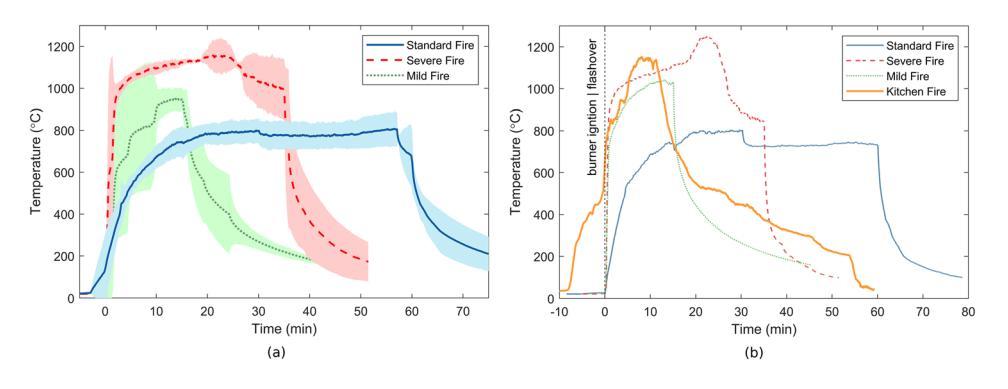
FIGURE 8 (A) Temperature-time curves for the investigated fires plotted as the mean value (line) and one standard deviation (shaded area) for the standard, severe, and mild fires and (B) comparison of the upper layer gas temperatures for individual tests of the oriented strand board (OSB) sheathed walls [Colour figure can be viewed at wileyonlinelibrary.com]

The average upper gas layer temperatures measured in all tests are plotted in Figure 8A as the average of the top three TCs of the two TC arrays. The Mild Fire showed the largest variation in gas temperatures; however, it had the largest number of test repeats: nine tests versus three for the Severe and Standard fires. The measured gas temperatures are close to the design values (compare Figure 8 with Figure 2) up to the decay phase. For the decay phase, in the experiments, the burners were shut off and the compartment cooled as dictated by the geometry and

materials in the compartment. This led to faster cooling than in the design fires. Additionally, the Standard Fire had a slower heating rate at the beginning and slightly lower maximum temperatures than the ones in the design fire. Figure 8B plots the upper gas layer temperature for OSB sheathed wall tests with various fire loads. The Kitchen Fire had similar duration to the Mild Fire with a slightly higher peak temperature. In the Severe Fire, the increase in temperature after 20 minutes is caused by the burning of the OSB.

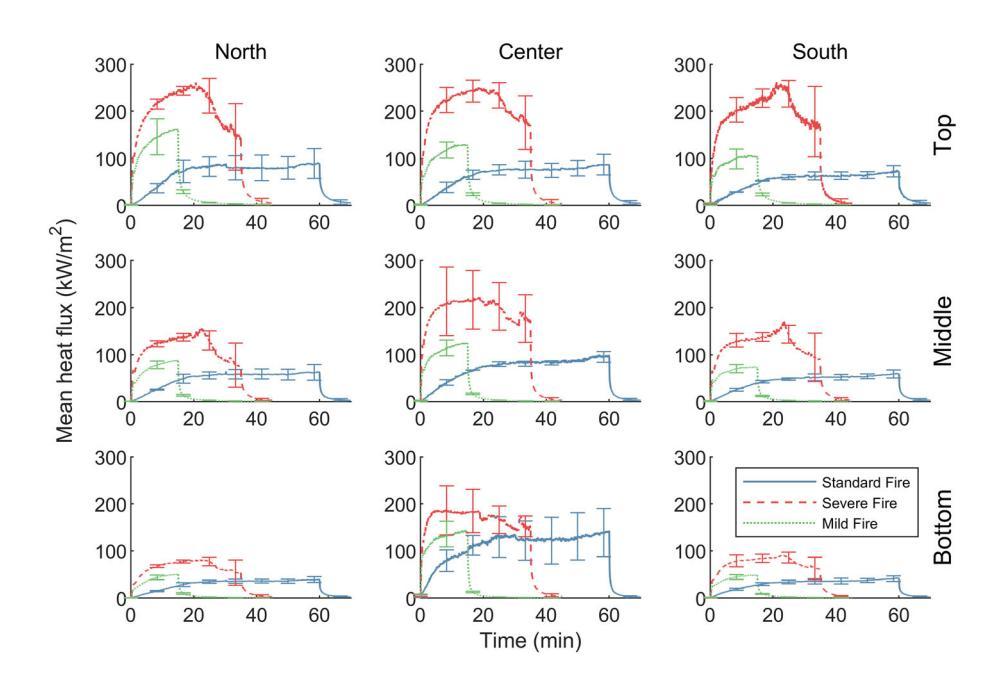
FIGURE 9 Heat flux (mean and standard deviation) in compartment for mild, standard, and severe fires [Colour figure can be viewed at wileyonlinelibrary.com]

Figure 9 plots incident heat fluxes obtained from the plate TC temperatures (T_{PT} , in K) and adjacent gas temperatures (T_{gas} , in K) at each time step (*i*) using Equation 3.²⁵

where $\left[\dot{q}_{inc}^{''}\right]^{i}$ is the incident heat flux in Watts, σ is the Stefan-Boltzmann constant (5.670E-8 W/m²/K⁴), *h* is the convective heat transfer coefficient assumed²⁶ to be 10 W/m²/K, K_{PT} is a heat transfer coefficient due to heat losses of the plate TC assumed²⁵ as 8 W/m²/K, C_{PT} is the lumped heat capacity of the plate TCs assumed²⁵ as 4200 J/m²/K, *t* is time (s), and ε_{PT} is the emissivity of the plate assumed to be 0.9. The incident heat fluxes plotted indicate that the highest values are at the top of the compartment and at the center directly above the burner. The incident heat fluxes are higher for the Mild Fire and Severe Fire than for the Standard Fire and are closer to the peak values obtained in the Kitchen Fire (Figure 10). The Standard Fire exposes the specimens to a lower incident heat flux for a longer period than the more realistic fire scenarios.

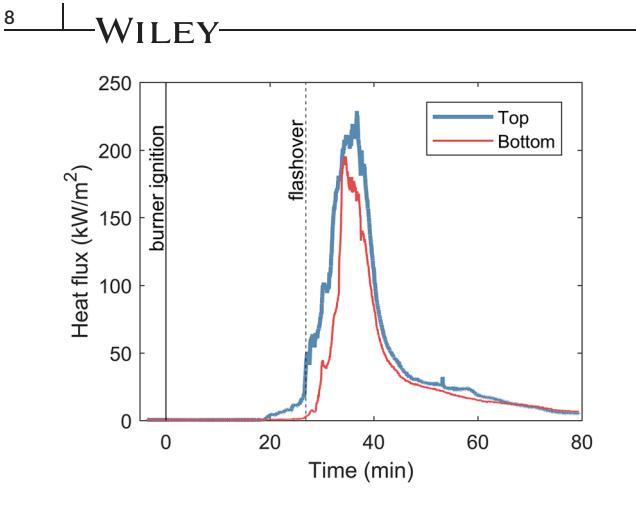
FIGURE 10 Measured heat flux to specimen for the kitchen fire [Colour figure can be viewed at wileyonlinelibrary.com]

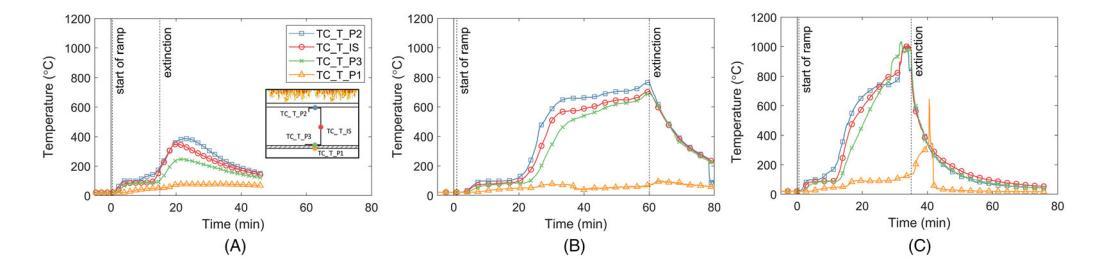
FIGURE 11 Temperatures through the specimen at an interior stud 46 cm from the top of gypsum-sheet steel composite panel sheathed walls: A, mild fire; B, standard fire; C, severe fire [Colour figure can be viewed at wileyonlinelibrary.com]

Figures 11–13 plot the cross-section temperatures 46 cm from the top of the wall at an interior stud for the Mild, Standard, and Severe fires. All figures show a plateau in temperatures occurring around 100°C. This plateau is due to the calcination reaction of the gypsum board as it releases its chemically free and bound water in a two-step endothermic reaction. This reaction is critical in providing fire protection for the wall. The length of the plateau depends on the incident heating; for fires with a faster heating rate, the plateau is shorter. The variation of the plateau length can be more easily seen in Figure 14, which compares just the interior stud temperatures. Although the interior studs experience lower peak temperatures during the Mild Fire than during the Standard Fire, the plateau is shorter due to the higher rate of heating and larger heat flux amplitudes.

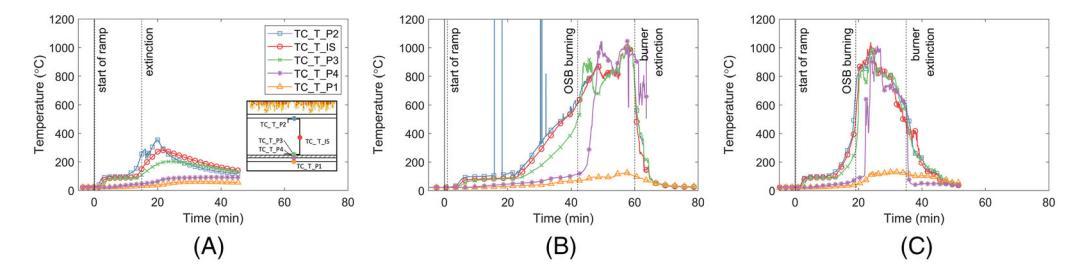
FIGURE 12 Temperatures through the specimen at an interior stud 46 cm from the top of oriented strand board (OSB) sheathed walls: A, mild fire; B, standard fire; C, severe fire [Colour figure can be viewed at wileyonlinelibrary.com]

Similar behavior was observed for the OSB sheathed walls with regard to the length of the plateau and the rapid heating following the calcination reaction. However, once the exposed gypsum board was sufficiently damaged by the fire, the OSB inside the wall ignited and continued to burn until the fire was supressed or until all of the OSB was consumed. Burning of the OSB occurred during the Severe Fire and the Standard Fire. Figure 15B shows an image of the OSB burning during the Severe Fire. Figure 16B summarizes the temperatures on the unexposed side of the OSB walls. Although the unexposed side temperature generally remained less than 139°C above the initial wall temperature, the gypsum detached from the OSB and fell from the wall preventing higher temperatures from being measured.

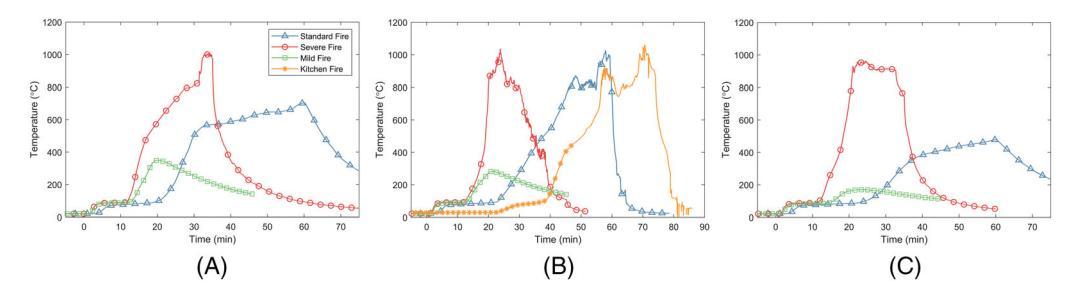
FIGURE 14 Interior stud temperatures 46 cm from the top the walls: A, gypsum-sheet steel composite panel sheathed walls; B, OSB sheathed walls; C, strap-braced walls [Colour figure can be viewed at wileyonlinelibrary.com]

The temperatures relevant to the thermal behavior of the structural elements include chord stud temperatures, interior stud temperatures, sheathing panel temperatures (sheathed walls), and the temperatures between the gusset plates and straps (braced walls). The top interior stud temperature (TC_T_IS) was generally a good overall indicator of the thermal damage to the wall.

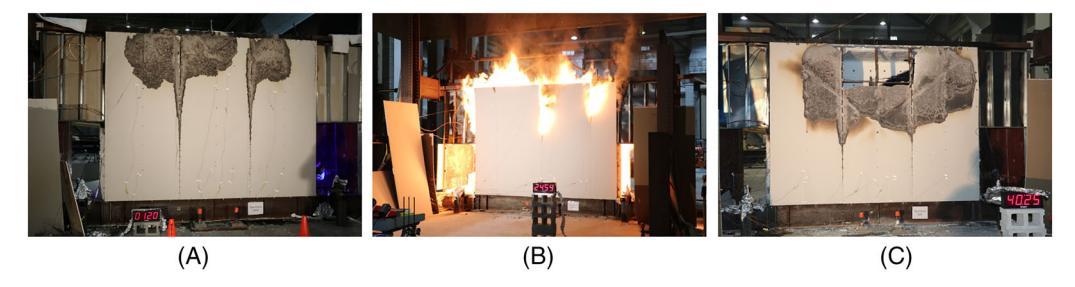
FIGURE 15 Photographs of unexposed side (Severe Fire): A, gypsum-sheet steel composite panel sheathed wall after the fire test; B, oriented strand board (OSB) sheathed wall 24 minutes and 59 seconds after ignition; C, strap-braced wall after the fire test [Colour figure can be viewed at wileyonlinelibrary.com]

For the gypsum-sheet steel composite panel sheathed walls, a puddle of water formed at the bottom of the walls (Figure 15A) coincident with the two-step calcination reaction. The water that evaporated from the gypsum boards condensed on the steel sheet and ran to the ground. After the calcination reaction had completed, the temperatures increased rapidly through the cross-section. The insulation criteria in ASTM E119 limits the temperature raise on the unexposed side of the walls or partitions to 250°F (139°C) above its initial temperature. The unexposed side temperatures (eight TCs) remained less than 139°C above the initial wall temperature (Figure 16A) in all cases except for the Severe Fire, where the paper on the unexposed side of the wall started to burn and temperatures increased locally near the top of the wall. However, the presence of the sheet steel prevented flame spread to the unexposed side of the wall even during the most severe fire investigated.

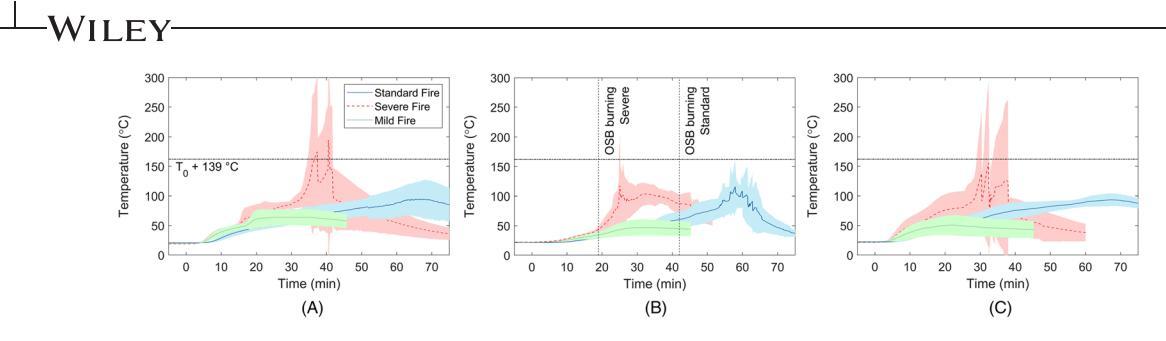
FIGURE 16 Temperatures (mean and standard deviation) on unexposed side: A, gypsum-sheet steel composite panel sheathed walls; B, oriented strand board (OSB) sheathed walls; C, strap-braced walls [Colour figure can be viewed at wileyonlinelibrary.com]

For the strap walls, during the Mild Fire and Standards Fire, all temperatures on the unexposed side of the wall remained less than 139°C above the initial wall temperature (Figure 16C) in all cases except for the Severe Fire. During the Severe Fire, a hole opened on the unexposed side of the wall (Figure 15C) that affected the fire dynamics within the compartment. The heating during the Severe Fire caused severe oxidation of the strap braces toward the south end of the wall.

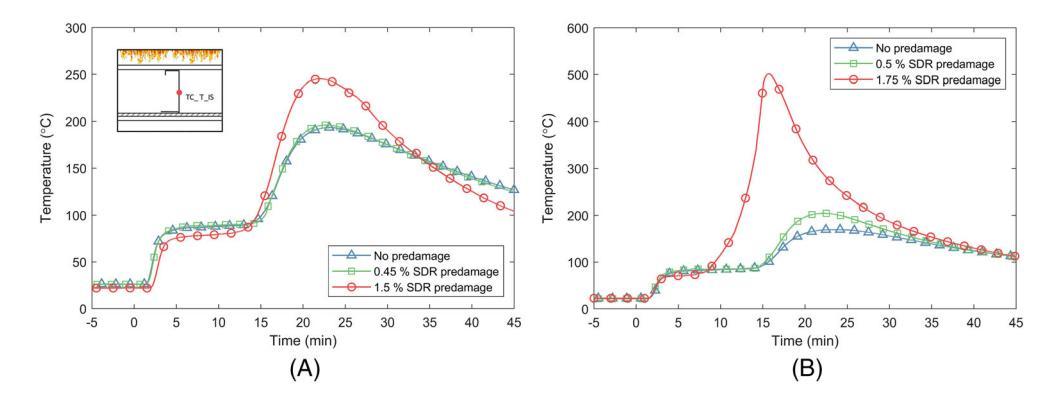
FIGURE 17 Interior stud temperatures for pre-damaged and undamaged walls exposed to the Mild Fire: A, oriented strand board (OSB) sheathed walls; B, steel strap-braced walls [Colour figure can be viewed at wileyonlinelibrary.com]

In select tests, the authors pre-damaged OSB sheathed and strapbraced walls[†] by subjecting them to reversed cyclic lateral deformation before the fire to study the influence on the thermal and postfire mechanical performance. The levels of pre-damage—defined by storey drift ratios (SDRs)—of approximately 0.5% and 1.5% correspond to the damage levels that might occur in a design earthquake (DE) and maximum considered earthquake (MCE), respectively. As mentioned above, the interior stud temperature near the top of the wall was generally a good indicator of the thermal damage through the wall. Hence, Figure 17A plots the top interior stud temperature of OSB sheathed walls that are undamaged, pre-damaged to 0.45% SDR, and predamaged to 1.5% SDR then exposed to the Mild Fire. Figure 17B provides similar plots[‡] for the strap-braced walls. The results showed that the smaller drift level (Drift Level 1) did not affect the thermal response of the wall. However, for larger drift level (Drift Level 2),

which tore the drywall joint compound and tape covering the joints of the gypsum boards, the temperatures achieved in the interior stud were notably higher. This increase of the temperature through the cross-section had limited effect on the strap-braced walls; however, for the OSB sheathed wall, the increase in temperature was sufficient to cause the OSB to ignite.

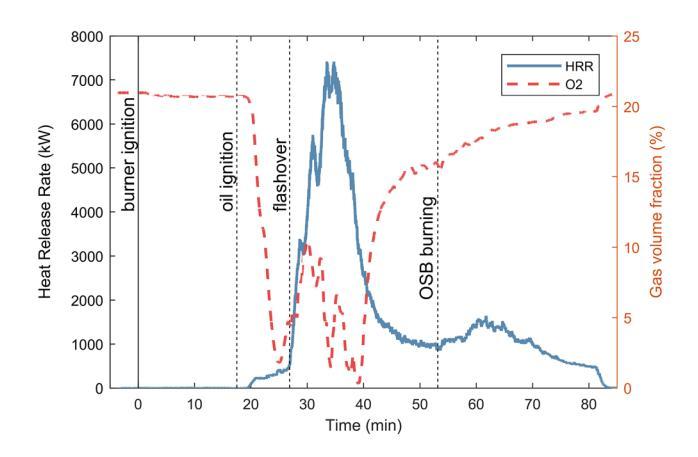
FIGURE 18 Heat release rate and compartment oxygen concentration during the kitchen fire [Colour figure can be viewed at wileyonlinelibrary.com]

The furnished kitchen compartment fire provides a comparison with the natural gas-fuelled fires. The fire development is illustrated in Figure 18 by HRR measured in the exhaust hood.[§] The fire was started by auto-ignition of the oil in pan on a gas stove 17 minutes and 31 seconds after the burner was turned on (Figure 19A). The fire spread to the cabinets above the stove in about 2 minutes (Figure 19B). Around 26 minutes, flashover of the compartment occurred (Figure 19C). Thirty-five minutes after burner ignition, there were indications of pyrolysis of the OSB inside the wall cavity (darker smoke emitted from holes in chord studs), but no flaming combustion of the OSB was observed. Most of the room furnishings were consumed by 40 minutes after burner ignition (Figure 19D), and the oxygen content started to raise in the compartment, reaching 15% 45 minutes after burner ignition. Flaming combustion of the OSB was clearly visible by 54 minutes after burner ignition (Figure 19E). A local peak in the HRR occurred between 60 minutes coincident with the flaming combustion of the OSB. The OSB continued to burn until it was consumed and the gypsum board on the unexposed side fell off. Remaining fire was suppressed using water 80 minutes after burner ignition when almost all the OSB had been consumed (Figure 19F).

Figure 18 also plots the oxygen concentration sampled at the center of the compartment 30 cm from the ceiling. Starting around 20 minutes,

as the fire grew and flashover occurred, the oxygen content in the compartment rapidly decreased. Around 40 minutes after ignition of the burner, when most of the content in the compartment had burnt, the oxygen concentration increased. After returning to an oxygen concentration of approximately 15%, the OSB inside of the wall exhibited flaming combustion. The results highlight the importance of considering oxygen concentration when studying the fire performance of building elements that include combustible materials. The times until flaming combustion of the OSB was visible is summarized in Table 3. For the Kitchen Fire, the times are provided relative to the time when compartment flashover occurred, which is the most direct comparison for the Mild and Severe Fires, and relative to the oil ignition. Temperatures through the cross-section 46 cm from the top of the wall at an interior stud during the Kitchen Fire are shown in Figure 20.

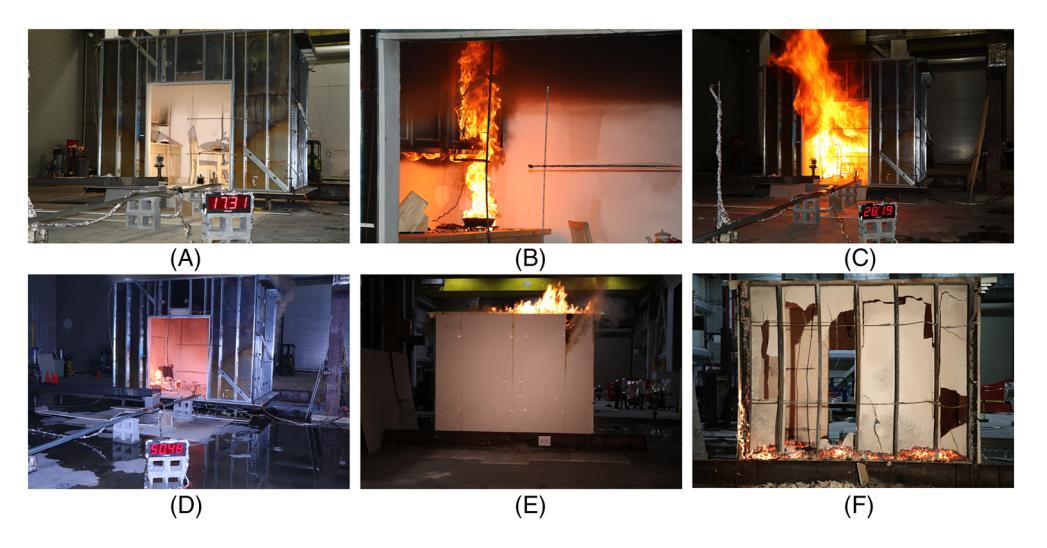
FIGURE 19 Photographs of growth and decay of kitchen fire: A, oil ignition; B, flame spread to cabinets; C, compartment flashover; D, furnishings consumed; E, burning of combustible sheathing; F, end of experiment [Colour figure can be viewed at wileyonlinelibrary.com]

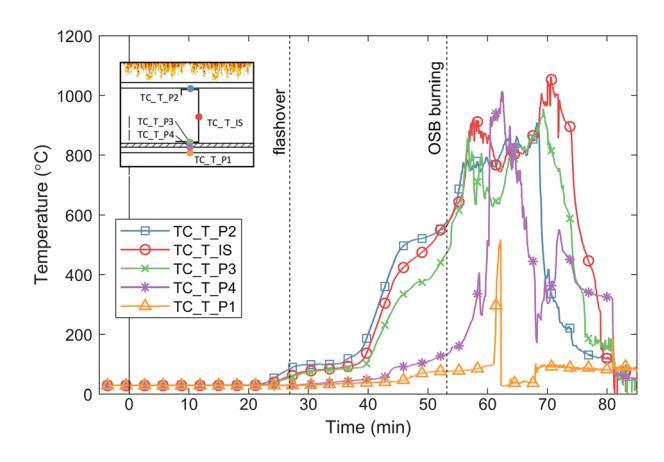
FIGURE 20 Temperatures through the specimen at an interior stud 46 cm from the top of an oriented strand board (OSB) sheathed wall during the kitchen fire [Colour figure can be viewed at wileyonlinelibrary.com]
