Transgranular Cracking in a Liquid Zn Embrittled High Strength Steel

Intergranular Zn-assisted liquid metal embrittlement (LME) cracks have been frequently reported in steels, involving austenite grain boundary penetration of liquid Zn at high temperature. In the present study, a Zn-coated high strength steel was deformed at an intercritical temperature, and the characteristics of LME cracking were studied in a mixed microstructure composed of ferrite and austenite. Crack propagation was intergranular in austenite; in contrast, the ferrite exhibited both intergranular LME and *transgranular* LME. Trace analysis of the crack plane orientation was consistent with cracking along {100} cleavage planes in ferrite.

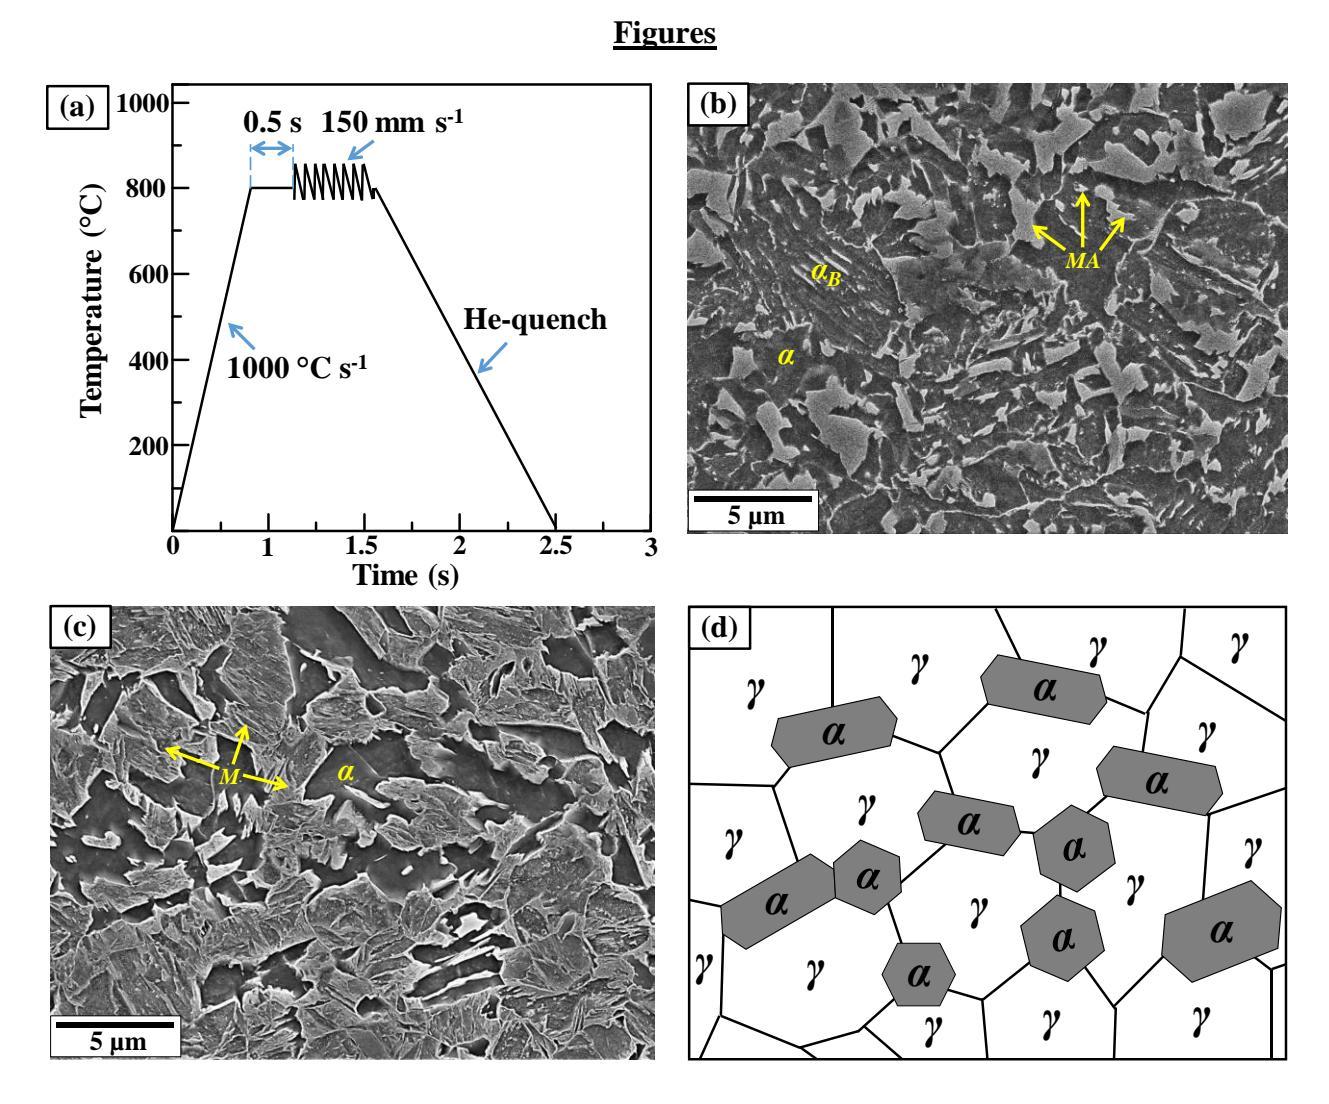
Figure 1- (a) Thermomechanical cycle imposed by the Gleeble 3500 simulator for hot tensile deformation of the Zn-coated steel at 800 °C, (b) SEM micrograph of the base microstructure of the Zn-coated steel prior to the hot tensile test, (c) SEM micrograph of the final microstructure of the steel substrate after hot deformation and subsequent quenching to RT, (d) schematic illustration of the high temperature microstructure of the steel at the 800 °C test temperature. (*ferrite* – ' α ', *austenite* – ' γ ', *bainite* – ' α_B ', *martensite* – *M*, *martensite/austenite* constituent – '*MA*')

The work presented here focusses on the characteristics of LME cracks formed in a Zn-coated high ductility AHSS steel of 1 GPa tensile strength. The Zn-coating was applied through industrial hot-dip galvanizing. The coating thickness was approximately 10 µm. LME cracks were generated through hot deformation of the Zn-coated steel carried out in a Gleeble 3500 thermomechanical process simulator. The dimensions of the uniaxial hot tensile specimen were 145 mm in length (having a reduced section of 25 mm at the center), 25 mm in width, and 1.5 mm in thickness. **Figure 1(a)** schematically presents the thermomechanical cycle imposed on the Zn-coated steel. Hot deformation was conducted at 800 °C, a temperature believed to be relevant to industrial spot welding behavior ^[13]. The specimen was heated to the test temperature at a rate of 1000 °C s⁻¹ and isothermally held for 0.5 s. The specimen was then deformed in tension until failure, using a constant displacement rate of 150 mm s⁻¹. The rapid heating rate, short hold time, and fast displacement rate were targeted to minimize Fe-Zn intermetallic formation during the thermal cycle ^[11-14], and thus maximize the availability of liquid Zn to induce LME. After fracture, the specimen was helium (He)-quenched to room temperature (RT) using a cooling rate of approximately 400 °C s⁻¹. The LME cracks were investigated using scanning electron microscopy (SEM)

Figure 1(b) shows an SEM micrograph of the base microstructure prior to hot tensile testing of the Zn-coated steel. The multiphase microstructure is composed of ferrite (a), bainite (a_B), and martensite- austenite (MA) constituents. The initial microstructure evolved with temperature during the thermal cycle; the high temperature microstructure present at the deformation temperature (*i.e.* at 800 °C) is of specific interest. **Figure 1(c)** shows an SEM image of the substrate microstructure recorded from the as-quenched fractured hot tensile specimen. The final microstructure is composed of ferrite (a) and martensite (M). Based on the final microstructure at RT (**Figure 1(c)**), it is confirmed that the steel was in the inter-critical temperature range at the deformation temperature. That is, the steel microstructure at 800 °C was composed of a mixture of ferrite and austenite, as schematically shown in **Figure 1(d)**. The martensite observed in the final microstructure would have resulted from the transformation of the austenite upon rapid quenching from the test temperature. The ferrite in the RT microstructure was present in the high temperature microstructure.

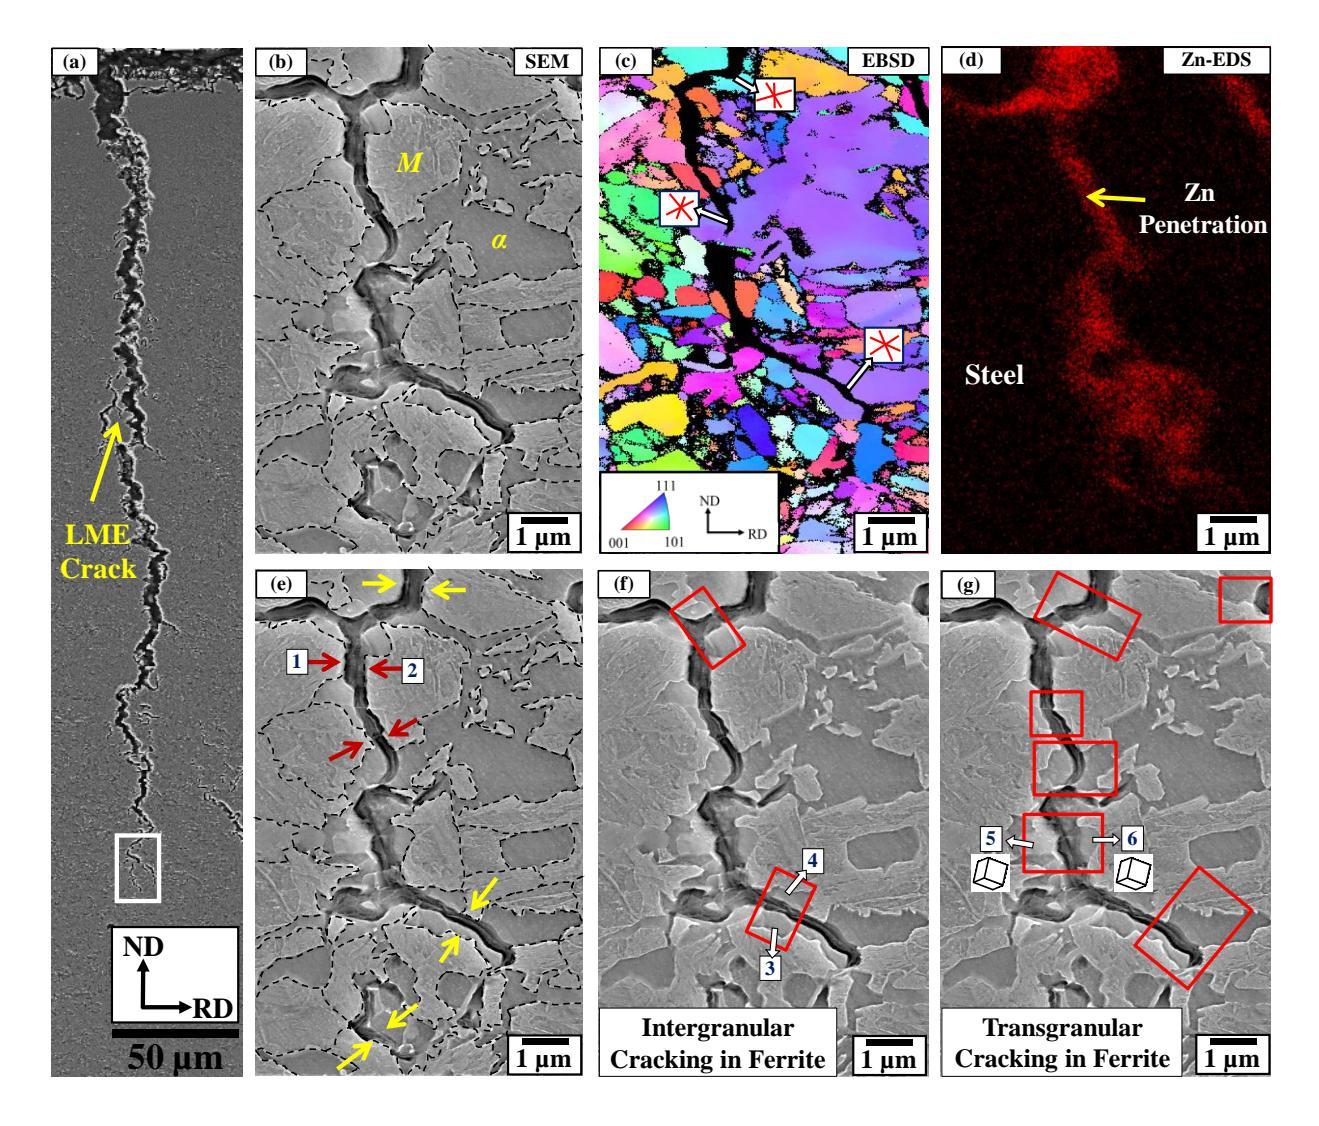
Figure 2 - (a) Cross-sectional SEM image of a representative LME crack formed in the Zn-coated steel during hot deformation at 800 °C. The tensile axis is parallel to rolling direction (RD), (b) SEM micrograph of the microstructure surrounding the crack tip (from the region labeled in (a)). *Ferrite* - ' α ' and martensite - 'M'. Dashed lines indicate prior austenite grain boundaries, (c) corresponding EBSD inverse pole figure (IPF) map of bcc phases in the microstructure. Example traces of {100} cleavage planes of bcc are overlaid for three grains, (d) corresponding SEM-EDS Zn elemental map. (e)-(g) highlight the different paths of crack propagation - (e) intergranular LME via prior austenite grain boundaries (red arrows) and ferrite-austenite interphase boundaries (yellow arrows), (f) intergranular LME in ferrite. At the labeled locations, the EBSD IPF map indicates different ferrite orientations on both sides of the LME crack, (g) transgranular LME in ferrite. At the labeled locations on both sides of the LME crack. As an example, the crystallographic orientation of the ferrite at sites '5' and '6' are overlaid (using cubes to represent crystal orientation).

Figure 2(a) shows a cross-sectional SEM micrograph of a representative LME crack formed on the Zn-coated steel during the hot deformation step. The LME crack initiated at the coating-substrate interface and propagated into the steel substrate in the normal direction (ND) *i.e.* perpendicular to the direction of applied stress (tensile direction was parallel to rolling direction (RD)). The tip of the crack in **Figure 2(a)** was characterized further, to study the characteristics of the crack path. **Figure 2(b)** shows a magnified view of the microstructure in the region surrounding the crack tip (from the region indicated in **Figure 2(a)**). **Figure 2(c)** presents the corresponding EBSD inverse pole figure (IPF) orientation map of the bcc phase in the microstructure. The steel substrate adjoining the LME crack is composed of bcc ferrite (*a*) and bct martensite (*M*) in the after-test RT microstructure (martensite is indexed as bcc). The martensite can be differentiated from the ferrite in **Figure 2(b)** based on its lath morphology in an etched microstructure. The martensitic regions in the RT microstructure correspond to locations that were austenitic at the deformation temperature (800 °C). The prior austenite grain boundaries (PAGBs) are indicated using dashed lines in **Figure 2(b)**. PAGBs were situated at the interfaces of ferrite and martensite in the RT microstructure. In addition, PAGBs were located within some martensitic regions; these PAGBs were identified using the EBSD IPF map as boundaries in the martensite having misorientation angles of $20^{\circ}-46^{\circ}$ ^[15-17]. **Figure 2(d)** shows the corresponding SEM-EDS Zn elemental map, confirming infiltration of Zn along the entire length of the LME crack.

The SEM micrograph and corresponding EBSD map (**Figures 2(b**) and (**c**)) were used conjointly to characterize the propagation path of the LME crack. The SEM micrograph helped identify the microstructural constituent present on adjacent sides of the crack. The EBSD IPF was used to study the crystallographic orientations of the corresponding regions. It is clear that at 800 °C, the crack in the substrate microstructure presented three different paths for liquid Zn penetration, bounded by γ/γ , γ/α , or α/α regions. LME crack propagation was often "intergranular". **Figure 2(e)** overlays red arrows on the SEM micrograph to highlight locations where the crack propagated via separation at prior austenite (γ/γ) grain boundaries. In such locations, martensite is situated on both sides of the crack. Intergranular cracking was noted based on the apparent PAGBs and then confirmed by measuring the crystallographic misorientation between the areas labeled '1' and '2' in **Figure 2(e)** is 37°, indicating that a PAGB (misorientation between 20° to 46° ⁽¹⁵⁻¹⁷⁾) was situated between the corresponding crystals prior to the crack propagation. Also exemplified in **Figure 2(e)** using yellow arrows, are locations, where the crack has ferrite and martensite on adjoining sides in the RT microstructure. At these locations, it is evident that intergranular cracking occurred following the interphase (γ/α) boundaries at high temperature.

LME crack propagation also followed some ferrite (α/α) grain boundaries. Figure 2(f) shows the SEM image labeled with locations of intergranular cracking in ferrite. The corresponding crystals in the EBSD map indicate different crystallographic orientations of the ferrite on adjoining flanks of the crack.

For instance, the misorientation between the ferrite crystals at locations labeled '3' and '4' in **Figure 2(f)** was 57°. A large misorientation between ferrite crystals situated on two sides of the crack confirms intergranular crack propagation.

In several locations, the SEM micrograph and EBSD IPF indicated that the LME crack propagated *within* a ferrite grain. In these instances, the IPF reveals essentially identical ferrite orientations on both sides of the crack. **Figure 2(g)** identifies some of these cracks within ferrite grains. As an example, the crystallographic orientations of the ferrite at sites labelled '5' and '6' are overlaid (using cubes to represent unit cell orientation) on the SEM image in **Figure 2(g)**. The similar crystallographic orientation of the ferrite at sites '5' and '6' (the misorientation was less than 3°) suggests that these sites belonged to the same ferrite grain at the time of cracking. That is, the LME crack propagated in a "transgranular" rather than "intergranular" fashion. The Zn-EDS map (**Figure 2(d)**) showed that Zn was present at all the locations with transgranular cracks highlighted in **Figure 2(g)**. This observation confirms that *transgranular LME* occurred in the ferrite. A trace analysis was also conducted to relate the direction of the transgranular crack surface to the {100} cleavage planes of bcc ferrite. Examples of the traces of {100} planes are presented for a few ferrite grains with transgranular cracks in **Figure 2(g)**. In all cases, the direction of the crack is approximately parallel to one of the {100} plane traces, suggesting the possibility or likelihood of cleavage fracture of ferrite on {100} planes.

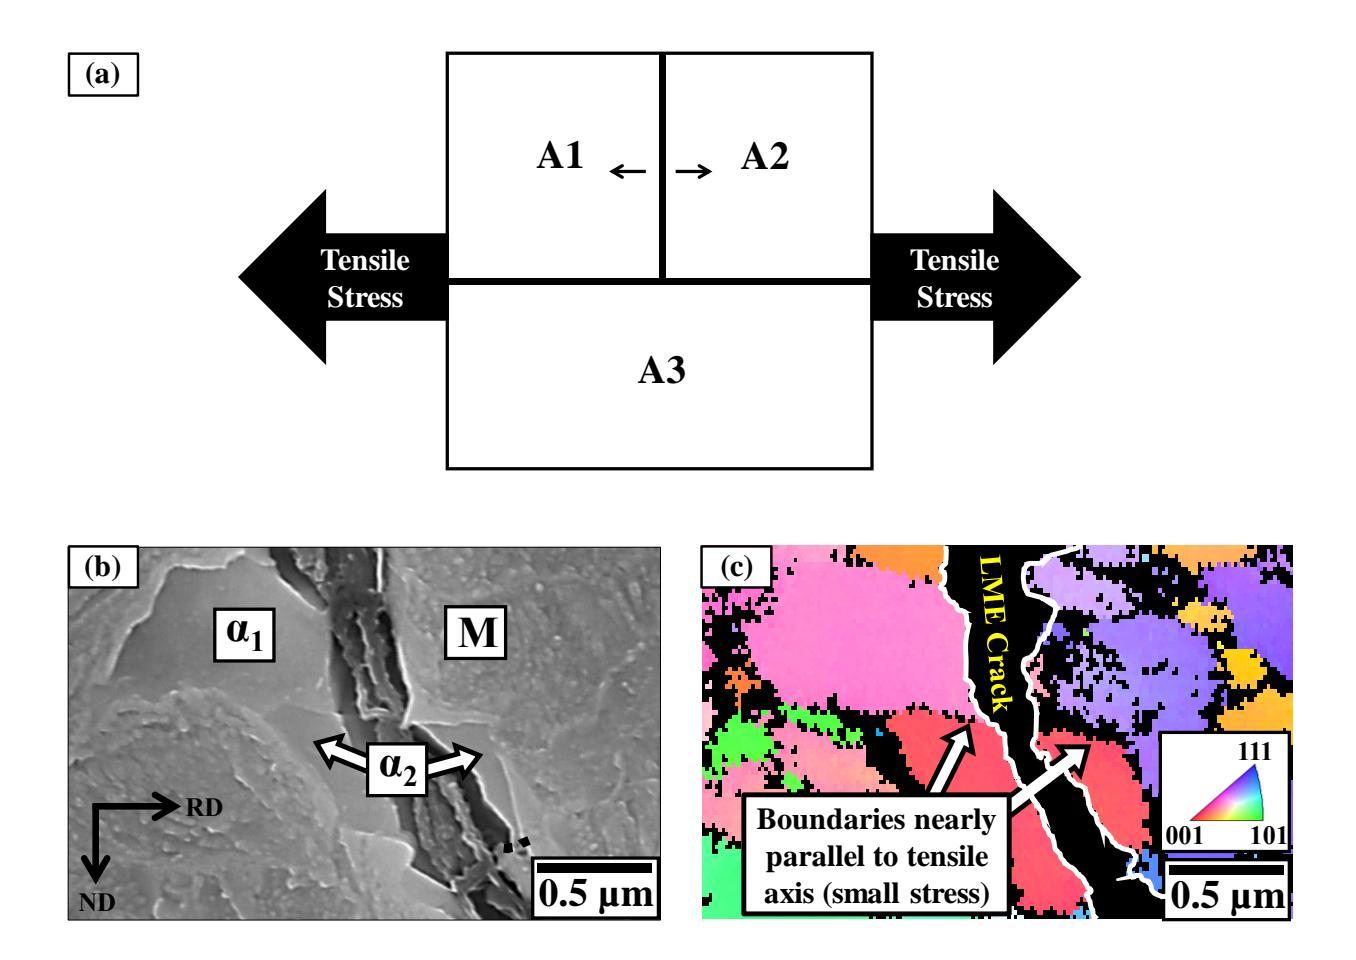
Figure 3 - (a) A simplified schematic of an idealized microstructure illustrating the existence of one type of grain boundary having a large tensile stress (A₁/A₂ type boundaries that are oriented perpendicular to the tensile direction), and another type of boundary having no tensile stress component normal to the boundary (A₁/A₃ or A₂/A₃ type boundaries oriented parallel to the tensile direction). In the event of liquid infiltration, cracking is likely to happen via separation along the A₁/A₂ type boundaries, while the A₁/A₃ or A₂/A₃ type boundaries would remain intact, (b) SEM micrograph and (c) corresponding EBSD IPF map from an actual site of transgranular LME cracking. α_1 and α_2 are ferrite grains (enclosed within blue and black dashed lines, respectively in (b)). *M* is a martensitic (prior austenite) region adjacent to the crack. The α_1 grain was intergranularly cracked; the α_2 grain was transgranularly cracking. The unfavorably oriented boundaries of the α_2 grain (A₁/A₃ or A₂/A₃ type boundaries in (a)) are indicated in (c).

critical tensile stress required for cracking. The different cracking susceptibilities of various boundaries present in a microstructure is illustrated using a schematic of an idealized microstructure in **Figure 3(a)**. The microstructure is composed of three grains labelled 'A₁', 'A₂', and 'A₃'. The direction of the applied tensile stress is indicated in **Figure 3(a)**. The A₁/A₂ type boundaries are oriented normal to the tensile direction, thus experiencing a large tensile stress normal to the boundary. In contrast, the A₁/A₃ or A₂/A₃ boundaries in this idealized microstructure are aligned with the tensile direction, thereby having no tensile stress resolved normal to the boundary. Supposing that all boundaries are infiltrated with Zn at high temperatures, only the A₁/A₂ type boundaries are susceptible to intergranular cracking, while the A₁/A₃ or A₂/A₃ boundaries should remain intact and thus resist LME cracking.

The hypothesis is evaluated/illustrated using one representative location with a transgranular crack along the LME crack path. **Figure 3(b)** and **(c)** present an SEM image and corresponding EBSD IPF map from a portion of the investigated LME crack in **Figure 2(a)**. The crack in this region is bounded by ferrite grains (labelled ' α_1 ' and ' α_2 ' in **Figure 3(b)**) and martensite (labelled 'M' in **Figure 3(b)**). ' α_1 ' contained an intergranular crack; we may consider that its cracked boundary plane was oriented nearly normal to the RD (tensile direction). Transgranular cracking occurred in ' α_2 ', situated directly in the path of the intergranular crack along ' α_1 '. In this case, we consider that the boundary presented by ' α_2 ' to the incoming crack was oriented nearly parallel to the tensile axis, indicated in **Figure 3(c)**. These boundaries were prevented from cracking due to a small resolved tensile stress normal to the boundaries.

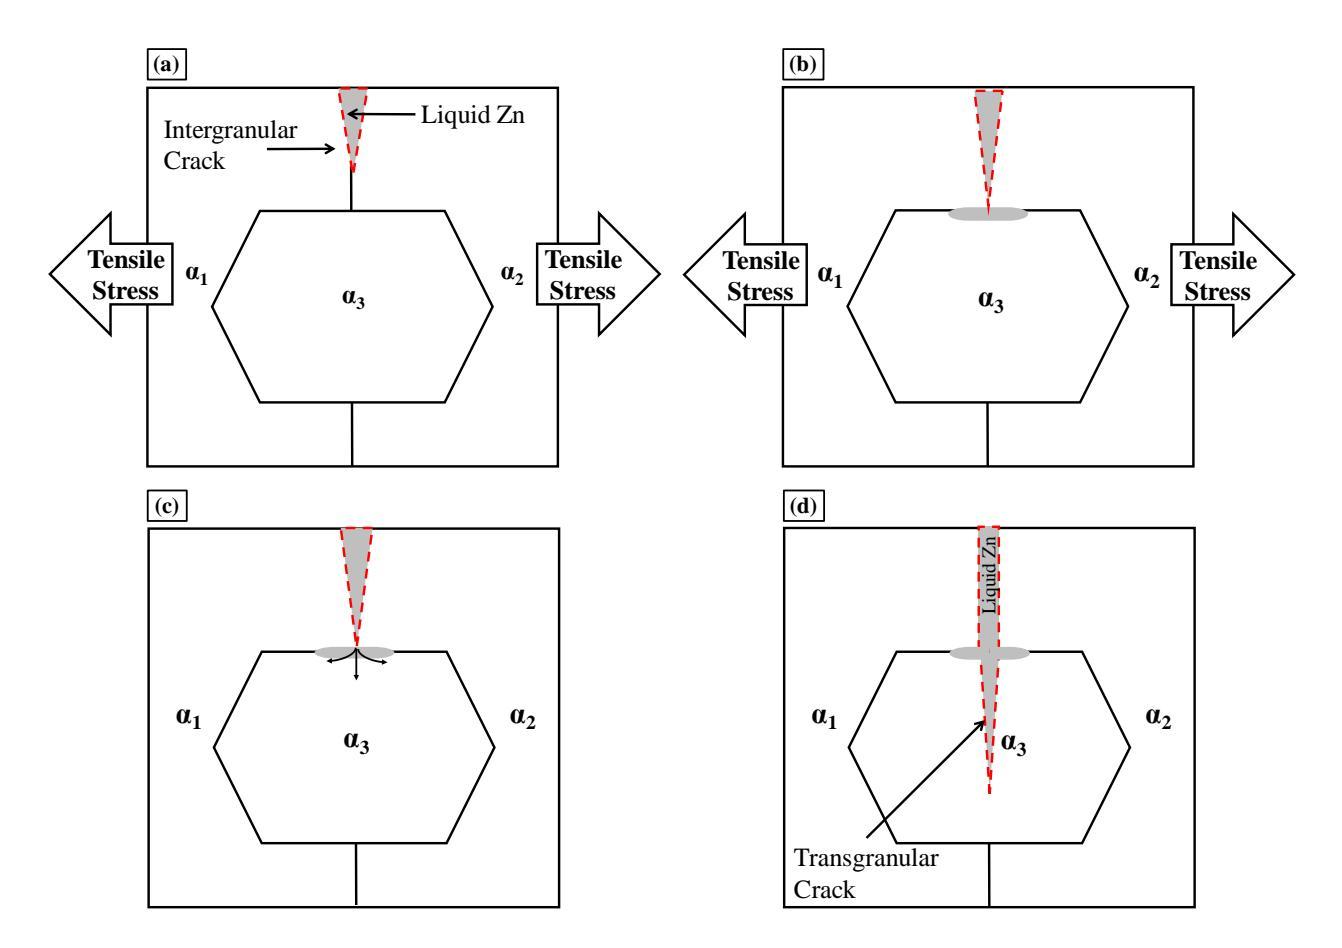
Figure 4 – Schematic illustrating the proposed sequence of events ((a) through (d)) leading to a transgranular Zn-assisted LME crack formation in a microstructure composed of ferrite grains labelled ' α_1 ', ' α_2 ', and ' α_3 '. (a) intergranular LME cracking along the α_1/α_2 boundary, (b) arrest of intergranular crack due to lack of tensile stress normal to α_1/α_3 and α_2/α_3 boundaries, (c) embrittlement of ' α_3 ' upon interaction with the liquid, (d) cleavage cracking of ' α_3 ' and subsequent percolation of liquid to continue the transgranular crack propagation.

Figure 4 (a) through (d) illustrate the proposed sequence of events leading to transgranular LME crack formation in a schematic microstructure composed of three ferrite grains labeled ' α_1 ', ' α_2 ', and ' α_3 '. For simplicity, it is assumed that all crystals in the microstructure are bcc, although the model should also apply in case the ' α_1 ' and/or ' α_2 ' grains were austenitic (fcc). The ' α_3 ' crystal in the schematic microstructure is more specifically ferritic, based on the observation here of transgranular LME cracking in a bcc crystal. The four steps in the sequence are explained as follows:

(a) The α_1/α_2 grain boundary area is infiltrated with liquid Zn at a high temperature. This boundary also experiences high tensile stress due to its orientation normal to the tensile direction. Satisfying the critical conditions for LME, the α_1/α_2 boundary suffers cracking.

(b) Liquid Zn infiltrates the α_1/α_3 and α_2/α_3 boundaries. These boundaries are oriented parallel to the tensile axis, and have no tensile stress normal to the boundaries. Consequently, the α_1/α_3 and α_2/α_3 do not experience LME cracking.

(c) The critical cleavage stress of ' α_3 ' is reduced either by adsorption of Zn atoms onto its cleavage planes, or by its enrichment with Zn beyond a critical limit via bulk Zn diffusion from the liquid.

(d) The stress concentration at the tip of the intergranular crack results in a large resolved normal stress on the cleavage planes of ' α_3 ', initiating a transgranular cleavage crack. Liquid Zn remains available to continue transgranular crack propagation.
