Experimental investigation of structural steel beams subjected to localized fire

Abstract

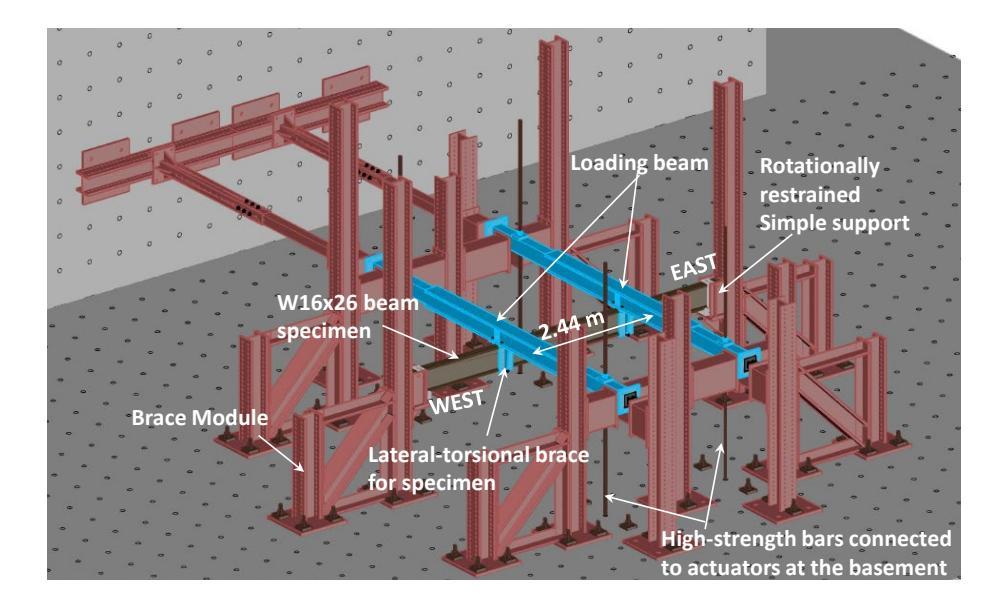
Fig. 1 shows a schematic of the test setup. The test setup was erected on a strong floor under the 13.7 m \times 15.2 m exhaust hood. The bearing-to-bearing length for the simply supported specimens was 5.87 m. The distance between the centerlines of the bolts on the web near the beam ends for the specimen with double angle connections was 6.05 m. The distance from the lower flange of the beam specimen to the strong floor was 1.6 m. The nominal values for flange width, flange thickness, web thickness, and the depth of the W16 \times 26 beam specimen were 140 mm, 8.8 mm, 6.3 mm, and 400 mm, respectively [19]. The W16 \times 26 beam was made of ASTM A992 [20] steel with the minimum yield and tensile strengths of 345 MPa and 450 MPa, respectively. From the coupon tests (8 specimens cut from the web and 8 specimens cut from the flange), Young's modulus, yield strength, and tensile strength of the beam material were 210 GPa, 390 MPa, and 480MPa, respectively.

As shown in Fig. 1, two loading beams spaced at 2.44 m were used to apply structural load to the specimens. Four 220 kN hydraulic actuators were mounted in the basement underneath the strong floor. High strength bars were used to transfer the load from the actuators to the loading beams. The specimens were laterally braced at the location of the loading beams. Fire was applied to the mid-span of the specimen using a fuel delivery system that consisted of two natural gas burners with a total nominal flame zone of one square meter that can provide a heat release rate of up to 1.5 MW. The top of the burner was 1.1 m below the lower flange of the specimen.

Fig. 1. A schematic of the Test setup. Source: NIST

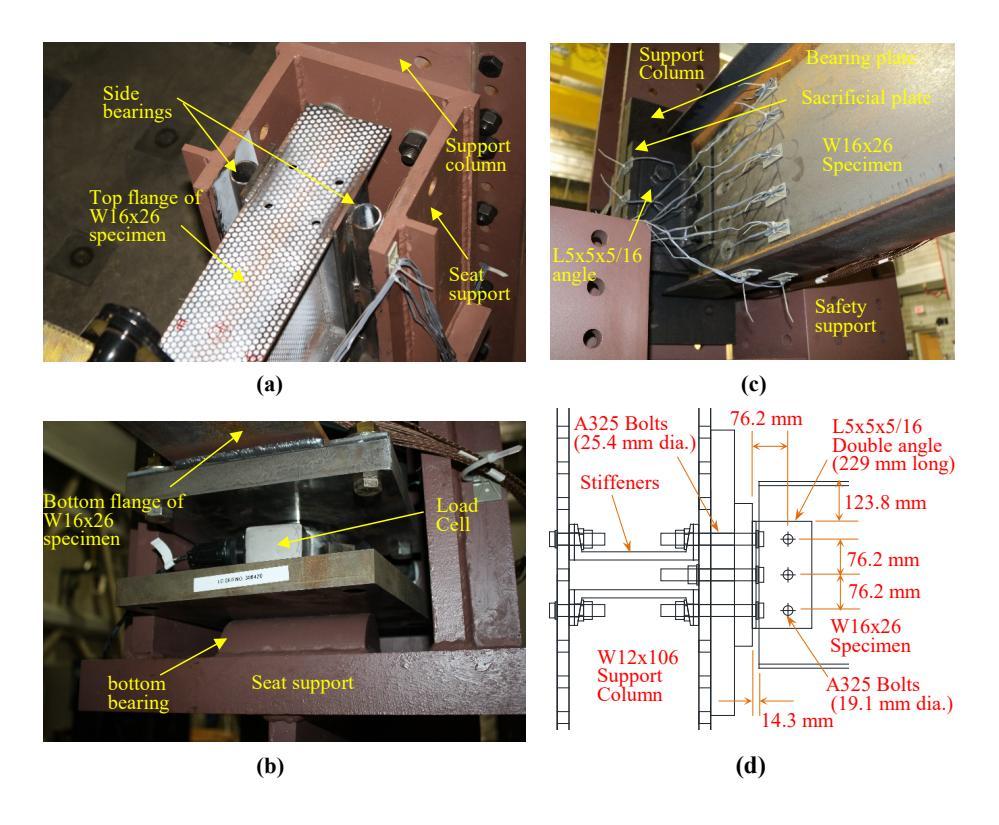
Fig. 2 shows the details of the end supports. The ends of specimens with simply supported boundary conditions were restrained against any lateral rotation of the specimen. For the specimen with the double angle connection, $L5 \times 5 \times 5/16$ [19] all-bolted double angles with 19.1 mm diameter ASTM A325 [21] bolts at three rows were used. The leg width, thickness, and the length of the ASTM A36 [22] $L5 \times 5 \times 5/16$ angles were 127 mm, 7.9 mm, and 229 mm, respectively [19].

Fig. 2. Details of the supports (a) simple support view from top, (b) simple support bottom part, (c) double angle connection-photograph, and (d) double angle connection-dimensions [18]. Source: NIST

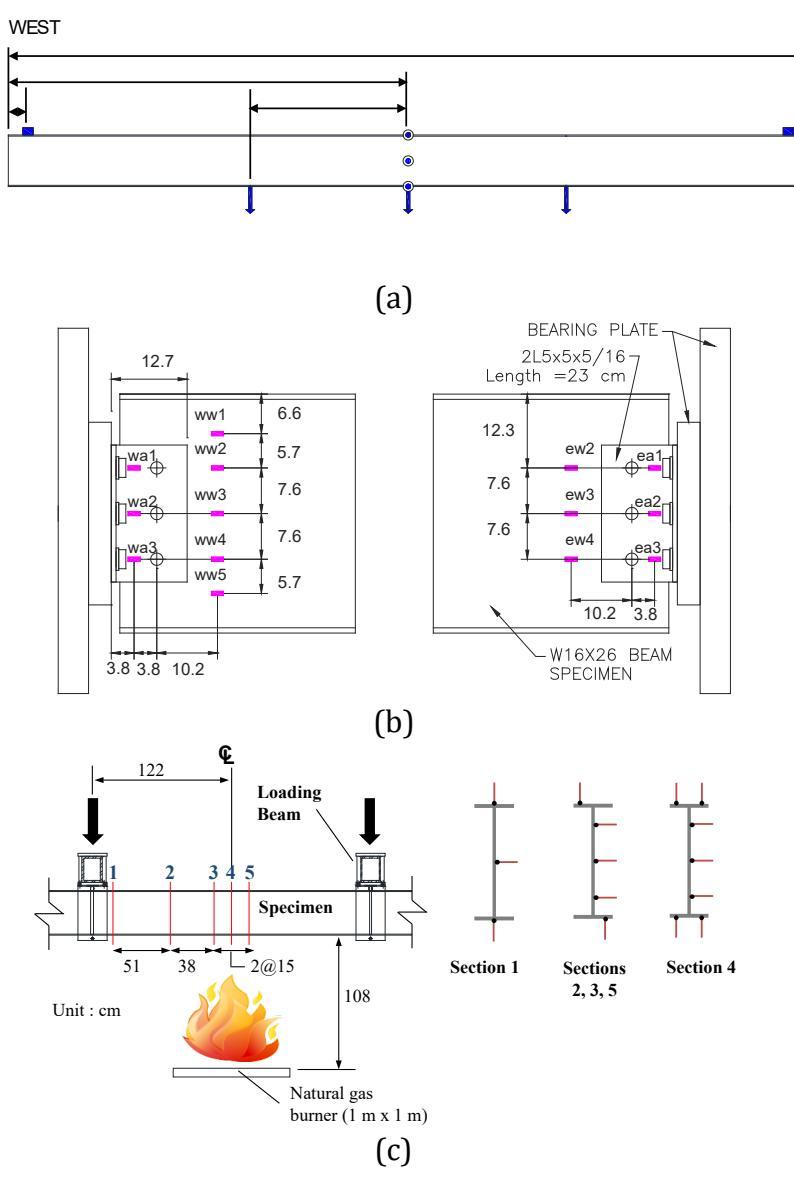
At the ends of the simply supported specimens, two 220 kN load cells were placed between the support and the specimen to measure the vertical reaction forces. At the mid-span of the fire test specimens, vertical and lateral displacements were measured using string potentiometers with special temperature-compensated probes [18], while conventional string potentiometers were used for the remaining displacement measurements (Fig. 3a). For Specimen 4 with double-angle connections, strain gauges were attached to the legs of the double-angles and the web of the beam (Fig. 3b). Glasssheathed, K-type, 24-gauge thermocouples were installed at 5 different sections along the length of the beams to measure the temperatures in the fire affected zone of the fire test specimens (Fig. 3c). In addition to the sensors shown in Fig. 3, the heat release rate (*HRR*) of the natural gas burners as well as force and displacement at each actuator were also measured. For each fire test, two HRRs were measured, one was determined using the measured mass flow and the composition of the natural gas of the burner (burner HRR), and the other was measured by the calorimeter (exhaust hood) based on the amount of oxygen consumed (calorimeter *HRR*). The differences between the two measured *HRRs* were negligible and the burner *HRRs* were presented in this paper. The uncertainty of measurements is reported in Choe et al [18]. The estimated total expanded uncertainty, with a coverage factor of 2, of the force, displacement, and strain measurements were approximately \pm 10 %, \pm 15 %, and \pm 5 %, respectively. The estimated total expanded uncertainty of the steel temperatures and the heat release rates measured using the burners were \pm 12 % and \pm 7 %, respectively.

Fig. 3. Locations of (a) the rotation and displacement sensors, (b) strain gauges in the double angle connection and (c) thermocouples in the specimens (Unit = cm).

Fig. 7b shows the average temperatures measured across the beam cross section at sections 3, 4, and 5 of the specimen as shown in Fig. 3. Locations of thermocouples mounted in the cross section are illustrated in Fig. 7c. A thermal gradient was developed as the bottom part of the specimen was directly exposed to fire. The average value of the bottom flange (BF) temperature over the duration of mechanical loading was 620 °C.

Fig. 11 shows the average temperature measured in Sections 3, 4, and 5 (Fig. 3) of Specimens 3 and 4. Fig. 12 shows the measured displacements of Specimens 3 and 4, with the secondary y-axis representing the bottom flange temperature. The vertical displacement of Specimen 3 was recorded until 25 min due to failure of a displacement sensor. Similar to Specimen 2, Specimens 3 and 4 started displacing downward due to material degradation at elevated temperatures. The lateral displacement started increasing when the bottom flange temperature reached about 500 to 550 °C. The bottom flange temperature of Specimens 3 and 4 at failure were 660 °C and 560°C, respectively.

Fig. 15a shows measured strains at the double angles for Specimen 4 (refer to Fig. 3b for the strain gauge layout). The strain values shown in this figure are the averaged values of the strains measured at the east and west connections. Under the ambient loading, small rotational restraints from the connections introduced negative bending moments in the connections. However, when exposed to fire, the connection region was subjected to compression due to the restraint to thermal elongation until the specimen failed by lateral torsional buckling. As in Fig. 15a, compressive strains increased at an average rate of 26.5 $\mu\epsilon$ /min during the fire exposure until failure. The compressive force in the double angle connection, estimated using the strain rate of 26.5 $\mu\epsilon/min$ and assuming a Young's modulus of 200 GPa for steel, increased at a rate of 19 kN/min resulting in a total compressive force of 240 kN developed during the 12.4 min fire exposure. After the beam lost its load-carrying capacity, the connections were then subjected to tension in order to carry applied loads on the beam. The connections eventually failed by tensile yielding as shown in Fig. 15b. Neither shear deformations of the bolts nor tear-out failure of bolt holes in the angles was observed. The beam ends exhibited small deformations of bolt holes in tension.

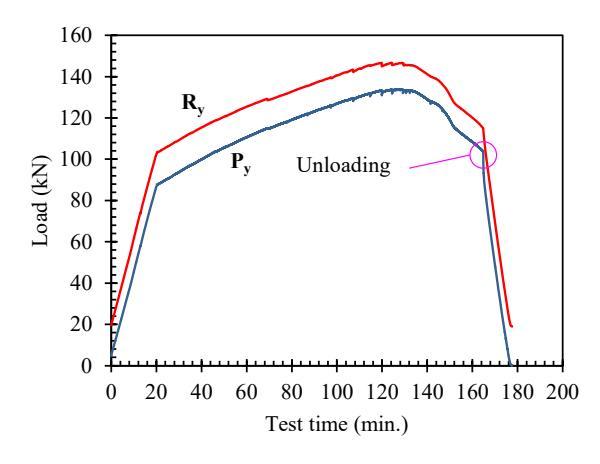
Fig. 4 shows the average point loads (P_y) applied to the specimen and the average reaction force (R_y) at each end. The point load value shown in the figure is the total load applied by the two actuators. The maximum point load applied on the specimen and the corresponding reaction force were 133.4 kN and 146.4 kN, respectively. The resulting peak moment, calculated for the four-point bending test setup using the measured reaction forces and the uniform self-weight of the specimen (0.38 kN/m), at the mid-span was 250 kN·m.

Fig. 4. Point load (P_y) and reaction force (R_y) time histories of ambient test.

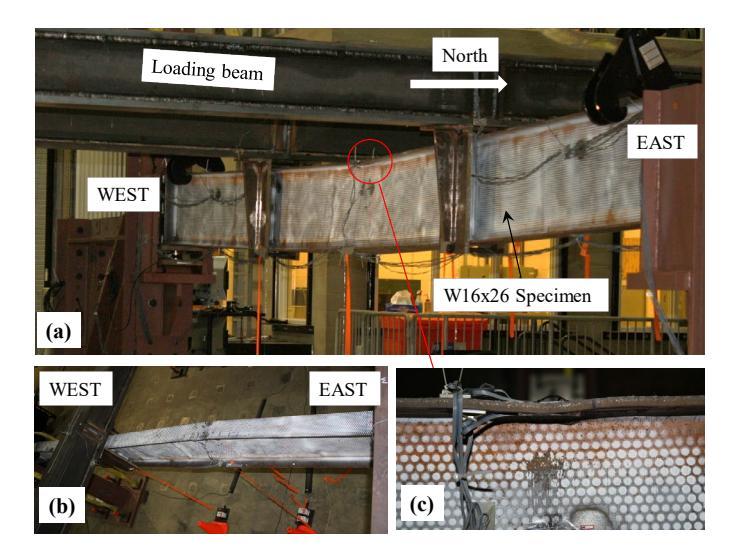
Fig. 5 shows photographs of the specimen under structural loads during the test. Fig. 6 shows the measured vertical and lateral displacements at mid-span. The positive value indicates the vertical displacement in the downward direction and the lateral displacement in the north direction. The specimen failed by lateral torsional buckling as shown in Fig. 5a and Fig. 5b. Fig. 5c shows local buckling of the top flange due to the excessive compressive forces.

Fig. 5. Ambient test photographs. (a) Front view, (b) top view, and (c) local failure of top flange. Source: NIST

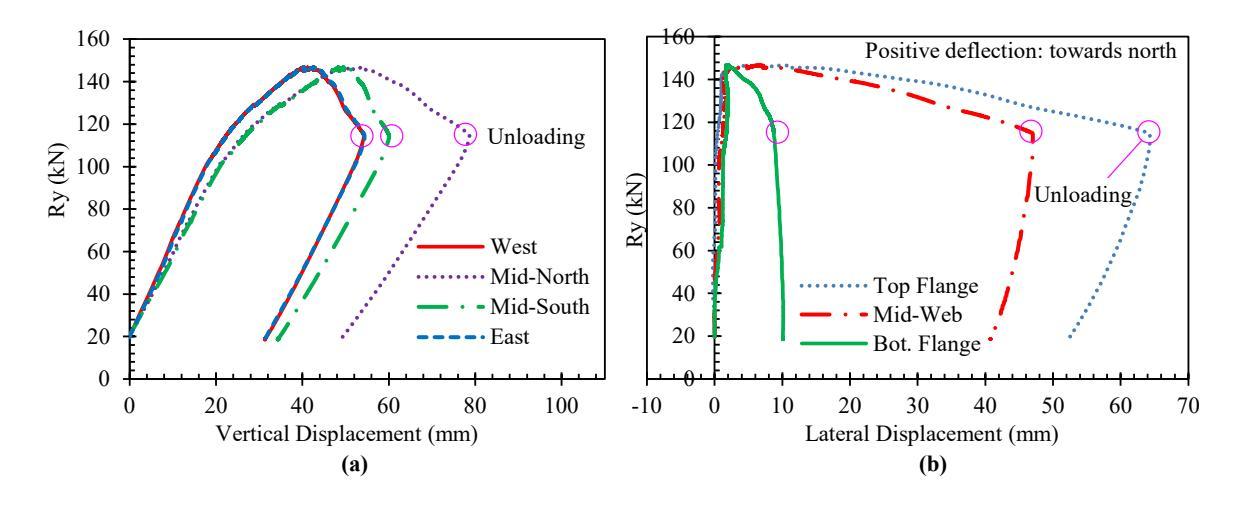
Fig. 6. Reaction force versus (a) vertical displacement and (b) lateral displacement of Specimen 1.

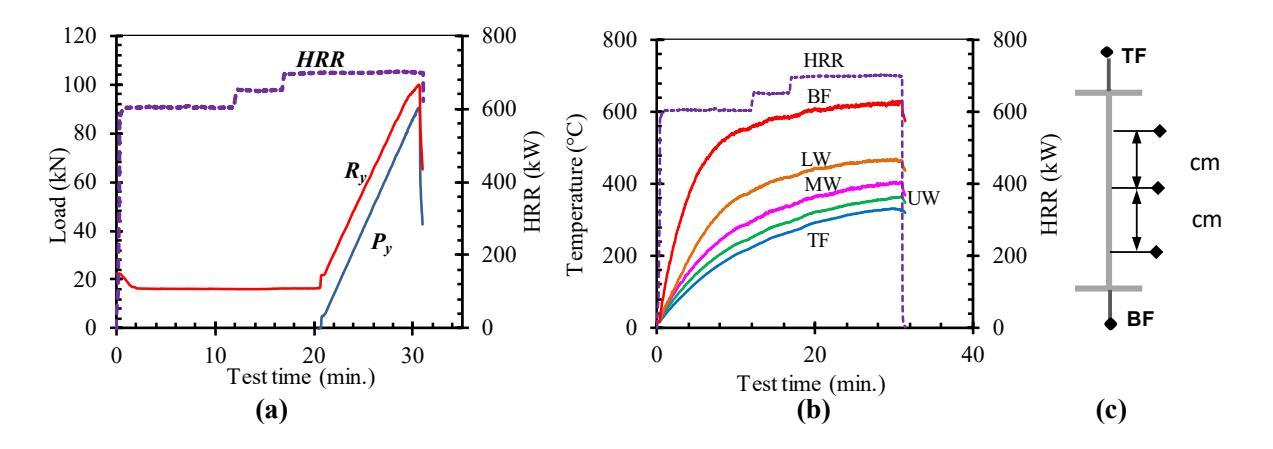
As shown in Fig. 7a, after the value of *HRR* was maintained at a target value of 700 kW, the increase in the bottom flange temperature became smaller (at less than 2 °C/min), practically reaching steady state. Mechanical loads were then applied to the specimen at a rate of 9 kN/min at each loading point. The maximum load of 90 kN reached at 31 min after the ignition. The corresponding flexural capacity of the steel beam was 170 kN·m.

Fig. 7. (a) *HRR*, *P_y*, and *R_y* time histories of the steady state test, (b) temperature time history and (c) locations of temperature measurements.

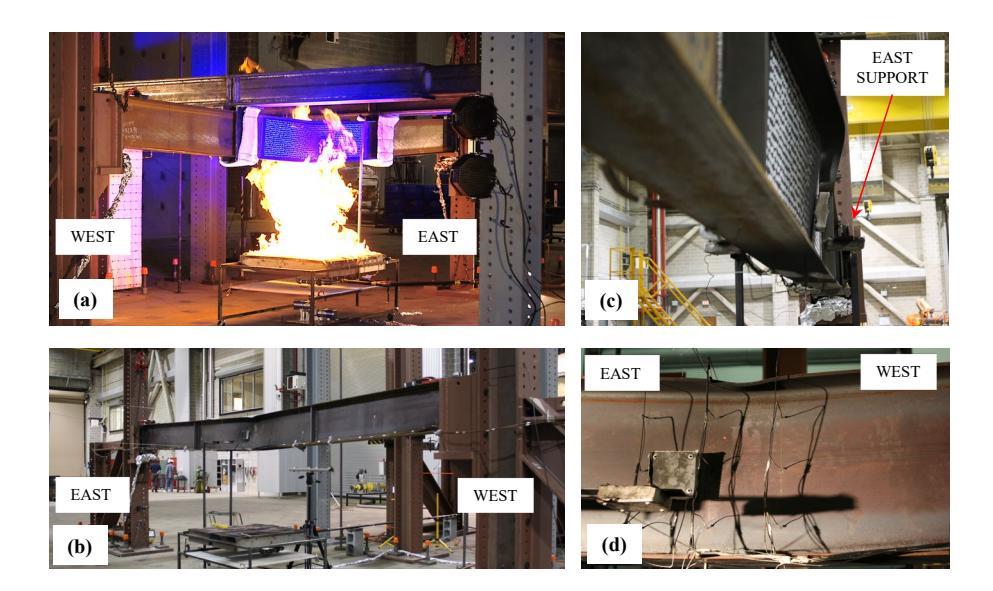
Fig. 8 shows photographs of the deflected shape of the specimen during the test and after cooling. Fig. 9 shows deflection responses of the specimen to applied loads. Initially, the mid-span vertical displacement increased linearly without increasing lateral displacements. As the point load reached greater than 60 kN, lateral displacements started increasing. At a peak load of 90 kN, the portion of the specimen between two loading beams twisted.

Fig. 8. Photographs of (a) deflected Specimen 2 during testing, (b) specimen after cooling-view 1, (c) specimen after cooling-view 2, and (d) local distortion in the flange-north part of top flange. Source: NIST

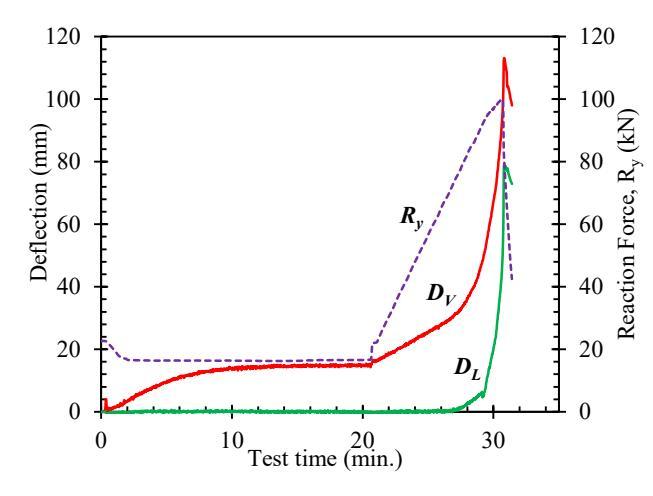
Fig. 9. Deflection response of the specimen (D_v = vertical displacement, D_L = lateral displacement, and R_y = reaction force at ends).

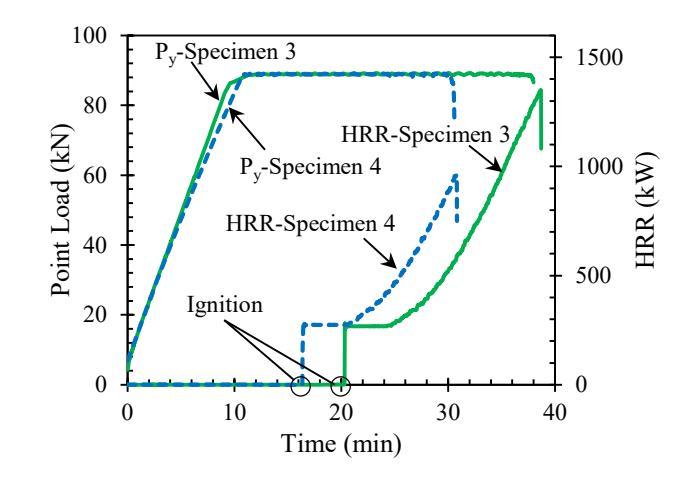
Both Specimen 3 (simply supported) and Specimen 4 (with double-angle connections) were tested under transient heating by increasing the *HRR* of the fire with time. Mechanical load at each loading point was increased to 90 kN at ambient temperature, and then the mid-portion of the beam was exposed to a growing fire until the specimen was failed. The magnitude of maintained mechanical loads was the same as the measured load capacity of Specimen 2 (tested at steady heating) and as approximately 67% of the ambient capacity. The fire was applied as the following: *HRR* was initially increased to 250 kW which was maintained up to 4 min, and increased by following a t-squared quadratic function of *HRR* = $4.5 \cdot t^2 + 250$, where *HRR* is in kW and t is the fire exposure time in min. Fig. 10 shows the average point load (*P_y*) and the heat release rate (*HRR*) of the burner for Specimens 3 and 4. The peak *HRR* value at failure was 1280 kW (at 17.5 min) for Specimen 3 and 940 kW (at 14.2 min) for Specimen4.

Fig. 10. Measured *HRR* and average point load (P_y) as a function of test time (Specimens 3 and 4).

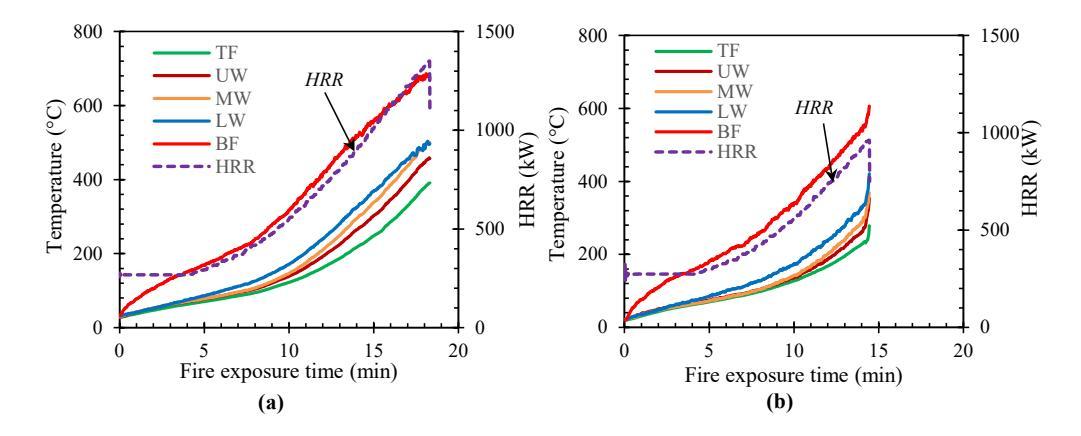
Fig. 11. Thermal response of (a) Specimen 3 and (b) Specimen 4.

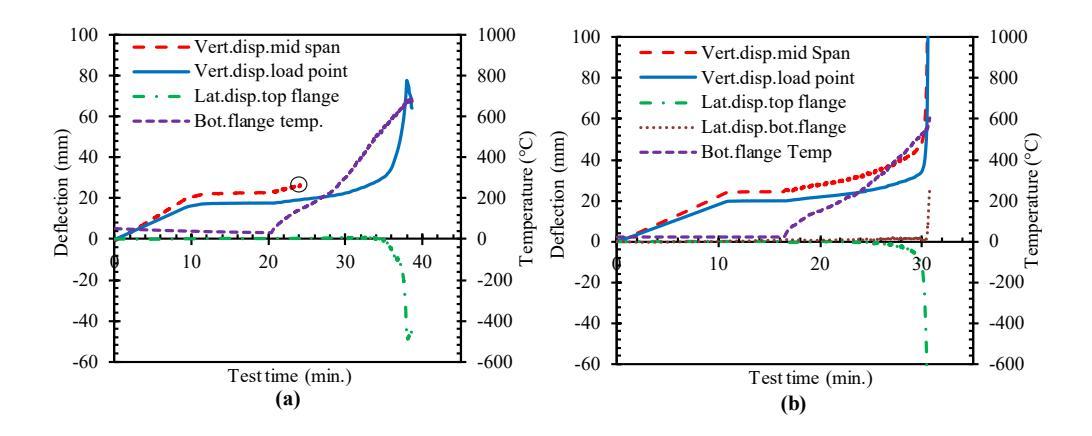
Fig. 12. Deflection responses of (a) Specimen 3 and (b) Specimen 4.

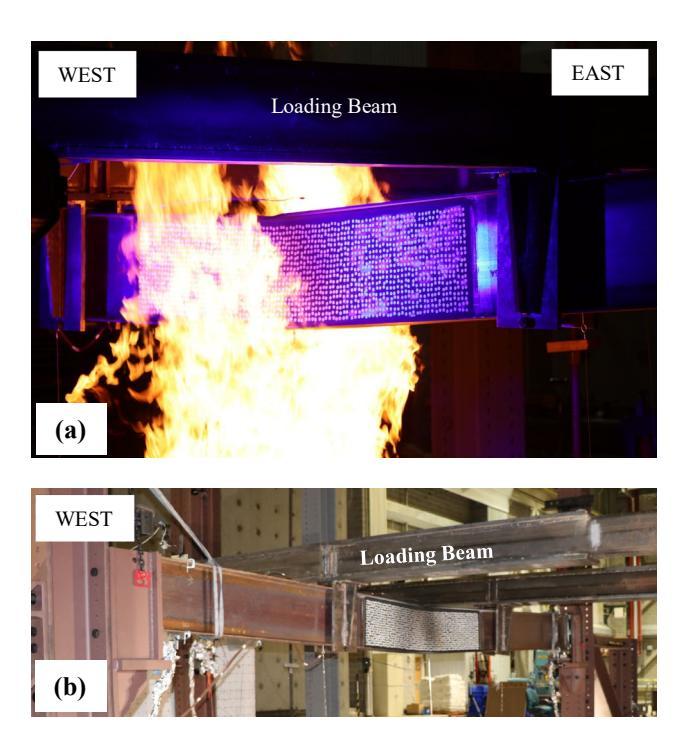
Fig. 13 and Fig. 14 show the deflected shapes of Specimen 3 and 4 during the test and after cooling. Both specimens exhibited permanent deformations due to lateral-torsional buckling. Local buckling of the top flange at mid-span caused by excessive compressive stress was also observed in both specimens. Fig. 14c and Fig. 14d show tensile fracture of the upper flange in the north side of the Specimen 4 due to lateral-torsional buckling, around a blind threaded hole that connected a string potentiometer [18].

Fig. 13. Deflected shapes of Specimen 3 (a) during the test and (b) after the cool down phase. Source: NIST

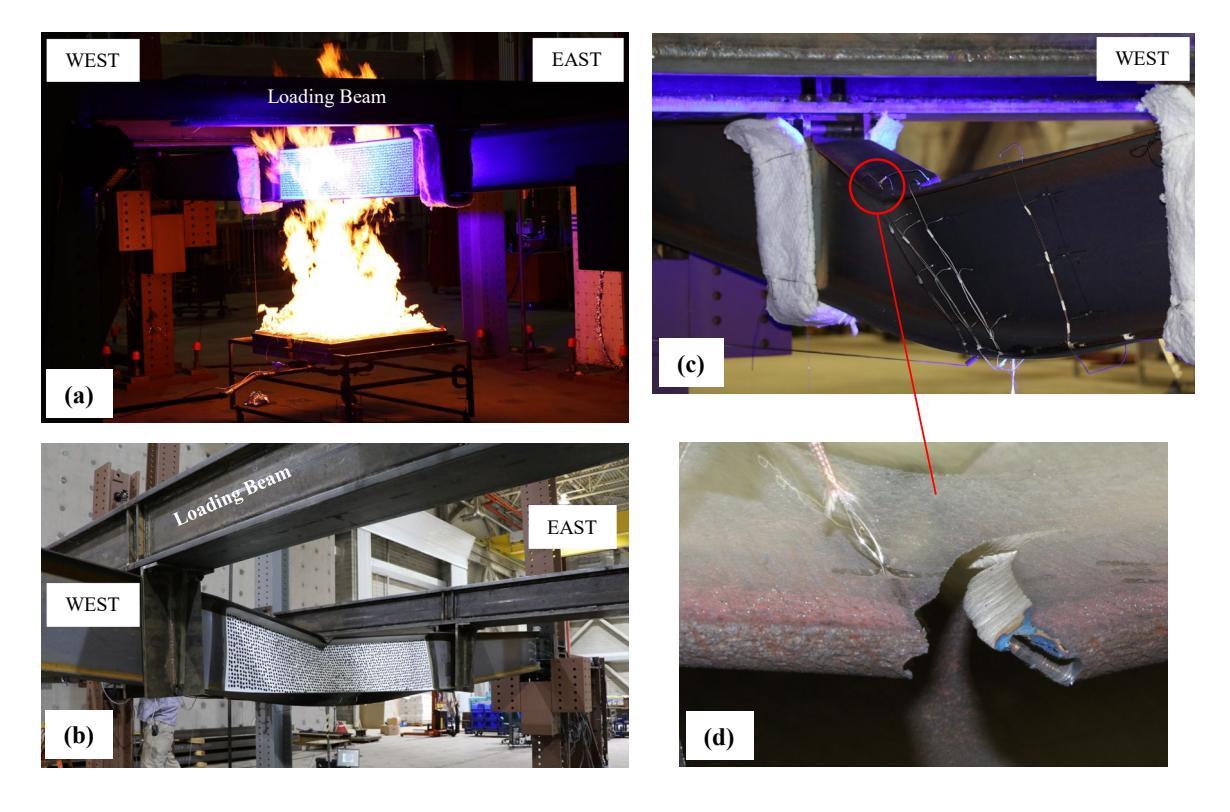
Fig. 14. Specimen 4 (a) during the test, (b) after the cool down phase, (c) Lateral-torsional buckling at mid-span, and (d) tensile fracture of top flange. Source: NIST

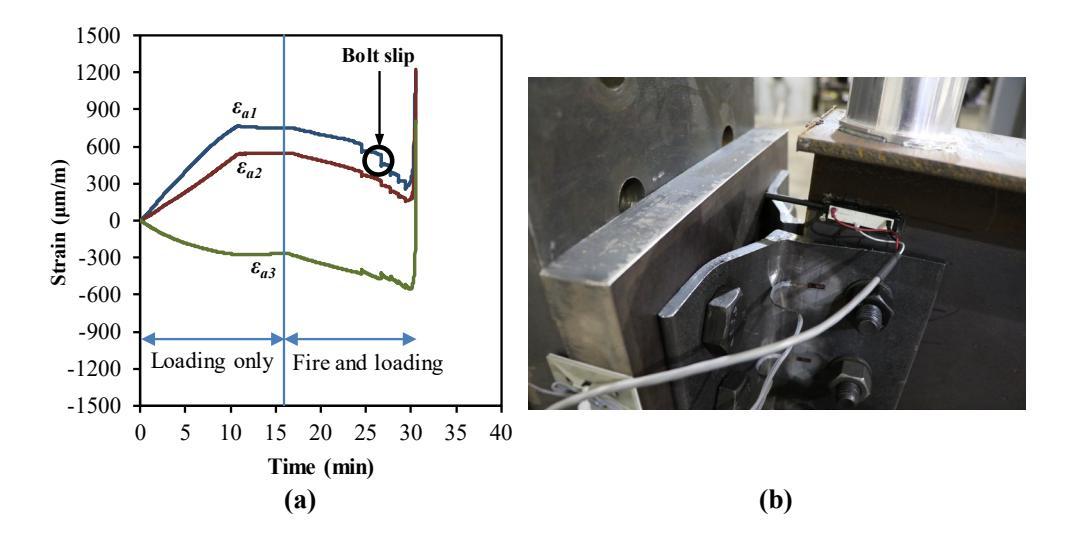
Fig. 15. (a) Strains measured in the double angles (b) deformed shape of double angle connection after the cool down phase (Specimen 4). Source: NIST

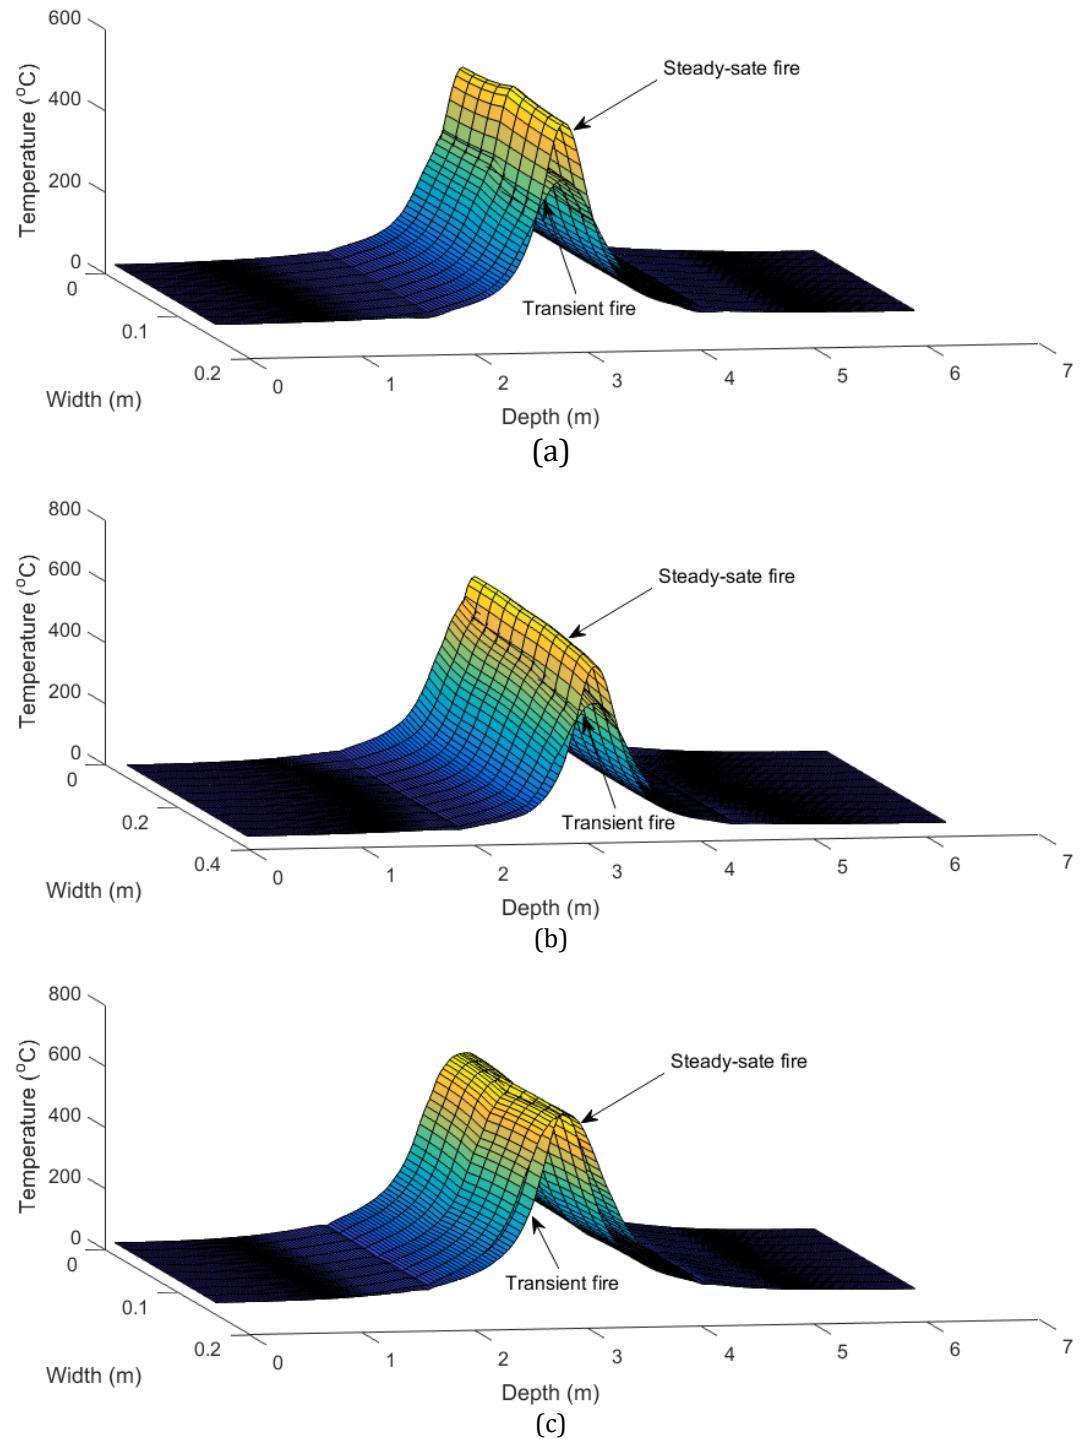
However, the specimen tested at transient fire (Specimen 3) failed at higher bottom flange temperature (660 °C) than the specimen tested at steady-state fire (Specimen 2, that failed at a bottom flange temperature of 620 °C). This result might have been caused by the difference in the degree of thermal gradients between two specimens. Fig. 16 compares the numerically predicted temperature distributions in the lower flange, web and upper flange of the specimen exposed to the steady-state and transient fires when the maximum temperature of 620 °C was reached in the lower flange of the specimen [17]. For both the web and upper flange, the steel temperatures for the transient fire case are comparatively lower than those for the steady-state fire case.

Fig. 16. Comparison of temperature distributions in specimen exposed to the steady-state and transient fire conditions. The maximum steel temperature for different fire conditions was 620 °C. (a) upper flange; (b) web and (c) lower flange.

At failure, the measured average temperatures at the mid-span section of Specimens 2 and 3 are 435 °C and 470 °C, respectively. Using the finite element model developed for the simply supported specimen described in [17] and assuming a uniform temperature rising in the specimen, failure mode of lateral torsional buckling was predicted and the (uniform or average) temperature in the specimen at failure was 452 °C, close to the average temperatures at the mid-span in localized fire tests. The little differences among those average temperatures does not necessarily indicate that the lateral torsional buckling capacity of steel beams in localized fire could be assessed by the average temperature at the mid-span section but it provides interesting information that would be considered in the future studies on the development of assessment models.
