USING INCANDESCENT LAMP FAILURE LEVELS FOR ASSESSMENT OF THE SURGE ENVIRONMENT

Hubert Bachl
Cooperative Testing
Institute
Vienna, Austria

François Martzloff
National Institute of Standards
and Technology
Gaithersburg MD USA

Doni Nastasi
Power Electronics
Applications Center
Knoxville TN USA

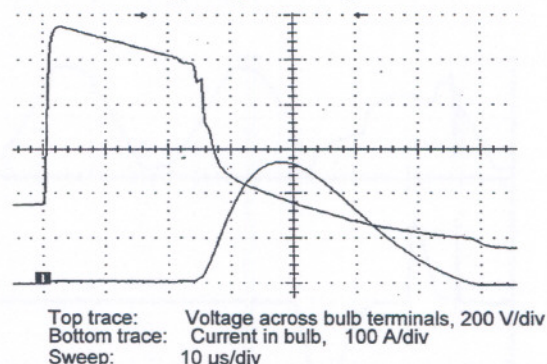
Figure 1: Voltage and current in bulb during application of a 1.2/50 μ s - 8/20 μ s surge, resulting in surge sparkover

Figures 1, 2, 3, and 4 present oscillograms of the voltage across an energized 120-V bulb and of the current flowing in the bulb. Figure 1 shows a narrow window, commensurate with the duration of the surge delivered by a 1.2/50 - 8/20 μ s surge generator. We observe the chopping of the voltage wave, typical of a gap sparkover, and the rise of the surge current after the sparkover. The scale of the current trace selected to record the surge (hundreds of amperes) does not show the normal current (1 A) in the bulb.¹ Observations during this test include hearing a pinging noise and seeing a bright flash of light, followed by darkness. After the test, the filament can be seen broken at one or both its points of attachment to the supporting connecting stems.

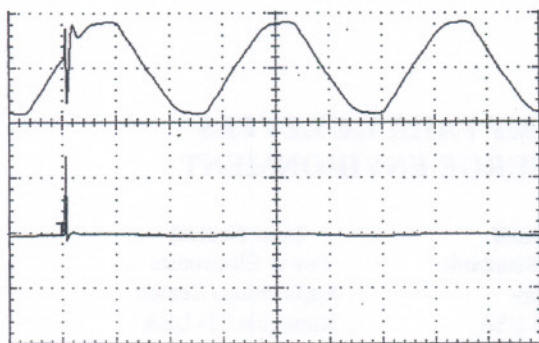
Top trace: Voltage across bulb terminals, 200 V/div
Bottom trace: Current in bulb, 100 A/div
Sweep: 5 ms/div

Figure 2: Voltage and current in bulb during application of a 1.2/50 - 8/20 μ s surge at 30°, with surge sparkover but no power-frequency flashover

Figure 2 was recorded (with a new bulb) with a longer window than Figure 1, so as to display three full cycles of the power frequency. At that sweep rate, the surge is no longer resolved, and its apparent peak shown on the trace may be lower than the actual peak because not enough data samples are collected around the peak. However, the timing of the surge, not its amplitude is what is important in this figure. The surge event appears as a voltage spike and a current spike, followed by return to practically normal voltage and no visible large power-frequency current.

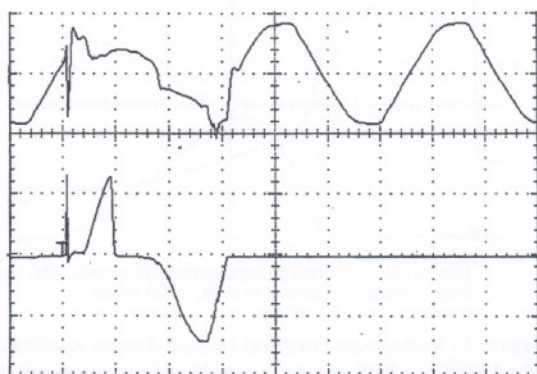
Top trace: Voltage across bulb terminals, 200 V/div
Bottom trace: Current in bulb, 100 A/div
Sweep: 5 ms/div

Figure 3: Voltage and current in bulb during application of a 1.2/50 - 8/20 μ s surge at 30°, resulting in surge sparkover, with delayed two-pulse power-frequency flashover

Figure 3 shows for the same bulb as that of Figure 2 the events during a subsequent shot under the same conditions. At first, after the surge, the pattern is identical to Figure 2. Then, suddenly, a pulse of power-frequency current appears, with a large amplitude -- the source of the observed flash. We believe that it is this current that causes the burn-out of the filament, not the "trigger" surge. The randomness of the process of igniting the power arc is such that in the case of Figure 2, the power arc was not ignited, while in the subsequent surge application on the same bulb (Figure 3) and in the same conditions, the power arc was ignited, resulting in burn-out of the filament -- a threshold situation.

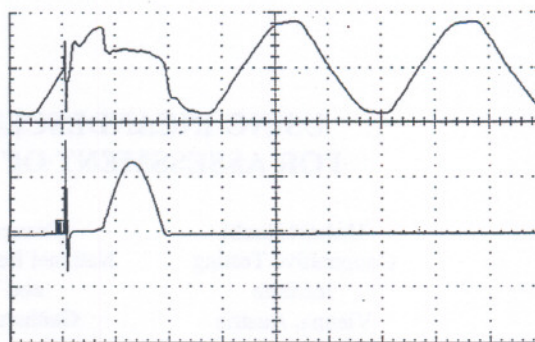
Top trace: Voltage across bulb terminals, 200 V/div
Bottom trace: Current in bulb, 100 A/div
Sweep: 5 ms/div

Figure 4: Voltage and current in bulb during application of a 1.2/50 - 8/20 μ s surge at 0°, with surge sparkover and delayed single-pulse power-frequency flashover

As further evidence, Figure 4 shows the process (in a new bulb) when the surge was applied at 0°, requiring more energy for ultimately igniting the power-frequency flashover. At zero degrees, there is the least power-frequency voltage to ignite a power arc. Figure 4 shows the last of a seven-shot sequence in which the first applied surge had an amplitude of 1200 V. The applied surge was then raised in 100-V steps to 1500 V, still with pinging heard but no fatal power-frequency arc. To explore the hypothesis that the filament might be burned out by the surge energy, we held the surge at 1500 V for the next three shots. Only the last of the three triggered the fatal flashover, recorded in Figure 4. At that level of energy deposited by the surge, enough plasma was generated in the path of the surge current to eventually ignite the power-frequency arc, but for that shot it had to wait until the power-frequency voltage had reached its peak, again indicating a threshold situation.

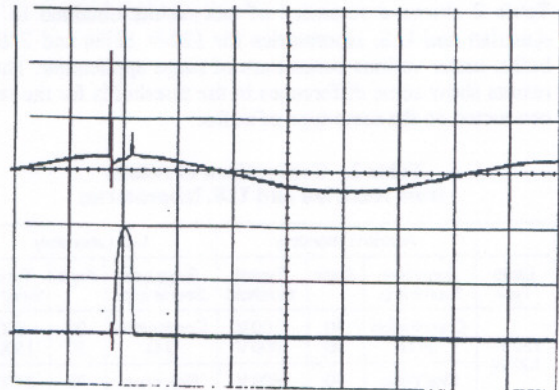
Top trace: Voltage across bulb terminals, 1000 V/div
Bottom trace: Current in bulb, 50 A/div
Sweep: 2.5 ms/div

Figure 5: Voltage and current in 230-V bulb during application of a 1.2/50 μ s - 8/20 μ s surge at 90°. Surge spark-over is followed immediately by power-frequency flashover

In Figure 5, a 230-V bulb shows the occurrence of a single-pulse of power-frequency flashover occurring immediately after the surge sparkover. Figures 6 and 7 show the occurrence of a delayed flashover with a single or double pulse, similar to the pattern for 120-V bulbs, respectively in Figures 4 and 3.

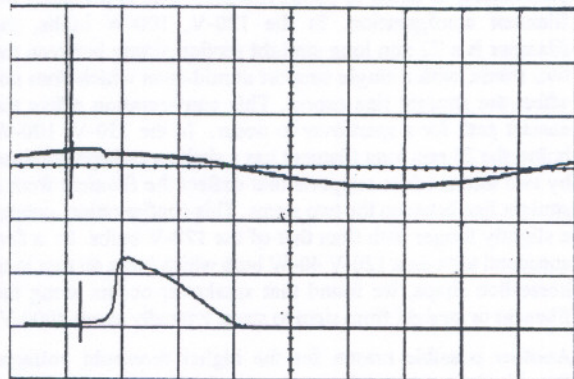
Top trace: Voltage across bulb terminals, 500 V/div
Bottom trace: Current in bulb, 50 A/div
Sweep: 2 ms/div

Figure 6: Voltage and current in 120-V bulb during application of a 1.2/50 μ s - 8/20 μ s surge at 90°. Surge spark-over and delayed one-pulse power-frequency flashover

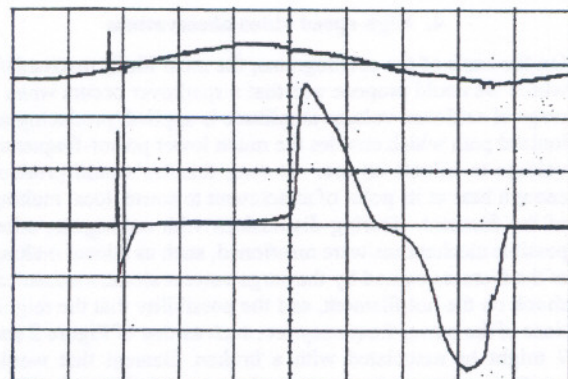
Top trace: Voltage across bulb terminals, 500 V/div
Bottom trace: Current in bulb, 20 A/div
Sweep: 2.5 ms/div

Figure 7: Voltage and current in 120-V bulb during application of a 1.2/50 μ s - 8/20 μ s surge at 350°. Surge spark-over and delayed two-pulse power-frequency flashover

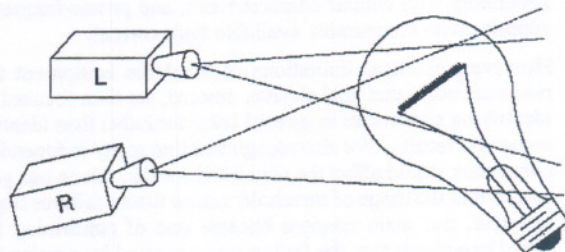
Figure 8: Arrangement of image converters to scan spark-over and flashover limited to the filament (L) and a full frame (R) including the base where the fuse is located

Figure 8 shows the arrangement of the two converters, with the left converter (L) controlled to perform four scans limited to the filament area, and the right (R) converter controlled to perform a full-frame view of the filament and fuse contained in the base stem of the bulb. The recording system was triggered by a signal from the surge generator, providing the beginning of the recording a few milliseconds before the surge, and lasting about 100 ms after the surge.

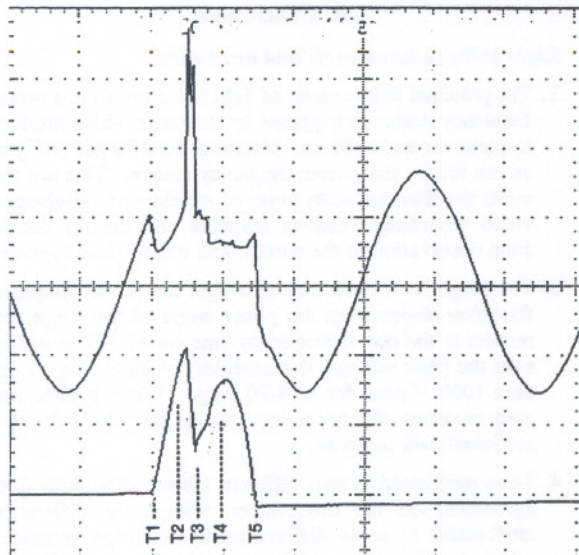
Top trace: Voltage across bulb terminal, 200 V/div
 Bottom trace: Current in bulb, 20 A/div
 Sweep: 5 ms/div

Figure 9: Failure of a 230-V, 100-W bulb triggered by a 100 kHz Ring Wave applied at 30°, showing fuse operation

With this arrangement, recordings such as those shown in Figure 9 and Figure 10 were obtained. As an example of many oscilloscope recordings, Figure 9 shows the electrical record of the failure of a 230-V, 100-W bulb triggered by a 100 kHz Ring Wave applied 60 electrical degrees after the zero crossing. At time T1, sparkover of the filament occurs, accompanied in this case by immediate flashover of the power frequency arc, which rises to a first peak at T2, about 2.3 ms after its beginning. At that time, the current is throttled while the voltage increases sharply, indicating operation of the fuse. The fuse does not force a current zero at time T3, but allows a second peak of current at time T4, before decaying to a natural current zero at time T5.

This type of oscilloscope recording was the only one that was available until the video system was obtained. From such oscillograms we could only draw speculative inferences on the mechanism and behaviour, hence the motivation to enhance our tests by video recording. Figure 9 shows the voltage across the lamp terminals (top trace) and the current through the lamp (bottom trace). With the sweep set to cover 2 cycles of the power frequency, neither the surge voltage nor the surge current are resolved in this oscillogram. In this test series performed after the preliminary series, a separate oscilloscope with faster sweep was used to record the surge voltage and the surge current, as was done in the case of Figure 1. To conserve space, these surge recordings are not shown here, but the peak values of the resulting sparkover voltages recorded by the second oscilloscope are listed in Table 2 in the column "Typical threshold".

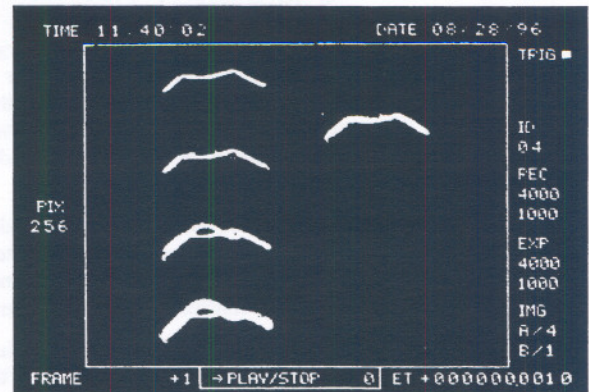
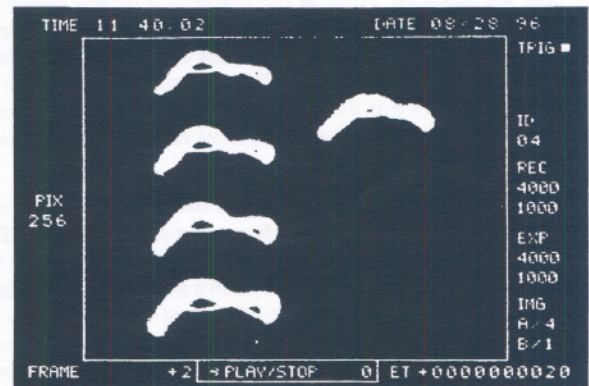
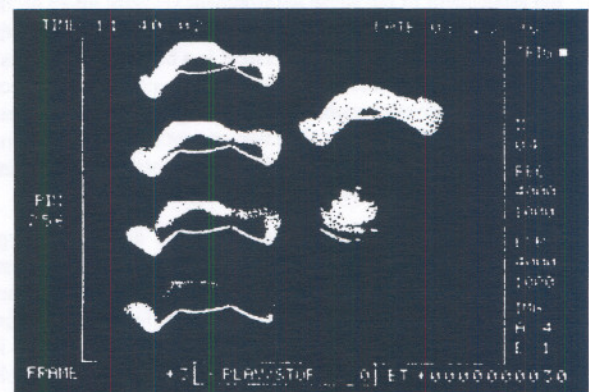
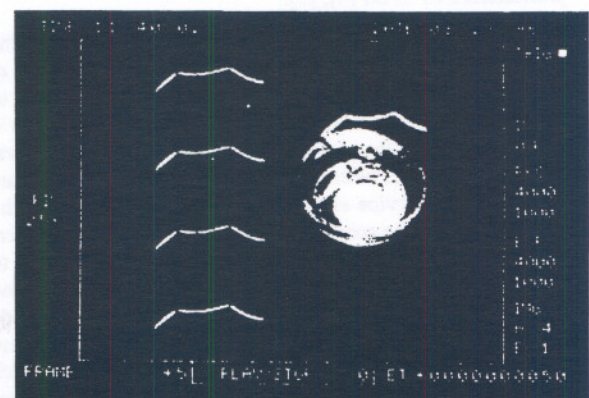
Figure 10: Sequence of flashover and fuse operation corresponding to the oscillogram of Figure 9

We now will examine in Figure 10, opposite page, four frames of video recording corresponding to the electrical record of Figure 9. The left half of the screen shows four scans from converter L of Figure 8, proceeding from top to bottom and each scanned in 250 μ s. The right side of the screen shows the full frame, scanned over a period of 1 ms. The timing of the frame is shown in the lower right corner of the picture, such as "ET + 000000010" which indicates the 1 ms window during which the surge was initiated. Other descriptive data in the margins are not significant to our story. Figure 10 shows the four frames respectively in the sequence from top to bottom for 0-1 ms; 1-2 ms; 2-3 ms; and 4-5 ms.

In the first frame, 0-1 ms, the Ring Wave sparkover is not visible because of its relatively low intensity/duration. The first 250- μ s scan (top) of the left side shows only the filament glow. Starting with the second scan, the beginning of the flashover (time T1 in Figure 9) is visible, while the right side scan, adjusted for less sensitivity, only shows the filament glow without the flashover beginning.

In the second frame, the flashover growth is visible on the four left scans (T1-T2 in Figure 9), while the right scan now has enough light integrated over the full 1 ms time to show the flashover.

In the third frame, the first two (top) left scans still show the flashover around the filament, but the last two (bottom) scans show the flashover current being starved as the fuse in the lamp base begins to operate and transfers the current to the space around the fuse. This corresponds to the time T2-T3 in Figure 9. The right side scan shows the beginning of the glow in the base of the lamp as the current around the fuse grows.

In the fourth frame, the four left scans show the filament still glowing, *but unchanged (not yet broken)*, while the right scan shows the integrated glow of the fuse operation, corresponding to the time interval T4-T5 of Figure 9.

These four frames, typical of many others recorded during our experiments, clearly show the mechanism of a flashover at the power-frequency current, and in this particular test sequence, the operation of the fuse in the base of the bulb. Other records taken with different light sensitivity show an intense glow near the connection of the filament, where the arc is concentrated at its point of attachment (the cathode hot spot) while the path around the filament is more diffuse. The concentrated heat near the point of attachment eventually causes a local melting of the filament. In other records, the filament is then seen separating from the stem and slowly falling in the time frame of about 20-50 ms after the flashover.
